NYC Department of Education
Building Condition Assessment Survey 2023 - 2024

Architectural Inspection

Asset: I.S. 14 - BROOKLYN, 2424 BATCHELDER STREET, New York, 11235

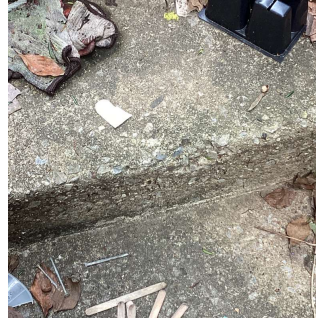
AW4

AREAWAY STAIRS: DETERIORATED TREADS/RISERS/NOSINGS

REPAIR

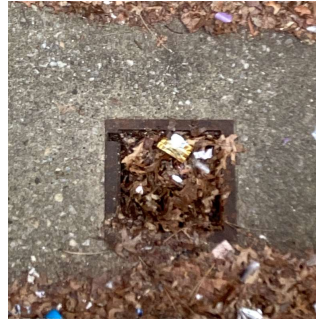
AW2

AREAWAY DRAINS: DETERIORATED

REPLACE

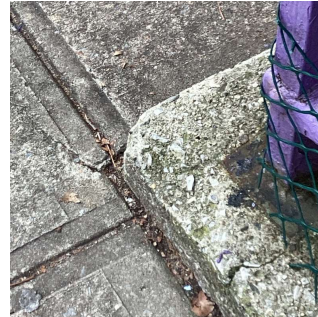
AW6

AREAWAY WALLS: CRACKS AND SPALLING

REPLACE

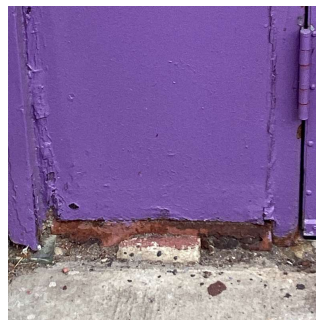
Facade G

METAL: DENTED, MAJOR RUSTING

REPLACE

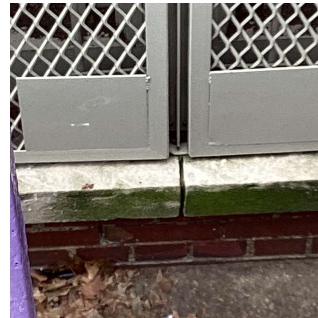
AW1

BRICK: MASONRY SILLS - DETERIORATED JOINTS

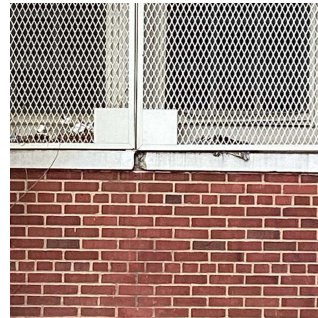
Facade D

BRICK: DETERIORATED MASONRY SILLS - MAJOR
K014

REMOVE AND REPLACE

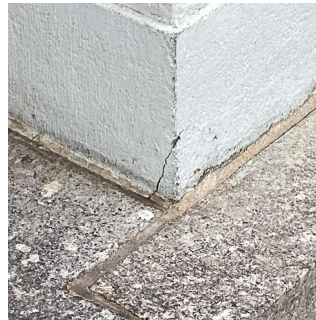
Facade A

STONE: CHIPPED/SPALLED/BROKEN PIECES - MINOR
K014

REPAIR

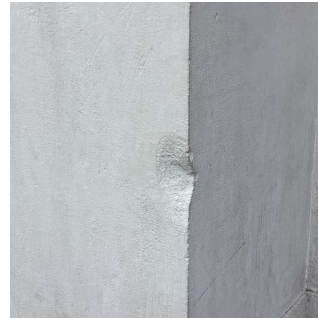
Facade A

STONE: CHIPPED/SPALLED/BROKEN PIECES - MAJOR

REPLACE

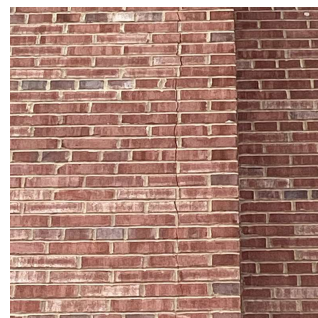
BRICK: CRACKS/DISPLACED/SPALLED BRICK AT BUILDING CORNERS

70
S.F.
REMOVE AND REBUILD
PRIORITY 4
LEVEL 2

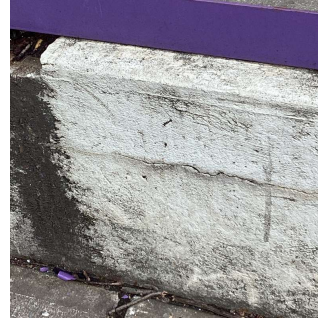
Facade G

CAST IN PLACE CONCRETE: CRACKS/SPALLING - MAJOR

REPLACE

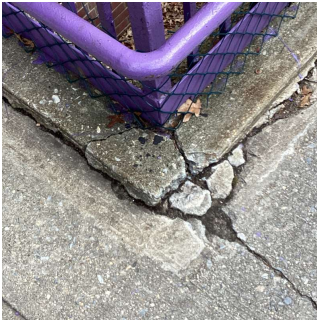
Question	Response
EXTERIOR	
STAIRS/RAMPS: EXTERIOR	
BUILDING CHEEK/FLANK WALLS	
Deficiency Photo1

Violations	Facade G No violations recorded.
RAILINGS	Inspected
Condition	2 - Between Good and Fair
Deficiency	No deficiencies recorded
STAIRS/RAMPS	Inspected
Condition	5 - Poor
Deficiency	STONE: CRACKS/SPALLING - MAJOR
Roof Plan reference	K014

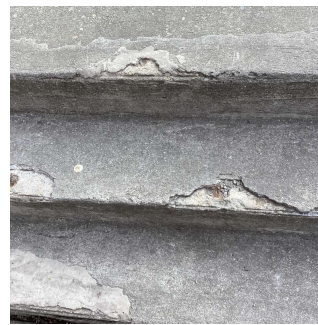
Facade G

CONCRETE: CRACKS/SPALLING - MAJOR

15
S.F.
REPLACE
PRIORITY 4
LEVEL 2

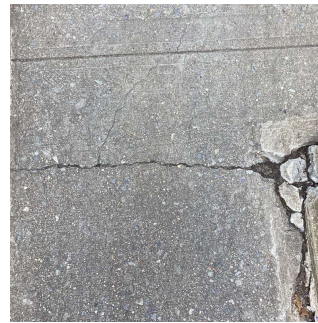
Facade G

STONE: DETERIORATED JOINTS

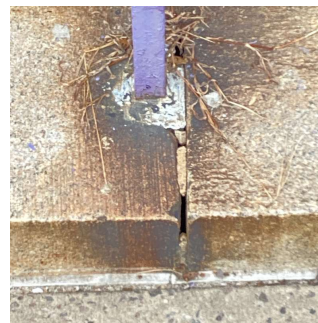
Facade B

DETERIORATED/TORN-OUT/MISSING

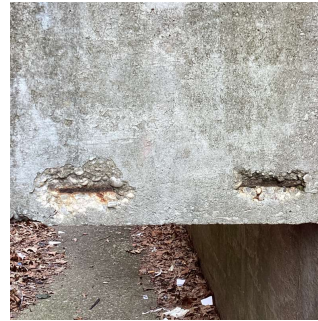
AW1

CONCRETE COLUMNS/BEAMS:
CRACKED/SPALLED/REINFORCEMENT EXPOSED

Areaway
10
S.F.
REPLACE
PRIORITY 4
LEVEL 5

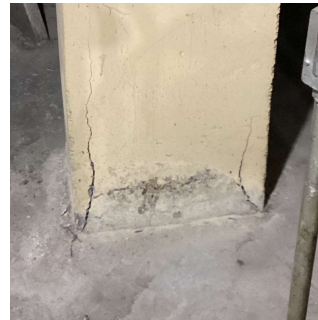
Room B9B (Boiler Room similar)

STEEL COLUMNS/BEAMS: DETERIORATED CONCRETE FIREPROOFING

REPLACE

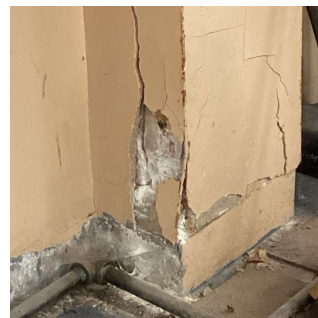
West Crawl Space (Room B1 similar)

STEEL COLUMNS/BEAMS: DETERIORATED CONCRETE FIREPROOFING

REPLACE

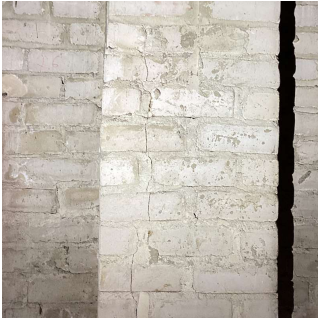
Question	Response
INTERIOR	
STRUCTURAL	
COLUMNS/BEAMS/BEARING WALLS	
Violations	No violations recorded.
Deficiency	STEEL COLUMNS/BEAMS: DETERIORATED MASONRY FIREPROOFING
Deficiency Location/Instance	Basement
Deficiency Quantity	100
Quantity Uom	S.F.
Potential Action	REPLACE
Urgency of Action	PRIORITY 3
Purpose of Action	LEVEL 5
Deficiency Photo1

East Crawl Space (West Crawl Space, Electrical Panel Room similar)
Violations	No violations recorded.
FLOOR STRUCTURE	
Condition	Inspected
Condition	3 - Fair
Deficiency	CONCRETE SLAB ON GRADE: THRU CRACKS
Deficiency Location/Instance	Basement
Deficiency Quantity	10
Quantity Uom	S.F.
Potential Action	REPLACE
Urgency of Action	PRIORITY 4
Purpose of Action	LEVEL 5
Deficiency Photo1	 
	Room B9B
Violations	No violations recorded.
Deficiency	CONCRETE: CRACKS/SPALLED/REINFORCEMENT EXPOSED
Deficiency Location/Instance	Basement
Deficiency Quantity	25
Quantity Uom	S.F.
Potential Action	REPAIR

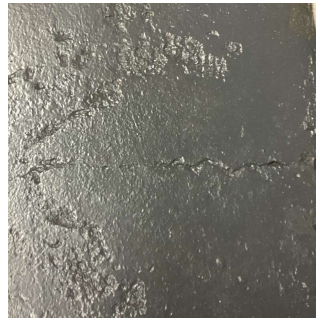
Room B28 (East Crawl Space, Boiler Room, Electrical Panel Room similar)

CONCRETE SLAB ON GRADE: THRU CRACKS

REPAIR

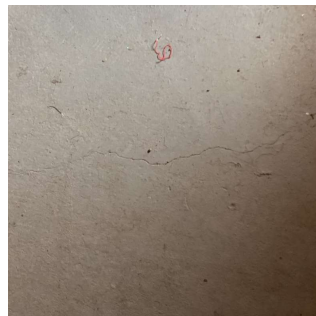
CONCRETE: CRACKS/SPALLED/REINFORCEMENT EXPOSED

REPAIR

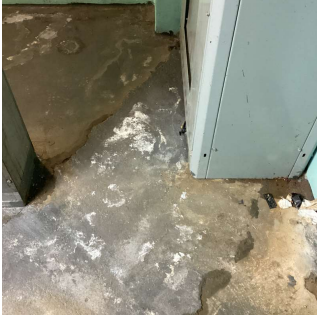
Question	Response
INTERIOR	
STRUCTURAL	
FLOOR STRUCTURE	Inspected
	BH3
Violations	No violations recorded.
FOUNDATION WALLS	Inspected
Material Type(s)	Concrete
Condition	4 - Between Fair and Poor
Deficiency	CONCRETE: WATER INFILTRATION IN ELECTRICAL PANEL ROOM
Deficiency Location/Instance	Electrical Panel Room
Deficiency Quantity	100
Quantity Uom	S.F.
Potential Action	INSTALL WATERPROOFING
Urgency of Action	PRIORITY 5
Purpose of Action	LEVEL 6
Deficiency Photo1

Electrical Panel Room
Violations	No violations recorded.
Deficiency	CONCRETE: CRACKED/SPALLED/REINFORCEMENT EXPOSED
Deficiency Location/Instance	Basement
Deficiency Quantity	20
Quantity Uom	S.F.
Potential Action	REPAIR
Urgency of Action	PRIORITY 4
Purpose of Action	LEVEL 5
Deficiency Photo1

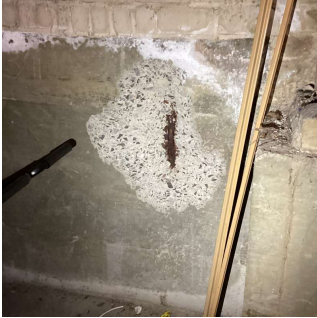
East Crawl Space
Violations	No violations recorded.
ROOF STRUCTURE	Inspected
Condition	3 - Fair
Deficiency	CONCRETE: CRACKED/SPALLED/REINFORCEMENT EXPOSED
Deficiency Location/Instance	PH

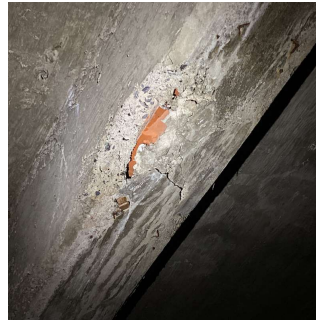
Tower
Violations	No violations recorded.
Deficiency	STEEL COLUMNS/BEAMS: DETERIORATED CONCRETE FIREPROOFING
Deficiency Location/Instance	PH
Deficiency Quantity	35
Quantity Uom	S.F.
Potential Action	REPLACE
Urgency of Action	PRIORITY 4
Purpose of Action	LEVEL 5

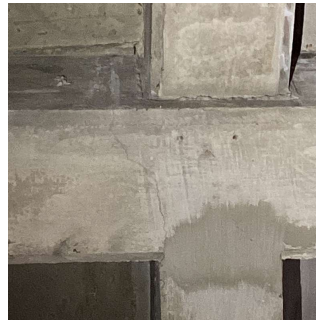
PH

STEEL COLUMNS/BEAMS: DETERIORATED CONCRETE FIREPROOFING

REPLACE

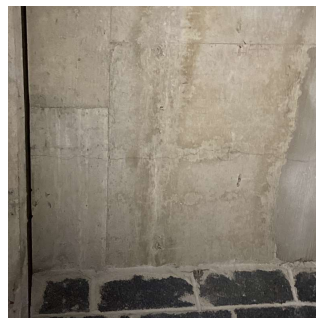
PH

CONCRETE: CRACKED/SPALLED/REINFORCEMENT EXPOSED

REPAIR

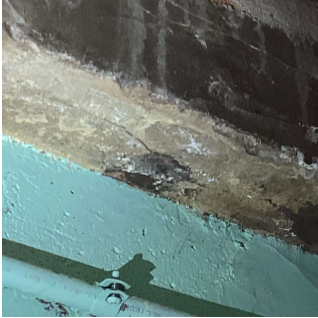
Question	Response
INTERIOR	
STRUCTURAL	
ROOF STRUCTURE	Inspected
Violations	No violations recorded.
VAULTS-BUNKERS	Inspected
Foundation Walls	Inspected
Condition	3 - Fair
Deficiency	WATER INFILTRATION IN NON- INSTRUCTIONAL SPACE
Deficiency Location/Instance	Vault
Deficiency Quantity	50
Quantity Uom	S.F.
Potential Action	INSTALL WATERPROOFING
Urgency of Action	PRIORITY 5
Purpose of Action	LEVEL 5
Deficiency Photo1	 
Violations	No violations recorded.
Slab Structure	Inspected
Condition	3 - Fair
Deficiency	STEEL COLUMNS/BEAMS: MAJOR RUSTING
Deficiency Location/Instance	Vault
Deficiency Quantity	20
Quantity Uom	S.F.
Potential Action	REPLACE
Urgency of Action	PRIORITY 4
Purpose of Action	LEVEL 5
Deficiency Photo1	 
Violations	No violations recorded.
Deficiency	STEEL COLUMNS/BEAMS: DETERIORATED CONCRETE FIREPROOFING
Deficiency Location/Instance	Vault
Deficiency Quantity	10
Quantity Uom	S.F.

Question	Response
INTERIOR	
STRUCTURAL	
VAULTS-BUNKERS	Inspected
Slab Structure	
Potential Action	REPAIR
Urgency of Action	PRIORITY 3
Purpose of Action	LEVEL 5
Deficiency Photo1

Violations	Vault No violations recorded.
Vault/Ash Hoist Doors and Framing	Inspected
Condition	2 - Between Good and Fair
Deficiency	No deficiencies recorded
AUDITORIUM	Inspected
Instance on 1st Floor (650 Seats)	Inspected
Ceiling	
Instance on 1st Floor (650 Seats)	Inspected
Condition	2 - Between Good and Fair
Deficiency	No deficiencies recorded
Door(s)	
Instance on 1st Floor (650 Seats)	Inspected
Condition	2 - Between Good and Fair
Deficiency	No deficiencies recorded
Fixed H/C Lift	
Instance on 1st Floor (650 Seats)	Does not Exist
Fixed Seating	
Instance on 1st Floor (650 Seats)	Inspected
Condition	5 - Poor
Deficiency	DAMAGED/BROKEN/INOPERABLE
Deficiency Location/Instance	Seats B/105, 10, E/12, 10, L/10, U/6
Deficiency Quantity	6
Quantity Uom	EACH

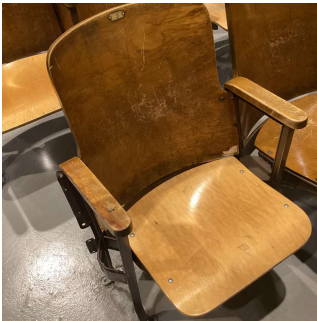
Violations	Seat B/105 No violations recorded.
Deficiency	IMPROPERLY ANCHORED
Deficiency Location/Instance	Seat D/1
Deficiency Quantity	1
Quantity Uom	EACH
Potential Action	MAINTENANCE
Urgency of Action	PRIORITY 5
Purpose of Action	LEVEL 6
Deficiency Photo1	No photo recorded
Violations	No violations recorded.
Deficiency	DAMAGED/BROKEN/INOPERABLE
Deficiency Location/Instance	Seat A/10,114,B/105,106 E/3 and others
Deficiency Quantity	80
Quantity Uom	EACH
Potential Action	REPLACE
Urgency of Action	PRIORITY 3
Purpose of Action	LEVEL 2
Deficiency Photo1

Violations	Seat E/3 No violations recorded.
Floor Finish	
Instance on 1st Floor (650 Seats)	Inspected
Condition	2 - Between Good and Fair
Deficiency	No deficiencies recorded
Sliding-folding Partition	
Instance on 1st Floor (650 Seats)	Does not Exist
Stage	
Instance on 1st Floor (650 Seats)	Inspected

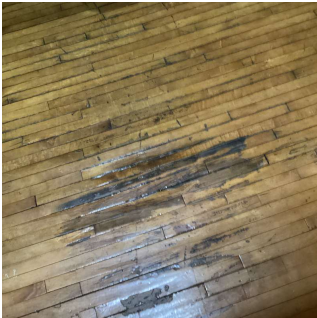
Question	Response
INTERIOR	
AUDITORIUM	
Stage	
Stage	Inspected
Instance on 1st Floor (650 Seats)	Inspected
Condition	3 - Fair
Deficiency	DAMAGED FLOOR
Deficiency Location/Instance	Center, Right Side
Deficiency Quantity	30
Quantity Uom	S.F.
Potential Action	REPLACE
Urgency of Action	PRIORITY 3
Purpose of Action	LEVEL 2
Deficiency Photo1

Center	
Violations	No violations recorded.
Stage Curtain Rigging	Inspected
Instance on 1st Floor (650 Seats)	Inspected
Condition	2 - Between Good and Fair
Deficiency	No deficiencies recorded
Stage Curtains	Inspected
Instance on 1st Floor (650 Seats)	Inspected
Condition	3 - Fair
Deficiency	WORN/DETERIORATED
Deficiency Location/Instance	Right Side
Deficiency Quantity	100
Quantity Uom	S.F.
Potential Action	REPLACE
Urgency of Action	PRIORITY 3
Purpose of Action	LEVEL 2
Deficiency Photo1

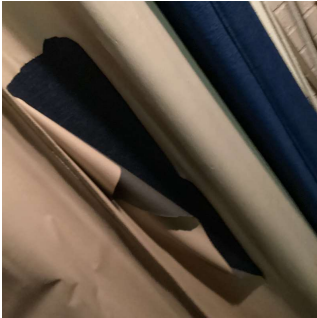
Right Side	
Violations	No violations recorded.
Walls

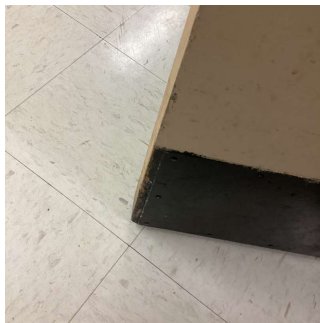
Question	Response
INTERIOR	
AUDITORIUM	
Walls	
Instance on 1st Floor (650 Seats)	Inspected
Condition	2 - Between Good and Fair
Deficiency	No deficiencies recorded
Window Curtains/Shades/Blinds	
Instance on 1st Floor (650 Seats)	Inspected
Condition	2 - Between Good and Fair
Deficiency	No deficiencies recorded
CAFETERIA	
Instance on Basement - Staff (600 SF)	Inspected
Instance on Basement - Student	Inspected
Ceiling	
Instance on Basement - Student	Inspected
Condition	2 - Between Good and Fair
Deficiency	No deficiencies recorded
Instance on Basement - Staff (600 SF)	Inspected
Condition	2 - Between Good and Fair
Deficiency	No deficiencies recorded
Door(s)	
Instance on Basement - Student	Inspected
Condition	5 - Poor
Deficiency	WOOD: DETERIORATED DOOR
Deficiency Location/Instance	Entrance (4 Doors)
Deficiency Quantity	4
Quantity Uom	EACH
Potential Action	MAINTENANCE
Urgency of Action	PRIORITY 3
Purpose of Action	LEVEL 2
Deficiency Photo1

Entrance	
Violations	No violations recorded.
Fixed Equipment	
Instance on Basement - Student	Does not Exist
Instance on Basement - Staff (600 SF)	Does not Exist
Floor Finish	
Instance on Basement - Student	Inspected
Condition	5 - Poor
Deficiency	VINYL TILES: BROKEN/DETERIORATED/MISSING TILES
Deficiency Location/Instance	Near Exit 9, Rear
Deficiency Quantity	2,000

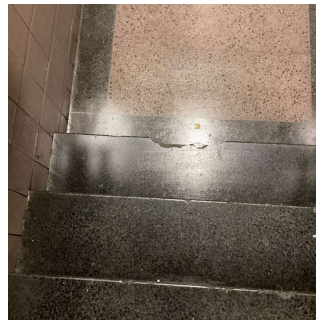
Exit 7

STONE: BROKEN/MISSING TILES

REPLACE

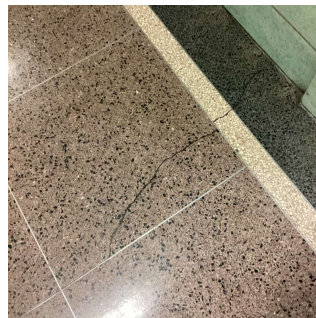
TERRAZZO: CRACKS

Question	Response
INTERIOR	
CLASSROOMS/CORRIDORS/ADMIN SPACES	
Floor Finish	
Violations	Corridor near Auditorium No violations recorded.
Deficiency	VINYL TILES: DETERIORATED SUBSTRATE
Deficiency Location/Instance	Corridor near room 332A, B28, B19B, B10,near student Cafeteria, and others
Deficiency Quantity	250
Quantity Uom	S.F.
Potential Action	REPLACE
Urgency of Action	PRIORITY 3
Purpose of Action	LEVEL 2
Deficiency Photo1

REPLACE

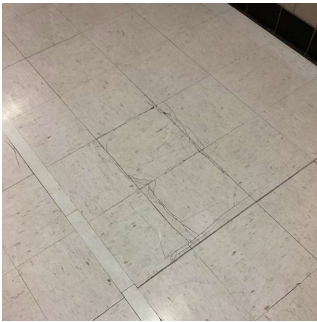
Violations	Corridor near room 332A No violations recorded.
Deficiency	VINYL TILES: BROKEN/DETERIORATED/MISSING TILES
Deficiency Location/Instance	Room 316, 328B,313,226, B28 and others
Deficiency Quantity	2,300
Quantity Uom	S.F.
Potential Action	REPLACE
Urgency of Action	PRIORITY 3
Purpose of Action	LEVEL 2
Deficiency Photo1

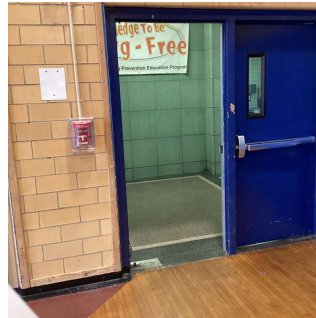
Rear Entrance

METAL: MISSING DOOR

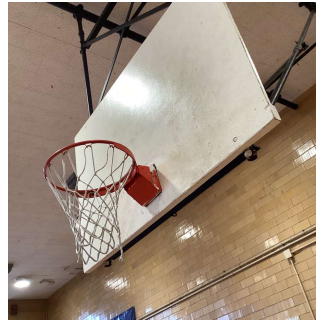
Rear

Instance on 1st Floor	Inspected
Condition	5 - Poor
Deficiency	DAMAGED/MISSING
Deficiency Location/Instance	Rear, Front
Deficiency Quantity	2
Quantity Uom	EACH
Potential Action	REPLACE
Urgency of Action	PRIORITY 3
Purpose of Action	LEVEL 2

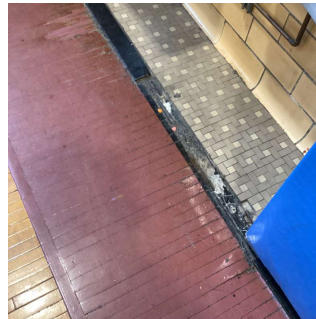
Instance on 1st Floor	Inspected
Condition	2 - Between Good and Fair
Deficiency	WOOD: DAMAGED/DETERIORATED
Deficiency Location/Instance	Near Drink Fountain
Deficiency Quantity	15
Quantity Uom	S.F.
Potential Action	REPLACE
Urgency of Action	PRIORITY 3
Purpose of Action	LEVEL 2
Deficiency Photo1

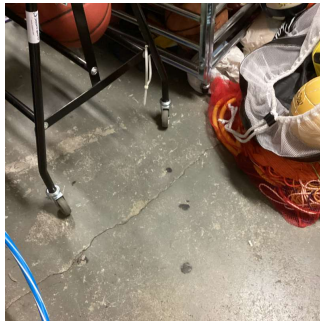
Deficiency	CONCRETE: CRACKS
Deficiency Location/Instance	Storage
Deficiency Quantity	20
Quantity Uom	S.F.
Potential Action	REPLACE
Urgency of Action	PRIORITY 3
Purpose of Action	LEVEL 2

Violations	Storage No violations recorded.
Seating	
Instance on 1st Floor	Does not Exist
Sliding-folding Partition	
Instance on 1st Floor	Inspected
Condition	3 - Fair
Deficiency	MOVABLE PANELS: DAMAGED
Deficiency Location/Instance	Center
Deficiency Quantity	80
Quantity Uom	S.F.
Potential Action	REPLACE
Urgency of Action	PRIORITY 3
Purpose of Action	LEVEL 2
Deficiency Photo1

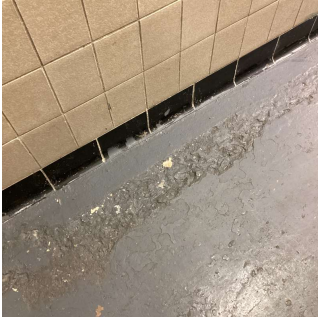
Instance on Basement	Inspected
Condition	3 - Fair
Deficiency	CONCRETE: CRACKS
Deficiency Location/Instance	Near room B18, Storage
Deficiency Quantity	40
Quantity Uom	S.F.
Potential Action	REPLACE
Urgency of Action	PRIORITY 3
Purpose of Action	LEVEL 2
Deficiency Photo1

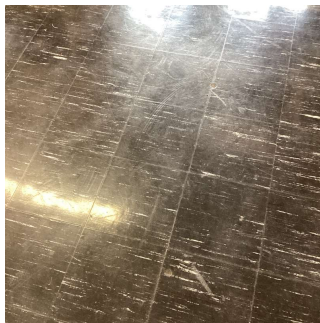
Question	Response
INTERIOR	
LIBRARY	Inspected
Floor Finish	
Deficiency Photo1

Center
Violations	No violations recorded.
Walls	
Instance on Room 320	Inspected
Condition	2 - Between Good and Fair
Deficiency	No deficiencies recorded
LOCKER ROOM	Does not Exist
MULTI-PURPOSE ROOM	Does not Exist
SCIENCE DEMO ROOM	Inspected
Instance on Room 202	Inspected
Alternative use	No
Instance on Rooms 200, 201,203,300,301,303	Inspected
Alternative use	Yes
Fixed Equipment	
Instance on Room 202	Inspected
Condition	5 - Poor
Deficiency	DEMO TABLE: DAMAGED/DETERIORATED
Deficiency Location/Instance	Room 202
Deficiency Quantity	1
Quantity Uom	EACH
Potential Action	REPLACE
Urgency of Action	PRIORITY 3
Purpose of Action	LEVEL 2
Deficiency Photo1	 
	Room 202
Violations	No violations recorded.
SCIENCE LAB	Does not Exist
SCIENCE PREP ROOM	Inspected
Instance on Room 301A	Inspected
Alternative use	Yes

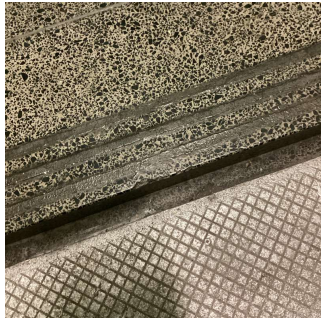
Question	Response
INTERIOR	
SCIENCE PREP ROOM	
Fixed Equipment	
Instance on Room 301A	Inspected
Condition	2 - Between Good and Fair
Deficiency	No deficiencies recorded
SHOWER ROOM	
	Does not Exist
STAIRS/RAMPS: INTERIOR	
Do Letter Stair Signs Exist?	Inspected
	Yes
Ceiling	
Condition	Inspected
	2 - Between Good and Fair
Deficiency	No deficiencies recorded
Door(s)	
Condition	Inspected
	2 - Between Good and Fair
Deficiency	No deficiencies recorded
Partition	
	Does not Exist
Railings	
Condition	Inspected
	2 - Between Good and Fair
Deficiency	No deficiencies recorded
Stairs and Landings	
Condition	Inspected
	3 - Fair
Deficiency	STONE: BROKEN/MISSING
Deficiency Location/Instance	Exit 1/2
Deficiency Quantity	10
Quantity Uom	S.F.
Potential Action	REPLACE
Urgency of Action	PRIORITY 3
Purpose of Action	LEVEL 2
Deficiency Photo1

Exit 1/2
Violations	No violations recorded.
Deficiency	
Deficiency	TERRAZZO: CRACKS
Deficiency Location/Instance	Exit/4

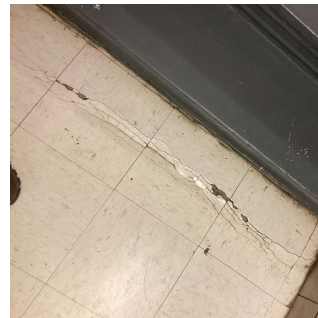
Stair B/Basement

VINYL TILES: DETERIORATED SUBSTRATE

REPLACE

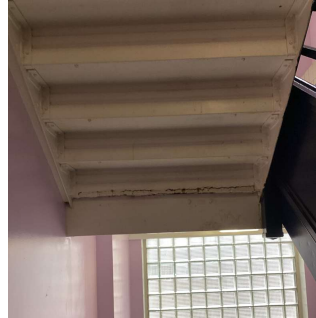
Stair C/2

Deficiency	METAL: RUST - MAJOR
Deficiency Location/Instance	Stairs C/2, E/3,
Deficiency Quantity	10
Quantity Uom	S.F.
Potential Action	REPLACE
Urgency of Action	PRIORITY 3
Purpose of Action	LEVEL 2
Deficiency Photo1

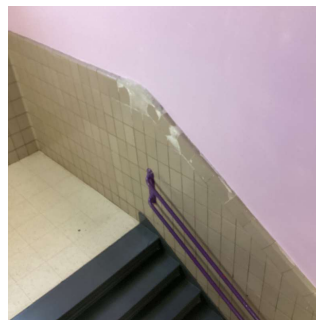
Condition	2 - Between Good and Fair
Deficiency	GLAZED BLOCK: CRACKS/SPALLING
Deficiency Location/Instance	Stair B/2
Deficiency Quantity	15
Quantity Uom	S.F.
Potential Action	REPLACE
Urgency of Action	PRIORITY 3
Purpose of Action	LEVEL 2
Deficiency Photo1

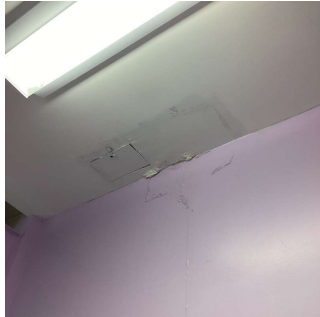
Condition	2 - Between Good and Fair
Deficiency	GYPSUM BOARD: DAMAGED/DETERIORATED
Deficiency Location/Instance	Kitchen Staff Women
Deficiency Quantity	10
Quantity Uom	S.F.
Potential Action	REPLACE
Urgency of Action	PRIORITY 3

Kitchen Staff Women
Violations	No violations recorded.
Door(s)	
Condition	Inspected
Deficiency	5 - Poor
Deficiency Location/Instance	METAL: DETERIORATED DOOR
Deficiency Quantity	Room 102
Quantity Uom	1
Potential Action	EACH
Urgency of Action	MAINTENANCE
Purpose of Action	PRIORITY 3
Deficiency Photo1	LEVEL 2

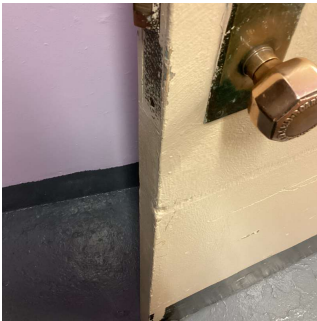
Violations	Room 102 No violations recorded.
Deficiency	WOOD: DETERIORATED DOOR
Deficiency Location/Instance	Kitchen Staff Women, Room 104B, Nurse
Deficiency Quantity	3
Quantity Uom	EACH
Potential Action	MAINTENANCE
Urgency of Action	PRIORITY 3
Purpose of Action	LEVEL 2

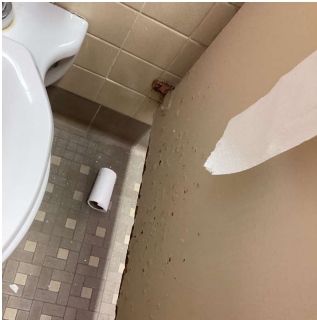
Violations	Kitchen Staff Women No violations recorded.
Floor Finish	Inspected
Condition	2 - Between Good and Fair
Deficiency	No deficiencies recorded
Stalls	Inspected
Condition	5 - Poor
Deficiency	RUST - MAJOR
Deficiency Location/Instance	Kitchen Staff Women, Kitchen Staff Men's, Room 102
Deficiency Quantity	3
Quantity Uom	EACH
Potential Action	REPLACE
Urgency of Action	PRIORITY 3
Purpose of Action	LEVEL 2
Deficiency Photo1

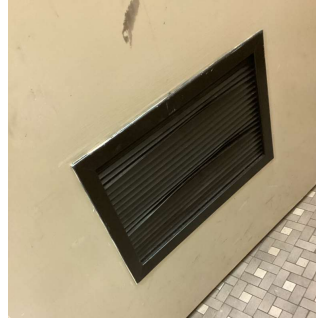
Room B12

Violations	Kitchen Staff Women No violations recorded.
Walls	Inspected
Condition	2 - Between Good and Fair
Deficiency	No deficiencies recorded
TOILET ROOMS - STUDENTS	
Ceiling	Inspected
Condition	2 - Between Good and Fair
Deficiency	No deficiencies recorded
Door(s)	Inspected
Condition	5 - Poor
Deficiency	METAL: DAMAGED LOUVER
Deficiency Location/Instance	Rooms 308, B12
Deficiency Quantity	2
Quantity Uom	EACH

Potential Action	MAINTENANCE
Urgency of Action	PRIORITY 3
Purpose of Action	LEVEL 2
Deficiency Photo1

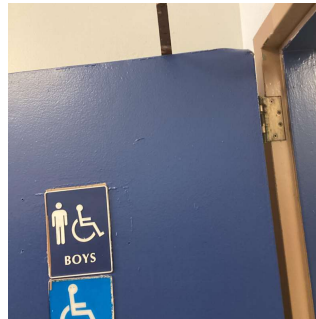
Deficiency	METAL: DETERIORATED DOOR
Deficiency Location/Instance	Room 330
Deficiency Quantity	1
Quantity Uom	EACH
Potential Action	MAINTENANCE
Urgency of Action	PRIORITY 3
Purpose of Action	LEVEL 2
Deficiency Photo1

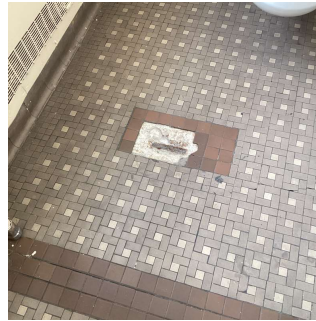
Room 308

Deficiency	CERAMIC TILE: BROKEN/MISSING TILES
Deficiency Location/Instance	Room 308, 3rd Floor Girls,B26, B12
Deficiency Quantity	40
Quantity Uom	S.F.
Potential Action	REPLACE
Urgency of Action	PRIORITY 3
Purpose of Action	LEVEL 2

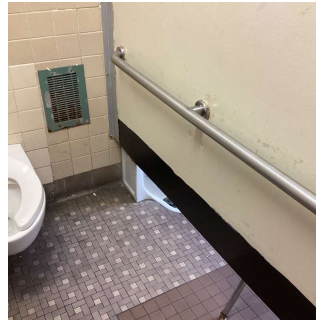
Room 330

RUST - MAJOR

REPLACE

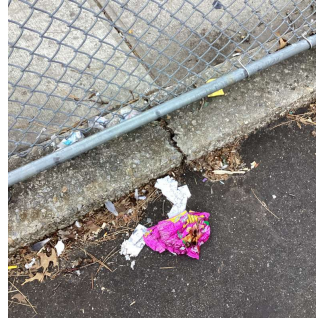
Brown Street

Question	Response
SITE	
Drainage System for Concrete	
Catch Basins/Manhole - Surrounded by concrete	
Deficiency Location/Instance	Walkway near schoolyard
Deficiency Quantity	2
Quantity Uom	EACH
Potential Action	MAINTENANCE
Urgency of Action	PRIORITY 3
Purpose of Action	LEVEL 2
Deficiency Photo1	 
Violations	Walkway near schoolyard No violations recorded.
Culverts - Concrete Covering	
	Does not Exist
Drainage System for Soil	
	Does not Exist
DRINKING FOUNTAINS	
	Does not Exist
FENCES	
Condition	Inspected 3 - Fair
Deficiency	WROUGHT IRON: DAMAGED/DETERIORATED
Deficiency Location/Instance	Brown Street, Avenue X, Batchelder Street
Deficiency Quantity	240
Quantity Uom	S.F.
Potential Action	REPLACE
Urgency of Action	PRIORITY 3
Purpose of Action	LEVEL 2
Deficiency Photo1	 
Violations	Avenue X No violations recorded.
Deficiency	CONCRETE CURB: DAMAGED/DETERIORATED
Deficiency Location/Instance	Brown Street, Avenue X, Batchelder Street

Deficiency Quantity	50
Quantity Uom	S.F.
Potential Action	REPLACE
Urgency of Action	PRIORITY 3
Purpose of Action	LEVEL 2

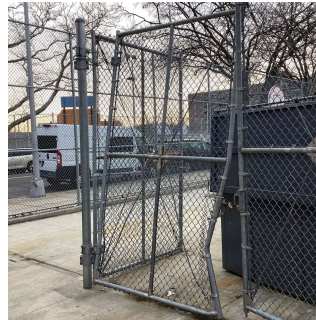
Near Exit 7

CHAIN LINK: DAMAGED/DETERIORATED

REPLACE

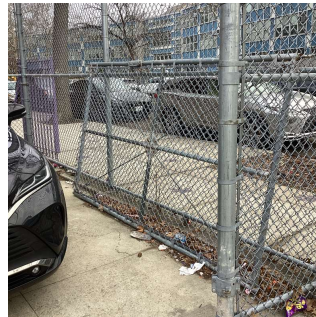
Near Exit 7

CHAIN LINK: MISSING SECTIONS

REPLACE

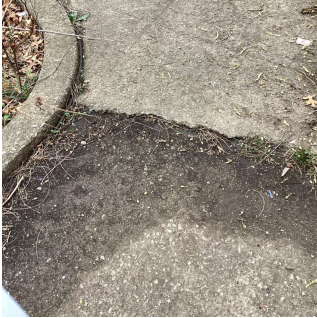
Question	Response
SITE	
IRRIGATION SYSTEM	Does not Exist
PAVING	Inspected
Student Non-Use	Inspected
Gravel Exists?	No
Asphalt	Does not Exist
Concrete	Inspected
Condition	3 - Fair
Deficiency	HEAVING
Deficiency Location/Instance	Courtyard on Avenue X
Deficiency Quantity	25
Quantity Uom	S.F.
Potential Action	REPLACE
Urgency of Action	PRIORITY 3
Purpose of Action	LEVEL 2
Deficiency Photo1

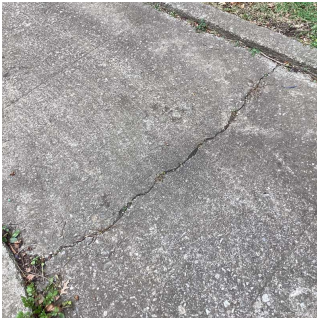
Courtyard on Avenue X
Violations	No violations recorded.
Deficiency	CRACKS - MAJOR
Deficiency Location/Instance	Courtyard on Avenue X
Deficiency Quantity	100
Quantity Uom	S.F.
Potential Action	REPLACE
Urgency of Action	PRIORITY 3
Purpose of Action	LEVEL 2
Deficiency Photo1

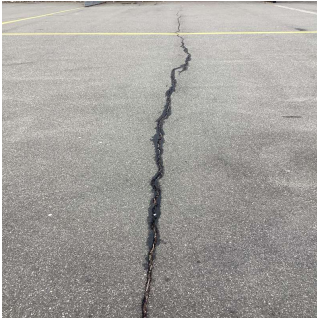
Courtyard on Avenue X
Violations	No violations recorded.
Pavers	Does not Exist
Student Use	Inspected
Gravel Exists?	Yes
Asphalt	Inspected
Condition	4 - Between Fair and Poor
Deficiency	CRACKS - MAJOR

Question	Response
SITE	
PAVING	Inspected
Student Use	
Asphalt	
Deficiency Location/Instance	Schoolyard
Deficiency Quantity	800
Quantity Uom	S.F.
Potential Action	REPLACE
Urgency of Action	PRIORITY 3
Purpose of Action	LEVEL 2
Deficiency Photo1

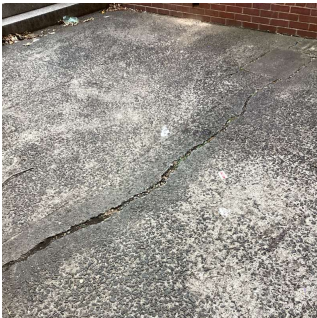
Violations	Schoolyard No violations recorded.
Concrete	Inspected
Condition	4 - Between Fair and Poor
Deficiency	CRACKS - MAJOR
Deficiency Location/Instance	Rear Courtyard
Deficiency Quantity	500
Quantity Uom	S.F.
Potential Action	REPLACE
Urgency of Action	PRIORITY 3
Purpose of Action	LEVEL 2
Deficiency Photo1

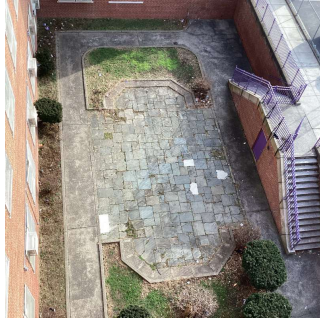
Violations	Rear Courtyard No violations recorded.
Pavers	Inspected
Condition	3 - Fair
Deficiency	DAMAGED/MISSING
Deficiency Location/Instance	Rear Courtyard
Deficiency Quantity	250
Quantity Uom	S.F.
Potential Action	REPLACE
Urgency of Action	PRIORITY 3
Purpose of Action	LEVEL 2

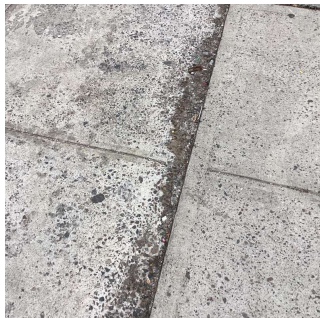
Violations	Rear Courtyard No violations recorded.
Site Sidewalks & Walkways	Inspected
Asphalt	Does not Exist
Concrete	Inspected
Condition	3 - Fair
Deficiency	CRACKS - MAJOR
Deficiency Location/Instance	Walkway near schoolyard
Deficiency Quantity	50
Quantity Uom	S.F.
Potential Action	REPLACE
Urgency of Action	PRIORITY 3
Purpose of Action	LEVEL 2
Deficiency Photo1

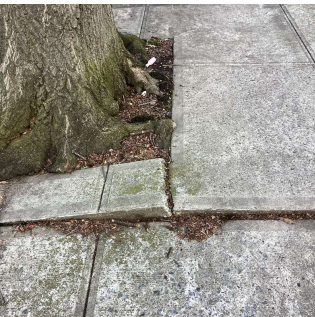
Violations	Walkway near schoolyard No violations recorded.
Pavers	Does not Exist
DOT Sidewalk	Inspected
Asphalt	Does not Exist
Concrete	Inspected
Condition	4 - Between Fair and Poor
Deficiency	HEAVING
Deficiency Location/Instance	Brown Street, Avenue X, Batchelder Street
Deficiency Quantity	250
Quantity Uom	S.F.
Potential Action	REPLACE
Urgency of Action	PRIORITY 3
Purpose of Action	LEVEL 2

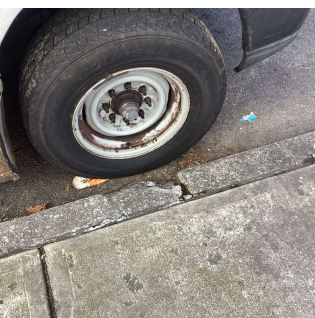
Brown Street No violations recorded.
Deficiency Deficiency Location/Instance Deficiency Quantity Quantity Uom Potential Action Urgency of Action Purpose of Action Deficiency Photo1 Violations	DAMAGED CURBS Brown Street, Avenue X, Batchelder Street 160 L.F. REPLACE PRIORITY 3 LEVEL 2

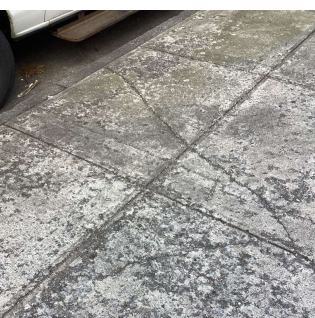
Brown Street No violations recorded.
Deficiency Deficiency Location/Instance Deficiency Quantity Quantity Uom Potential Action Urgency of Action Purpose of Action Deficiency Photo1	DAMAGED/DETERIORATED/MISSING SECTIONS Brown Street, Avenue X, Batchelder Street 2,100 S.F. REPLACE PRIORITY 3 LEVEL 2
