NYC Department of Education
Building Condition Assessment Survey 2023 - 2024

Architectural Inspection

Asset: **I.S. 62 - BROOKLYN, 700 CORTELYOU ROAD, New York, 11218**

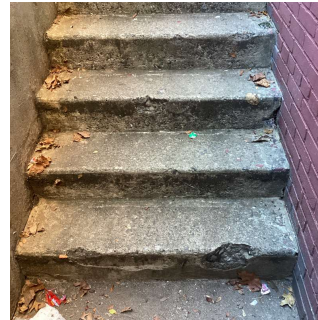
AW9

AREAWAY STAIRS: DETERIORATED
TREADS/RISERS/NOSINGS

REPLACE

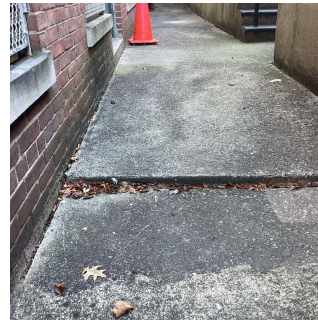
AW4

AREAWAY SLAB: CRACKS AND SPALLING

REPLACE

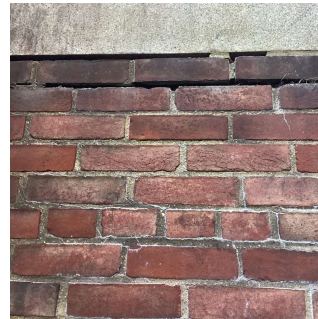
AW4

AREAWAY WALLS: CRACKS AND SPALLING

REPLACE

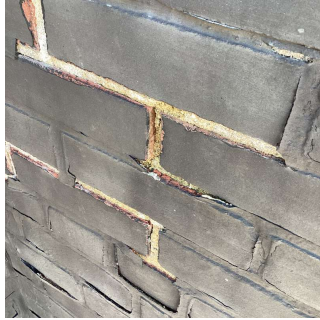
Violations	CH No violations recorded.
Deficiency	BRICK: DETERIORATED JOINTS
Roof Plan reference	K062

Deficiency Quantity	60
Quantity Uom	S.F.
Potential Action	REPOINT
Urgency of Action	PRIORITY 3
Purpose of Action	LEVEL 2
Deficiency Photo1

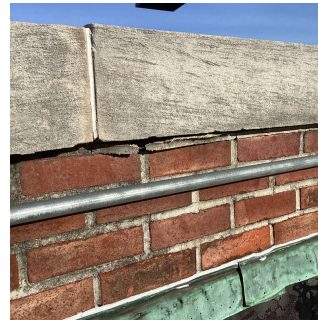
Roof 1

CAST STONE: DETERIORATED TRANSVERSE JOINTS

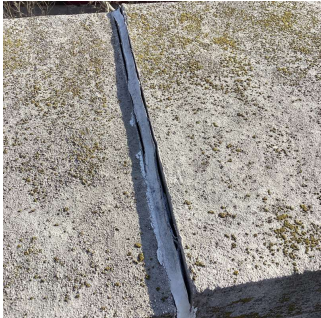
Violations	Roof 1 No violations recorded.
Deficiency	CAST STONE: CRACKED/BROKEN PIECES
Roof Plan reference	K062

Deficiency Quantity	60
Quantity Uom	L.F.
Potential Action	REPLACE-IN-KIND
Urgency of Action	PRIORITY 4
Purpose of Action	LEVEL 2
Deficiency Photo1

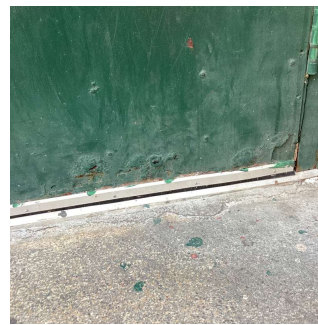
Facade C

METAL: DETERIORATED DOOR - MAJOR DETERIORATION

REPLACE

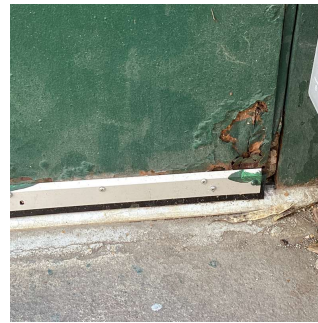
Facade G

METAL: DETERIORATED DOOR AND FRAME - MAJOR DETERIORATION

REPLACE

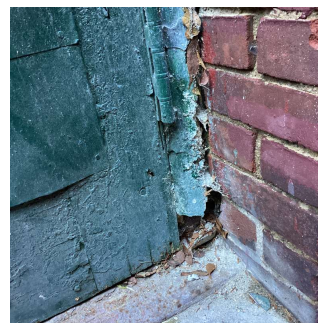
Facade H

METAL: DETERIORATED DOOR AND FRAME - MINOR DETERIORATION

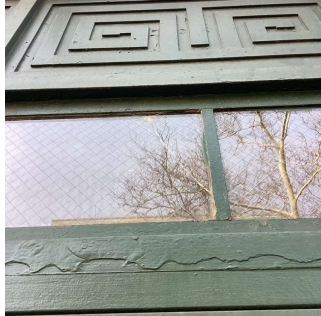
Violations	<p>Facade C</p> <p>No violations recorded.</p>
Deficiency	METAL: DENTED, MAJOR RUSTING
Roof Plan reference	<p>K062</p>

Deficiency Quantity	60
Quantity Uom	S.F.
Potential Action	REPLACE
Urgency of Action	PRIORITY 4
Purpose of Action	LEVEL 2
Deficiency Photo1

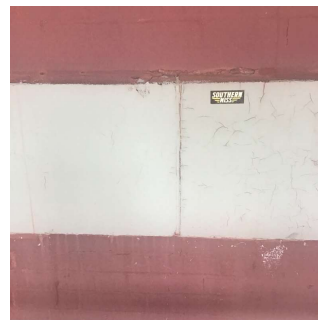
Facade H

BRICK: DETERIORATED JOINTS

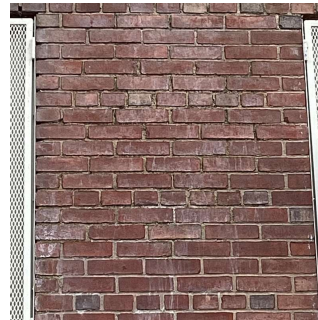
Facade B

STONE: CHIPPED/SPALLED/BROKEN PIECES - MAJOR

REPLACE

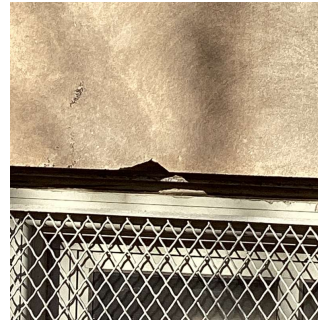
Facade H

BRICK: MINOR CRACKS AND SPALLING

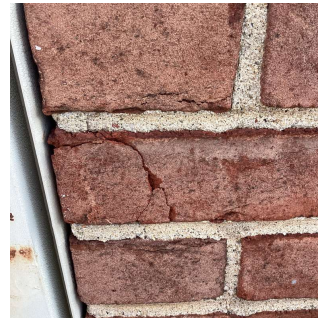
Facade A

BRICK: DETERIORATED MASONRY SILLS - MAJOR

REMOVE AND REPLACE

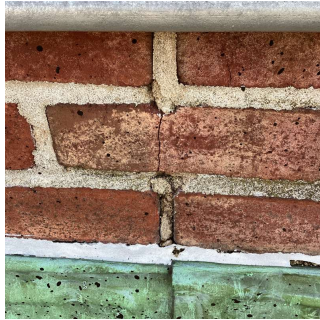
Violations	Roof 1 No violations recorded.
Deficiency	CONCRETE: MAJOR DETERIORATION/CRACKS
Roof Plan reference	<p>K062</p>

Deficiency Quantity	10
Quantity Uom	S.F.
Potential Action	REMOVE AND REBUILD
Urgency of Action	PRIORITY 4
Purpose of Action	LEVEL 2
Deficiency Photo1

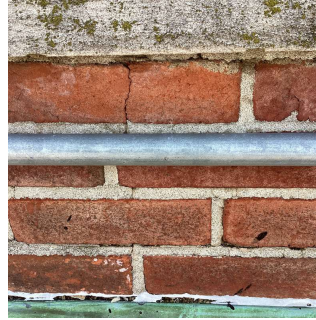
Roof 1

BRICK: MAJOR DETERIORATION/CRACKS

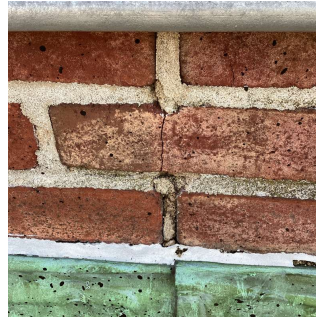
Roof 1

BRICK: DETERIORATED JOINTS

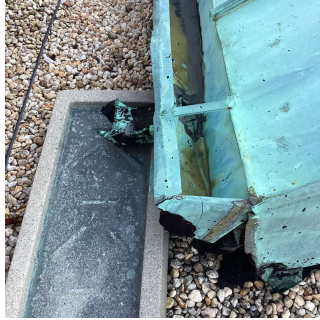
DAMAGED/MISSING

Question	Response
EXTERIOR	
ROOF	
Roofing	
LEADERS, GUTTERS, DOWNSPOUTS, SCUPPERS	
Urgency of Action	PRIORITY 4
Purpose of Action	LEVEL 2
Deficiency Photo1

REPLACE

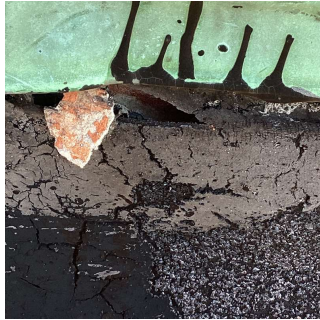
Roof 1
Instance Quantity	31,500
Instance Quantity Uom	S.F.
Does the roof have major mechanical equipment sitting on Dunnage Steel less than 18" above the Roofing?	No
Does this roof instance have a Sustainable Roof System?	No
Do solar panels exist on these roofs?	No
Is/Are the roof(s) suitable for Solar Panel installation?	Yes
Installation Year	1998
Source of Installation	Custodial Staff
Deficiency	BUILT-UP: FLASHING: BASE FLASHING DETERIORATED
Roof Plan reference	<p>K062</p>

Question	Response
EXTERIOR	
ROOF	
Roofing	
ROOFING	
Potential Action	REPAIR
Urgency of Action	PRIORITY 3
Purpose of Action	LEVEL 2
Deficiency Photo1

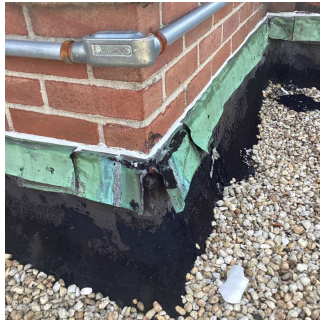
Violations	Roof 1 No violations recorded.
Deficiency	BUILT-UP: FLASHING: CAP FLASHING DAMAGED
Roof Plan reference	<p>K062</p>

Deficiency Quantity	30
Quantity Uom	L.F.
Potential Action	REPLACE
Urgency of Action	PRIORITY 4
Purpose of Action	LEVEL 2
Deficiency Photo1

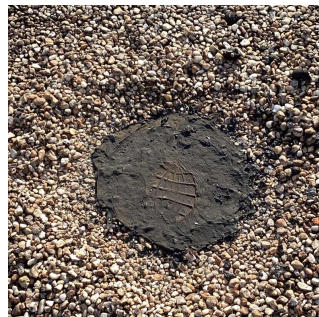
Violations	Roof 1 No violations recorded.
Deficiency	BUILT-UP: ROOFING: LOSS OF GRAVEL

Deficiency Quantity	50
Quantity Uom	S.F.
Potential Action	INSTALL NEW GRAVEL
Urgency of Action	PRIORITY 3
Purpose of Action	LEVEL 2
Deficiency Photo1

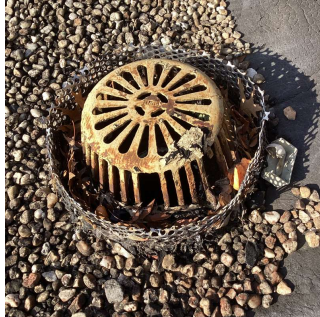
Violations	<p>Roof 1</p> <p>No violations recorded.</p>
ROOFING DRAINS	Inspected
Condition	5 - Poor
Deficiency	DETERIORATED
Roof Plan reference

Question	Response
EXTERIOR	
ROOF	
Roofing	
ROOFING DRAINS	
Deficiency Photo1

Deficiency Quantity	3
Quantity Uom	EACH
Potential Action	REPLACE
Urgency of Action	PRIORITY 4
Purpose of Action	LEVEL 2

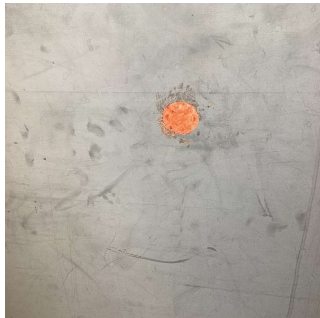
Violations	Roof 1 No violations recorded.
Specialties	Inspected
BULKHEAD/PENTHOUSE	Inspected
Condition	5 - Poor
Deficiency	BULKHEAD/PENTHOUSE DOORS: DETERIORATED DOOR
Roof Plan reference	<p>K062</p>

Deficiency Quantity	1
Quantity Uom	EACH
Potential Action	REPLACE DOOR
Urgency of Action	PRIORITY 4
Purpose of Action	LEVEL 2
Deficiency Photo1

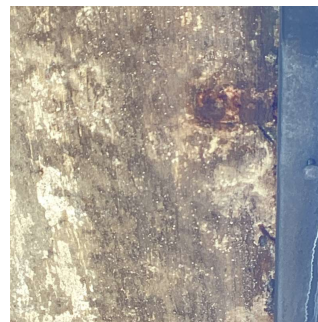
Violations	BH1 No violations recorded.
Deficiency	BULKHEAD/PENTHOUSE ROOF: DETERIORATED

10
S.F.
REPLACE
PRIORITY 4
LEVEL 2

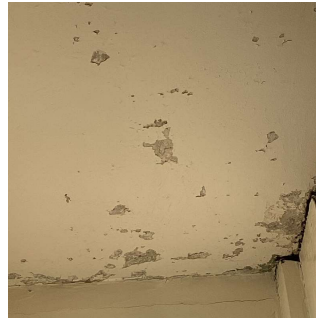
BH2

BULKHEAD/PENTHOUSE ROOF: MAJOR LEAKAGE

200
S.F.
REPLACE
PRIORITY 5
LEVEL 2

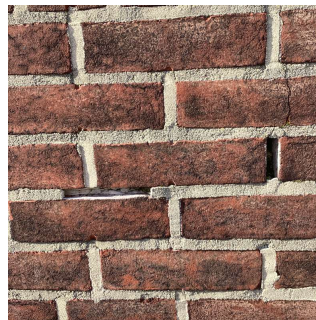
BH3

BULKHEAD/PENTHOUSE WALLS/EXTERIOR: DETERIORATED JOINTS

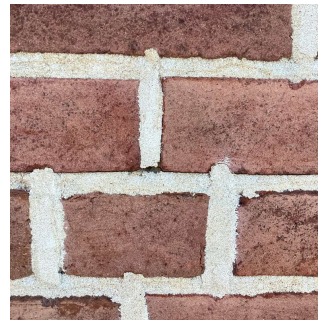
BH3
No violations recorded.

BULKHEAD/PENTHOUSE WALLS/EXTERIOR: DETERIORATED JOINTS

50
S.F.
REPOINT
PRIORITY 3
LEVEL 2

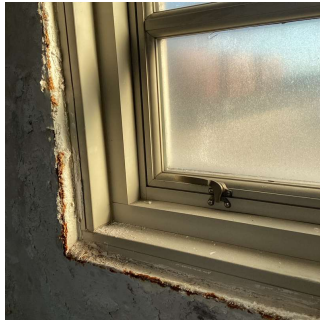
BULKHEAD/PENTHOUSE WINDOWS: AIR/WATER INFILTRATION WITH DAMAGED TRIM OR SILLS

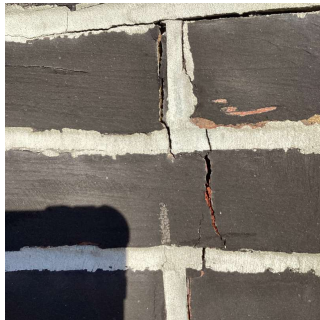
Violations	BH1 No violations recorded.
Deficiency	BULKHEAD/PENTHOUSE WALLS/EXTERIOR: CRACKS/SPALLING - MAJOR
Roof Plan reference	<p>K062</p>

Deficiency Quantity	40
Quantity Uom	S.F.
Potential Action	REPLACE
Urgency of Action	PRIORITY 4
Purpose of Action	LEVEL 2
Deficiency Photo1

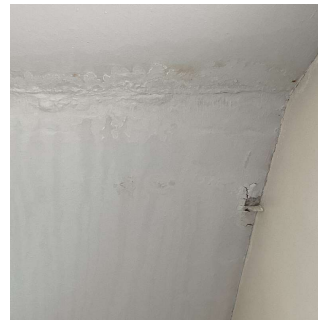
Violations	BH1 No violations recorded.
Deficiency	BULKHEAD/PENTHOUSE CEILING: PLASTER DAMAGED/DETERIORATED

80
S.F.
REPLACE
PRIORITY 3
LEVEL 2

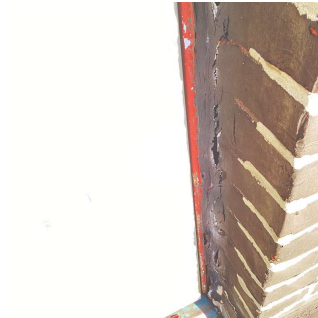
BH1

BULKHEAD/PENTHOUSE DOORS: AIR/WATER INFILTRATION WITH DAMAGED CAULKING

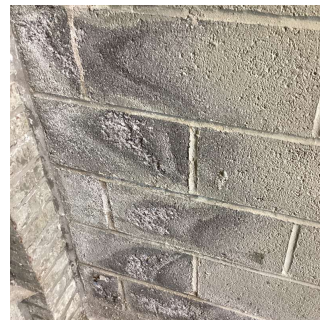
PH1

BULKHEAD/PENTHOUSE WALLS/INTERIOR: CMU
 CRACKS/SPALLING

REPLACE

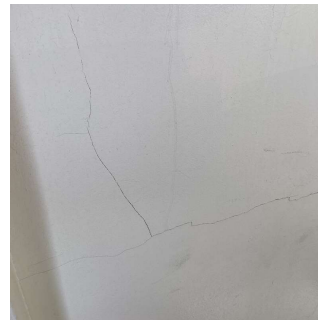
BH1
No violations recorded.

BULKHEAD/PENTHOUSE WALLS/INTERIOR: PLASTER
 CRACKS/SPALLING

100
S.F.
REPLACE
PRIORITY 4
LEVEL 2

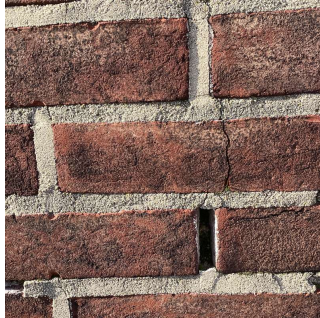
Deficiency	BULKHEAD/PENTHOUSE WALLS/EXTERIOR: CRACKS/SPALLING - MINOR
------------	---

50
S.F.
REPAIR
PRIORITY 3
LEVEL 2

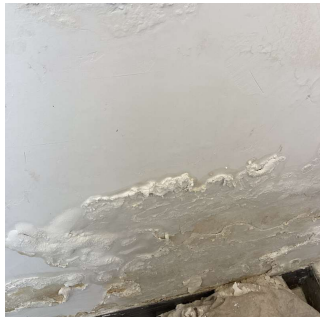
Violations	BH3 No violations recorded.
Deficiency	BULKHEAD/PENTHOUSE WALLS/EXTERIOR: WATER INFILTRATION
Roof Plan reference

Deficiency Quantity	300
Quantity Uom	S.F.
Potential Action	REPAIR
Urgency of Action	PRIORITY 5
Purpose of Action	LEVEL 2
Deficiency Photo1

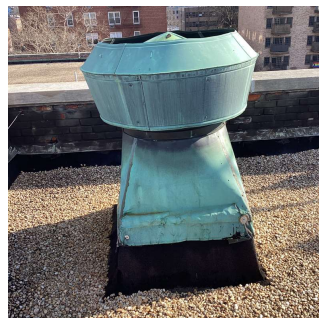
Violations	BH1 No violations recorded.
CUPOLA/ SPIRES/ TOWERS	Does not Exist
DORMER	Does not Exist
DUNNAGE STEEL	Does not Exist
SKYLIGHT/ROOF VENT	Inspected
Material Type(s)	Glass
Condition	3 - Fair
Deficiency	SHAFT VENTS DAMAGED

Deficiency Quantity	1
Quantity Uom	EACH
Potential Action	MAINTENANCE
Urgency of Action	PRIORITY 3
Purpose of Action	LEVEL 2
Deficiency Photo1

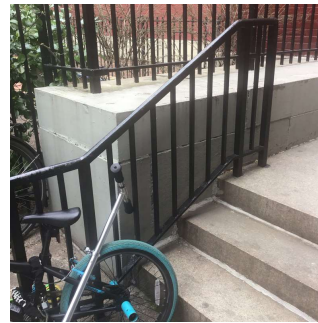
Facade A

Violations	Roof 1 No violations recorded.
ROOF/GRAVITY TANK	Does not Exist
STAIRS/RAMPS: EXTERIOR	Inspected
BUILDING CHEEK/FLANK WALLS	Inspected
Condition	5 - Poor
Deficiency	STONE: DETERIORATED JOINTS
Roof Plan reference

Deficiency Quantity	20
Quantity Uom	S.F.
Potential Action	REPOINT
Urgency of Action	PRIORITY 3
Purpose of Action	LEVEL 2

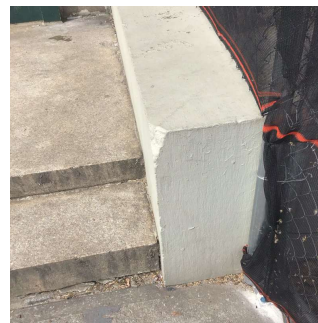
Facade E

STONE: CRACKS/SPALLING - MINOR

REPAIR

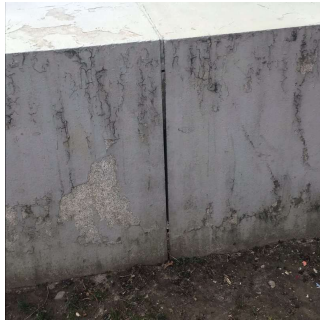
STONE: DETERIORATED JOINTS

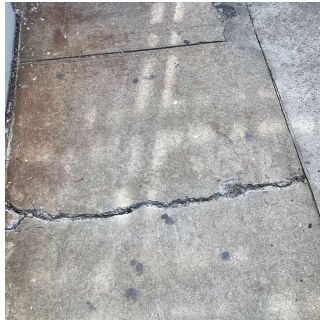
Violations	<p>Facade G</p> <p>No violations recorded.</p>
RAILINGS	Inspected
Condition	2 - Between Good and Fair
Deficiency	No deficiencies recorded
STAIRS/RAMPS	Inspected
Condition	5 - Poor
Deficiency	CONCRETE: CRACKS/SPALLING - MAJOR
Roof Plan reference	<p>K062</p>

Deficiency Quantity	10
Quantity Uom	S.F.
Potential Action	REPLACE
Urgency of Action	PRIORITY 4
Purpose of Action	LEVEL 2
Deficiency Photo1

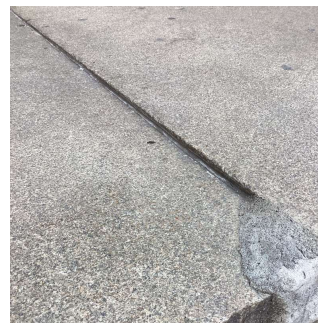
Facade A

Violations	<p>Facade A</p> <p>No violations recorded.</p>
Deficiency	CONCRETE: DETERIORATED SUBSTRATE

REPLACE SUBSTRATE AND RESET

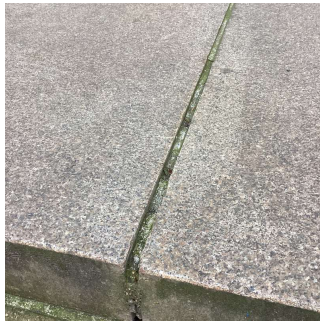
STONE: DETERIORATED JOINTS

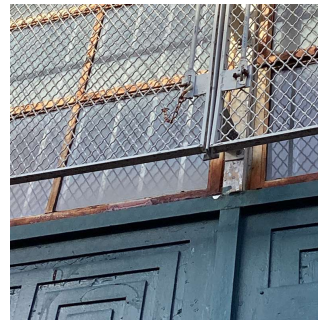
Facade H

Deficiency Quantity	2,000
Quantity Uom	L.F.
Potential Action	MAINTENANCE
Urgency of Action	PRIORITY 3
Purpose of Action	LEVEL 2
Deficiency Photo1	No photo recorded
Violations	No violations recorded.
Instance on Steel: Stairwell Facades	Inspected
Instance Condition	5 - Poor
Instance Quantity	1,200
Instance Quantity Uom	S.F.
Are these windows insulated	No
Installation Year	1957
Source of Installation	Custodial Staff
Deficiency	STEEL: DETERIORATED

REPLACE WINDOW

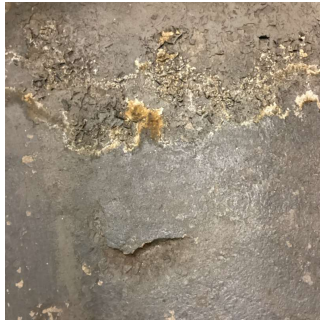
Violations	Basement - Boiler Room No violations recorded.
ROOF STRUCTURE	Inspected
Condition	3 - Fair
Deficiency	STEEL COLUMNS/BEAMS: DETERIORATED MASONRY FIREPROOFING
Deficiency Location/Instance	PH1
Deficiency Quantity	30
Quantity Uom	S.F.
Potential Action	REPLACE
Urgency of Action	PRIORITY 3
Purpose of Action	LEVEL 5
Deficiency Photo1

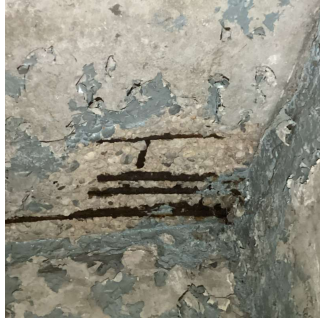
Violations	Basement - Fan Room No violations recorded.
Deficiency	CONCRETE: CRACKS/SPALLED/REINFORCEMENT EXPOSED
Deficiency Location/Instance	PH1, Basement - Vault
Deficiency Quantity	10
Quantity Uom	S.F.
Potential Action	REPAIR
Urgency of Action	PRIORITY 4
Purpose of Action	LEVEL 5
Deficiency Photo1

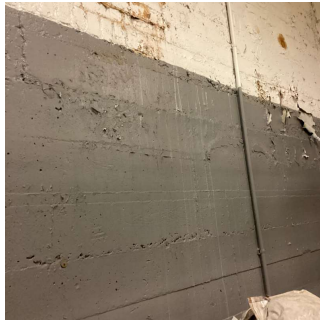
Violations	Basement - Vault No violations recorded.
FOUNDATION WALLS	Inspected
Material Type(s)	Concrete
Condition	3 - Fair
Deficiency	CONCRETE: CRACKED/SPALLED/REINFORCEMENT EXPOSED
Deficiency Location/Instance	Basement - Boiler Room
Deficiency Quantity	40
Quantity Uom	S.F.
Potential Action	REPAIR
Urgency of Action	PRIORITY 4
Purpose of Action	LEVEL 5

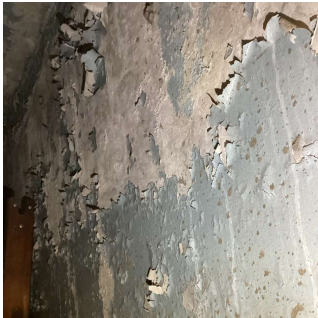
Question	Response
INTERIOR	
STRUCTURAL	
VAULTS-BUNKERS	
Foundation Walls	
Deficiency Photo1

Violations	Basement - Vault No violations recorded.
Deficiency	CRACKS, SPALLING
Deficiency Location/Instance	Basement - Vault
Deficiency Quantity	50
Quantity Uom	S.F.
Potential Action	REPAIR
Urgency of Action	PRIORITY 4
Purpose of Action	LEVEL 5
Deficiency Photo1

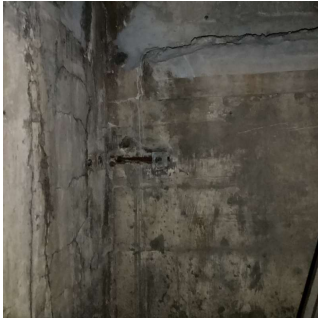
Violations	Basement - Vault No violations recorded.
Slab Structure	Inspected
Condition	4 - Between Fair and Poor
Deficiency	CONCRETE: WATER INFILTRATION IN NON- INSTRUCTIONAL SPACE
Deficiency Location/Instance	Basement - Vault
Deficiency Quantity	100
Quantity Uom	S.F.
Potential Action	INSTALL WATERPROOFING
Urgency of Action	PRIORITY 5
Purpose of Action	LEVEL 5

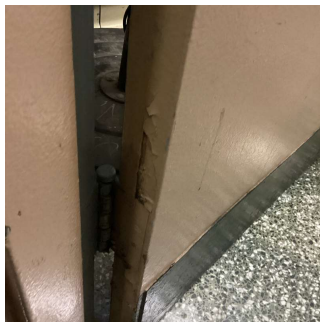
Violations	Basement - Vault No violations recorded.
Vault/Ash Hoist Doors and Framing	Does not Exist
AUDITORIUM	Inspected
Instance on 1st Floor	Inspected
Ceiling	
Instance on 1st Floor	Inspected
Condition	2 - Between Good and Fair
Deficiency	No deficiencies recorded
Door(s)	
Instance on 1st Floor	Inspected
Condition	3 - Fair
Deficiency	METAL: DETERIORATED DOOR
Deficiency Location/Instance	Right Side Exit
Deficiency Quantity	1
Quantity Uom	EACH
Potential Action	MAINTENANCE
Urgency of Action	PRIORITY 3
Purpose of Action	LEVEL 2
Deficiency Photo1

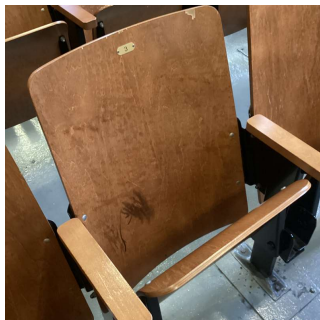
Violations	Right Side Exit No violations recorded.
Fixed H/C Lift	
Instance on 1st Floor	Does not Exist
Fixed Seating	
Instance on 1st Floor	Inspected
Condition	2 - Between Good and Fair
Deficiency	DAMAGED/BROKEN/INOPERABLE
Deficiency Location/Instance	Seats E/114, G/3, K/3

Question	Response
INTERIOR	
AUDITORIUM	
Fixed Seating	
Deficiency Quantity	3
Quantity Uom	EACH
Potential Action	REPLACE
Urgency of Action	PRIORITY 3
Purpose of Action	LEVEL 2
Deficiency Photo1

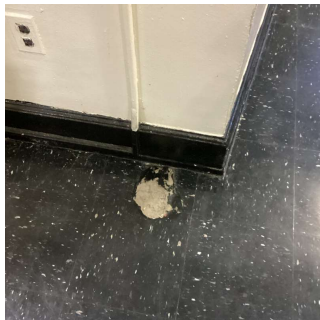
Seat G/3
Violations	No violations recorded.
Floor Finish	
Instance on 1st Floor	Inspected
Condition	2 - Between Good and Fair
Deficiency	VINYL TILES: BROKEN/DETERIORATED/MISSING TILES
Deficiency Location/Instance	Near Main Entrance
Deficiency Quantity	10
Quantity Uom	S.F.
Potential Action	REPLACE
Urgency of Action	PRIORITY 3
Purpose of Action	LEVEL 2
Deficiency Photo1

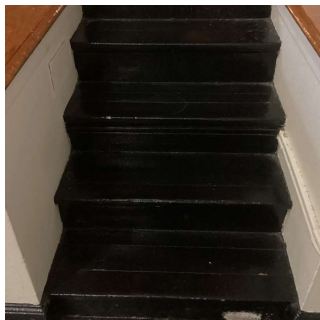
Near Main Entrance
Violations	No violations recorded.
Sliding-folding Partition	
Instance on 1st Floor	Does not Exist
Stage	
Instance on 1st Floor	Inspected
Stage	
Instance on 1st Floor	Inspected
Condition	2 - Between Good and Fair
Deficiency	DAMAGED STEPS
Deficiency Location/Instance	Left Side
Deficiency Quantity	10

Question	Response
INTERIOR	
AUDITORIUM	
Stage	
Stage	
Quantity Uom	S.F.
Potential Action	REPLACE
Urgency of Action	PRIORITY 3
Purpose of Action	LEVEL 2
Deficiency Photo1

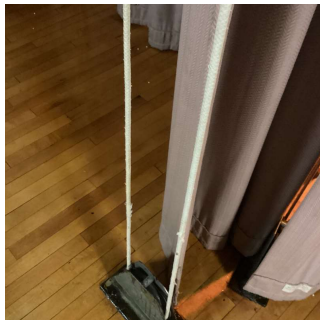
Left Side
Violations	No violations recorded.
Stage Curtain Rigging	Inspected
Instance on 1st Floor	Inspected
Condition	3 - Fair
Deficiency	DAMAGED/DETERIORATED
Deficiency Location/Instance	Left Side
Deficiency Quantity	1
Quantity Uom	EACH
Potential Action	REPLACE
Urgency of Action	PRIORITY 3
Purpose of Action	LEVEL 2
Deficiency Photo1

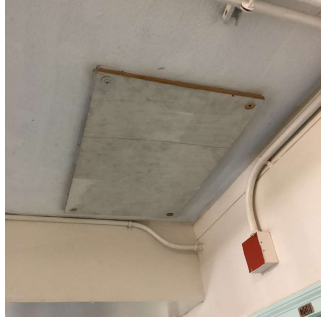
Question	Response
INTERIOR	
CAFETERIA	
Walls	
Deficiency	GLAZED BLOCK: CRACKS/SPALLING
Deficiency Location/Instance	Columns, near Windows, By Drinking Fountain
Deficiency Quantity	80
Quantity Uom	S.F.
Potential Action	REPLACE
Urgency of Action	PRIORITY 3
Purpose of Action	LEVEL 2
Deficiency Photo1	 
	Columns
Violations	No violations recorded.
Window Curtains/Shades/Blinds	
Instance on Basement	Does not Exist
CLASSROOMS/CORRIDORS/ADMIN SPACES	
Ceiling	
Condition	Inspected
	2 - Between Good and Fair
Deficiency	PLASTER: CRACKS/SPALLING - ACTIVE LEAK
Deficiency Location/Instance	Corridor near Stairs E/Basement, F/Basement, Room B1
Deficiency Quantity	40
Quantity Uom	S.F.
Potential Action	REPLACE
Urgency of Action	PRIORITY 5
Purpose of Action	LEVEL 2
Deficiency Photo1	 
	Near Stair EF/Basement
Violations	No violations recorded.
Deficiency	PLASTER: CRACKS/SPALLING
Deficiency Location/Instance	Rooms 122, 344, Corridor near Rooms 309, 208, B3 and others

Question	Response
INTERIOR	
CLASSROOMS/CORRIDORS/ADMIN SPACES	
Ceiling	
Purpose of Action	LEVEL 2
Deficiency Photo1

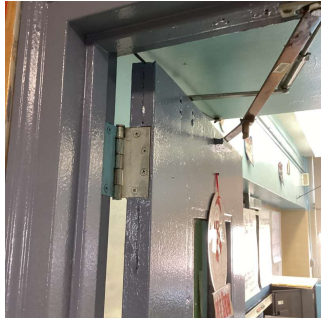
Violations	Corridor near Room 208 No violations recorded.
Door(s)	Inspected
Condition	5 - Poor
Deficiency	METAL: DETERIORATED DOOR
Deficiency Location/Instance	Room 300, Corridor near Room B14, by Exit 11
Deficiency Quantity	4
Quantity Uom	EACH
Potential Action	MAINTENANCE
Urgency of Action	PRIORITY 3
Purpose of Action	LEVEL 2
Deficiency Photo1

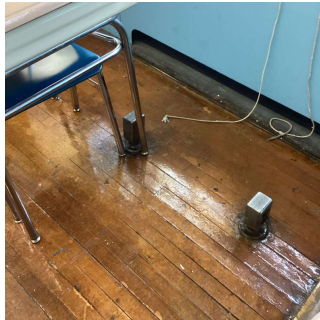
Question	Response
INTERIOR	
CLASSROOMS/CORRIDORS/ADMIN SPACES	
Door(s)	Inspected
Deficiency Photo1	 
	Room 126
Violations	No violations recorded.
Floor Finish	Inspected
Condition	2 - Between Good and Fair
Deficiency	WOOD: TRIPPING HAZARD - ELECTRICAL OUTLET
Deficiency Location/Instance	Rooms 318, 323
Deficiency Quantity	30
Quantity Uom	S.F.
Potential Action	REMOVE
Urgency of Action	PRIORITY 5
Purpose of Action	LEVEL 6
Deficiency Photo1

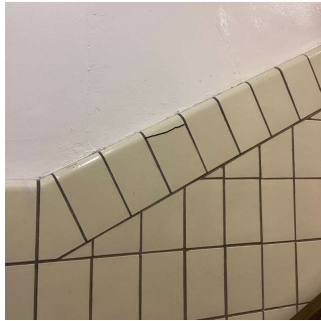
Question	Response
INTERIOR	
CLASSROOMS/CORRIDORS/ADMIN SPACES	
Walls	
Deficiency	GLAZED BLOCK: CRACKS/SPALLING
Deficiency Location/Instance	Corridor near Auditorium Exit, By Rooms B25, 239, Next to Girls Toilet Room - 1st Floor, Close to Cafeteria and others
Deficiency Quantity	80
Quantity Uom	S.F.
Potential Action	REPLACE
Urgency of Action	PRIORITY 3
Purpose of Action	LEVEL 2
Deficiency Photo1

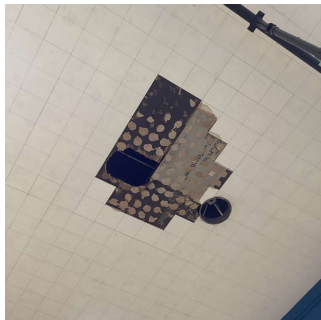
Corridor near Auditorium Exit
Violations	No violations recorded.
Specialties	Does not Exist
GYMNASIUM	Inspected
Instance on 1st Floor	Inspected
Ceiling	
Instance on 1st Floor	Inspected
Condition	2 - Between Good and Fair
Deficiency	ACOUSTIC TILES ON PLASTER: DAMAGED/MISSING
Deficiency Location/Instance	Near Main Entrance, Center
Deficiency Quantity	60
Quantity Uom	S.F.
Potential Action	REPLACE
Urgency of Action	PRIORITY 3
Purpose of Action	LEVEL 2
Deficiency Photo1

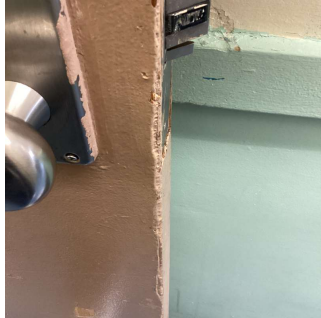
Door(s)	
Instance on 1st Floor	Inspected
Condition	5 - Poor
Deficiency	WOOD: DETERIORATED DOOR

Question	Response
INTERIOR	
GYMNASIUM	
Door(s)	
Deficiency Location/Instance	Office Room, Main Entrance
Deficiency Quantity	3
Quantity Uom	EACH
Potential Action	MAINTENANCE
Urgency of Action	PRIORITY 3
Purpose of Action	LEVEL 2
Deficiency Photo1

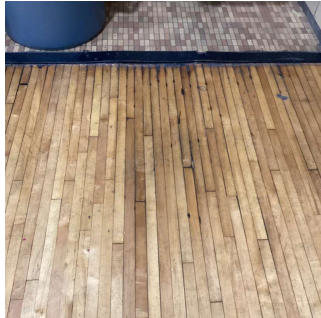
Office Room
Violations	No violations recorded.
Fixed Equipment	
Instance on 1st Floor	Inspected
Condition	2 - Between Good and Fair
Deficiency	No deficiencies recorded
Floor Finish	
Instance on 1st Floor	Inspected
Condition	2 - Between Good and Fair
Deficiency	WOOD: DAMAGED/DETERIORATED
Deficiency Location/Instance	Near Drinking Fountain, By Main Entrance
Deficiency Quantity	30
Quantity Uom	S.F.
Potential Action	REPLACE
Urgency of Action	PRIORITY 3
Purpose of Action	LEVEL 2
Deficiency Photo1

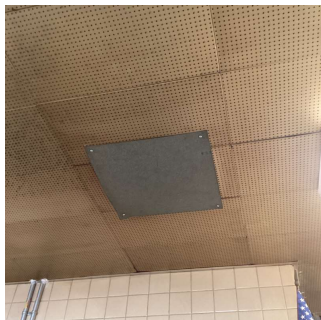
Question	Response
INTERIOR	
GYMNASIUM	
Walls	
Urgency of Action	PRIORITY 3
Purpose of Action	LEVEL 2
Deficiency Photo1	 
Violations	Near Windows No violations recorded.
Window Curtains/Shades/Blinds	
Instance on 1st Floor	Does not Exist
INTERIOR DOOR HARDWARE	Inspected
Condition	3 - Fair
Deficiency	No deficiencies recorded
INTERIOR GUARDS	Inspected
Condition	2 - Between Good and Fair
Deficiency	No deficiencies recorded
KITCHEN	Inspected
Instance on Basement	Inspected
Ceiling	
Instance on Basement	Inspected
Condition	3 - Fair
Deficiency	PLASTER: CRACKS/SPALLING
Deficiency Location/Instance	Sink Room
Deficiency Quantity	10
Quantity Uom	S.F.
Potential Action	REPLACE
Urgency of Action	PRIORITY 3
Purpose of Action	LEVEL 2
Deficiency Photo1	 
Violations	Sink Room No violations recorded.
Deficiency	METAL PAN: DAMAGED/MISSING
Deficiency Location/Instance	Near Office Room, By Fridges, Next to Windows, Preparation Area
Deficiency Quantity	40

Question	Response
INTERIOR	
KITCHEN	
Ceiling	
Quantity Uom	S.F.
Potential Action	REPLACE
Urgency of Action	PRIORITY 3
Purpose of Action	LEVEL 2
Deficiency Photo1

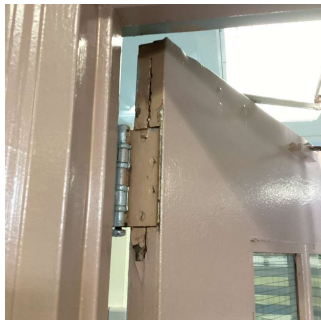
Near Office Room
Violations	No violations recorded.
Door(s)	
Instance on Basement	Inspected
Condition	5 - Poor
Deficiency	METAL: DETERIORATED DOOR
Deficiency Location/Instance	Servery, Office Room
Deficiency Quantity	3
Quantity Uom	EACH
Potential Action	MAINTENANCE
Urgency of Action	PRIORITY 3
Purpose of Action	LEVEL 2
Deficiency Photo1

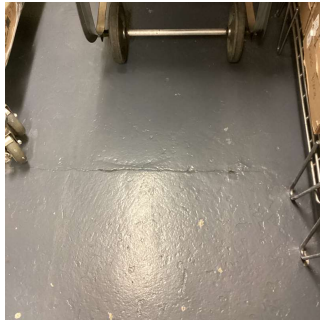
Servery
Violations	No violations recorded.
Floor Finish	
Instance on Basement	Inspected
Condition	3 - Fair
Deficiency	CONCRETE: CRACKS
Deficiency Location/Instance	Storage Room
Deficiency Quantity	10
Quantity Uom	S.F.
Potential Action	REPLACE
Urgency of Action	PRIORITY 3
Purpose of Action	LEVEL 2

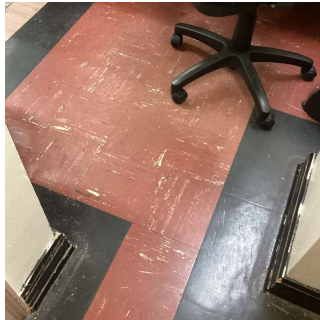
Violations	Storage Room No violations recorded.
Deficiency	VINYL TILES: BROKEN/DETERIORATED/MISSING TILES
Deficiency Location/Instance	Office Room
Deficiency Quantity	10
Quantity Uom	S.F.
Potential Action	REPLACE
Urgency of Action	PRIORITY 3
Purpose of Action	LEVEL 2
Deficiency Photo1

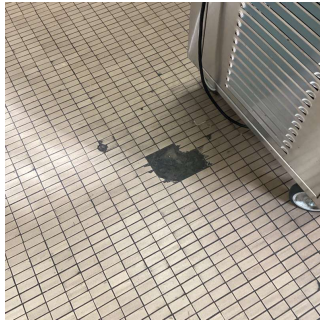
Violations	Office Room No violations recorded.
Deficiency	CERAMIC TILE: BROKEN/MISSING TILES
Deficiency Location/Instance	Servery Area, near Right Sink, Preparation Area
Deficiency Quantity	40
Quantity Uom	S.F.
Potential Action	REPLACE
Urgency of Action	PRIORITY 3
Purpose of Action	LEVEL 2
Deficiency Photo1

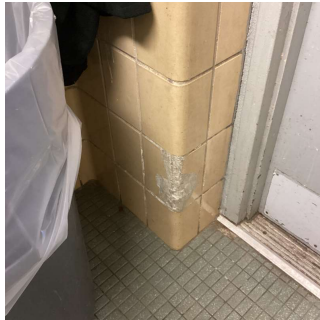
Question	Response
INTERIOR	
KITCHEN	
Walls	
Instance on Basement	Inspected
Condition	3 - Fair
Deficiency	GLAZED BLOCK: CRACKS/SPALLING
Deficiency Location/Instance	Exit -Vestibule
Deficiency Quantity	10
Quantity Uom	S.F.
Potential Action	REPLACE
Urgency of Action	PRIORITY 3
Purpose of Action	LEVEL 2
Deficiency Photo1

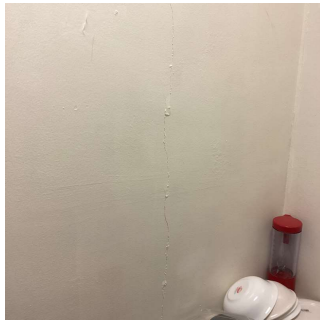
Violations	Exit -Vestibule No violations recorded.
Deficiency	PLASTER: CRACKS/SPALLING
Deficiency Location/Instance	Office Room
Deficiency Quantity	10
Quantity Uom	S.F.
Potential Action	REPLACE
Urgency of Action	PRIORITY 3
Purpose of Action	LEVEL 2
Deficiency Photo1

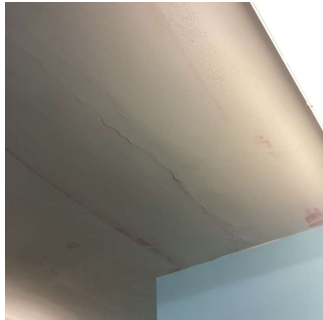
Question	Response
INTERIOR	
LIBRARY	Inspected
Walls	
Instance on Room 333	Inspected
Condition	2 - Between Good and Fair
Deficiency	No deficiencies recorded
LOCKER ROOM	Inspected
Instance on 1st Floor - Girls (750 Lockers)	Inspected
Alternative use	No
Instance on Basement - Boys (633 Lockers)	Inspected
Alternative use	No
Ceiling	
Instance on Basement - Boys (633 Lockers)	Inspected
Condition	2 - Between Good and Fair
Deficiency	PLASTER: CRACKS/SPALLING
Deficiency Location/Instance	Near Boys Toilet Room
Deficiency Quantity	10
Quantity Uom	S.F.
Potential Action	REPLACE
Urgency of Action	PRIORITY 3
Purpose of Action	LEVEL 2
Deficiency Photo1

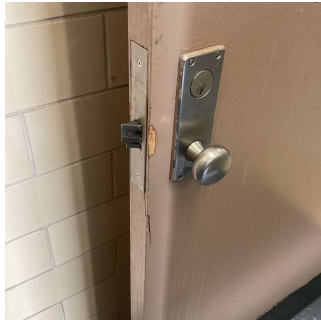
Question	Response
INTERIOR	
LOCKER ROOM	
Door(s)	
Instance on 1st Floor - Girls (750 Lockers)	Inspected
Condition	3 - Fair
Deficiency	WOOD: DETERIORATED DOOR
Deficiency Location/Instance	Main Entrance
Deficiency Quantity	1
Quantity Uom	EACH
Potential Action	MAINTENANCE
Urgency of Action	PRIORITY 3
Purpose of Action	LEVEL 2
Deficiency Photo1

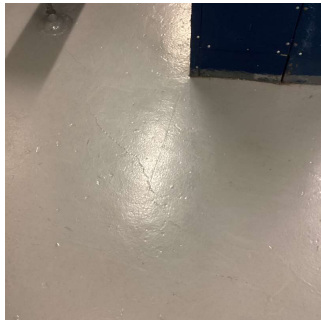
Violations	Main Entrance No violations recorded.
Floor Finish	
Instance on Basement - Boys (633 Lockers)	Inspected
Condition	3 - Fair
Deficiency	CONCRETE: CRACKS
Deficiency Location/Instance	Near Window, By Exit
Deficiency Quantity	50
Quantity Uom	S.F.
Potential Action	REPLACE
Urgency of Action	PRIORITY 3
Purpose of Action	LEVEL 2
Deficiency Photo1

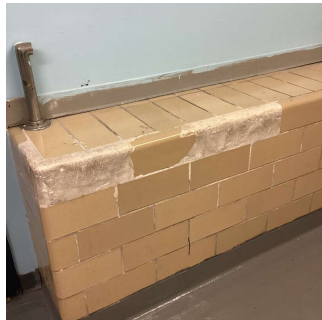
Question	Response
INTERIOR	
LOCKER ROOM	
Locker Room Lockers	
Deficiency	No deficiencies recorded
Walls	
Instance on Basement - Boys (633 Lockers)	Inspected
Condition	2 - Between Good and Fair
Deficiency	GLAZED BLOCK: CRACKS/SPALLING
Deficiency Location/Instance	Near Locker 595, Left Side
Deficiency Quantity	40
Quantity Uom	S.F.
Potential Action	REPLACE
Urgency of Action	PRIORITY 3
Purpose of Action	LEVEL 2
Deficiency Photo1

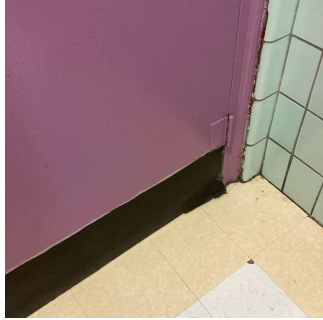
Question	Response
INTERIOR	
SCIENCE PREP ROOM	
Alternative use	No
Fixed Equipment	
Instance on Room 242	Inspected
Condition	2 - Between Good and Fair
Deficiency	No deficiencies recorded
SHOWER ROOM	
	Inspected
Instance on 1st Floor - Girls	Inaccessible
Instance on Basement - Boys	Inaccessible
STAIRS/RAMPS: INTERIOR	
Do Letter Stair Signs Exist?	Yes
Ceiling	
	Inspected
Condition	2 - Between Good and Fair
Deficiency	No deficiencies recorded
Door(s)	
	Inspected
Condition	4 - Between Fair and Poor
Deficiency	METAL: DETERIORATED DOOR
Deficiency Location/Instance	Stairs F/Basement, G/1
Deficiency Quantity	1
Quantity Uom	EACH
Potential Action	MAINTENANCE
Urgency of Action	PRIORITY 3
Purpose of Action	LEVEL 2
Deficiency Photo1

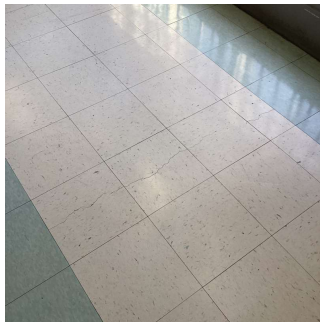
Question	Response
INTERIOR	
STAIRS/RAMPS: INTERIOR	
Stairs and Landings	
Deficiency Photo1	 
Violations	Main Entrance Lobby No violations recorded.
Deficiency	STONE: BROKEN/MISSING
Deficiency Location/Instance	Stairs BC/3, D/3, 2, G/Basement, HI/3 and others
Deficiency Quantity	80
Quantity Uom	S.F.
Potential Action	REPLACE
Urgency of Action	PRIORITY 3
Purpose of Action	LEVEL 2
Deficiency Photo1	 
Violations	Stair BC/3 No violations recorded.
Deficiency	VINYL TILES: BROKEN/DETERIORATED/MISSING TILES
Deficiency Location/Instance	Stairs BC/3, D/3, EF/2, 3, HI/1 and others
Deficiency Quantity	60
Quantity Uom	S.F.
Potential Action	REPLACE
Urgency of Action	PRIORITY 3
Purpose of Action	LEVEL 2
Deficiency Photo1

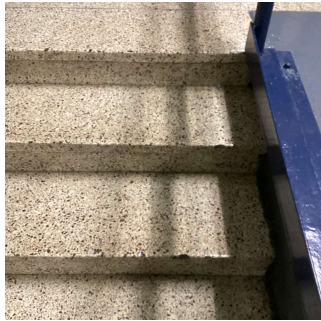
Question	Response
INTERIOR	
STAIRS/RAMPS: INTERIOR	
Stairs and Landings	
Deficiency	TERRAZZO: CRACKS
Deficiency Location/Instance	Stair BC/1, Corridor near Main Entrance Lobby, By Gymnasium, Exit 2/3 - Vestibule
Deficiency Quantity	70
Quantity Uom	S.F.
Potential Action	REPLACE
Urgency of Action	PRIORITY 3
Purpose of Action	LEVEL 2
Deficiency Photo1

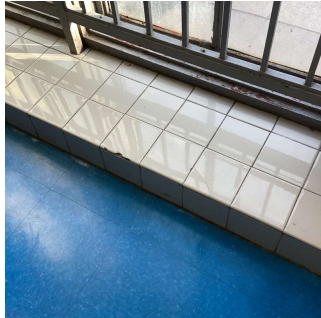
Violations	Near Main Entrance Lobby No violations recorded.
Walls	
Condition	Inspected 2 - Between Good and Fair
Deficiency	CERAMIC TILE: BROKEN/ MISSING
Deficiency Location/Instance	Stairs EF/2, HI/2
Deficiency Quantity	20
Quantity Uom	S.F.
Potential Action	REPLACE
Urgency of Action	PRIORITY 3
Purpose of Action	LEVEL 2
Deficiency Photo1

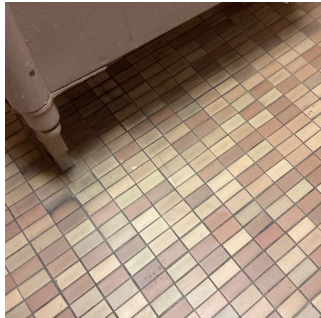
Question	Response
INTERIOR	
TOILET ROOMS - STAFF	
Floor Finish	
Violations	Room 120 No violations recorded.
Deficiency	CERAMIC TILE: DETERIORATED SUBSTRATE
Deficiency Location/Instance	In Room 122
Deficiency Quantity	10
Quantity Uom	S.F.
Potential Action	REPLACE
Urgency of Action	PRIORITY 3
Purpose of Action	LEVEL 2
Deficiency Photo1

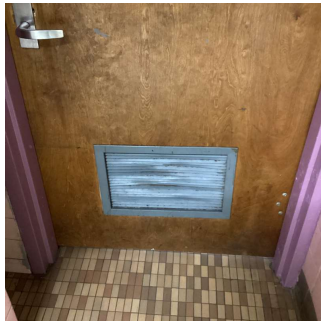
Question	Response
INTERIOR	
TOILET ROOMS - STUDENTS	
Door(s)	
Deficiency Photo1

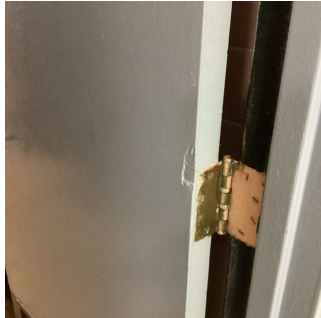
Violations	Girls Toilet Room - 1st Floor No violations recorded.
Deficiency	WOOD: DETERIORATED DOOR
Deficiency Location/Instance	Rooms 328, 314, 228, 214, In Girls Locker Room
Deficiency Quantity	5
Quantity Uom	EACH
Potential Action	MAINTENANCE
Urgency of Action	PRIORITY 3
Purpose of Action	LEVEL 2
Deficiency Photo1

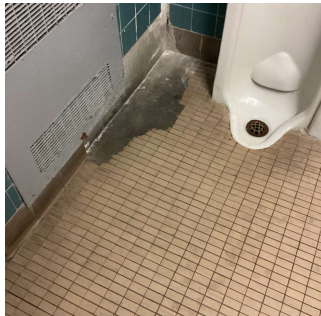
Violations	Room 314 No violations recorded.
Floor Finish	Inspected
Condition	2 - Between Good and Fair
Deficiency	CERAMIC TILE: BROKEN/MISSING TILES
Deficiency Location/Instance	In Boys Locker Room, Room 214
Deficiency Quantity	20
Quantity Uom	S.F.
Potential Action	REPLACE
Urgency of Action	PRIORITY 3
Purpose of Action	LEVEL 2
Deficiency Photo1

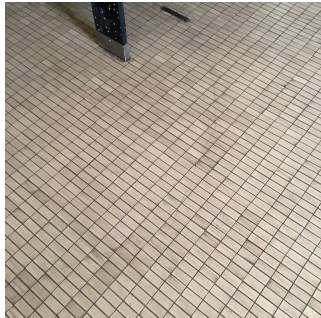
Question	Response
INTERIOR	
TOILET ROOMS - STUDENTS	
Floor Finish	
Violations	In Boys Locker Room No violations recorded.
Deficiency	CERAMIC TILE: DETERIORATED SUBSTRATE
Deficiency Location/Instance	Rooms 328, 228, 214, In Girls Locker Room
Deficiency Quantity	40
Quantity Uom	S.F.
Potential Action	REPLACE
Urgency of Action	PRIORITY 3
Purpose of Action	LEVEL 2
Deficiency Photo1

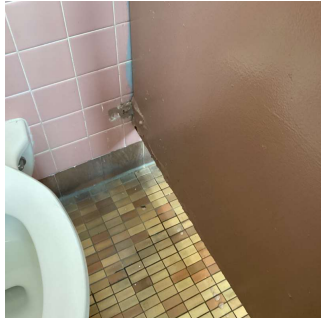
Violations	Room 328 No violations recorded.
Stalls	Inspected
Condition	4 - Between Fair and Poor
Deficiency	RUST - MAJOR
Deficiency Location/Instance	In Girls Locker Room
Deficiency Quantity	3
Quantity Uom	EACH
Potential Action	REPLACE
Urgency of Action	PRIORITY 3
Purpose of Action	LEVEL 2
Deficiency Photo1

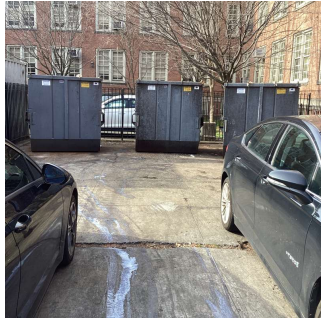
Question	Response
INTERIOR	Inspected
TOILET ROOMS - STUDENTS	Inspected
Walls	
Violations	Room 314 No violations recorded.
LIFE SAFETY	Inspected
F.D. HOLDING AREA	Does not Exist
STEEL STAIRS	Does not Exist
SITE	Inspected
CONTAINERIZATION	Inspected
Condition	5 - Poor
Deficiency	FENCING MISSING
Deficiency Location/Instance	E 8th Street
Deficiency Quantity	300
Quantity Uom	S.F.
Potential Action	INSTALL NEW
Urgency of Action	PRIORITY 3
Purpose of Action	LEVEL 2
Deficiency Photo1	 
Violations	E 8th Street No violations recorded.
Deficiency	CONTAINER DAMAGED
Deficiency Location/Instance	E 8th Street
Deficiency Quantity	3
Quantity Uom	EACH
Potential Action	REPLACE
Urgency of Action	PRIORITY 3
Purpose of Action	LEVEL 2
Deficiency Photo1

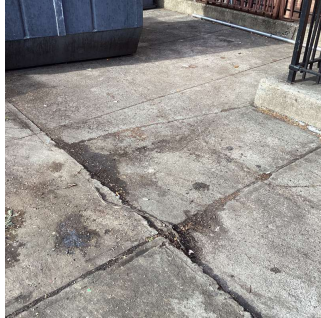
Violations	E 8th Street No violations recorded.
Deficiency	CONCRETE PAD DAMAGED
Deficiency Location/Instance	E 8th Street

Question	Response
SITE	
CONTAINERIZATION	
Deficiency Quantity	200
Quantity Uom	S.F.
Potential Action	REPAIR
Urgency of Action	PRIORITY 3
Purpose of Action	LEVEL 2
Deficiency Photo1

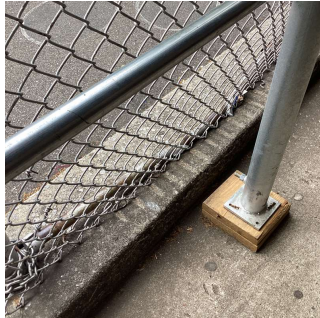
Deficiency Photo1	No photo recorded
Violations	No violations recorded.
FENCES	Inspected
Condition	4 - Between Fair and Poor
Deficiency	CHAIN LINK: DAMAGED POST/RAIL
Deficiency Location/Instance	Schoolyard
Deficiency Quantity	20
Quantity Uom	L.F.
Potential Action	REPLACE
Urgency of Action	PRIORITY 3
Purpose of Action	LEVEL 2

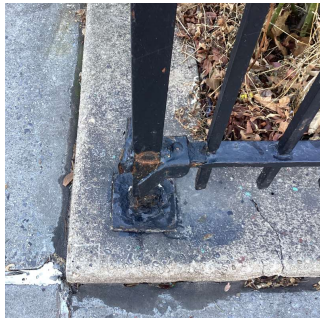
Violations	Schoolyard No violations recorded.
Deficiency	WROUGHT IRON: RUST - MAJOR
Deficiency Location/Instance	E 7th Street, Cortelyou Road, E 8th Street
Deficiency Quantity	160
Quantity Uom	S.F.
Potential Action	REPLACE
Urgency of Action	PRIORITY 3
Purpose of Action	LEVEL 2
Deficiency Photo1

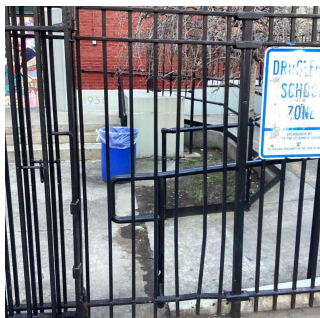
Violations	E 7th Street No violations recorded.
Deficiency	WROUGHT IRON: DAMAGED/DETERIORATED
Deficiency Location/Instance	E 7th Street, E 8th Street, Cortelyou Road
Deficiency Quantity	440
Quantity Uom	S.F.
Potential Action	REPLACE
Urgency of Action	PRIORITY 3
Purpose of Action	LEVEL 2
Deficiency Photo1

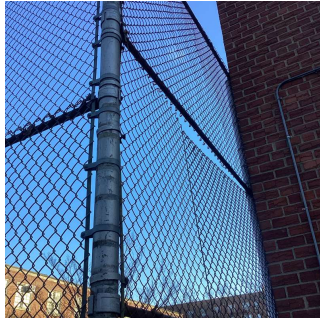
Violations	E 7th Street No violations recorded.
Deficiency	CHAIN LINK: DAMAGED/DETERIORATED

Question	Response
SITE	
FENCES	
Deficiency Location/Instance	Schoolyard, E 7th Street
Deficiency Quantity	350
Quantity Uom	S.F.
Potential Action	REPLACE
Urgency of Action	PRIORITY 3
Purpose of Action	LEVEL 2
Deficiency Photo1

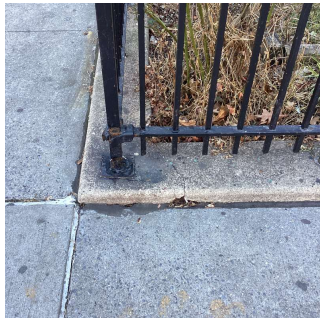
Violations	E 7th Street No violations recorded.
Deficiency	CONCRETE CURB: DAMAGED/DETERIORATED
Deficiency Location/Instance	E 7th Street, E 8th Street, Cortelyou Road, near Schoolyard
Deficiency Quantity	250
Quantity Uom	S.F.
Potential Action	REPLACE
Urgency of Action	PRIORITY 3
Purpose of Action	LEVEL 2
Deficiency Photo1

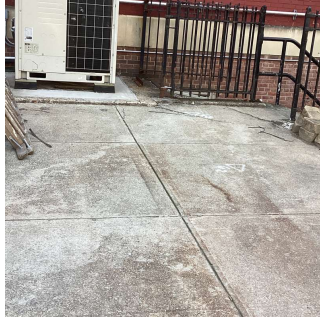
Violations	E 7th Street No violations recorded.
IRRIGATION SYSTEM	Does not Exist
PAVING	Inspected
Student Non-Use	Inspected
Gravel Exists?	No
Asphalt	Does not Exist
Concrete	Inspected
Condition	3 - Fair
Deficiency	DAMAGED/DETERIORATED/MISSING SECTIONS
Deficiency Location/Instance	E 7th Street, E 8th Street
Deficiency Quantity	250
Quantity Uom	S.F.
Potential Action	REPLACE

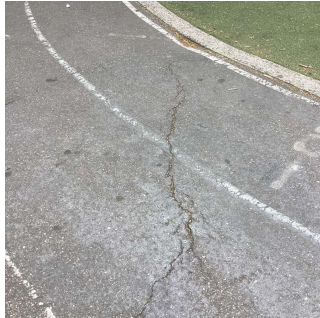
E 7th Street
Violations	No violations recorded.
Pavers	Does not Exist
Student Use	Inspected
Gravel Exists?	No
Asphalt	Inspected
Condition	4 - Between Fair and Poor
Deficiency	HEAVING
Deficiency Location/Instance	Schoolyard
Deficiency Quantity	150
Quantity Uom	S.F.
Potential Action	REPLACE
Urgency of Action	PRIORITY 3
Purpose of Action	LEVEL 2
Deficiency Photo1

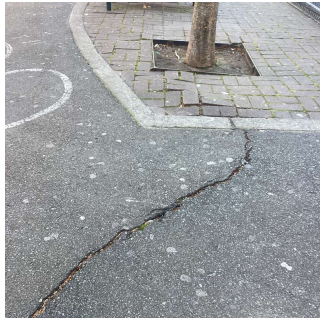
Schoolyard
Violations	No violations recorded.
Deficiency	CRACKS - MAJOR
Deficiency Location/Instance	Schoolyard
Deficiency Quantity	800
Quantity Uom	S.F.
Potential Action	REPLACE
Urgency of Action	PRIORITY 3
Purpose of Action	LEVEL 2

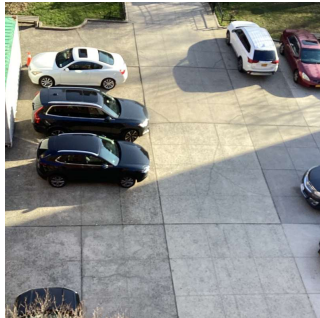
Violations	Schoolyard No violations recorded.
Concrete	Inspected
Condition	4 - Between Fair and Poor
Deficiency	DAMAGED/DETERIORATED/MISSING SECTIONS
Deficiency Location/Instance	E 8th Street
Deficiency Quantity	1,200
Quantity Uom	S.F.
Potential Action	REPLACE
Urgency of Action	PRIORITY 3
Purpose of Action	LEVEL 2
Deficiency Photo1

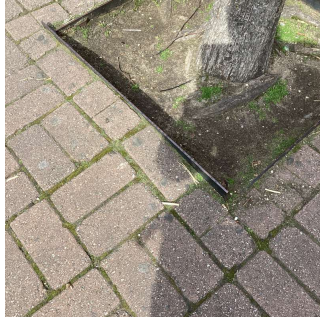
Violations	E 8th Street No violations recorded.
Pavers	Inspected
Condition	4 - Between Fair and Poor
Deficiency	HEAVING
Deficiency Location/Instance	Schoolyard
Deficiency Quantity	100
Quantity Uom	S.F.
Potential Action	REPLACE
Urgency of Action	PRIORITY 5
Purpose of Action	LEVEL 6

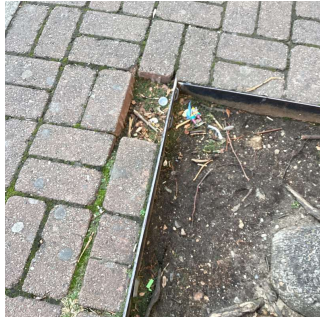
Violations	Schoolyard No violations recorded.
Deficiency	DAMAGED/MISSING
Deficiency Location/Instance	Near Artificial Turf
Deficiency Quantity	10
Quantity Uom	S.F.
Potential Action	REPLACE
Urgency of Action	PRIORITY 3
Purpose of Action	LEVEL 2
Deficiency Photo1

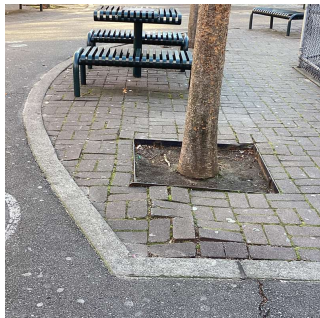
Violations	Near Artificial Turf No violations recorded.
Deficiency	HEAVING
Deficiency Location/Instance	Schoolyard
Deficiency Quantity	650
Quantity Uom	S.F.
Potential Action	REPLACE
Urgency of Action	PRIORITY 3
Purpose of Action	LEVEL 2
Deficiency Photo1

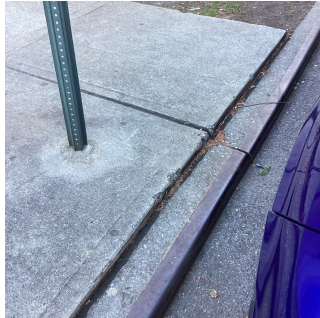
Question	Response
SITE	
PAVING	
Site Sidewalks & Walkways	Inspected
Pavers	
Deficiency Quantity	30
Quantity Uom	S.F.
Potential Action	REPLACE
Urgency of Action	PRIORITY 3
Purpose of Action	LEVEL 2
Deficiency Photo1	 
	E 7th Street
Violations	No violations recorded.
DOT Sidewalk	Inspected
Asphalt	Does not Exist
Concrete	Inspected
Condition	4 - Between Fair and Poor
Deficiency	HEAVING
Deficiency Location/Instance	E 7th Street, E 8th Street, Cortelyou Road
Deficiency Quantity	200
Quantity Uom	S.F.
Potential Action	REPLACE
Urgency of Action	PRIORITY 3
Purpose of Action	LEVEL 2
Deficiency Photo1

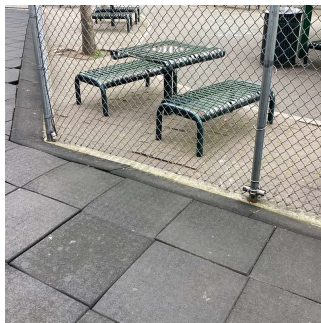
Question	Response
SITE	
PLAYGROUNDS	
Fence	
Deficiency Photo1

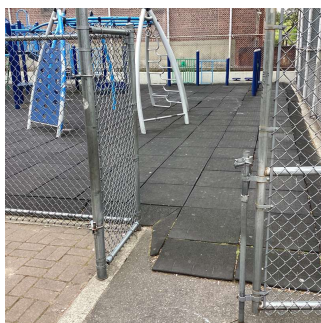
Violations	South Side No violations recorded.
Deficiency	CHAIN LINK: MISSING SECTIONS
Deficiency Location/Instance	Entrance Gate
Deficiency Quantity	50
Quantity Uom	S.F.
Potential Action	REPLACE
Urgency of Action	PRIORITY 3
Purpose of Action	LEVEL 2
Deficiency Photo1

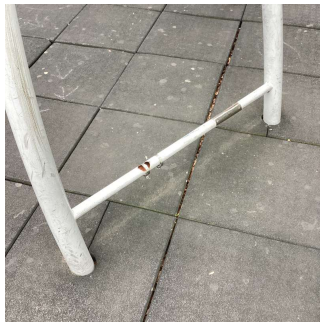
Violations	Entrance Gate No violations recorded.
Pavement	
Instance on Schoolyard	Does not Exist
Play Equipment	
Instance on Schoolyard	Inspected
Condition	5 - Poor
Deficiency	BROKEN/DETERIORATED/MISSING
Deficiency Location/Instance	Near Fences
Deficiency Quantity	1
Quantity Uom	EACH
Potential Action	REPLACE
Urgency of Action	PRIORITY 3
Purpose of Action	LEVEL 2

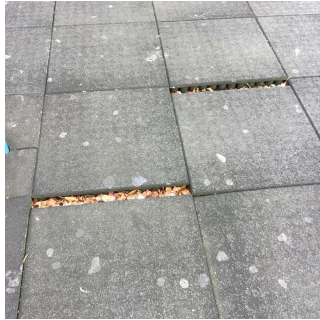
Violations	<p>Near Fences</p> <p>No violations recorded.</p>
Safety Surfacing	
Instance on Schoolyard	Inspected
Condition	5 - Poor
Deficiency	DETERIORATED/MISSING
Deficiency Location/Instance	Near E 7th Street, Near Entrance, Right Side
Deficiency Quantity	80
Quantity Uom	S.F.
Potential Action	REPLACE
Urgency of Action	PRIORITY 3
Purpose of Action	LEVEL 2
Deficiency Photo1
