NYC Department of Education
Building Condition Assessment Survey 2023 - 2024

Architectural Inspection

Asset: **P.S. 84 - BROOKLYN, 250 BERRY STREET, New York, 11211**

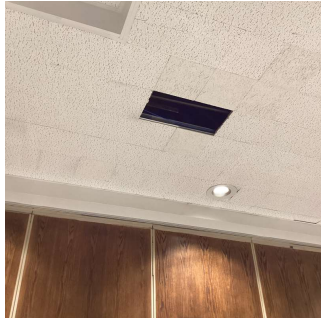
Violations	Basement - Ash Hoist Vault No violations recorded.
AUDITORIUM	Inspected
Instance on 1st Floor (324 Seats)	Inspected
Ceiling	
Instance on 1st Floor (324 Seats)	Inspected
Condition	2 - Between Good and Fair
Deficiency	ACOUSTIC TILES: DAMAGED/MISSING
Deficiency Location/Instance	Rear
Deficiency Quantity	10
Quantity Uom	S.F.
Potential Action	REPLACE
Urgency of Action	PRIORITY 3
Purpose of Action	LEVEL 2
Deficiency Photo1

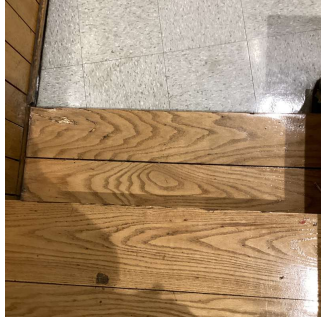
Near center
Violations	No violations recorded.
Deficiency	DAMAGED STEPS
Deficiency Location/Instance	Right side, left side
Deficiency Quantity	20
Quantity Uom	S.F.
Potential Action	REPLACE
Urgency of Action	PRIORITY 3
Purpose of Action	LEVEL 2

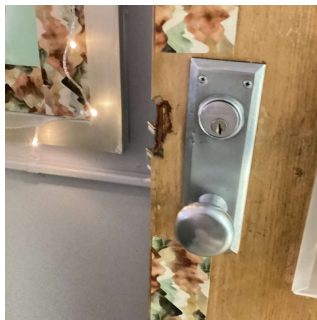
Question	Response
INTERIOR	
CLASSROOMS/CORRIDORS/ADMIN SPACES	
Door(s)	
Deficiency Quantity	20
Quantity Uom	EACH
Potential Action	MAINTENANCE
Urgency of Action	PRIORITY 3
Purpose of Action	LEVEL 2
Deficiency Photo1

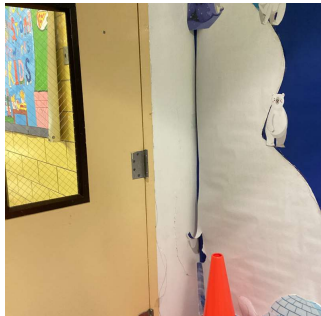
Violations	Room 207 No violations recorded.
Deficiency	PLASTER: CRACKS/SPALLING
Deficiency Location/Instance	Main Entrance Lobby
Deficiency Quantity	10
Quantity Uom	S.F.
Potential Action	REPLACE
Urgency of Action	PRIORITY 3
Purpose of Action	LEVEL 2
Deficiency Photo1

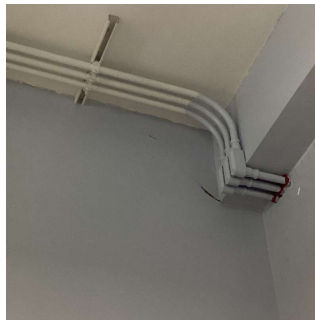
Question	Response
INTERIOR	
KITCHEN	
Walls	
Instance on 1st Floor	Inspected
Condition	2 - Between Good and Fair
Deficiency	PLASTER: CRACKS/SPALLING
Deficiency Location/Instance	Storage
Deficiency Quantity	10
Quantity Uom	S.F.
Potential Action	REPLACE
Urgency of Action	PRIORITY 3
Purpose of Action	LEVEL 2
Deficiency Photo1

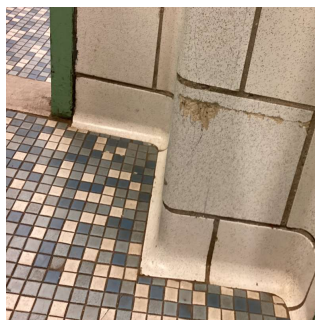
Violations	Storage No violations recorded.
Deficiency	GLAZED BLOCK: CRACKS/SPALLING
Deficiency Location/Instance	Near exit
Deficiency Quantity	10
Quantity Uom	S.F.
Potential Action	REPLACE
Urgency of Action	PRIORITY 3
Purpose of Action	LEVEL 2
Deficiency Photo1

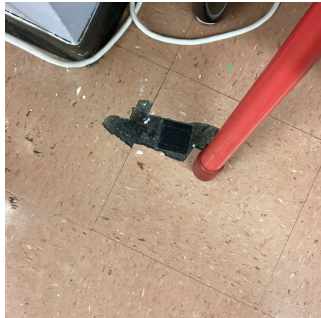
Question	Response
INTERIOR	
LIBRARY	
Door(s)	
Purpose of Action	LEVEL 2
Deficiency Photo1	 
	Entrance
Violations	No violations recorded.
Floor Finish	
Instance on Room 208	Inspected
Condition	2 - Between Good and Fair
Deficiency	VINYL TILES: BROKEN/DETERIORATED/MISSING TILES
Deficiency Location/Instance	Near Entrance, window
Deficiency Quantity	10
Quantity Uom	S.F.
Potential Action	REPLACE
Urgency of Action	PRIORITY 3
Purpose of Action	LEVEL 2
Deficiency Photo1

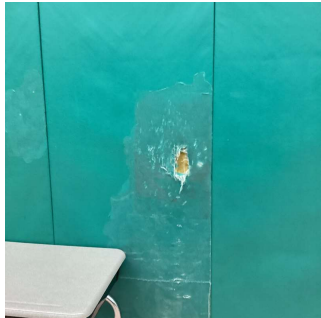
Question	Response
INTERIOR	
MULTI-PURPOSE ROOM	
Walls	
Violations	Near Windows No violations recorded.
Deficiency	WALL PADDING: DETERIORATED
Deficiency Location/Instance	Near center
Deficiency Quantity	220
Quantity Uom	S.F.
Potential Action	REPLACE
Urgency of Action	PRIORITY 3
Purpose of Action	LEVEL 2
Deficiency Photo1

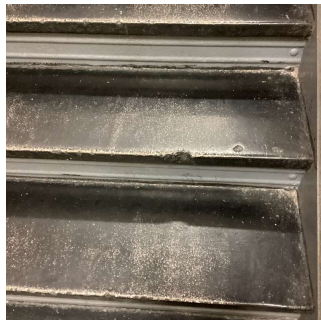
Stair D/2
Violations	No violations recorded.
Deficiency	CONCRETE: CRACKS/SPALLING - MAJOR
Deficiency Location/Instance	Stair D/3, 2, C/1, 3, A/1, and others
Deficiency Quantity	200
Quantity Uom	S.F.
Potential Action	REPLACE
Urgency of Action	PRIORITY 3
Purpose of Action	LEVEL 2
Deficiency Photo1

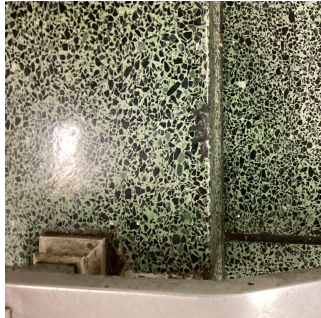
Question	Response
INTERIOR	
STAIRS/RAMPS: INTERIOR	
Stairs and Landings	
Deficiency	TERRAZZO: CRACKS
Deficiency Location/Instance	Stair near Room 116
Deficiency Quantity	20
Quantity Uom	S.F.
Potential Action	REPLACE
Urgency of Action	PRIORITY 3
Purpose of Action	LEVEL 2
Deficiency Photo1

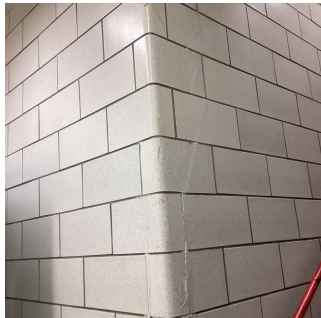
Corridor near Room 116
Violations	No violations recorded.
Walls	Inspected
Condition	2 - Between Good and Fair
Deficiency	GLAZED BLOCK: CRACKS/SPALLING
Deficiency Location/Instance	Stair A/3, 2, 1, C/2, 1, and others
Deficiency Quantity	100
Quantity Uom	S.F.
Potential Action	REPLACE
Urgency of Action	PRIORITY 3
Purpose of Action	LEVEL 2
Deficiency Photo1

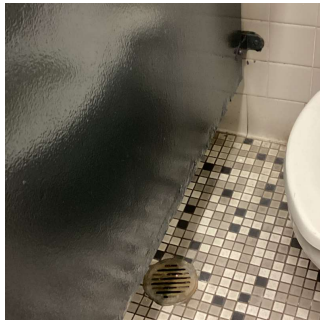
Violations	Room 344 No violations recorded.
Deficiency	RUST - MAJOR
Deficiency Location/Instance	Room 344, 334, 320, 244, 234
Deficiency Quantity	16
Quantity Uom	EACH
Potential Action	REPLACE
Urgency of Action	PRIORITY 3
Purpose of Action	LEVEL 2
Deficiency Photo1

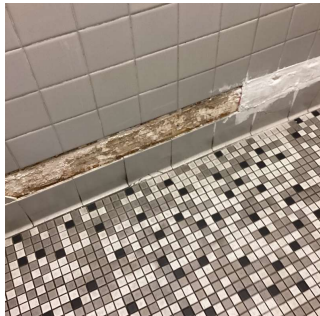
Violations	Room 334 No violations recorded.
Walls	Inspected
Condition	2 - Between Good and Fair
Deficiency	CERAMIC TILE: BROKEN/ MISSING
Deficiency Location/Instance	Room 322, 342, 334, 320, 316, and others
Deficiency Quantity	80
Quantity Uom	S.F.
Potential Action	REPLACE
Urgency of Action	PRIORITY 3
Purpose of Action	LEVEL 2
Deficiency Photo1

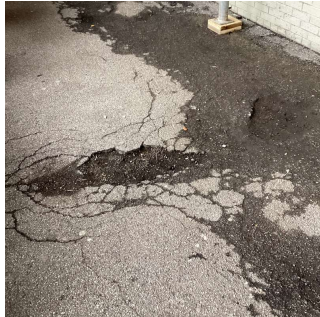
Asphalt	Does not Exist
Concrete	Inspected
Condition	2 - Between Good and Fair
Deficiency	No deficiencies recorded
Pavers	Does not Exist
Site Sidewalks & Walkways	Inspected
Asphalt	Inspected
Condition	3 - Fair
Deficiency	POTHoles
Deficiency Location/Instance	Near exit 10
Deficiency Quantity	30
Quantity Uom	S.F.
Potential Action	REPAIR
Urgency of Action	PRIORITY 5
Purpose of Action	LEVEL 6

Violations	Near exit 10 No violations recorded.
Deficiency	CRACKS - MAJOR
Deficiency Location/Instance	Near exit 3
Deficiency Quantity	200
Quantity Uom	S.F.
Potential Action	REPLACE
Urgency of Action	PRIORITY 3
Purpose of Action	LEVEL 2
Deficiency Photo1

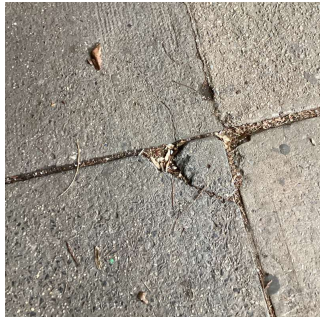
Violations	Near exit 3 No violations recorded.
Concrete	Inspected
Condition	3 - Fair
Deficiency	DAMAGED/DETERIORATED/MISSING SECTIONS
Deficiency Location/Instance	Near exit 1, Exit 2, Exit 4
Deficiency Quantity	350
Quantity Uom	S.F.
Potential Action	REPLACE
Urgency of Action	PRIORITY 3
Purpose of Action	LEVEL 2

Near exit 1
Violations	No violations recorded.
Pavers	Does not Exist
DOT Sidewalk	Inspected
Asphalt	Does not Exist
Concrete	Inspected
Condition	4 - Between Fair and Poor
Deficiency	DAMAGED/DETERIORATED/MISSING SECTIONS
Deficiency Location/Instance	Along Berry Street, Grand Street, South 1st Street
Deficiency Quantity	1,600
Quantity Uom	S.F.
Potential Action	REPLACE
Urgency of Action	PRIORITY 3
Purpose of Action	LEVEL 2
Deficiency Photo1

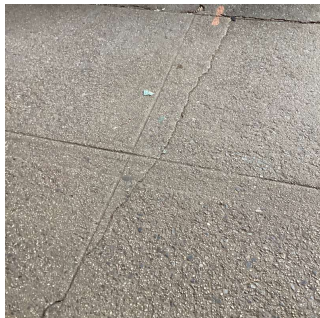
Along Berry Street
Violations	No violations recorded.
Deficiency	DAMAGED CURBS
Deficiency Location/Instance	Along Berry Street, Grand Street, South 1st Street
Deficiency Quantity	30
Quantity Uom	L.F.
Potential Action	REPLACE
Urgency of Action	PRIORITY 3
Purpose of Action	LEVEL 2

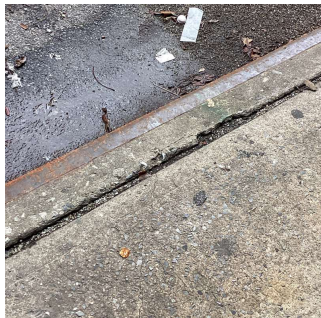
Violations	Along Berry Street No violations recorded.
Deficiency	HEAVING
Deficiency Location/Instance	Along Berry Street
Deficiency Quantity	50
Quantity Uom	S.F.
Potential Action	REPLACE
Urgency of Action	PRIORITY 5
Purpose of Action	LEVEL 6
Deficiency Photo1

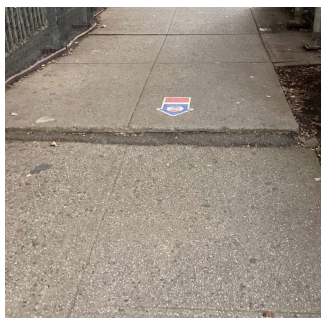
Violations	Along Berry Street No violations recorded.
Pavers	Does not Exist
PLAYGROUNDS	Inspected
Instance on Courtyard	Inspected
Benches	
Instance on Courtyard	Does not Exist
Fence	
Instance on Courtyard	Inspected
Condition	2 - Between Good and Fair
Deficiency	CHAIN LINK: DAMAGED POST/RAIL
Deficiency Location/Instance	Courtyard
Deficiency Quantity	10
Quantity Uom	L.F.
Potential Action	REPLACE
Urgency of Action	PRIORITY 3
Purpose of Action	LEVEL 2

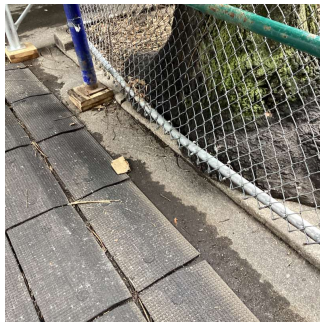
Violations	Courtyard No violations recorded.
Deficiency	CONCRETE CURB: DAMAGED/DETERIORATED
Deficiency Location/Instance	Courtyard
Deficiency Quantity	10
Quantity Uom	S.F.
Potential Action	REPLACE
Urgency of Action	PRIORITY 3
Purpose of Action	LEVEL 2
Deficiency Photo1

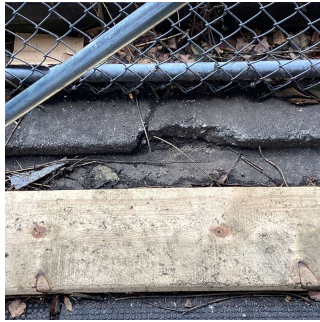
Violations	Courtyard No violations recorded.
Pavement	
Instance on Courtyard	Inspected
Condition	4 - Between Fair and Poor
Deficiency	ASPHALT: CRACKS - MAJOR
Deficiency Location/Instance	Courtyard
Deficiency Quantity	300
Quantity Uom	S.F.
Potential Action	REPLACE
Urgency of Action	PRIORITY 3
Purpose of Action	LEVEL 2

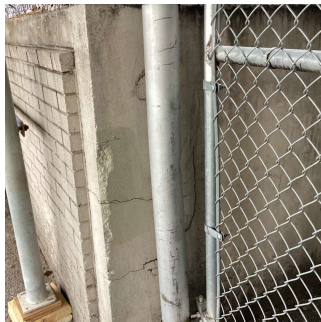
Question	Response
SITE	
PLAYGROUNDS	
Safety Surfacing	
Deficiency Photo1	 
Violations	Courtyard No violations recorded.
Unpaved Area	
Instance on Courtyard	Does not Exist
PLAYING SURFACE	Does not Exist
RETAINING WALLS	Inspected
Are there any Retaining Walls 6' OR higher facing public street/sidewalk?	No
Condition	3 - Fair
Deficiency	BRICK: DETERIORATED COPING STONE
Deficiency Location/Instance	Near exit 10
Deficiency Quantity	20
Quantity Uom	S.F.
Potential Action	REPLACE
Urgency of Action	PRIORITY 3
Purpose of Action	LEVEL 2
Deficiency Photo1	 
Violations	Near exit 10 No violations recorded.
Deficiency	CAST IN PLACE CONCRETE: CRACKS/SPALLING - MAJOR
Deficiency Location/Instance	Near exit 10
Deficiency Quantity	10
Quantity Uom	S.F.
Potential Action	REPLACE
Urgency of Action	PRIORITY 3
Purpose of Action	LEVEL 2

Violations	Near exit 10 No violations recorded.
SEATING	Does not Exist
SITE WALLS (NOT RETAINING WALLS)	Does not Exist
STAIRS/RAMPS: EXTERIOR	Does not Exist
ARTWORK	Inspected
Instance	Interior - Lobby - 20044
Instance Photo
