NYC Department of Education
Building Condition Assessment Survey 2023 - 2024

Architectural Inspection

Asset: P.S. 152 - BROOKLYN, 725 EAST 23RD STREET, New York, 11210

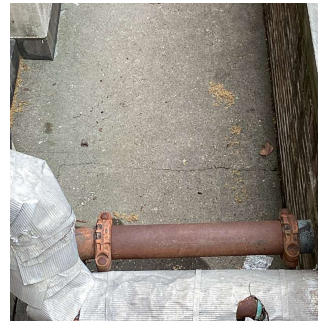
AW2

AREAWAY WALLS: DETERIORATED JOINTS AT COPING STONES

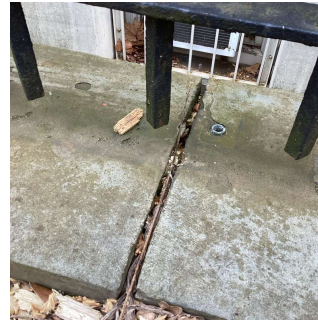
AW1

AREAWAY WALLS: DETERIORATED COPING STONE

REPLACE

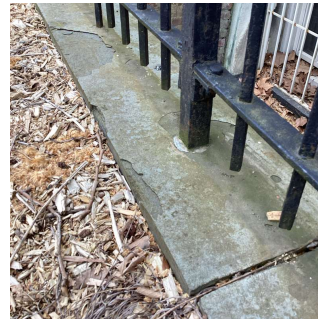
AW1

AREAWAY WALLS: DETERIORATED JOINTS

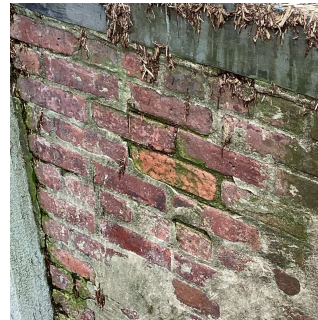
AW1

AREAWAY WALLS: CRACKS AND SPALLING

REPLACE

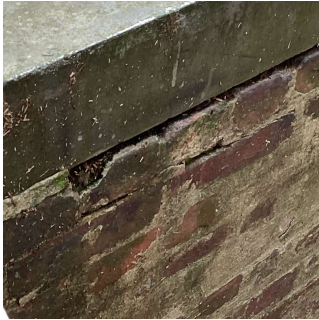
Violations	<p>AW1</p> <p>No violations recorded.</p>
AWNINGS AND CANOPIES	Inspected
Condition	2 - Between Good and Fair
Deficiency	No deficiencies recorded
CHIMNEY	Inspected
Material Type(s)	Masonry
Condition	2 - Between Good and Fair
Deficiency	No deficiencies recorded
COPING	Inspected
Condition	3 - Fair
Deficiency	CAST STONE: DISINTEGRATING / FREEZE THAW
Roof Plan reference	<p>K152</p>

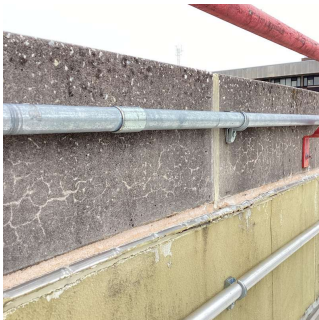
Violations	<p>Roof 8</p> <p>No violations recorded.</p>
Deficiency	CAST STONE: CRACKED/BROKEN PIECES

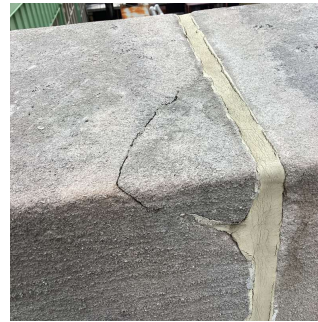
Roof 8

CAST STONE: DETERIORATED TRANSVERSE JOINTS

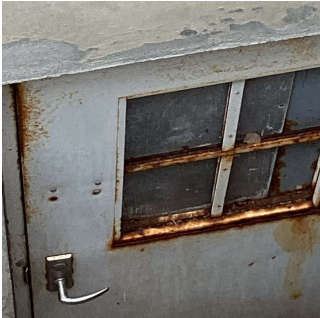
Violations	Facade D No violations recorded.
Deficiency	METAL: DETERIORATED DOOR AND FRAME - MINOR DETERIORATION

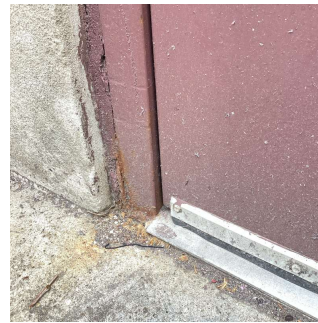
Facade A

WOOD: DETERIORATED DOOR AND FRAME - MAJOR DETERIORATION

REPLACE

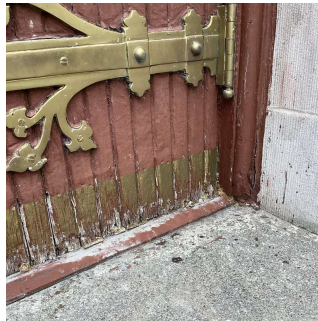
Violations	Facade A No violations recorded.
DOOR HARDWARE	Inspected
Condition	3 - Fair
Deficiency	No deficiencies recorded
LINTELS	Inspected
Condition	2 - Between Good and Fair
Deficiency	No deficiencies recorded
TRANSOM/SIDE LIGHT	Inspected
Condition	5 - Poor
Deficiency	WOOD: EXCESSIVELY WEATHERED
Roof Plan reference

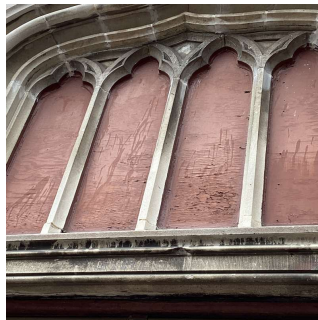
Violations	Facade C No violations recorded.
EXTERIOR WALLS	Inspected

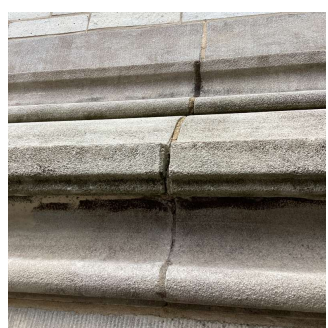
Violations	Facade C No violations recorded.
Deficiency	STONE: CRACKS AT BUILDING CORNERS

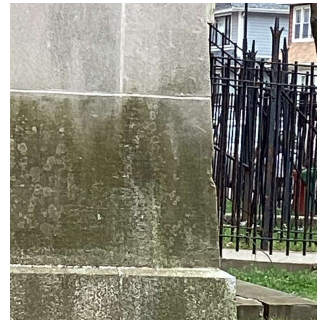
Facade B

STONE: CHIPPED/SPALLED/BROKEN PIECES - MINOR

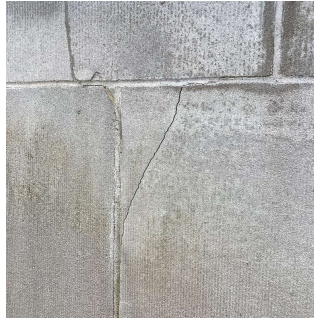
Facade A

STONE: DETERIORATED MASONRY SILLS - MINOR

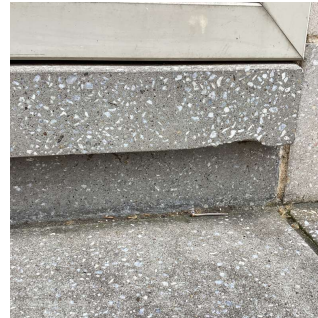
Facade A

BRICK: MINOR CRACKS AND SPALLING

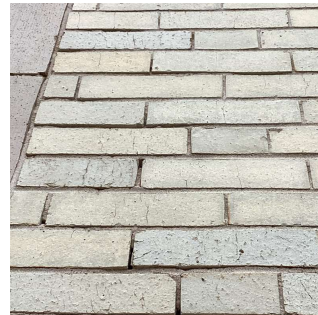
Facade J

BRICK: MASONRY SILLS - DETERIORATED JOINTS

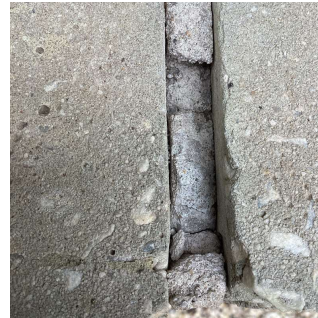
Facade J

BRICK: DETERIORATED MASONRY SILLS - MAJOR

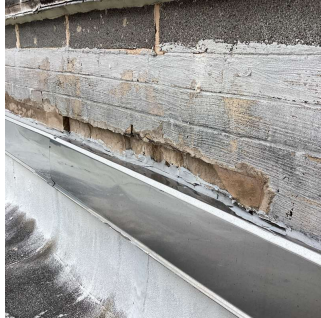
Question	Response
EXTERIOR	
PARAPETS	
Deficiency Quantity	20
Quantity Uom	S.F.
Potential Action	REMOVE AND REBUILD
Urgency of Action	PRIORITY 4
Purpose of Action	LEVEL 2
Deficiency Photo1

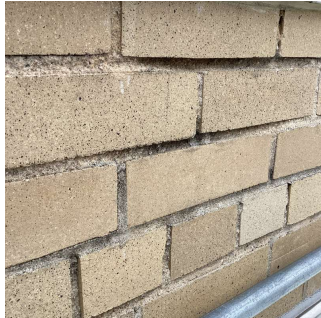
Violations	Roof 8 No violations recorded.
Deficiency	BRICK: DETERIORATED JOINTS
Roof Plan reference	<p>K152</p>

<p>Roof 1 Synthetic Slate Roof 2 Metal Roof 3 BUR Roofs 4-17 Mod. Bitumen</p>
Deficiency Quantity	30
Quantity Uom	S.F.
Potential Action	REPOINT
Urgency of Action	PRIORITY 3
Purpose of Action	LEVEL 2
Deficiency Photo1

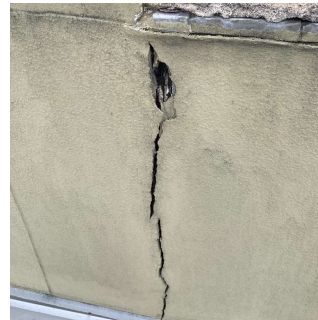
Violations	Roof 8 No violations recorded.
Deficiency	CONCRETE: MAJOR DETERIORATION/CRACKS

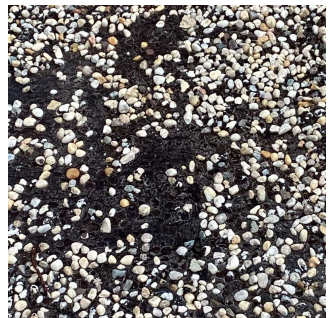
Question	Response
EXTERIOR	
ROOF	
Roofing	
ROOFING	
Source of Installation	Custodial Staff
Deficiency	BUILT-UP: ROOFING: LOSS OF GRAVEL
RooF Plan reference

<p>Roof 1 Synthetic Slate Roof 2 Metal Roof 3 BUR Roofs 4-17 Mod. Bitumen</p>
Deficiency Quantity	20
Quantity Uom	S.F.
Potential Action	INSTALL NEW GRAVEL
Urgency of Action	PRIORITY 3
Purpose of Action	LEVEL 2
Deficiency Photo1

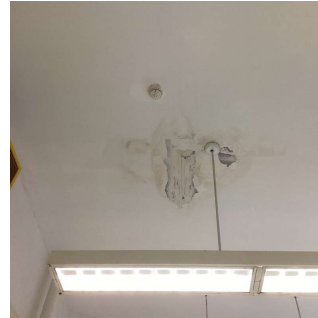
Roof 4 - Room 413 (shown), Roof 12 - Room 237, Corridor near
Room 237 (similar)

MODIFIED BITUMEN: ROOFING: MAJOR ACTIVE ROOF
LEAKS IN INSTRUCTIONAL SPACE

REPLACE ROOFING WITHOUT MAJOR EQUIPMENT
REMOVAL

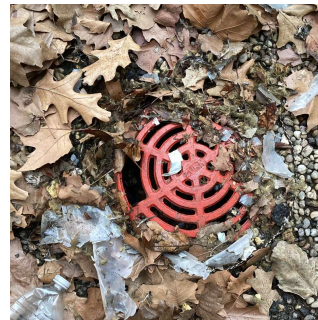
Roof 3
No violations recorded.

Question	Response
EXTERIOR	
ROOF	
Roofing	
ROOFING	
Deficiency Photo1	 
Violations	Roof 8 No violations recorded.
Deficiency	MODIFIED BITUMEN: ROOFING: MAJOR ACTIVE ROOF LEAKS IN NON-INSTRUCTIONAL SPACE
Roof Plan reference	  <p>K152 East 24th Street East 23rd Street Glenwood Road Campus Road</p> <p>Roof 1 Synthetic Slate Roof 2 Metal Roof 3 BUR Roofs 4-17 Mod. Bitumen</p>
Deficiency Quantity	100
Quantity Uom	S.F.
Potential Action	REPLACE ROOFING WITHOUT MAJOR EQUIPMENT REMOVAL
Urgency of Action	PRIORITY 5
Purpose of Action	LEVEL 2
Deficiency Photo1	 
Violations	Roof 10 - Boiler Room No violations recorded.
ROOFING DRAINS	Inspected
Condition	5 - Poor
Deficiency	DETERIORATED

5
EACH
REPLACE
PRIORITY 4
LEVEL 2

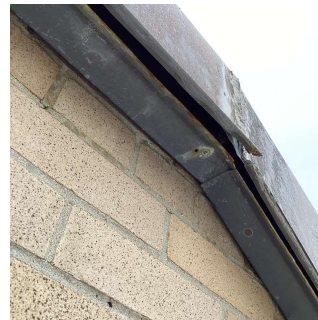
Question	Response
EXTERIOR	
ROOF	
Specialties	
BULKHEAD/PENTHOUSE	
Deficiency Photo1	 
Violations	BH2 No violations recorded.
Deficiency	BULKHEAD/PENTHOUSE WALLS/INTERIOR: PLASTER CRACKS/SPALLING
Roof Plan reference	  <p>Roof 1 Synthetic Slate Roof 2 Metal Roof 3 BUR Roofs 4-17 Mod. Bitumen</p>
Deficiency Quantity	100
Quantity Uom	S.F.
Potential Action	REPLACE
Urgency of Action	PRIORITY 4
Purpose of Action	LEVEL 2
Deficiency Photo1	 
Violations	BH2 No violations recorded.
Deficiency	BULKHEAD/PENTHOUSE ROOF: DETERIORATED

10
S.F.
REPLACE
PRIORITY 4
LEVEL 2

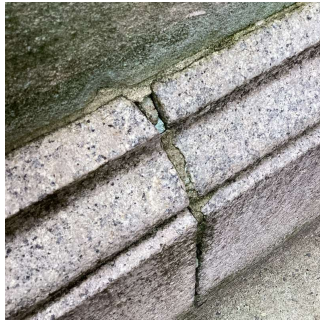
Violations	Roof 1 - Attic No violations recorded.
STAIRS/RAMPS: EXTERIOR	Inspected
BUILDING CHEEK/FLANK WALLS	Inspected
Condition	5 - Poor
Deficiency	STONE: DETERIORATED JOINTS
Roof Plan reference

<p>Roof 1 Synthetic Slate Roof 2 Metal Roof 3 BUR Roofs 4-17 Mod. Bitumen</p>
Deficiency Quantity	10
Quantity Uom	S.F.
Potential Action	REPOINT
Urgency of Action	PRIORITY 4
Purpose of Action	LEVEL 2
Deficiency Photo1

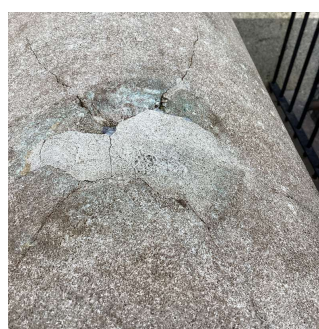
<p>Facade C</p>
Violations	No violations recorded.

Violations	Facade C No violations recorded.
Deficiency	STONE: CRACKS/SPALLING - MAJOR

<p>Roof 1 Synthetic Slate Roof 2 Metal Roof 3 BUR Roofs 4-17 Mod. Bitumen</p>
Deficiency Quantity	10
Quantity Uom	S.F.
Potential Action	REPLACE
Urgency of Action	PRIORITY 4
Purpose of Action	LEVEL 2
Deficiency Photo1

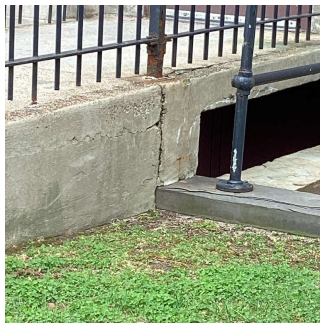
CAST IN PLACE CONCRETE: CRACKS/SPALLING - MAJOR

<p>Roof 1 Synthetic Slate Roof 2 Metal Roof 3 BUR Roofs 4-17 Mod. Bitumen</p>
Deficiency Quantity	20
Quantity Uom	S.F.
Potential Action	REPLACE
Urgency of Action	PRIORITY 4
Purpose of Action	LEVEL 2

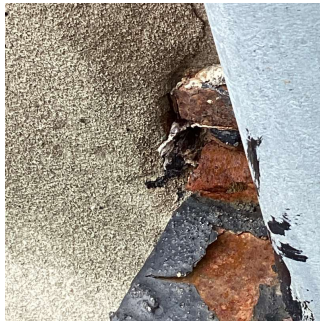
Violations	<p>Facade A</p> <p>No violations recorded.</p>
RAILINGS	Inspected
Condition	5 - Poor
Deficiency	RUST - MAJOR
Roof Plan reference

Deficiency Quantity	15
Quantity Uom	L.F.
Potential Action	REPLACE
Urgency of Action	PRIORITY 4
Purpose of Action	LEVEL 2
Deficiency Photo1

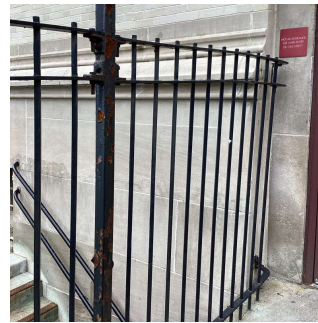
Facade A

Violations	<p>Facade A</p> <p>No violations recorded.</p>
Deficiency	DAMAGED

REPLACE

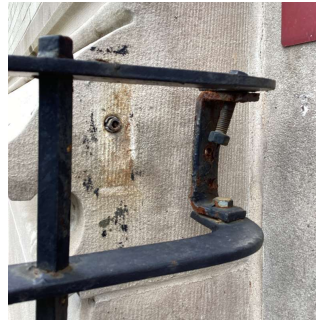
Facade A

RAILINGS

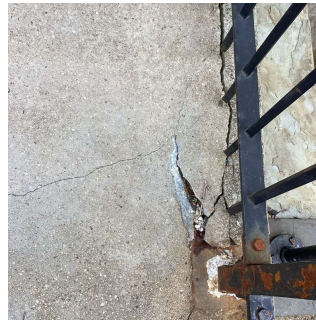
Facade A

CONCRETE: WORN-OUT TREAD/RISER/NOSING

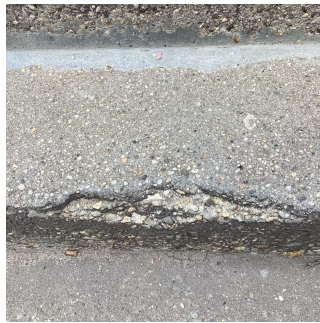
Question	Response
EXTERIOR	
STAIRS/RAMPS: EXTERIOR	
STAIRS/RAMPS	
Roof Plan reference

Deficiency Quantity	30
Quantity Uom	S.F.
Potential Action	REPLACE
Urgency of Action	PRIORITY 4
Purpose of Action	LEVEL 2
Deficiency Photo1

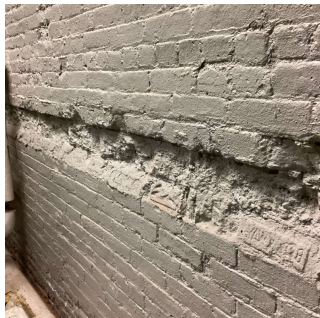
Question	Response
EXTERIOR	Inspected
WINDOWS	
WINDOWS	
Are these windows insulated	No
Installation Year	1999
Source of Installation	Custodial Staff
Deficiency	No deficiencies recorded
INTERIOR	Inspected
POOLS	Does not Exist
STRUCTURAL	Inspected
COLUMNS/BEAMS/BEARING WALLS	Inspected
Condition	3 - Fair
Deficiency	MASONRY BEARING WALL: CRACKED/SPALLED
Deficiency Location/Instance	Basement - Fan Room, Boiler Room
Deficiency Quantity	40
Quantity Uom	S.F.
Potential Action	RESTITCH
Urgency of Action	PRIORITY 4
Purpose of Action	LEVEL 5
Deficiency Photo1

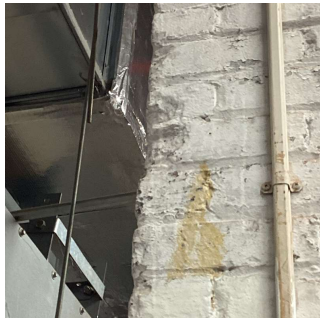
Basement - Custodian Workshop
Violations	No violations recorded.

Basement - Fan Room
Violations	No violations recorded.
Deficiency	STEEL COLUMNS/BEAMS: DETERIORATED MASONRY FIREPROOFING
Deficiency Location/Instance	Basement - Custodian Workshop
Deficiency Quantity	20
Quantity Uom	S.F.
Potential Action	REPLACE
Urgency of Action	PRIORITY 3
Purpose of Action	LEVEL 5
Deficiency Photo1

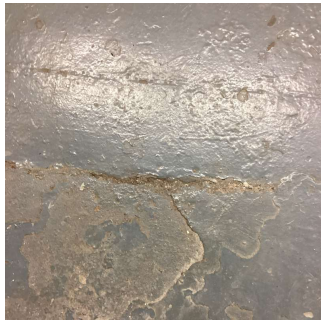
Question	Response
INTERIOR	Inspected
STRUCTURAL	
COLUMNS/BEAMS/BEARING WALLS	
Deficiency	CONCRETE COLUMNS/BEAMS: CRACKED/SPALLED/REINFORCEMENT EXPOSED
Deficiency Location/Instance	Basement - Mechanical Room
Deficiency Quantity	10
Quantity Uom	S.F.
Potential Action	REPLACE
Urgency of Action	PRIORITY 4
Purpose of Action	LEVEL 5
Deficiency Photo1	 
	Basement - Mechanical Room
Violations	No violations recorded.
FLOOR STRUCTURE	Inspected
Condition	3 - Fair
Deficiency	CONCRETE SLAB ON GRADE: THRU CRACKS
Deficiency Location/Instance	Basement - Mechanical Room, Boiler Room, Corridor, Elevator Machine Room
Deficiency Quantity	40
Quantity Uom	S.F.
Potential Action	REPAIR
Urgency of Action	PRIORITY 3
Purpose of Action	LEVEL 5
Deficiency Photo1

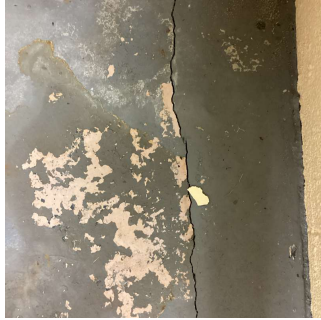
Question	Response
INTERIOR	
STRUCTURAL	
FLOOR STRUCTURE	
Deficiency Photo1	 
Violations	1st Floor - Kitchen Storage No violations recorded.
Deficiency	CONCRETE SLAB ON GRADE: THRU CRACKS
Deficiency Location/Instance	Basement - Dry Food Storage, Non-Food Storage
Deficiency Quantity	30
Quantity Uom	S.F.
Potential Action	REPLACE
Urgency of Action	PRIORITY 4
Purpose of Action	LEVEL 5
Deficiency Photo1

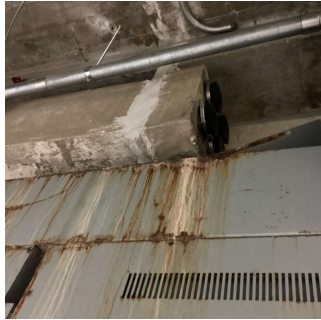
Violations	Basement - Boiler Room No violations recorded.
Deficiency	CONCRETE: WATER INFILTRATION IN ELECTRICAL PANEL ROOM
Deficiency Location/Instance	Basement - Electrical Panel Room
Deficiency Quantity	100
Quantity Uom	S.F.
Potential Action	INSTALL WATERPROOFING
Urgency of Action	PRIORITY 5
Purpose of Action	LEVEL 6
Deficiency Photo1

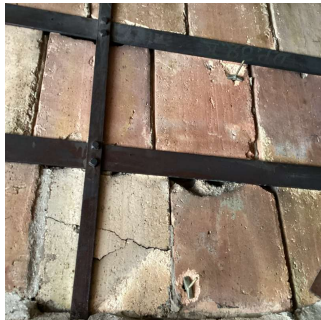
BH2
Violations	No violations recorded.
Deficiency	CLAY/CONCRETE TILES: MISSING/CRACKED/SPALLED
Deficiency Location/Instance	Roof 1 - Attic
Deficiency Quantity	230
Quantity Uom	S.F.
Potential Action	REPLACE
Urgency of Action	PRIORITY 3
Purpose of Action	LEVEL 5
Deficiency Photo1

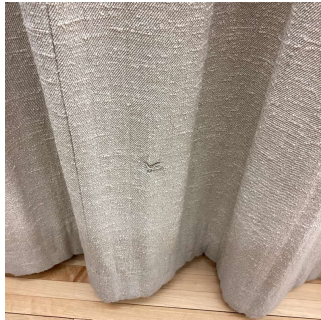
Question	Response
INTERIOR	
AUDITORIUM	
Stage	
Stage Curtains	
Condition	3 - Fair
Deficiency	WORN/DETERIORATED
Deficiency Location/Instance	Right Side
Deficiency Quantity	100
Quantity Uom	S.F.
Potential Action	REPLACE
Urgency of Action	PRIORITY 3
Purpose of Action	LEVEL 2
Deficiency Photo1

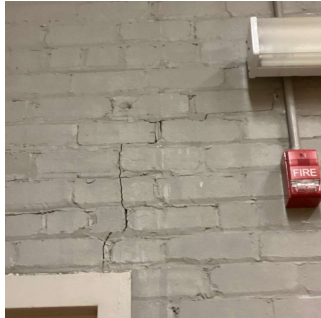
Right Side
Violations	No violations recorded.
Walls	
Instance on 2nd Floor (640 Seats)	Inspected
Condition	2 - Between Good and Fair
Deficiency	BRICK: CRACKS/SPALLING
Deficiency Location/Instance	Left Side, Storage Room
Deficiency Quantity	20
Quantity Uom	S.F.
Potential Action	REPLACE
Urgency of Action	PRIORITY 3
Purpose of Action	LEVEL 2
Deficiency Photo1

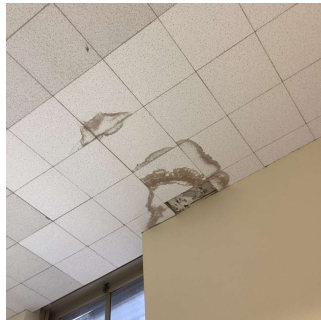
Question	Response
INTERIOR	
CAFETERIA	
Ceiling	
Instance on 1st Floor - Staff	Inspected
Condition	2 - Between Good and Fair
Deficiency	ACOUSTIC TILES ON PLASTER: DAMAGED/MISSING
Deficiency Location/Instance	Near Windows
Deficiency Quantity	20
Quantity Uom	S.F.
Potential Action	REPLACE
Urgency of Action	PRIORITY 3
Purpose of Action	LEVEL 2
Deficiency Photo1

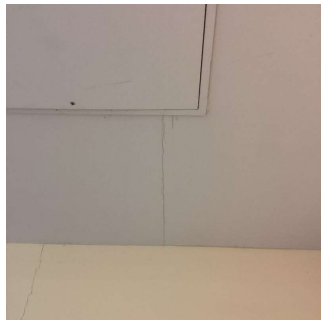
Violations	Near Windows No violations recorded.
Deficiency	GYPSUM BOARD: DAMAGED/DETERIORATED
Deficiency Location/Instance	Near Servery, by Main Entrance
Deficiency Quantity	20
Quantity Uom	S.F.
Potential Action	REPLACE
Urgency of Action	PRIORITY 3
Purpose of Action	LEVEL 2
Deficiency Photo1

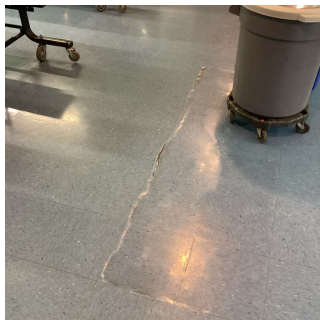
Near Windows
Violations	No violations recorded.
Instance on 1st Floor - Students	Inspected
Condition	2 - Between Good and Fair
Deficiency	VINYL TILES: DETERIORATED SUBSTRATE
Deficiency Location/Instance	Near Main Entrance
Deficiency Quantity	30
Quantity Uom	S.F.
Potential Action	REPLACE
Urgency of Action	PRIORITY 3
Purpose of Action	LEVEL 2
Deficiency Photo1

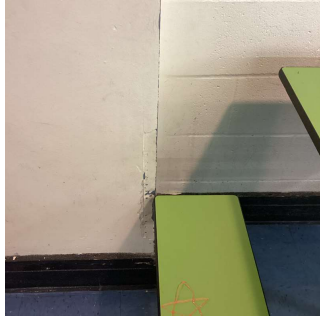
Near Main Entrance
Violations	No violations recorded.
Sliding-folding Partition	
Instance on 1st Floor - Staff	Does not Exist
Instance on 1st Floor - Students	Does not Exist
Stage	
Instance on 1st Floor - Students	Does not Exist
Instance on 1st Floor - Staff	Does not Exist
Walls	
Instance on 1st Floor - Students	Inspected
Condition	2 - Between Good and Fair
Deficiency	GYPSUM BOARD: DETERIORATED
Deficiency Location/Instance	Near West Side - Students Toilet Room

Deficiency Quantity	20
Quantity Uom	S.F.
Potential Action	REPLACE

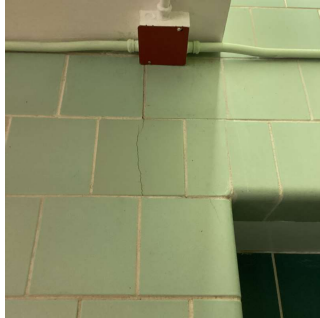
Near West Side - Students Toilet Room
Violations	No violations recorded.
Deficiency	GLAZED BLOCK: CRACKS/SPALLING
Deficiency Location/Instance	Near West Side - Students Toilet Rooms, by Left Side Main Entrance
Deficiency Quantity	20
Quantity Uom	S.F.
Potential Action	REPLACE
Urgency of Action	PRIORITY 3
Purpose of Action	LEVEL 2
Deficiency Photo1

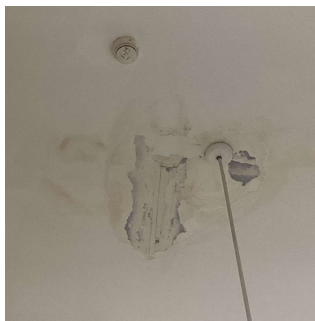
Question	Response
INTERIOR	
CLASSROOMS/CORRIDORS/ADMIN SPACES	
Ceiling	
Violations	No violations recorded.
Deficiency	PLASTER: CRACKS/SPALLING - ACTIVE LEAK
Deficiency Location/Instance	Room 413, Corridor near Room 305, by Elevator A/4
Deficiency Quantity	60
Quantity Uom	S.F.
Potential Action	REPLACE
Urgency of Action	PRIORITY 5
Purpose of Action	LEVEL 2
Deficiency Photo1

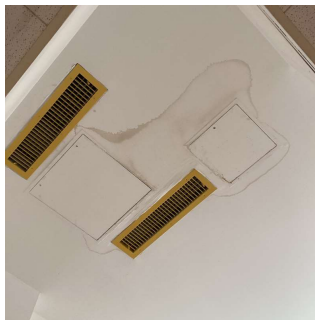
Violations	Room 413 No violations recorded.
Deficiency	GYPSUM BOARD: DAMAGED/DETERIORATED
Deficiency Location/Instance	Corridor near Cafeteria, by Rooms 203, 238
Deficiency Quantity	60
Quantity Uom	S.F.
Potential Action	REPLACE
Urgency of Action	PRIORITY 3
Purpose of Action	LEVEL 2
Deficiency Photo1

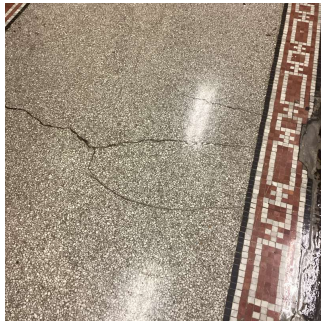
Question	Response
INTERIOR	
CLASSROOMS/CORRIDORS/ADMIN SPACES	
Floor Finish	
Violations	Corridor near Room 217 No violations recorded.
Deficiency	TERRAZZO: CRACKS
Deficiency Location/Instance	Corridor near Stair C/2, by Auditorium, close to Rooms 208, 209, 211 and others
Deficiency Quantity	150
Quantity Uom	S.F.
Potential Action	REPLACE
Urgency of Action	PRIORITY 3
Purpose of Action	LEVEL 2
Deficiency Photo1

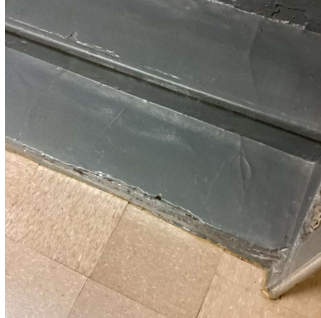
Violations	Corridor near Stair C/2 No violations recorded.
Deficiency	STONE: BROKEN/MISSING TILES
Deficiency Location/Instance	Stair D/1
Deficiency Quantity	10
Quantity Uom	S.F.
Potential Action	REPLACE
Urgency of Action	PRIORITY 3
Purpose of Action	LEVEL 2
Deficiency Photo1

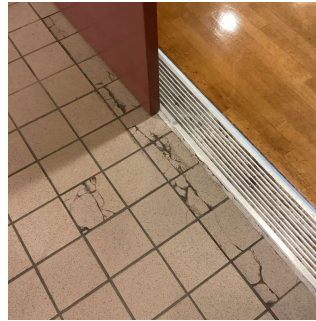
Corridor by Gymnasium

Violations	Stair D/1 No violations recorded.
Deficiency	QUARRY TILE: DETERIORATED SUBSTRATE
Deficiency Location/Instance	Main Entrance, Corridor near Rooms 103, 104, by Gymnasium
Deficiency Quantity	50
Quantity Uom	S.F.
Potential Action	REPLACE

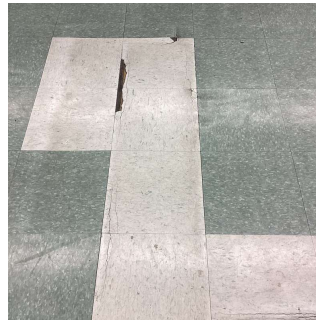
Room 413

VINYL TILES: DETERIORATED SUBSTRATE

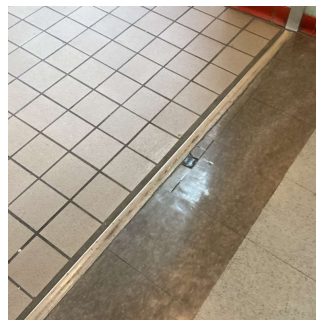
Corridor near Cafeteria

VINYL TILES: BROKEN/DETERIORATED/MISSING TILES

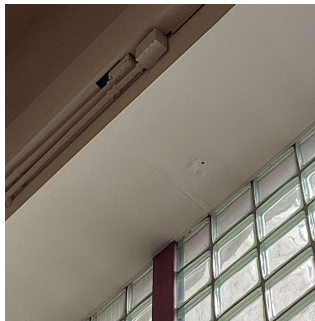
Deficiency	GYPSUM BOARD: DAMAGED/DETERIORATED

Question	Response
INTERIOR	
GYMNASIUM	
Ceiling	
Deficiency Location/Instance	Near Windows
Deficiency Quantity	10
Quantity Uom	S.F.
Potential Action	REPLACE
Urgency of Action	PRIORITY 3
Purpose of Action	LEVEL 2
Deficiency Photo1

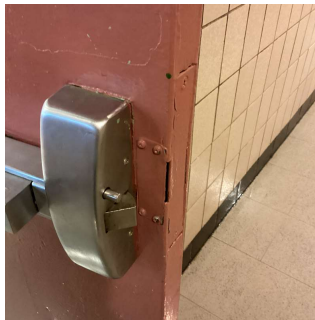
Violations	Near Windows No violations recorded.
Door(s)	
Instance on 1st Floor	Inspected
Condition	5 - Poor
Deficiency	METAL: DETERIORATED DOOR
Deficiency Location/Instance	Right and Left Side Main Entrance
Deficiency Quantity	3
Quantity Uom	EACH
Potential Action	MAINTENANCE
Urgency of Action	PRIORITY 3
Purpose of Action	LEVEL 2
Deficiency Photo1

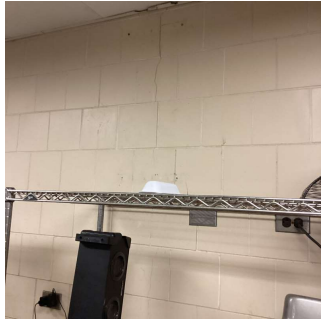
Violations	Sink Room No violations recorded.
Walls	
Instance on 1st Floor	Inspected
Condition	2 - Between Good and Fair
Deficiency	GLAZED BLOCK: CRACKS/SPALLING
Deficiency Location/Instance	Near Office Room, by Main Entrance, Sink Room
Deficiency Quantity	20
Quantity Uom	S.F.
Potential Action	REPLACE
Urgency of Action	PRIORITY 3
Purpose of Action	LEVEL 2
Deficiency Photo1

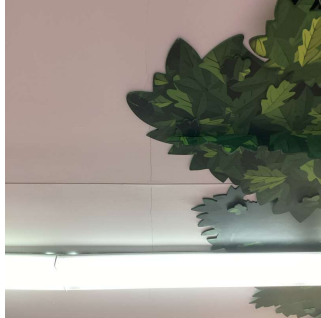
Question	Response
INTERIOR	
KITCHEN	Inspected
Walls	
Deficiency Photo1	 
	Kitchen Men Locker Room
Violations	No violations recorded.
LIBRARY	Inspected
Instance on 1st Floor	Inspected
Instance on Room 303	Inspected
Built-in Furnishing	
Instance on Room 303	Inspected
Condition	2 - Between Good and Fair
Deficiency	No deficiencies recorded
Instance on 1st Floor	Does not Exist
Ceiling	
Instance on Room 303	Inspected
Condition	3 - Fair
Deficiency	GYPSUM BOARD: DAMAGED/DETERIORATED
Deficiency Location/Instance	Rear Wall, Center
Deficiency Quantity	20
Quantity Uom	S.F.
Potential Action	REPLACE
Urgency of Action	PRIORITY 3
Purpose of Action	LEVEL 2
Deficiency Photo1	 
	Rear Wall
Violations	No violations recorded.
Instance on 1st Floor	Inspected
Condition	2 - Between Good and Fair
Deficiency	GYPSUM BOARD: DAMAGED/DETERIORATED
Deficiency Location/Instance	Center
Deficiency Quantity	10
Quantity Uom	S.F.
Potential Action	REPLACE

Question	Response
INTERIOR	
LIBRARY	Inspected
Ceiling	
Urgency of Action	PRIORITY 3
Purpose of Action	LEVEL 2
Deficiency Photo1

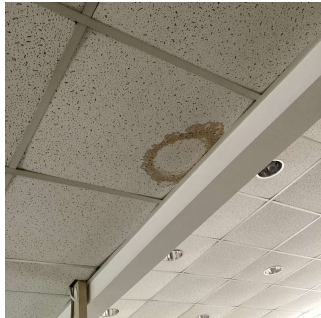
Violations	Center No violations recorded.
Instance on Room 303	Inspected
Condition	3 - Fair
Deficiency	ACOUSTIC TILES: DAMAGED/MISSING
Deficiency Location/Instance	Near Main Entrance
Deficiency Quantity	50
Quantity Uom	S.F.
Potential Action	REPLACE
Urgency of Action	PRIORITY 3
Purpose of Action	LEVEL 2
Deficiency Photo1

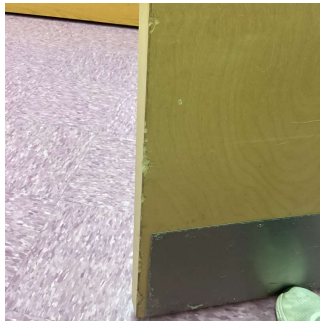
Violations	Near Main Entrance No violations recorded.
Door(s)	
Instance on 1st Floor	Inspected
Condition	3 - Fair
Deficiency	WOOD: DETERIORATED DOOR
Deficiency Location/Instance	Exit Door
Deficiency Quantity	1
Quantity Uom	EACH
Potential Action	MAINTENANCE
Urgency of Action	PRIORITY 3
Purpose of Action	LEVEL 2

Question	Response
INTERIOR	
LIBRARY	
Door(s)	
Deficiency Photo1

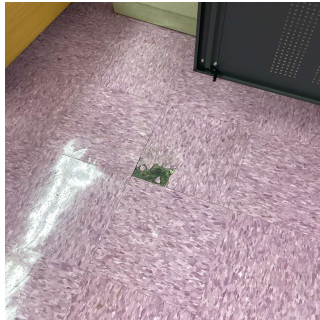
Exit Door
Violations	No violations recorded.
Floor Finish	
Instance on 1st Floor	Inspected
Condition	2 - Between Good and Fair
Deficiency	VINYL TILES: BROKEN/DETERIORATED/MISSING TILES
Deficiency Location/Instance	Near Windows
Deficiency Quantity	10
Quantity Uom	S.F.
Potential Action	REPLACE
Urgency of Action	PRIORITY 3
Purpose of Action	LEVEL 2
Deficiency Photo1

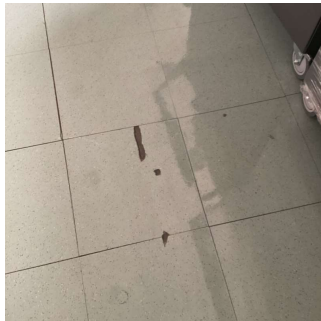
Near Windows
Violations	No violations recorded.
Instance on Room 303	Inspected
Condition	2 - Between Good and Fair
Deficiency	VINYL TILES: BROKEN/DETERIORATED/MISSING TILES
Deficiency Location/Instance	Near Main Entrance, By Windows
Deficiency Quantity	20
Quantity Uom	S.F.
Potential Action	REPLACE
Urgency of Action	PRIORITY 3
Purpose of Action	LEVEL 2

Question	Response
INTERIOR	
LIBRARY	
Floor Finish	
Deficiency Photo1

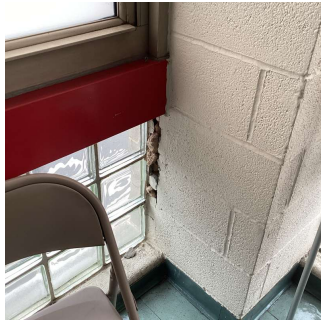
Violations	By Windows No violations recorded.
Walls	
Instance on Room 303	Inspected
Condition	2 - Between Good and Fair
Deficiency	MASONRY: CRACKS/SPALLING
Deficiency Location/Instance	By Windows
Deficiency Quantity	10
Quantity Uom	S.F.
Potential Action	REPLACE
Urgency of Action	PRIORITY 3
Purpose of Action	LEVEL 2
Deficiency Photo1

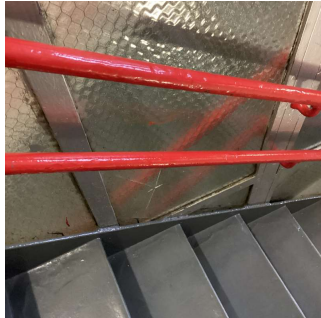
Question	Response
INTERIOR	
STAIRS/RAMPS: INTERIOR	
Door(s)	Inspected
	Stair F/3
Violations	No violations recorded.
Partition	Inspected
Condition	3 - Fair
Deficiency	GLASS PANEL: DAMAGED/DETERIORATED
Deficiency Location/Instance	Stairs C/4, 3, D/4, 3, 1 and others
Deficiency Quantity	60
Quantity Uom	S.F.
Potential Action	REPLACE
Urgency of Action	PRIORITY 3
Purpose of Action	LEVEL 2
Deficiency Photo1

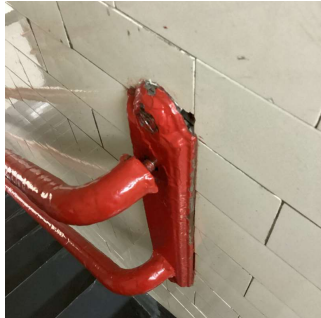
Violations	Stair C/4 No violations recorded.
Railings	Inspected
Condition	3 - Fair
Deficiency	METAL: BROKEN BRACKET
Deficiency Location/Instance	Stairs C/1
Deficiency Quantity	1
Quantity Uom	EACH
Potential Action	REPLACE
Urgency of Action	PRIORITY 3
Purpose of Action	LEVEL 2
Deficiency Photo1

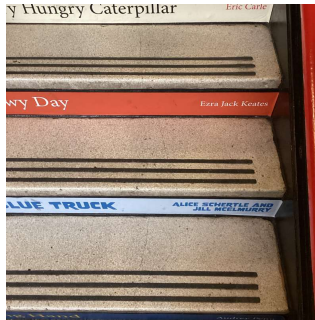
Violations	Stair C/1 No violations recorded.
Stairs and Landings	Inspected
Condition	3 - Fair
Deficiency	TERRAZZO: CRACKS
Deficiency Location/Instance	Stairs A/2, 4
Deficiency Quantity	30

Question	Response
INTERIOR	
STAIRS/RAMPS: INTERIOR	
Stairs and Landings	
Quantity Uom	S.F.
Potential Action	REPLACE
Urgency of Action	PRIORITY 3
Purpose of Action	LEVEL 2
Deficiency Photo1

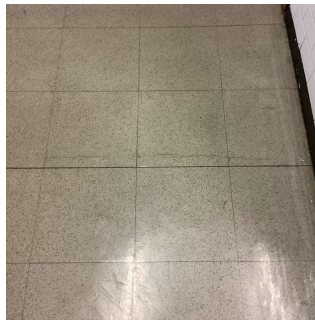
Violations	<p>Stair A/2</p> <p>No violations recorded.</p>
Deficiency	VINYL TILES: DETERIORATED SUBSTRATE
Deficiency Location/Instance	Stairs C/4, 1, F/3
Deficiency Quantity	30
Quantity Uom	S.F.
Potential Action	REPLACE
Urgency of Action	PRIORITY 3
Purpose of Action	LEVEL 2
Deficiency Photo1

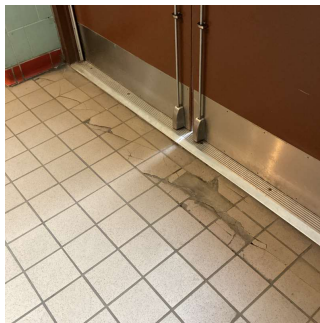
Violations	<p>Stair C/4</p> <p>No violations recorded.</p>
Deficiency	QUARRY TILE: DETERIORATED SUBSTRATE
Deficiency Location/Instance	Stairs B/1, H/Basement, I/Exit - Vestibule, Interior Ramp near Stair A/2
Deficiency Quantity	70
Quantity Uom	S.F.
Potential Action	REPLACE
Urgency of Action	PRIORITY 3
Purpose of Action	LEVEL 2

Question	Response
INTERIOR	
STAIRS/RAMPS: INTERIOR	
Stairs and Landings	
Deficiency Photo1

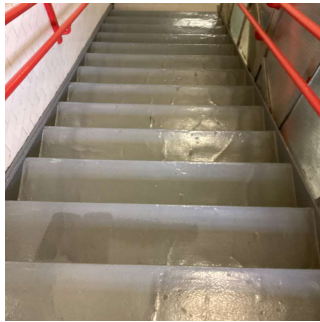
Violations	Stair I/Exit - Vestibule No violations recorded.
Deficiency	ROLLED ASPHALT: CRACKS
Deficiency Location/Instance	Stairs C/3, D/4, 3
Deficiency Quantity	210
Quantity Uom	S.F.
Potential Action	REPLACE
Urgency of Action	PRIORITY 3
Purpose of Action	LEVEL 2
Deficiency Photo1

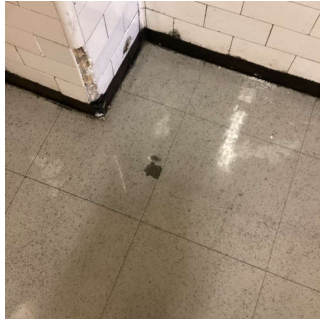
Violations	Stair D/4 No violations recorded.
Deficiency	VINYL TILES: BROKEN/DETERIORATED/MISSING TILES
Deficiency Location/Instance	Stairs C/4, 3, D/4, 2, Interior Ramp near Stair G/2 and others
Deficiency Quantity	80
Quantity Uom	S.F.
Potential Action	REPLACE
Urgency of Action	PRIORITY 3
Purpose of Action	LEVEL 2
Deficiency Photo1

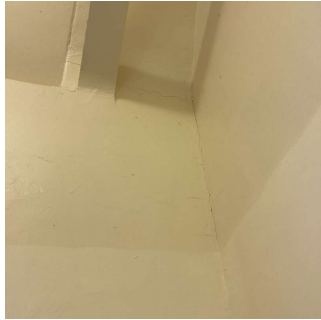
Question	Response
INTERIOR	
STAIRS/RAMPS: INTERIOR	
Walls	Inspected
Condition	2 - Between Good and Fair
Deficiency	PLASTER: CRACKS/SPALLING
Deficiency Location/Instance	Stairs C/1, D/4, 2, F/3
Deficiency Quantity	50
Quantity Uom	S.F.
Potential Action	REPLACE
Urgency of Action	PRIORITY 3
Purpose of Action	LEVEL 2
Deficiency Photo1

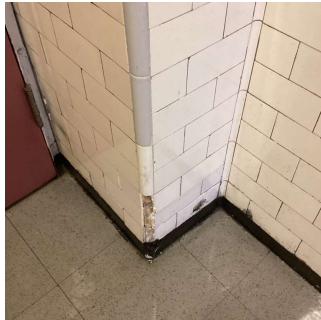
Violations	Stair D/4 No violations recorded.
Deficiency	CERAMIC TILE: BROKEN/ MISSING
Deficiency Location/Instance	Stairs C/1, D/4, 3, 2, 1 and others
Deficiency Quantity	70
Quantity Uom	S.F.
Potential Action	REPLACE
Urgency of Action	PRIORITY 3
Purpose of Action	LEVEL 2
Deficiency Photo1

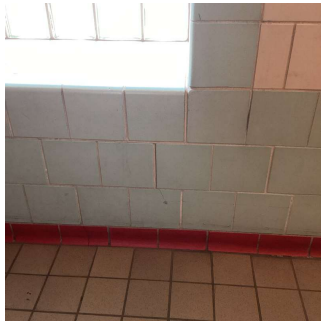
Violations	Stair D/4 No violations recorded.
Deficiency	GLAZED BLOCK: CRACKS/SPALLING
Deficiency Location/Instance	Stairs A/3, G/3, 1, I/Exit - Vestibule, Exit 6 - Vestibule and others
Deficiency Quantity	50
Quantity Uom	S.F.
Potential Action	REPLACE
Urgency of Action	PRIORITY 3
Purpose of Action	LEVEL 2

Question	Response
INTERIOR	
STAIRS/RAMPS: INTERIOR	
Walls	
Deficiency Photo1

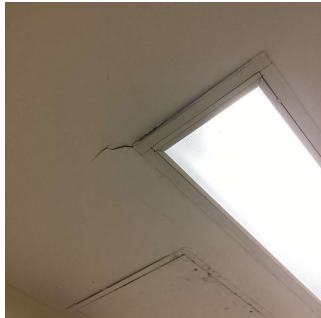
Violations	Stair I/Exit - Vestibule No violations recorded.
TOILET ROOMS - STAFF	Inspected
Ceiling	Inspected
Condition	2 - Between Good and Fair
Deficiency	GYPSUM BOARD: DAMAGED/DETERIORATED
Deficiency Location/Instance	Men Toilet Room - Staff Cafeteria
Deficiency Quantity	10
Quantity Uom	S.F.
Potential Action	REPLACE
Urgency of Action	PRIORITY 3
Purpose of Action	LEVEL 2
Deficiency Photo1

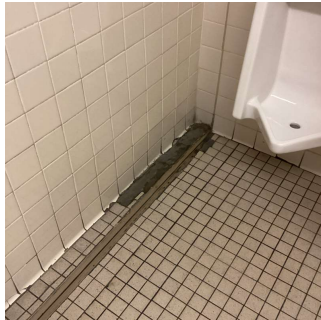
Question	Response
INTERIOR	
TOILET ROOMS - STUDENTS	
Floor Finish	Inspected
Condition	2 - Between Good and Fair
Deficiency	CERAMIC TILE: BROKEN/MISSING TILES
Deficiency Location/Instance	Boys Toilet Room - 3rd Floor, Girls Toilet Room - 4th Floor, Students Toilet Room - Gymnasium
Deficiency Quantity	30
Quantity Uom	S.F.
Potential Action	REPLACE
Urgency of Action	PRIORITY 3
Purpose of Action	LEVEL 2
Deficiency Photo1

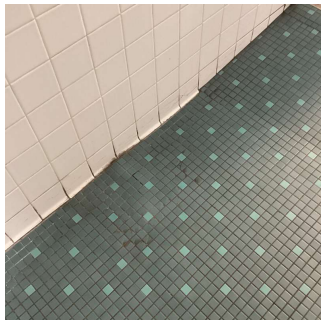
Violations	Boys Toilet Room - 3rd Floor No violations recorded.
Deficiency	CERAMIC TILE: DETERIORATED SUBSTRATE
Deficiency Location/Instance	Girls Toilet Room - East Side Students Cafeteria
Deficiency Quantity	10
Quantity Uom	S.F.
Potential Action	REPLACE
Urgency of Action	PRIORITY 3
Purpose of Action	LEVEL 2
Deficiency Photo1

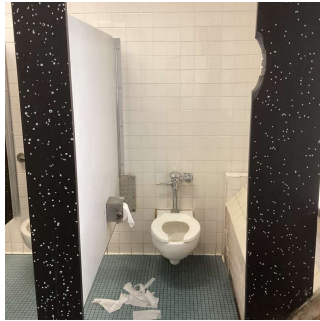
Violations	Girls Toilet Room - East Side Students Cafeteria No violations recorded.
Stalls	Inspected
Condition	2 - Between Good and Fair
Deficiency	BROKEN/MISSING
Deficiency Location/Instance	Boys Toilet Room - 4th Floor

Deficiency Quantity	2
Quantity Uom	EACH
Potential Action	REPLACE
Urgency of Action	PRIORITY 3
Purpose of Action	LEVEL 2

Question	Response
INTERIOR	
TOILET ROOMS - STUDENTS	
Stalls	
Deficiency Photo1

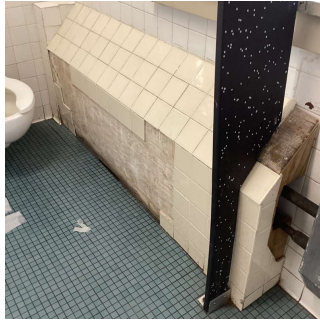
Violations	Boys Toilet Room - 4th Floor No violations recorded.
Walls	Inspected
Condition	2 - Between Good and Fair
Deficiency	CERAMIC TILE: BROKEN/ MISSING
Deficiency Location/Instance	Girls Toilet Room - East and West Side Students Cafeteria, Girls Toilet Room - 4th, 3rd Floor, Boys Toilet Room - 3rd Floor and others
Deficiency Quantity	100
Quantity Uom	S.F.
Potential Action	REPLACE
Urgency of Action	PRIORITY 3
Purpose of Action	LEVEL 2
Deficiency Photo1

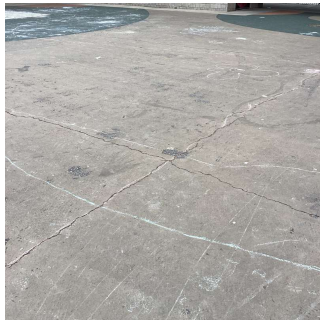
Question	Response
SITE	
PAVING	
Student Use	
Asphalt	Inspected
Condition	4 - Between Fair and Poor
Deficiency	CRACKS - MAJOR
Deficiency Location/Instance	Courtyard, near Playground
Deficiency Quantity	520
Quantity Uom	S.F.
Potential Action	REPLACE
Urgency of Action	PRIORITY 3
Purpose of Action	LEVEL 2
Deficiency Photo1

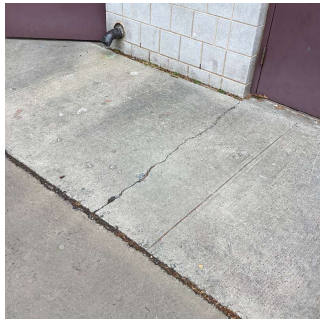
Violations	Courtyard No violations recorded.
Concrete	Inspected
Condition	3 - Fair
Deficiency	DAMAGED/DETERIORATED/MISSING SECTIONS
Deficiency Location/Instance	Courtyard, near Playground
Deficiency Quantity	175
Quantity Uom	S.F.
Potential Action	REPLACE
Urgency of Action	PRIORITY 3
Purpose of Action	LEVEL 2
Deficiency Photo1

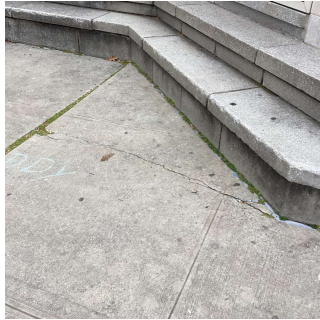
Question	Response
SITE	
PAVING	
Site Sidewalks & Walkways	
Concrete	
Deficiency	DAMAGED/DETERIORATED/MISSING SECTIONS
Deficiency Location/Instance	E 23rd Street, Glenwood Road, E 24th Street, near Exits 5, 6
Deficiency Quantity	325
Quantity Uom	S.F.
Potential Action	REPLACE
Urgency of Action	PRIORITY 3
Purpose of Action	LEVEL 2
Deficiency Photo1

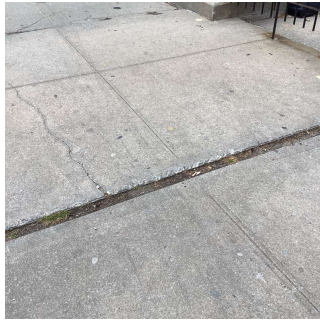
Violations	E 23rd Street No violations recorded.
Pavers	Does not Exist
DOT Sidewalk	Inspected
Asphalt	Does not Exist
Concrete	Inspected
Condition	4 - Between Fair and Poor
Deficiency	HEAVING
Deficiency Location/Instance	Campus Road
Deficiency Quantity	50
Quantity Uom	S.F.
Potential Action	REPLACE
Urgency of Action	PRIORITY 3
Purpose of Action	LEVEL 2
Deficiency Photo1

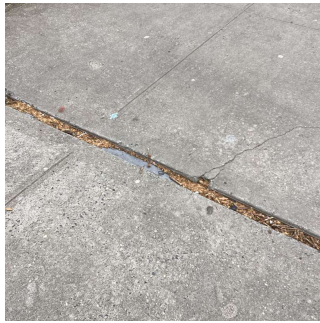
Question	Response
SITE	
PAVING	
DOT Sidewalk	
Concrete	
Urgency of Action	PRIORITY 5
Purpose of Action	LEVEL 6
Deficiency Photo1

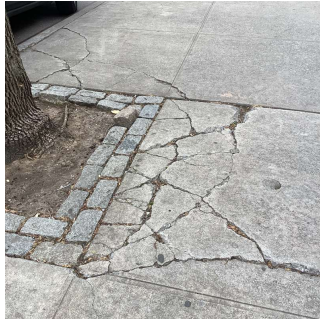
E 23rd Street
Violations	No violations recorded.
Deficiency	DAMAGED/DETERIORATED/MISSING SECTIONS
Deficiency Location/Instance	E 23rd Street, Glenwood Road, E 24th Street, Campus Road
Deficiency Quantity	3,675
Quantity Uom	S.F.
Potential Action	REPLACE
Urgency of Action	PRIORITY 3
Purpose of Action	LEVEL 2
Deficiency Photo1

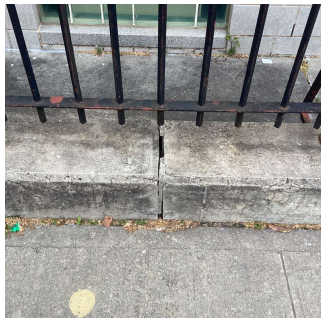
Question	Response
SITE	
PLAYGROUNDS	Inspected
Unpaved Area	
Instance on East of the building (by East 24th Street)	Does not Exist
PLAYING SURFACE	Does not Exist
RETAINING WALLS	Inspected
Are there any Retaining Walls 6' OR higher facing public street/sidewalk?	No
Condition	3 - Fair
Deficiency	CAST IN PLACE CONCRETE: DETERIORATED CONTROL/EXPANSION JOINT
Deficiency Location/Instance	E 23rd Street
Deficiency Quantity	10
Quantity Uom	L.F.
Potential Action	REPLACE
Urgency of Action	PRIORITY 3
Purpose of Action	LEVEL 2
Deficiency Photo1

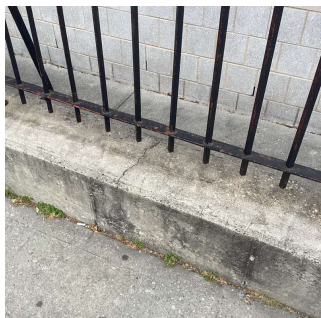
E 23rd Street
Violations	No violations recorded.
Deficiency	CAST IN PLACE CONCRETE: CRACKS/SPALLING - MAJOR
Deficiency Location/Instance	E 23rd Street, Campus Road
Deficiency Quantity	80
Quantity Uom	S.F.
Potential Action	REPLACE
Urgency of Action	PRIORITY 3
Purpose of Action	LEVEL 2
Deficiency Photo1
