NYC Department of Education
Building Condition Assessment Survey 2023 - 2024

Architectural Inspection

Asset: **P.S. 178 - BROOKLYN, 2163 DEAN STREET, New York, 11212**

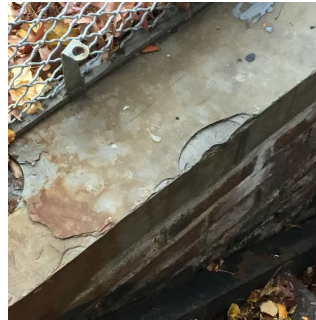
AW1	No violations recorded.
-----	-------------------------

Deficiency	AREAWAY WALLS: DETERIORATED COPING STONE
Roof Plan reference	K178

Deficiency Quantity	15
Quantity Uom	S.F.
Potential Action	REPAIR
Urgency of Action	PRIORITY 3
Purpose of Action	LEVEL 2
Deficiency Photo1

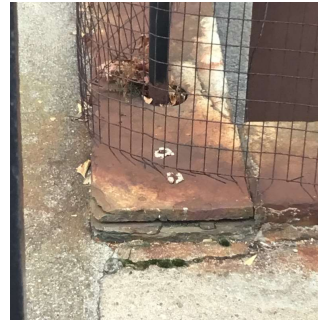
AW1

Deficiency	AREAWAY WALLS: DETERIORATED COPING STONE
Roof Plan reference	K178

Deficiency Quantity	20
Quantity Uom	S.F.
Potential Action	REPLACE
Urgency of Action	PRIORITY 4
Purpose of Action	LEVEL 2

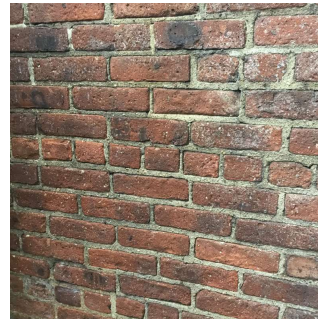
AW1

AREAWAY WALLS: DETERIORATED JOINTS

REPAIR

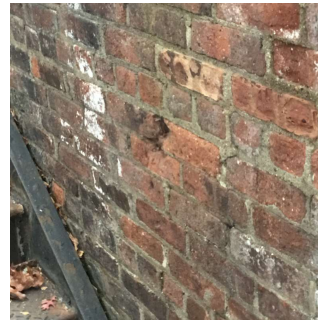
AW1

AREAWAY WALLS: CRACKS AND SPALLING

REPLACE

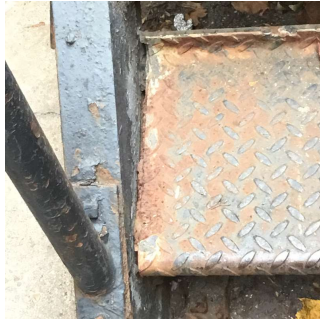
AREAWAY STAIRS: DETERIORATED
TREADS/RISERS/NOSINGS

REPLACE

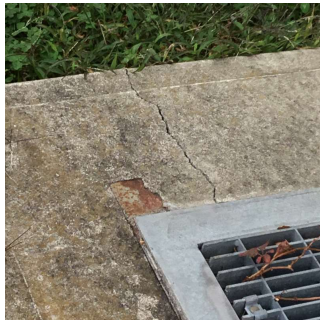
Violations	AW1 No violations recorded.
Instance on AW2-AW6	Inspected
Instance Condition	3 - Fair
Instance Quantity	6
Instance Quantity Uom	EACH
Deficiency	AREAWAY WALLS: CRACKS AND SPALLING
Roof Plan reference	K178

Deficiency Quantity	20
Quantity Uom	S.F.
Potential Action	REPAIR
Urgency of Action	PRIORITY 3
Purpose of Action	LEVEL 2
Deficiency Photo1

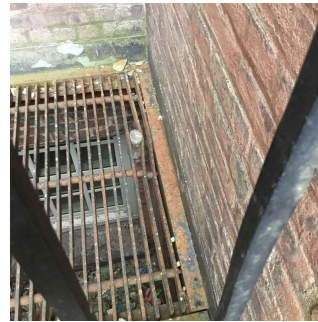
AW6

Violations	AW7 No violations recorded.
Deficiency	AREAWAY GRATINGS: MAJOR RUSTING / OR BROKEN

REPLACE

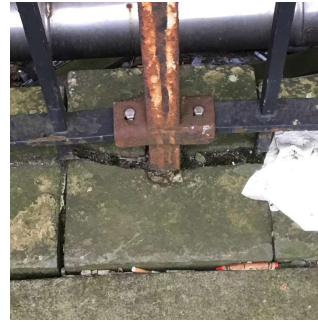
AW4

AREAWAY WALLS: DETERIORATED COPING STONE

REPLACE

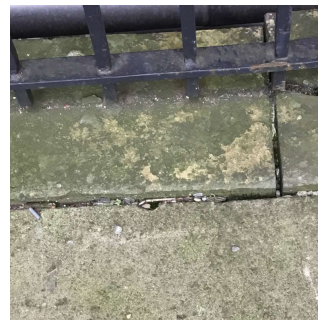
AW4

AREAWAY WALLS: DETERIORATED JOINTS AT COPING STONES

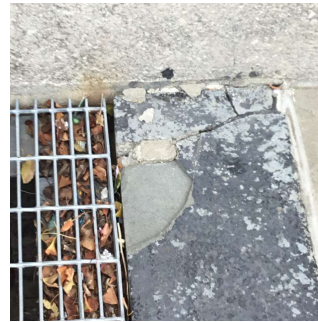
AW2

AREAWAY WALLS: CRACKS AND SPALLING

REPLACE

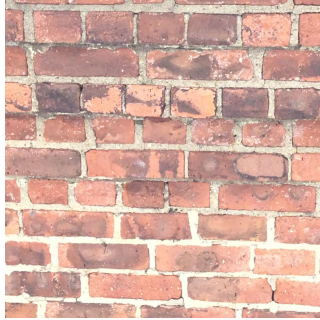
BRICK: DETERIORATED JOINTS

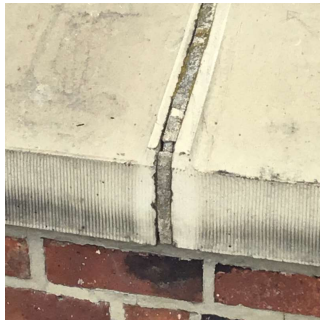
Violations	<p>CH2</p> <p>No violations recorded.</p>
COPING	Inspected
Condition	4 - Between Fair and Poor
Deficiency	TERRA COTTA: DETERIORATED TRANSVERSE JOINTS
Roof Plan reference	K178
Deficiency Quantity	75
Quantity Uom	L.F.
Potential Action	MAINTENANCE
Urgency of Action	PRIORITY 3
Purpose of Action	LEVEL 2
Deficiency Photo1

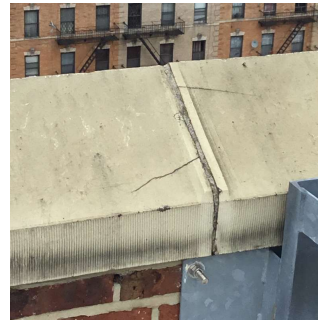
Roof 2

Violations	<p>Roof 2</p> <p>No violations recorded.</p>
Deficiency	TERRA COTTA: CRACKED/BROKEN PIECES

REPLACE-IN-KIND

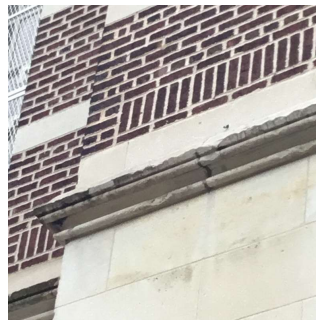
Facade B

STONE: MAJOR CRACKS, SPALLING

REPLACE

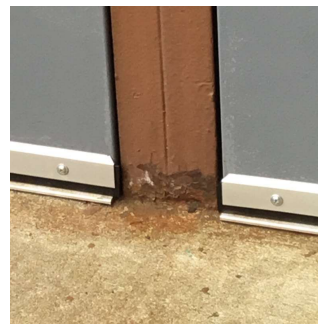
Facade F

METAL: DETERIORATED DOOR AND FRAME - MINOR DETERIORATION

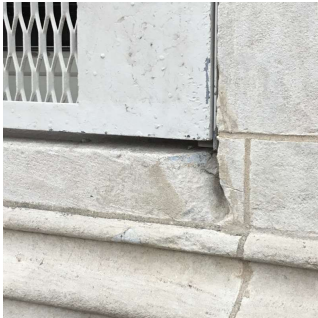
Question	Response
EXTERIOR	
EXTERIOR WALLS	Inspected
Material Type(s)	Masonry
Replacement Quantity	42,500
Replacement Uom	S.F.
Instance on All Facades	Inspected
Instance Condition	4 - Between Fair and Poor
Instance Quantity	42,500
Instance Quantity Uom	S.F.
Deficiency	STONE: DETERIORATED MASONRY SILLS - MAJOR
Roof Plan reference	K178
Elevation

Deficiency Quantity	15
Quantity Uom	L.F.
Potential Action	REMOVE AND REPLACE
Urgency of Action	PRIORITY 4
Purpose of Action	LEVEL 2
Deficiency Photo1

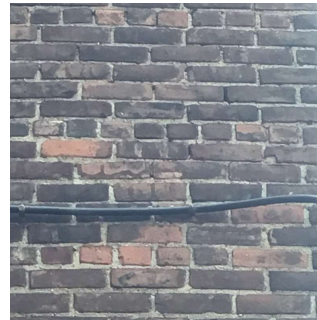
Facade H

Violations	Facade L No violations recorded.
Deficiency	BRICK: DETERIORATED JOINTS

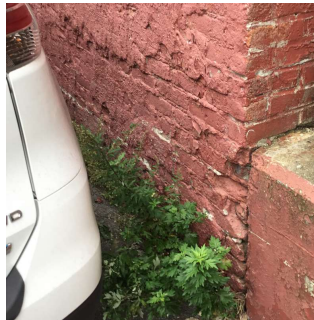
Facade G

BRICK: MAJOR / THRU CRACKS

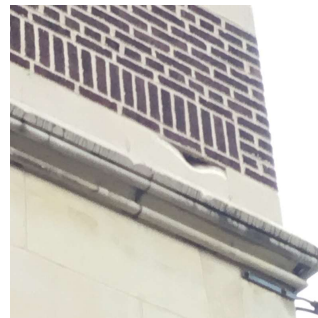
Facade B

STONE: CHIPPED/SPALLED/BROKEN PIECES - MAJOR
K178

REPLACE

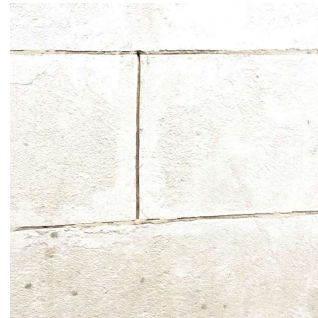
Facade A

STONE: DETERIORATED JOINTS

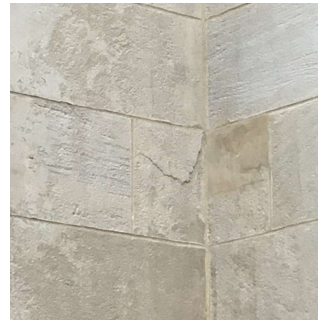
Facade A

STONE: CHIPPED/SPALLED/BROKEN PIECES - MINOR

REPAIR

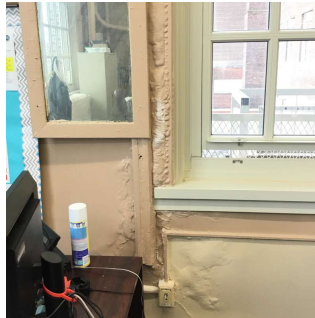
BRICK: WATER INFILTRATION IN INSTRUCTIONAL SPACE
K178

<p>Facade D - Room 302 (Facade A - Rooms 509, 511, Facade L - Rooms 312, 412, 512, Facade M - Rooms 311, 413</p>
Violations	No violations recorded.
EXTERIOR SOFFITS	Inspected
Condition	3 - Fair
Deficiency	CONCRETE: MAJOR CRACKS/SPALLING
Roof Plan reference	K178

REPAIR

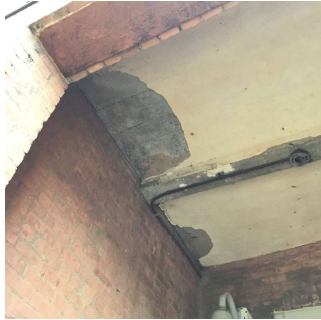
Deficiency Quantity	25
Quantity Uom	S.F.
Potential Action	REPLACE
Urgency of Action	PRIORITY 4
Purpose of Action	LEVEL 2

Violations	<p>Facade K</p> <p>No violations recorded.</p>
LOADING DOCK	Does not Exist
LOUVER	Inspected
Condition	3 - Fair
Deficiency	BROKEN/ DENTED BLADES
Roof Plan reference	K178

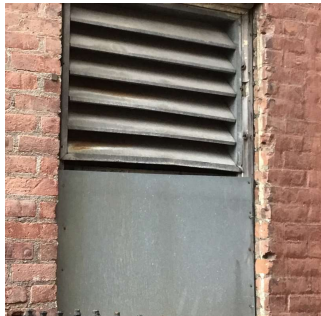
Deficiency Quantity	10
Quantity Uom	S.F.
Potential Action	REPLACE
Urgency of Action	PRIORITY 4
Purpose of Action	LEVEL 2
Deficiency Photo1

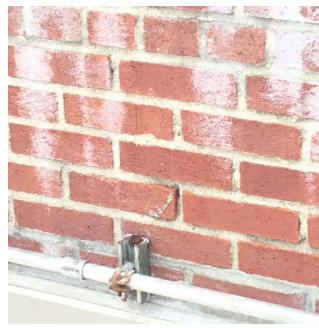
Roof 1
Violations	No violations recorded.
Deficiency	BRICK: MAJOR DETERIORATION/CRACKS
Roof Plan reference	K178

Question	Response
EXTERIOR	
LOUVER	Inspected
	Facade K
Violations	No violations recorded.
PARAPETS	Inspected
Material Type(s)	Masonry
Replacement Quantity	3,000
Replacement Uom	C.F.
Instance on All Roofs	Inspected
Instance Condition	5 - Poor
Instance Quantity	3,000
Instance Quantity Uom	C.F.
Deficiency	BRICK: DETERIORATED JOINTS
Roof Plan reference	K178

Deficiency Quantity	40
Quantity Uom	S.F.
Potential Action	REPOINT
Urgency of Action	PRIORITY 3
Purpose of Action	LEVEL 2
Deficiency Photo1

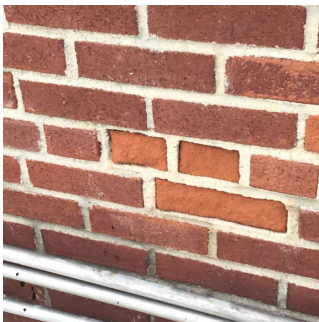
Violations	Roof 1 No violations recorded.
Deficiency	BRICK: EFFLORESCENCE
Roof Plan reference	K178

Question	Response
EXTERIOR	
PARAPETS	Inspected
Deficiency Quantity	10
Quantity Uom	S.F.
Potential Action	REMOVE AND REBUILD
Urgency of Action	PRIORITY 4
Purpose of Action	LEVEL 2
Deficiency Photo1

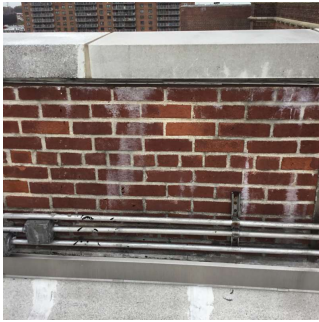
Violations	Roof 1 No violations recorded.
Deficiency	BRICK: DETERIORATED JOINTS

Deficiency Quantity	80
Quantity Uom	S.F.
Potential Action	MAINTENANCE
Urgency of Action	PRIORITY 1
Purpose of Action	LEVEL 1
Deficiency Photo1

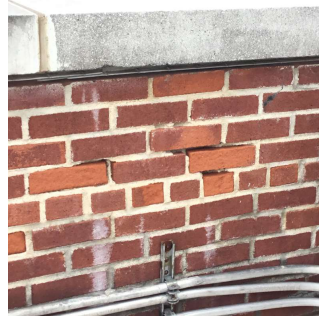
Deficiency Quantity	200
Quantity Uom	S.F.
Potential Action	REPOINT
Urgency of Action	PRIORITY 4
Purpose of Action	LEVEL 2
Deficiency Photo1

Violations	<p>Roof 1</p> <p>No violations recorded.</p>
PLAZA DECK	Does not Exist
ROOF	Inspected
Roofing	Inspected
Replacement Quantity	15,000
Replacement Uom	S.F.
ROOF HATCH/SMOKE HATCH	Does not Exist
LEADERS, GUTTERS, DOWNSPOUTS, SCUPPERS	Inspected
Condition	2 - Between Good and Fair
Deficiency	No deficiencies recorded
ROOF BARRIER/FENCE	Inspected
Condition	1 - Good
Deficiency	No deficiencies recorded
ROOF CAGE	Does not Exist
ROOFING	Inspected
Instance on Modified Bitumen: All Roofs	Inspected
Instance Condition	1 - Good
Instance Photo

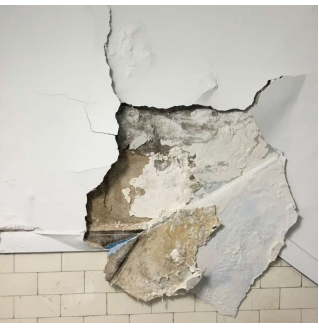
Question	Response
EXTERIOR	
ROOF	
Roofing	
ROOFING	Roof 1
Instance Quantity	15,000
Instance Quantity Uom	S.F.
Does the roof have major mechanical equipment sitting on Dunnage Steel less than 18" above the Roofing?	No
Does this roof instance have a Sustainable Roof System?	Yes
Sustainable Roof Type	White Roof
Sustainable Roof Location (Roof Number)	All Roof
Do solar panels exist on these roofs?	No
Is/Are the roof(s) suitable for Solar Panel installation?	Yes
Installation Year	2019
Source of Installation	Custodial Staff
Deficiency	No deficiencies recorded
ROOFING DRAINS	Inspected
Condition	1 - Good
Deficiency	No deficiencies recorded
Specialties	Inspected
BULKHEAD/PENTHOUSE	Inspected
Condition	5 - Poor
Deficiency	BULKHEAD/PENTHOUSE WALLS/EXTERIOR: WATER INFILTRATION
Roof Plan reference	<p>K178</p>

Deficiency Quantity	250
Quantity Uom	S.F.
Potential Action	REPAIR
Urgency of Action	PRIORITY 5
Purpose of Action	LEVEL 2

Violations	BH2
Deficiency	No violations recorded.
	BULKHEAD/PENTHOUSE DOORS: DETERIORATED DOOR AND FRAME

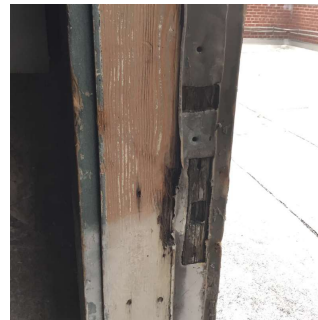
West Fan Room

1
EACH
REPLACE DOOR AND FRAME
PRIORITY 4
LEVEL 2

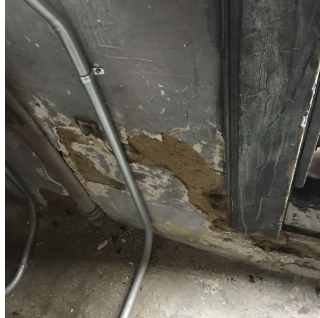
BULKHEAD/PENTHOUSE WALLS/INTERIOR: PLASTER CRACKS/SPALLING

250
S.F.
REPLACE
PRIORITY 4
LEVEL 2

Violations	East Fan Room No violations recorded.
Deficiency	BULKHEAD/PENTHOUSE DOORS: DETERIORATED DOOR
Roof Plan reference	K178

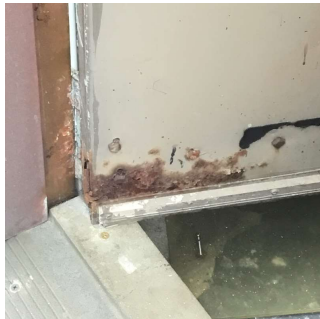
Deficiency Quantity	3
Quantity Uom	EACH
Potential Action	REPLACE DOOR
Urgency of Action	PRIORITY 3
Purpose of Action	LEVEL 2
Deficiency Photo1

Violations	BH3 No violations recorded.
CUPOLA/ SPIRES/ TOWERS	Does not Exist
DORMER	Does not Exist
DUNNAGE STEEL	Does not Exist
SKYLIGHT/ROOF VENT	Inspected
Material Type(s)	Glass
Condition	3 - Fair
Deficiency	DAMAGED FLASHING

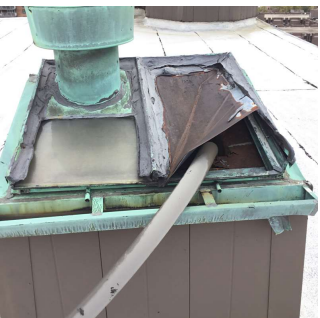
Deficiency Quantity	20
Quantity Uom	L.F.
Potential Action	MAINTENANCE
Urgency of Action	PRIORITY 3
Purpose of Action	LEVEL 2
Deficiency Photo1

Violations	<p>SK1</p> <p>No violations recorded.</p>
ROOF/GRAVITY TANK	Does not Exist
STAIRS/RAMPS: EXTERIOR	Inspected
BUILDING CHEEK/FLANK WALLS	Inspected
Condition	5 - Poor
Deficiency	STONE: DETERIORATED COPING STONE
Roof Plan reference	<p>K178</p>

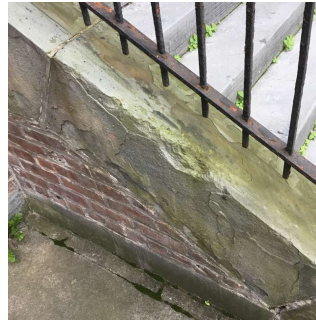
Facade D

Deficiency Quantity	20
Quantity Uom	S.F.
Potential Action	REPLACE
Urgency of Action	PRIORITY 4
Purpose of Action	LEVEL 2

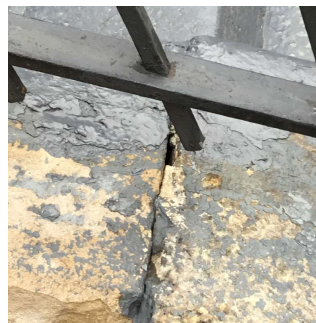
Facade B

STONE: DETERIORATED JOINTS

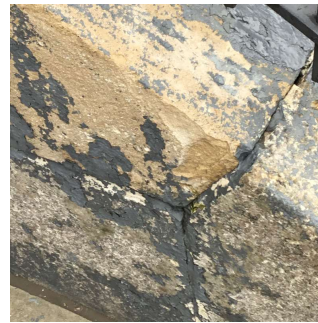
Facade B

STONE: CRACKS/SPALLING - MINOR

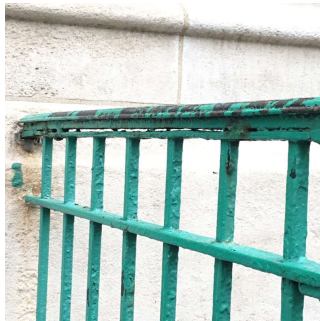
RUST - MAJOR

Violations	<p>Facade B</p> <p>No violations recorded.</p>
Deficiency	DAMAGED
Roof Plan reference	<p>K178</p>

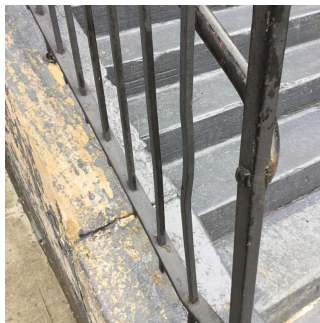
Deficiency Quantity	15
Quantity Uom	L.F.
Potential Action	REPLACE
Urgency of Action	PRIORITY 4
Purpose of Action	LEVEL 2
Deficiency Photo1

Violations	<p>Facade B</p> <p>No violations recorded.</p>
STAIRS/RAMPS	Inspected
Condition	5 - Poor
Deficiency	STONE: WORN-OUT TREAD/RISER/NOSING

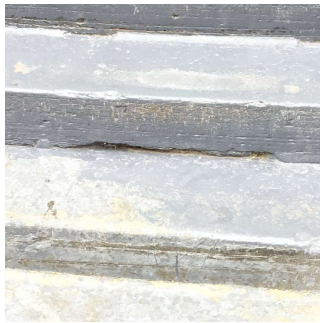
STONE: CRACKS/SPALLING - MAJOR

Violations	<p>Facade B</p> <p>No violations recorded.</p>
Deficiency	<p>STONE: DETERIORATED JOINTS</p>
Roof Plan reference	<p>K178</p>

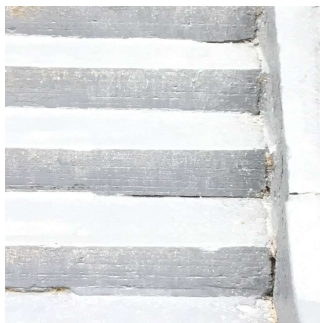
Deficiency Quantity	25
Quantity Uom	L.F.
Potential Action	REPOINT
Urgency of Action	PRIORITY 4
Purpose of Action	LEVEL 2
Deficiency Photo1

Violations	<p>Facade B</p> <p>No violations recorded.</p>
Deficiency	<p>CONCRETE: CRACKS/SPALLING - MAJOR</p>

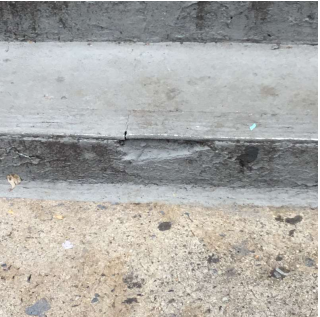
Deficiency Quantity	30
Quantity Uom	S.F.
Potential Action	REPLACE
Urgency of Action	PRIORITY 4
Purpose of Action	LEVEL 2
Deficiency Photo1

Violations	<p>Facade A</p> <p>No violations recorded.</p>
WINDOWS	Inspected
Replacement Quantity	12,000
Replacement Uom	S.F.
EXTERIOR GUARDS	Inspected
Condition	1 - Good
Deficiency	No deficiencies recorded
LINTELS	Inspected
Condition	2 - Between Good and Fair
Deficiency	No deficiencies recorded
WINDOWS	Inspected
Material Type(s)	Aluminum
Instance on Aluminum - Double Hung: All Facades	Inspected
Instance Condition	1 - Good
Instance Quantity	12,000
Instance Quantity Uom	S.F.
Are these windows insulated	No
Installation Year	2019
Source of Installation	Custodial Staff
Deficiency	No deficiencies recorded
INTERIOR	Inspected
POOLS	Does not Exist

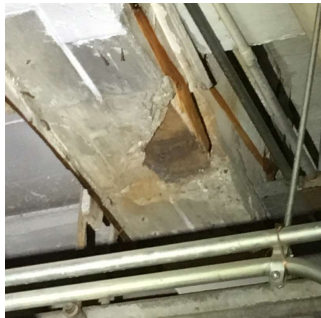
Question	Response
INTERIOR	
STRUCTURAL	Inspected
COLUMNS/BEAMS/BEARING WALLS	Inspected
Condition	3 - Fair
Deficiency	STEEL COLUMNS/BEAMS: DETERIORATED CONCRETE FIREPROOFING
Deficiency Location/Instance	Basement
Deficiency Quantity	20
Quantity Uom	S.F.
Potential Action	REPLACE
Urgency of Action	PRIORITY 4
Purpose of Action	LEVEL 5
Deficiency Photo1

Violations	Boiler Room (Oil Tank Room similar) No violations recorded.
Deficiency	STEEL COLUMNS/BEAMS: DETERIORATED CONCRETE FIREPROOFING
Deficiency Location/Instance	Basement
Deficiency Quantity	45
Quantity Uom	S.F.
Potential Action	REPLACE
Urgency of Action	PRIORITY 3
Purpose of Action	LEVEL 5
Deficiency Photo1

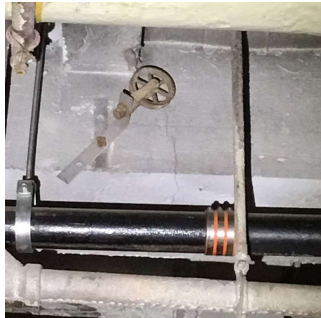
Violations	Boiler Room (Basement Storage Room, Basement Corridor similar) No violations recorded.
Deficiency	STEEL COLUMNS/BEAMS: DETERIORATED MASONRY FIREPROOFING
Deficiency Location/Instance	Basement
Deficiency Quantity	60
Quantity Uom	S.F.
Potential Action	REPLACE

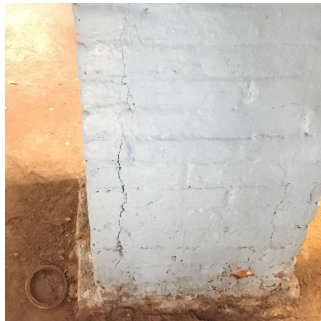
Urgency of Action	PRIORITY 4
Purpose of Action	LEVEL 5

Violations	Boiler Room No violations recorded.
FLOOR STRUCTURE	Inspected
Condition	3 - Fair
Deficiency	CONCRETE: CRACKS/SPALLED/REINFORCEMENT EXPOSED
Deficiency Location/Instance	Basement
Deficiency Quantity	20
Quantity Uom	S.F.
Potential Action	REPAIR
Urgency of Action	PRIORITY 4
Purpose of Action	LEVEL 5
Deficiency Photo1

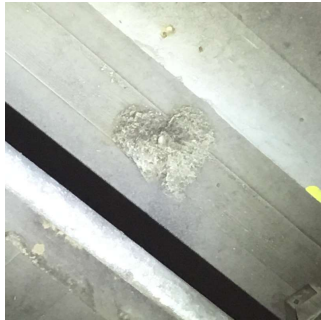
Violations	Basement Storage Area (Boiler Room similar) No violations recorded.
Deficiency	CONCRETE SLAB ON GRADE: THRU CRACKS
Deficiency Location/Instance	Basement
Deficiency Quantity	75
Quantity Uom	S.F.
Potential Action	REPAIR
Urgency of Action	PRIORITY 3
Purpose of Action	LEVEL 5
Deficiency Photo1

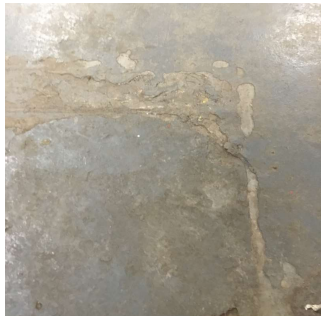
Question	Response
INTERIOR	
STRUCTURAL	
FLOOR STRUCTURE	
Violations	Boiler Room No violations recorded.
Deficiency	CONCRETE SLAB ON GRADE: THRU CRACKS
Deficiency Location/Instance	Basement
Deficiency Quantity	60
Quantity Uom	S.F.
Potential Action	REPLACE
Urgency of Action	PRIORITY 4
Purpose of Action	LEVEL 5
Deficiency Photo1

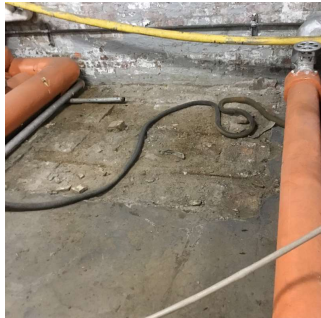
Violations	Boiler Room No violations recorded.
FOUNDATION WALLS	
Material Type(s)	Inspected Masonry
Condition	4 - Between Fair and Poor
Deficiency	BRICK: CRACKED/SPALLED
Deficiency Location/Instance	Basement
Deficiency Quantity	70
Quantity Uom	S.F.
Potential Action	RESTITCH
Urgency of Action	PRIORITY 4
Purpose of Action	LEVEL 5
Deficiency Photo1

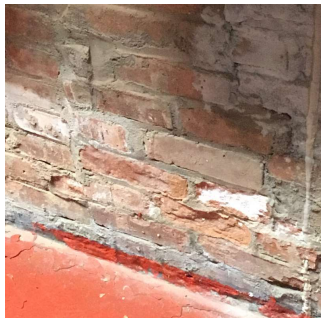
Violations	Electrical Panel Room (Gas Meter Room similar) No violations recorded.
Deficiency	BRICK: CRACKED/SPALLED
Deficiency Location/Instance	Basement
Deficiency Quantity	160
Quantity Uom	S.F.
Potential Action	RESTITCH
Urgency of Action	PRIORITY 3

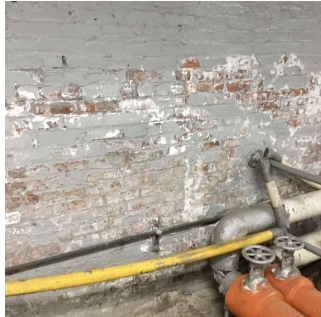
Violations	Boiler Room (Basement Corridor similar) No violations recorded.
Deficiency	BRICK: WATER INFILTRATION IN NON- INSTRUCTIONAL SPACE
Deficiency Location/Instance	Basement
Deficiency Quantity	150
Quantity Uom	S.F.
Potential Action	INSTALL WATERPROOFING
Urgency of Action	PRIORITY 5
Purpose of Action	LEVEL 5
Deficiency Photo1

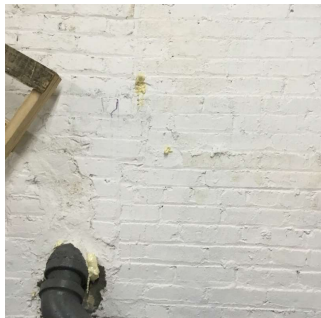
Violations	Basement Storage Room (Basement Corridor similar) No violations recorded.
ROOF STRUCTURE	Inspected
Condition	2 - Between Good and Fair
Deficiency	No deficiencies recorded
VAULTS-BUNKERS	Inspected
Foundation Walls	Inspected
Condition	3 - Fair
Deficiency	CRACKS, SPALLING
Deficiency Location/Instance	Vault
Deficiency Quantity	30
Quantity Uom	S.F.
Potential Action	REPAIR
Urgency of Action	PRIORITY 3
Purpose of Action	LEVEL 5

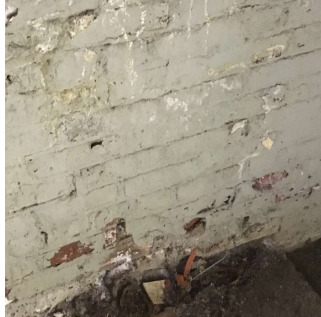
Violations	Vault No violations recorded.
Slab Structure	Inspected
Condition	1 - Good
Deficiency	No deficiencies recorded
Vault/Ash Hoist Doors and Framing	Inspected
Condition	5 - Poor
Deficiency	WATER INFILTRATION
Deficiency Location/Instance	Vault
Deficiency Quantity	10
Quantity Uom	S.F.
Potential Action	REPAIR
Urgency of Action	PRIORITY 5
Purpose of Action	LEVEL 2
Deficiency Photo1

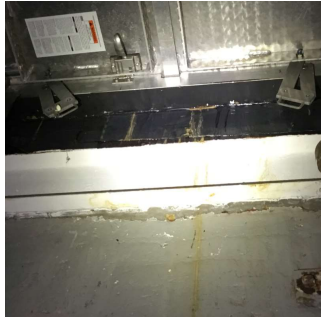
Violations	Vault No violations recorded.
AUDITORIUM	Inspected
Instance on 1st Floor (425 seats)	Inspected
Ceiling	
Instance on 1st Floor (425 seats)	Inspected
Condition	2 - Between Good and Fair
Deficiency	No deficiencies recorded
Door(s)	
Instance on 1st Floor (425 seats)	Inspected
Condition	3 - Fair
Deficiency	WOOD: DETERIORATED DOOR
Deficiency Location/Instance	Stage
Deficiency Quantity	1

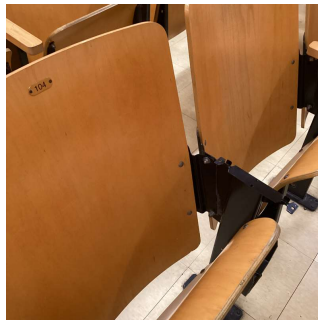
Question	Response
INTERIOR	
AUDITORIUM	
Door(s)	
Quantity Uom	EACH
Potential Action	MAINTENANCE
Urgency of Action	PRIORITY 3
Purpose of Action	LEVEL 2
Deficiency Photo1	 
	Stage
Violations	No violations recorded.
Fixed H/C Lift	
Instance on 1st Floor (425 seats)	Does not Exist
Fixed Seating	
Instance on 1st Floor (425 seats)	Inspected
Condition	3 - Fair
Deficiency	DAMAGED/BROKEN/INOPERABLE
Deficiency Location/Instance	Seat A/111, B/7, F/3, G/14, N/13, and others
Deficiency Quantity	12
Quantity Uom	EACH
Potential Action	REPLACE
Urgency of Action	PRIORITY 3
Purpose of Action	LEVEL 2
Deficiency Photo1	 
	Seat N/13
Violations	No violations recorded.
Deficiency	DAMAGED/BROKEN/INOPERABLE
Deficiency Location/Instance	Seats C/104, D/13
Deficiency Quantity	2
Quantity Uom	EACH
Potential Action	REPLACE
Urgency of Action	PRIORITY 5
Purpose of Action	LEVEL 6

Violations	Seat C/101 No violations recorded.
Floor Finish	
Instance on 1st Floor (425 seats)	Inspected
Condition	3 - Fair
Deficiency	TERRAZZO: CRACKS
Deficiency Location/Instance	Auditorium Exit Vestibule
Deficiency Quantity	10
Quantity Uom	S.F.
Potential Action	REPLACE
Urgency of Action	PRIORITY 3
Purpose of Action	LEVEL 2
Deficiency Photo1

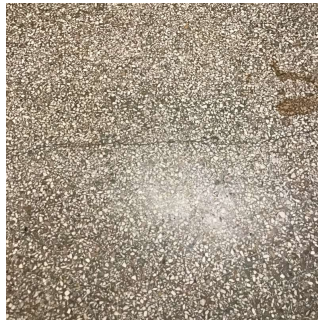
Violations	Auditorium Exit Vestibule No violations recorded.
Deficiency	VINYL TILES: DETERIORATED SUBSTRATE
Deficiency Location/Instance	Near Entrance, windows, center
Deficiency Quantity	150
Quantity Uom	S.F.
Potential Action	REPLACE
Urgency of Action	PRIORITY 3
Purpose of Action	LEVEL 2

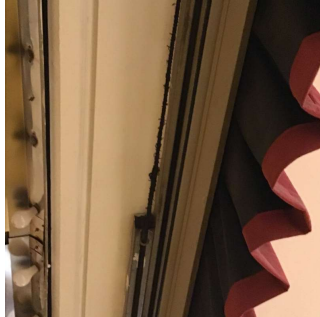
Question	Response
INTERIOR	
AUDITORIUM	
Stage	
Stage	
Deficiency Photo1	 
Violations	Near center No violations recorded.
Deficiency	DAMAGED FASCIA
Deficiency Location/Instance	Near center
Deficiency Quantity	10
Quantity Uom	S.F.
Potential Action	REPLACE
Urgency of Action	PRIORITY 3
Purpose of Action	LEVEL 2
Deficiency Photo1	 
Violations	Near center No violations recorded.
Stage Curtain Rigging	Inspected
Instance on 1st Floor (425 seats)	Inspected
Condition	3 - Fair
Deficiency	DAMAGED/DETERIORATED
Deficiency Location/Instance	Center
Deficiency Quantity	1
Quantity Uom	EACH
Potential Action	REPLACE
Urgency of Action	PRIORITY 3
Purpose of Action	LEVEL 2

Center
Violations	No violations recorded.
Stage Curtains	Inspected
Instance on 1st Floor (425 seats)	Inspected
Condition	3 - Fair
Deficiency	WORN/DETERIORATED
Deficiency Location/Instance	Right side
Deficiency Quantity	100
Quantity Uom	S.F.
Potential Action	REPLACE
Urgency of Action	PRIORITY 3
Purpose of Action	LEVEL 2
Deficiency Photo1

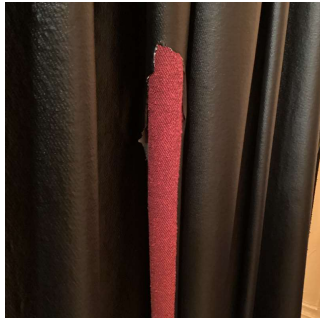
Right side
Violations	No violations recorded.
Walls	
Instance on 1st Floor (425 seats)	Inspected
Condition	2 - Between Good and Fair
Deficiency	CERAMIC TILE: BROKEN/ MISSING
Deficiency Location/Instance	Auditorium Exit Vestibule
Deficiency Quantity	10
Quantity Uom	S.F.
Potential Action	REPLACE
Urgency of Action	PRIORITY 3
Purpose of Action	LEVEL 2

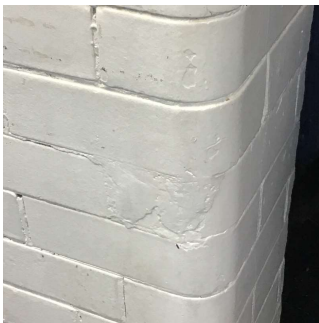
Question	Response
INTERIOR	
CAFETERIA	
Walls	
Potential Action	REPLACE
Urgency of Action	PRIORITY 3
Purpose of Action	LEVEL 2
Deficiency Photo1

Near Entrance
Violations	No violations recorded.
Window Curtains/Shades/Blinds	
Instance on 1st Floor	Does not Exist
CLASSROOMS/CORRIDORS/ADMIN SPACES	
Ceiling	Inspected
Condition	2 - Between Good and Fair
Deficiency	ACOUSTIC TILES ON PLASTER: DAMAGED/MISSING
Deficiency Location/Instance	Room 512
Deficiency Quantity	10
Quantity Uom	S.F.
Potential Action	REPLACE
Urgency of Action	PRIORITY 3
Purpose of Action	LEVEL 2
Deficiency Photo1

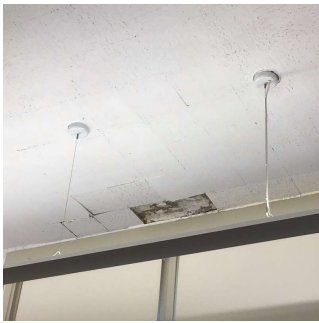
Room 512
Violations	No violations recorded.
Door(s)	
Condition	4 - Between Fair and Poor
Deficiency	WOOD: DETERIORATED DOOR
Deficiency Location/Instance	Room 311, 212, 211, 207
Deficiency Quantity	4
Quantity Uom	EACH
Potential Action	MAINTENANCE
Urgency of Action	PRIORITY 3
Purpose of Action	LEVEL 2

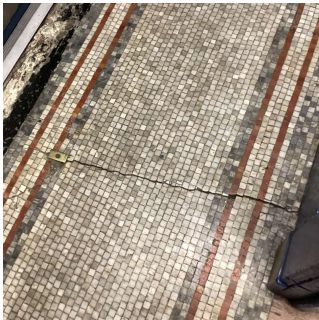
Room 311
Violations	No violations recorded.
Floor Finish	Inspected
Condition	2 - Between Good and Fair
Deficiency	CERAMIC TILE: BROKEN/MISSING TILES
Deficiency Location/Instance	Main Entrance Vestibule
Deficiency Quantity	10
Quantity Uom	S.F.
Potential Action	REPLACE
Urgency of Action	PRIORITY 3
Purpose of Action	LEVEL 2
Deficiency Photo1

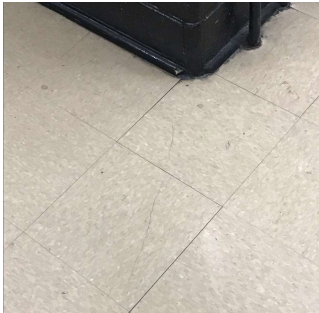
Main Entrance Vestibule
Violations	No violations recorded.
Deficiency	VINYL TILES: BROKEN/DETERIORATED/MISSING TILES
Deficiency Location/Instance	Room 501, 503, 504, 505, Corridor near Stair E/5, and others
Deficiency Quantity	200
Quantity Uom	S.F.
Potential Action	REPLACE
Urgency of Action	PRIORITY 3
Purpose of Action	LEVEL 2
Deficiency Photo1

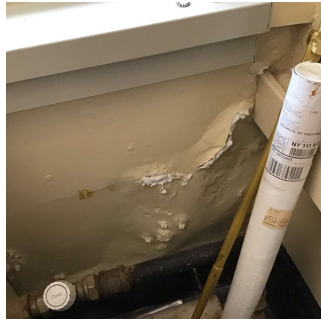
Question	Response
INTERIOR	
CLASSROOMS/CORRIDORS/ADMIN SPACES	
Floor Finish	Inspected
	Corridor near Stair E/5
Violations	No violations recorded.
Walls	Inspected
Condition	2 - Between Good and Fair
Deficiency	PLASTER: CRACKS/SPALLING - ACTIVE LEAK
Deficiency Location/Instance	Rooms 513, 511, 509, 412, 411, 312, 311, 302
Deficiency Quantity	60
Quantity Uom	S.F.
Potential Action	REPLACE
Urgency of Action	PRIORITY 5
Purpose of Action	LEVEL 2
Deficiency Photo1

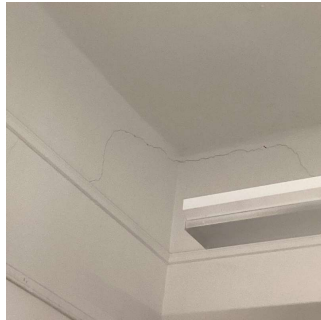
Room 501
Violations	No violations recorded.
Specialties	Does not Exist
GYMNASIUM	Inspected
Instance on 6th Floor (1200 S.F.)	Inspected
Ceiling	
Instance on 6th Floor (1200 S.F.)	Inspected

Room 509
Violations	No violations recorded.
Deficiency	PLASTER: CRACKS/SPALLING
Deficiency Location/Instance	Rooms 501, 513, Corridor near Room 506, 508A, 406, and others
Deficiency Quantity	150
Quantity Uom	S.F.
Potential Action	REPLACE
Urgency of Action	PRIORITY 3
Purpose of Action	LEVEL 2
Deficiency Photo1

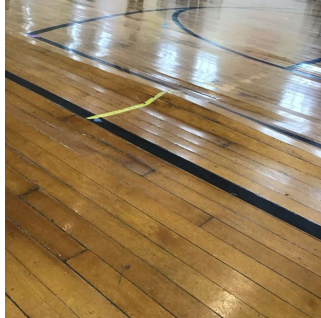
Question	Response
INTERIOR	
GYMNASIUM	
Ceiling	
Deficiency	No deficiencies recorded
Door(s)	
Instance on 6th Floor (1200 S.F.)	Inspected
Condition	2 - Between Good and Fair
Deficiency	No deficiencies recorded
Fixed Equipment	
Instance on 6th Floor (1200 S.F.)	Inspected
Condition	1 - Good
Deficiency	No deficiencies recorded
Floor Finish	
Instance on 6th Floor (1200 S.F.)	Inspected
Condition	2 - Between Good and Fair
Deficiency	WOOD: DETERIORATED SUBSTRATE
Deficiency Location/Instance	Near Windows
Deficiency Quantity	20
Quantity Uom	S.F.
Potential Action	REPLACE
Urgency of Action	PRIORITY 5
Purpose of Action	LEVEL 6
Deficiency Photo1

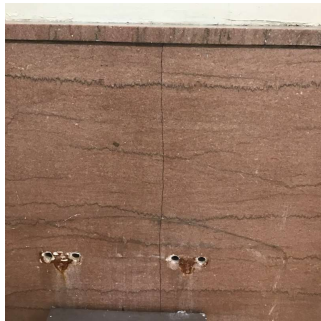
Deficiency	STONE: CRACKS/SPALLING
Deficiency Location/Instance	Gymnasium Vestibule
Deficiency Quantity	10
Quantity Uom	S.F.
Potential Action	REPLACE
Urgency of Action	PRIORITY 3
Purpose of Action	LEVEL 2

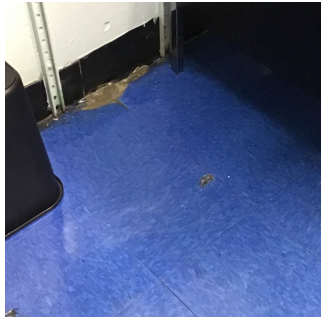
Kitchen Office
Violations	No violations recorded.
Deficiency	CERAMIC TILE: BROKEN/MISSING TILES
Deficiency Location/Instance	Near center, windows, entrance, exit
Deficiency Quantity	40
Quantity Uom	S.F.
Potential Action	REPLACE
Urgency of Action	PRIORITY 3
Purpose of Action	LEVEL 2

Question	Response
INTERIOR	
KITCHEN	
Door(s)	
Deficiency Location/Instance	Exit 4
Deficiency Quantity	1
Quantity Uom	EACH
Potential Action	MAINTENANCE
Urgency of Action	PRIORITY 3
Purpose of Action	LEVEL 2
Deficiency Photo1	 
	Exit 4
Violations	No violations recorded.
Floor Finish	
Instance on 1st Floor	Inspected
Condition	3 - Fair
Deficiency	VINYL TILES: BROKEN/DETERIORATED/MISSING TILES
Deficiency Location/Instance	Kitchen Office
Deficiency Quantity	10
Quantity Uom	S.F.
Potential Action	REPLACE
Urgency of Action	PRIORITY 3
Purpose of Action	LEVEL 2
Deficiency Photo1

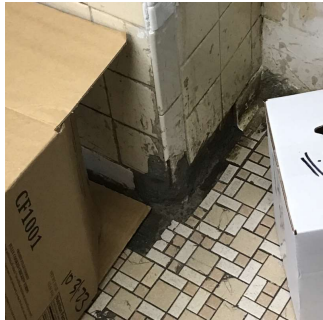
Near Exit
Violations	No violations recorded.
Walls	
Instance on 1st Floor	Inspected
Condition	3 - Fair
Deficiency	CERAMIC TILE: BROKEN/ MISSING
Deficiency Location/Instance	Left side, right side, Near Entrance, Exit
Deficiency Quantity	50
Quantity Uom	S.F.
Potential Action	REPLACE
Urgency of Action	PRIORITY 3
Purpose of Action	LEVEL 2
Deficiency Photo1

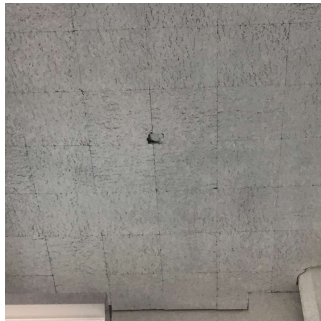
Near exit
Violations	No violations recorded.
LIBRARY	
Instance on Room 309	Inspected
Built-in Furnishing	
Instance on Room 309	Does not Exist
Ceiling	
Instance on Room 309	Inspected
Condition	2 - Between Good and Fair
Deficiency	ACOUSTIC TILES ON PLASTER: DAMAGED/MISSING
Deficiency Location/Instance	Near Windows
Deficiency Quantity	10
Quantity Uom	S.F.
Potential Action	REPLACE
Urgency of Action	PRIORITY 3
Purpose of Action	LEVEL 2

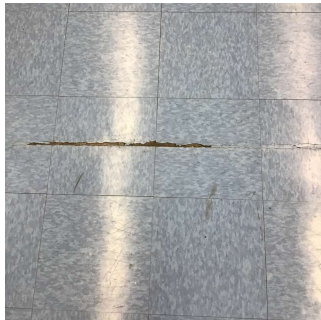
Violations	Near Windows No violations recorded.
Door(s)	
Instance on Room 309	Inspected
Condition	2 - Between Good and Fair
Deficiency	No deficiencies recorded
Floor Finish	
Instance on Room 309	Inspected
Condition	2 - Between Good and Fair
Deficiency	VINYL TILES: DETERIORATED SUBSTRATE
Deficiency Location/Instance	Near center, windows
Deficiency Quantity	20
Quantity Uom	S.F.
Potential Action	REPLACE
Urgency of Action	PRIORITY 3
Purpose of Action	LEVEL 2
Deficiency Photo1

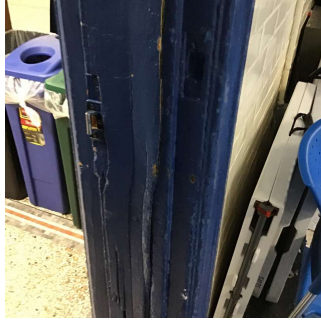
Question	Response
INTERIOR	
MULTI-PURPOSE ROOM	
Door(s)	
Instance on 1st Floor	Inspected
Condition	3 - Fair
Deficiency	WOOD: DETERIORATED DOOR AND FRAME
Deficiency Location/Instance	Entrance
Deficiency Quantity	1
Quantity Uom	EACH
Potential Action	MAINTENANCE
Urgency of Action	PRIORITY 3
Purpose of Action	LEVEL 2
Deficiency Photo1

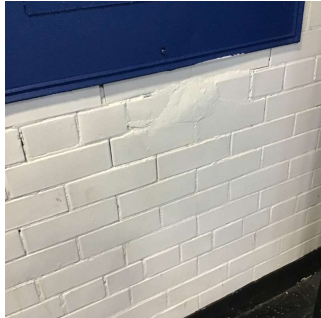
Question	Response
INTERIOR	
MULTI-PURPOSE ROOM	
Stage	
Instance on 1st Floor	Does not Exist
Walls	
Instance on 1st Floor	Inspected
Condition	2 - Between Good and Fair
Deficiency	BRICK: CRACKS/SPALLING
Deficiency Location/Instance	Near stair D/1, windows
Deficiency Quantity	20
Quantity Uom	S.F.
Potential Action	REPLACE
Urgency of Action	PRIORITY 3
Purpose of Action	LEVEL 2
Deficiency Photo1

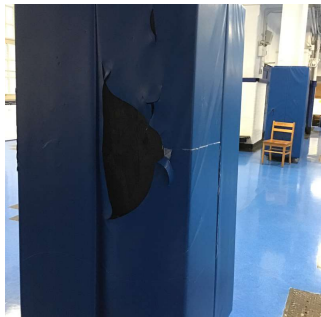
Violations	Near stair D/1 No violations recorded.
Deficiency	WALL PADDING: DETERIORATED
Deficiency Location/Instance	Near center
Deficiency Quantity	100
Quantity Uom	S.F.
Potential Action	REPLACE
Urgency of Action	PRIORITY 3
Purpose of Action	LEVEL 2
Deficiency Photo1

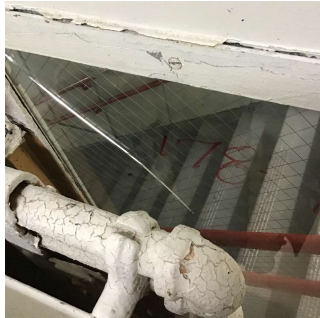
Question	Response
INTERIOR	
SCIENCE LAB	Inspected
Fixed Equipment	
Instance on Room 506	Inspected
Condition	2 - Between Good and Fair
Deficiency	No deficiencies recorded
SCIENCE PREP ROOM	Inspected
Instance on Room 508A	Inspected
Alternative use	No
Fixed Equipment	
Instance on Room 508A	Inspected
Condition	2 - Between Good and Fair
Deficiency	No deficiencies recorded
SHOWER ROOM	Does not Exist
STAIRS/RAMPS: INTERIOR	Inspected
Do Letter Stair Signs Exist?	Yes
Ceiling	Inspected
Condition	2 - Between Good and Fair
Deficiency	No deficiencies recorded
Door(s)	Inspected
Condition	2 - Between Good and Fair
Deficiency	No deficiencies recorded
Partition	Inspected
Condition	2 - Between Good and Fair
Deficiency	GLASS PANEL: DAMAGED/DETERIORATED
Deficiency Location/Instance	Stair A/5, 4, E/5, 4, 3
Deficiency Quantity	30
Quantity Uom	S.F.
Potential Action	REPLACE
Urgency of Action	PRIORITY 3
Purpose of Action	LEVEL 2
Deficiency Photo1

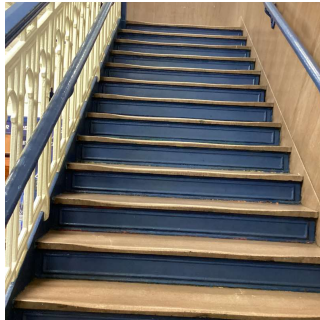
Violations	Stair E/5 No violations recorded.
Railings	Inspected
Condition	2 - Between Good and Fair
Deficiency	No deficiencies recorded
Stairs and Landings	Inspected
Condition	3 - Fair
Deficiency	STONE: WORN-OUT TREAD/NOSINGS
Deficiency Location/Instance	Lobby Stair
Deficiency Quantity	230

Question	Response
INTERIOR	
STAIRS/RAMPS: INTERIOR	
Stairs and Landings	
Quantity Uom	S.F.
Potential Action	REPLACE
Urgency of Action	PRIORITY 3
Purpose of Action	LEVEL 2
Deficiency Photo1

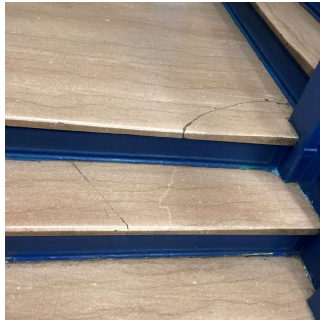
Violations	Lobby Stair No violations recorded.
Deficiency	STONE: BROKEN/MISSING
Deficiency Location/Instance	Lobby Stair
Deficiency Quantity	40
Quantity Uom	S.F.
Potential Action	REPLACE
Urgency of Action	PRIORITY 3
Purpose of Action	LEVEL 2
Deficiency Photo1

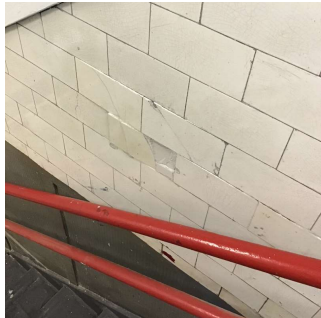
Question	Response
INTERIOR	
STAIRS/RAMPS: INTERIOR	
Walls	
Violations	Stair D/6 No violations recorded.
Deficiency	CERAMIC TILE: BROKEN/ MISSING
Deficiency Location/Instance	Stair A/Bulkhead, 4, 3, 2, 1, and others
Deficiency Quantity	75
Quantity Uom	S.F.
Potential Action	REPLACE
Urgency of Action	PRIORITY 3
Purpose of Action	LEVEL 2
Deficiency Photo1

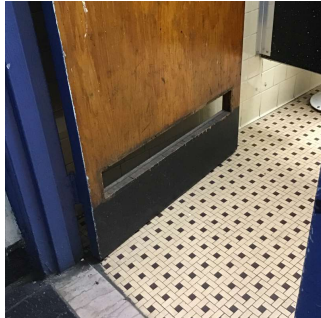
1st Floor - Girls
Violations	No violations recorded.
Deficiency	WOOD: DETERIORATED DOOR
Deficiency Location/Instance	5th Floor - Boys, 3rd Floor - Girls, Room 212
Deficiency Quantity	3
Quantity Uom	EACH
Potential Action	MAINTENANCE
Urgency of Action	PRIORITY 3
Purpose of Action	LEVEL 2

Room 212
Violations	No violations recorded.
Door(s)	Inspected
Condition	5 - Poor
Deficiency	WOOD: DAMAGED LOUVER
Deficiency Location/Instance	1st Floor - Girls
Deficiency Quantity	1
Quantity Uom	EACH
Potential Action	MAINTENANCE
Urgency of Action	PRIORITY 3
Purpose of Action	LEVEL 2
Deficiency Photo1

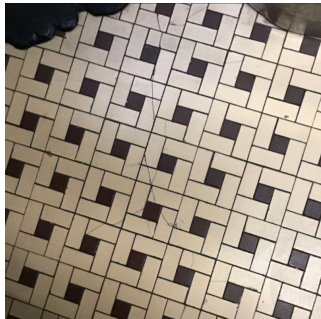
Violations	5th Floor - boys No violations recorded.
Floor Finish	Inspected
Condition	3 - Fair
Deficiency	CERAMIC TILE: BROKEN/MISSING TILES
Deficiency Location/Instance	5th/4th/ 3rd/2nd/1st Floor - Boys, Girls, and others
Deficiency Quantity	100
Quantity Uom	S.F.
Potential Action	REPLACE
Urgency of Action	PRIORITY 3
Purpose of Action	LEVEL 2
Deficiency Photo1

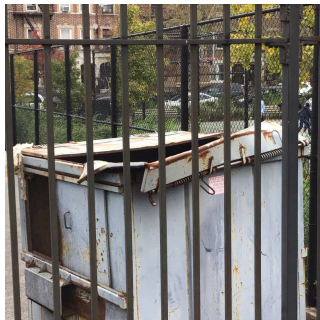
Question	Response
INTERIOR	
TOILET ROOMS - STUDENTS	
Walls	
Deficiency Photo1	 
Violations	5th Floor - Boys No violations recorded.
LIFE SAFETY	Inspected
F.D. HOLDING AREA	Does not Exist
STEEL STAIRS	Does not Exist
SITE	Inspected
CONTAINERIZATION	Inspected
Condition	5 - Poor
Deficiency	FENCING MISSING
Deficiency Location/Instance	Parking Lot
Deficiency Quantity	450
Quantity Uom	S.F.
Potential Action	INSTALL NEW
Urgency of Action	PRIORITY 3
Purpose of Action	LEVEL 2
Deficiency Photo1	No photo recorded
Violations	No violations recorded.
Deficiency	CONCRETE PAD MISSING
Deficiency Location/Instance	Parking Lot
Deficiency Quantity	200
Quantity Uom	S.F.
Potential Action	INSTALL NEW
Urgency of Action	PRIORITY 3
Purpose of Action	LEVEL 2
Deficiency Photo1	No photo recorded
Violations	No violations recorded.
Deficiency	CONTAINER DAMAGED
Deficiency Location/Instance	Parking lot
Deficiency Quantity	2
Quantity Uom	EACH
Potential Action	REPLACE

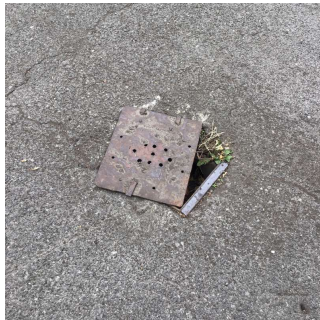
Violations	Parking lot No violations recorded.
Drainage System for Asphalt	Inspected
Catch Basins/Manhole - Surrounded by asphalt	Inspected
Condition	3 - Fair
Deficiency	DAMAGED COVER
Deficiency Location/Instance	Parking Lot
Deficiency Quantity	1
Quantity Uom	EACH
Potential Action	REPLACE
Urgency of Action	PRIORITY 3
Purpose of Action	LEVEL 2
Deficiency Photo1

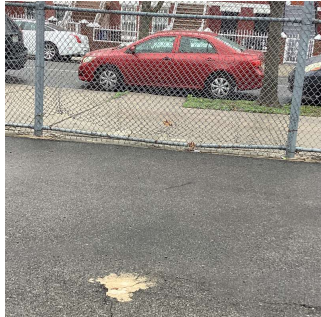
DRINKING FOUNTAINS	Does not Exist
FENCES	Inspected
Condition	4 - Between Fair and Poor
Deficiency	CHAIN LINK: DAMAGED POST/RAIL

Question	Response
SITE	
FENCES	
Deficiency Location/Instance	Parking Lot
Deficiency Quantity	10
Quantity Uom	L.F.
Potential Action	REPLACE
Urgency of Action	PRIORITY 3
Purpose of Action	LEVEL 2
Deficiency Photo1

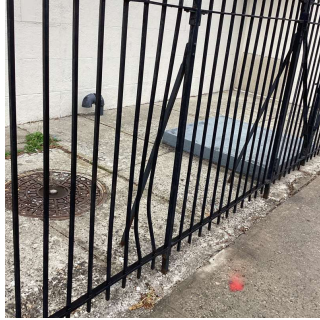
Violations	Parking Lot No violations recorded.
Deficiency	CHAIN LINK: RUST - MAJOR
Deficiency Location/Instance	Parking Lot
Deficiency Quantity	1,500
Quantity Uom	S.F.
Potential Action	REPLACE
Urgency of Action	PRIORITY 3
Purpose of Action	LEVEL 2
Deficiency Photo1	 
Violations	Parking Lot No violations recorded.
Deficiency	WROUGHT IRON: DAMAGED/DETERIORATED
Deficiency Location/Instance	Dean Street
Deficiency Quantity	80
Quantity Uom	S.F.
Potential Action	REPLACE
Urgency of Action	PRIORITY 3
Purpose of Action	LEVEL 2

Question	Response
SITE	
FENCES	
Deficiency Photo1

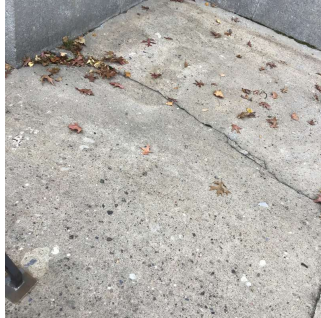
Violations	Dean Street No violations recorded.
IRRIGATION SYSTEM	Does not Exist
PAVING	Inspected
Student Non-Use	Inspected
Gravel Exists?	No
Asphalt	Inspected
Condition	4 - Between Fair and Poor
Deficiency	CRACKS - MAJOR
Deficiency Location/Instance	Parking Lot
Deficiency Quantity	3,675
Quantity Uom	S.F.
Potential Action	REPLACE
Urgency of Action	PRIORITY 3
Purpose of Action	LEVEL 2
Deficiency Photo1	 
Violations	Parking Lot No violations recorded.
Concrete	Inspected
Condition	3 - Fair
Deficiency	CRACKS - MAJOR
Deficiency Location/Instance	Along Dean Street
Deficiency Quantity	100
Quantity Uom	S.F.
Potential Action	REPLACE
Urgency of Action	PRIORITY 3
Purpose of Action	LEVEL 2

Question	Response
SITE	
PAVING	
Student Non-Use	
Concrete	
Deficiency Photo1

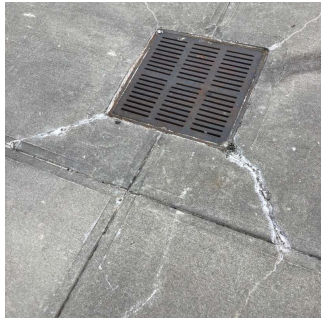
Violations	Along Dean Street No violations recorded.
Pavers	Does not Exist
Student Use	Inspected
Gravel Exists?	No
Asphalt	Does not Exist
Concrete	Inspected
Condition	3 - Fair
Deficiency	CRACKS - MAJOR
Deficiency Location/Instance	Schoolyard
Deficiency Quantity	125
Quantity Uom	S.F.
Potential Action	REPLACE
Urgency of Action	PRIORITY 3
Purpose of Action	LEVEL 2
Deficiency Photo1

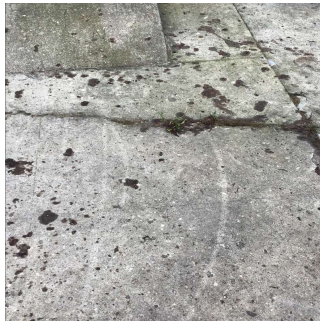
Violations	Schoolyard No violations recorded.
Pavers	Does not Exist
Site Sidewalks & Walkways	Inspected
Asphalt	Does not Exist
Concrete	Inspected
Condition	3 - Fair
Deficiency	CRACKS - MAJOR
Deficiency Location/Instance	Near Exit 4, exit 7, exit 8,
Deficiency Quantity	400
Quantity Uom	S.F.
Potential Action	REPLACE

Question	Response
SITE	
PAVING	
Site Sidewalks & Walkways	
Concrete	
Urgency of Action	PRIORITY 3
Purpose of Action	LEVEL 2
Deficiency Photo1

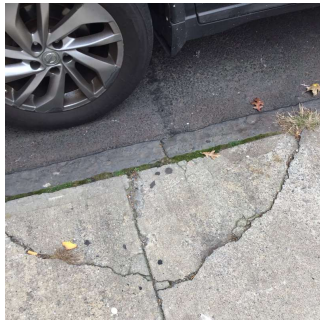
Near Exit 4
Violations	No violations recorded.
Pavers	Does not Exist
DOT Sidewalk	Inspected
Asphalt	Does not Exist
Concrete	Inspected
Condition	4 - Between Fair and Poor
Deficiency	DAMAGED/DETERIORATED/MISSING SECTIONS
Deficiency Location/Instance	Along Dean Street, Pacific Street
Deficiency Quantity	2,250
Quantity Uom	S.F.
Potential Action	REPLACE
Urgency of Action	PRIORITY 3
Purpose of Action	LEVEL 2
Deficiency Photo1

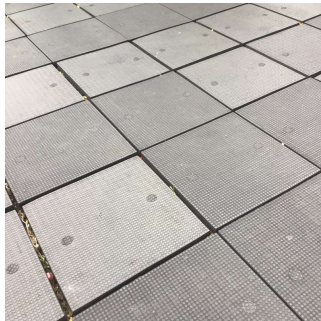
Question	Response
SITE	
PLAYGROUNDS	
Pavement	
Potential Action	REPLACE
Urgency of Action	PRIORITY 3
Purpose of Action	LEVEL 2
Deficiency Photo1	 
	Near Playground
Violations	No violations recorded.
Play Equipment	
Instance on East of the Building	Inspected
Condition	5 - Poor
Deficiency	BROKEN/DETERIORATED/MISSING
Deficiency Location/Instance	Playground
Deficiency Quantity	1
Quantity Uom	EACH
Potential Action	REPLACE
Urgency of Action	PRIORITY 5
Purpose of Action	LEVEL 6
Deficiency Photo1	 
	Playground
Violations	No violations recorded.
Safety Surfacing	
Instance on East of the Building	Inspected
Condition	3 - Fair
Deficiency	DETERIORATED/MISSING
Deficiency Location/Instance	Playground
Deficiency Quantity	50
Quantity Uom	S.F.
Potential Action	MAINTENANCE
Urgency of Action	PRIORITY 3
Purpose of Action	LEVEL 2

Question	Response
SITE	
PLAYGROUNDS	
Safety Surfacing	
Deficiency Photo1

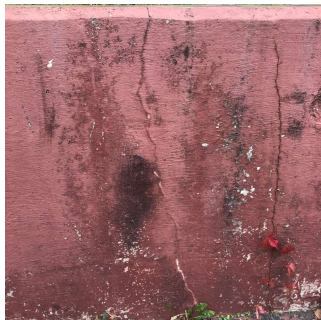
Violations	Playground No violations recorded.
Unpaved Area	
Instance on East of the Building	Inspected
Condition	2 - Between Good and Fair
Deficiency	No deficiencies recorded
PLAYING SURFACE	Does not Exist
RETAINING WALLS	Inspected
Are there any Retaining Walls 6' OR higher facing public street/sidewalk?	No
Condition	3 - Fair
Deficiency	CAST IN PLACE CONCRETE: CRACKS/SPALLING - MAJOR
Deficiency Location/Instance	Parking Lot, Schoolyard
Deficiency Quantity	30
Quantity Uom	S.F.
Potential Action	REPLACE
Urgency of Action	PRIORITY 3
Purpose of Action	LEVEL 2
Deficiency Photo1
