NYC Department of Education
Building Condition Assessment Survey 2023 - 2024

Architectural Inspection

Asset: **P.S. 205 - BROOKLYN, 6701 20 AVENUE, New York, 11204**

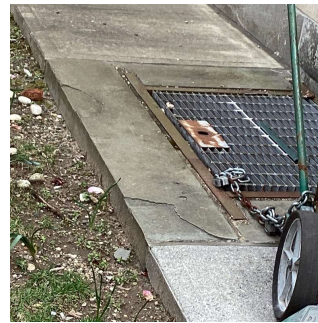
AW1

AREAWAY WALLS: DETERIORATED COPING STONE

REPLACE

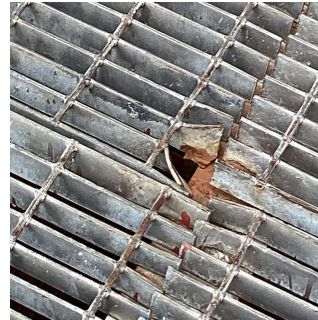
AW6

AREAWAY GRATINGS: MAJOR RUSTING / OR BROKEN

REPLACE

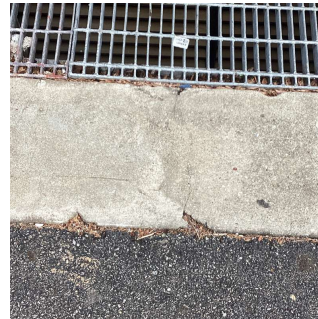
AW5

AREAWAY WALLS: CRACKS AND SPALLING

REPAIR

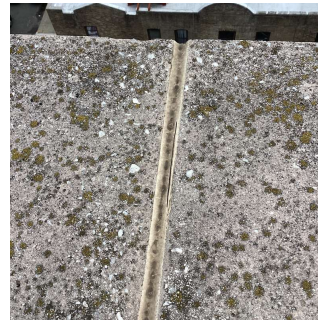
Roof 1 - Near BH2

CAST STONE: DETERIORATED TRANSVERSE JOINTS

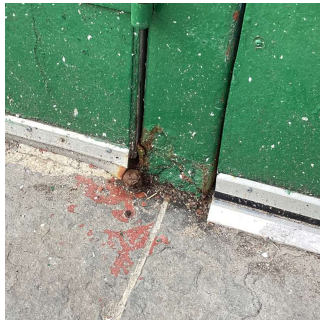
Violations	Facade C - Kitchen Service Entrance No violations recorded.
Deficiency	METAL CLAD: DETERIORATED DOOR AND FRAME - MAJOR DETERIORATION
Roof Plan reference	K205

Deficiency Quantity	8
Quantity Uom	EACH
Potential Action	REPLACE
Urgency of Action	PRIORITY 4
Purpose of Action	LEVEL 2
Deficiency Photo1

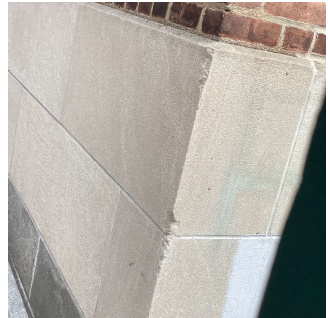
Question	Response
EXTERIOR	
EXTERIOR WALLS	
Material Type(s)	Masonry
Replacement Quantity	43,000
Replacement Uom	S.F.
Instance on All Facades	Inspected
Instance Condition	3 - Fair
Instance Quantity	43,000
Instance Quantity Uom	S.F.
Deficiency	STONE: CRACKS AT BUILDING CORNERS
Roof Plan reference	<div> <div>K205</div>

</div>
Deficiency Quantity	10
Quantity Uom	S.F.
Potential Action	REPLACE
Urgency of Action	PRIORITY 4
Purpose of Action	LEVEL 2
Deficiency Photo1	<div>

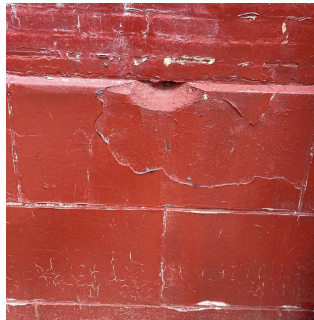
</div>
Violations	Corner of Facade A and Facade H No violations recorded.
Deficiency	STONE: CHIPPED/SPALLED/BROKEN PIECES - MAJOR

REPLACE

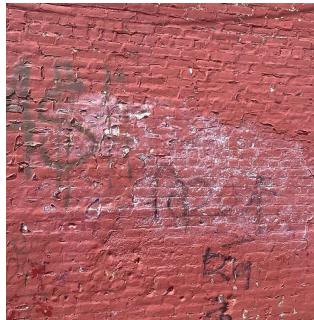
Facade G

BRICK: EFFLORESCENCE

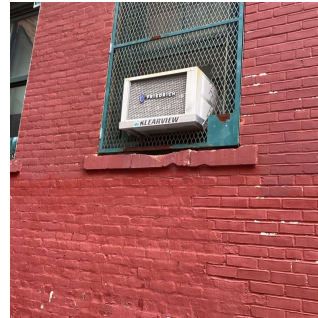
Facade D - Roof 4

BRICK: DETERIORATED MASONRY SILLS - MAJOR

REMOVE AND REPLACE

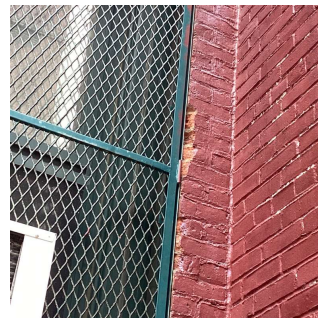
Facade D

BRICK: MAJOR / THRU CRACKS

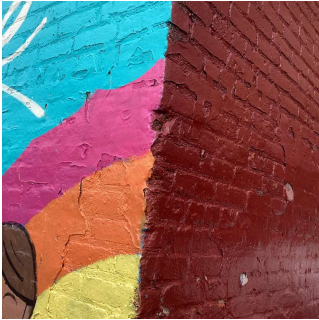
Question	Response
EXTERIOR	
EXTERIOR WALLS	
Violations	No violations recorded.
Deficiency	BRICK: CRACKS/DISPLACED/SPALLED BRICK AT BUILDING CORNERS
Roof Plan reference

Deficiency Quantity	60
Quantity Uom	S.F.
Potential Action	REMOVE AND REBUILD
Urgency of Action	PRIORITY 4
Purpose of Action	LEVEL 2
Deficiency Photo1

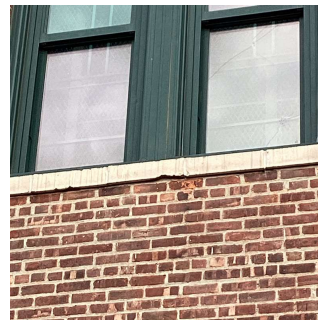
Facade C

Violations	<p>Facade C</p> <p>No violations recorded.</p>
Deficiency	BRICK: DETERIORATED MASONRY SILLS - MINOR

REPAIR

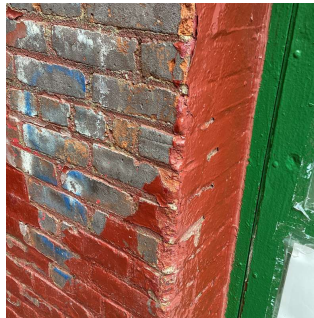
Facade D - Near HC Entrance

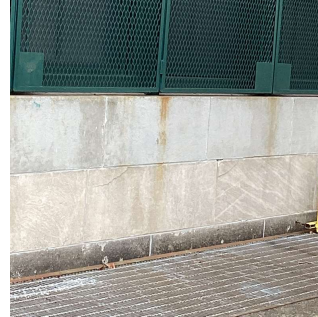
STONE: CHIPPED/SPALLED/BROKEN PIECES - MINOR

Facade A - Near Main Entrance

REPAIR

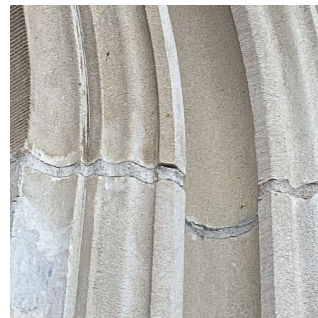
STONE: DETERIORATED JOINTS

Facade A - Main Entrance

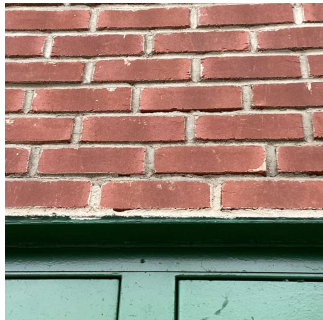
Question	Response
EXTERIOR	
EXTERIOR WALLS	
Violations	No violations recorded.
Deficiency	BRICK: DETERIORATED JOINTS
Roof Plan reference	K205

<p>Facade A - Main Entrance</p>
Violations	No violations recorded.
EXTERIOR SOFFITS	Does not Exist
LOADING DOCK	Does not Exist
LOUVER	Inspected
Condition	3 - Fair
Deficiency	MISSING/DAMAGED SCREEN

Deficiency Quantity	100
Quantity Uom	S.F.
Potential Action	REPOINT
Urgency of Action	PRIORITY 3
Purpose of Action	LEVEL 2
Deficiency Photo1

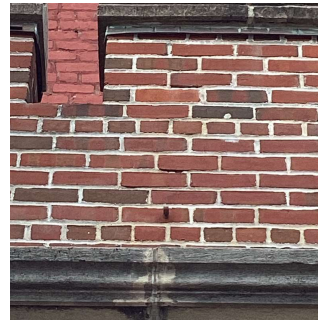
Facade G

BRICK: DETERIORATED JOINTS

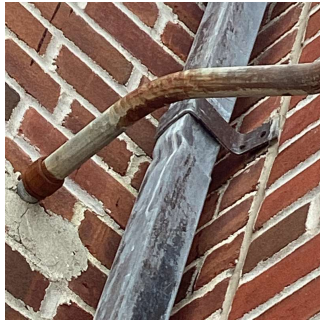
Question	Response
EXTERIOR	
PARAPETS	
Deficiency Photo1	 
Violations	Facade D No violations recorded.
PLAZA DECK	Does not Exist
ROOF	Inspected
Roofing	Inspected
Replacement Quantity	23,000
Replacement Uom	S.F.
ROOF HATCH/SMOKE HATCH	Does not Exist
LEADERS, GUTTERS, DOWNSPOUTS, SCUPPERS	Inspected
Condition	3 - Fair
Deficiency	DAMAGED/MISSING
Roof Plan reference	K205

Violations	Roof 1 - Near PH No violations recorded.
ROOF BARRIER/FENCE	Inspected
Condition	3 - Fair

Deficiency Quantity	10
Quantity Uom	L.F.
Potential Action	REPLACE
Urgency of Action	PRIORITY 4
Purpose of Action	LEVEL 2
Deficiency Photo1

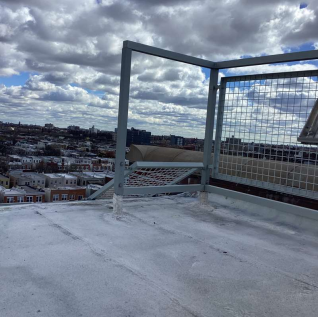
Question	Response
EXTERIOR	
ROOF	
Roofing	
ROOF BARRIER/FENCE	
Deficiency	RAILINGS/PANELS: DETERIORATED, MAJOR RUSTING
Roof Plan reference	K205

Violations	Roof 3 - Bulkhead Roof No violations recorded.
ROOF CAGE	Does not Exist
ROOFING	Inspected
Instance on Built-Up: Roofs 2-4, 6-8	Inspected
Instance Condition	4 - Between Fair and Poor
Instance Photo

Deficiency Quantity	20
Quantity Uom	S.F.
Potential Action	REPLACE
Urgency of Action	PRIORITY 4
Purpose of Action	LEVEL 2
Deficiency Photo1

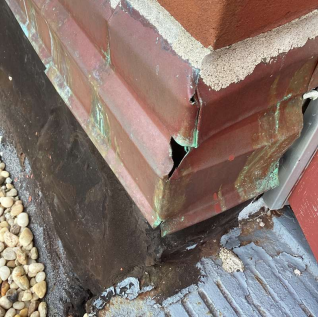
Question	Response
EXTERIOR	
ROOF	
Roofing	
ROOFING	
<p>Deficiency</p> <p>Roof Plan reference</p>	<p>BUILT-UP: FLASHING: CAP FLASHING DAMAGED</p> <p>K205</p>

<p>Roof 2 - Near BH4</p>
<p>Violations</p>	<p>No violations recorded.</p>
<p>Deficiency</p> <p>Roof Plan reference</p>	<p>BUILT-UP: FLASHING: BASE FLASHING DETERIORATED</p> <p>K205</p>

<p>20TH AVENUE</p> <p>67th STREET</p> <p>68th STREET</p>
<p>Deficiency Quantity</p> <p>Quantity Uom</p> <p>Potential Action</p> <p>Urgency of Action</p> <p>Purpose of Action</p> <p>Deficiency Photo1</p>	<p>10</p> <p>L.F.</p> <p>REPLACE</p> <p>PRIORITY 4</p> <p>LEVEL 2</p>

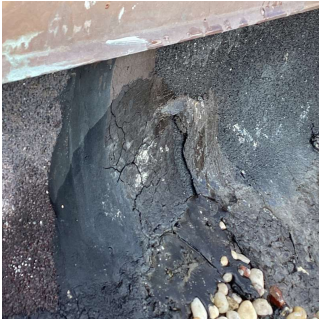
Roof 2 - Near BH4	
Violations	No violations recorded.	
Deficiency	BUILT-UP: FLASHING: DRIP EDGE/GRAVEL STOP DAMAGED	
Roof Plan reference	<div>K205</div>

<p>20TH AVENUE</p> <p>67th STREET</p> <p>68th STREET</p>
<p>Deficiency Quantity</p> <p>Quantity Uom</p> <p>Potential Action</p> <p>Urgency of Action</p> <p>Purpose of Action</p>	<p>30</p> <p>S.F.</p> <p>REMOVE AND REPLACE</p> <p>PRIORITY 4</p> <p>LEVEL 2</p>

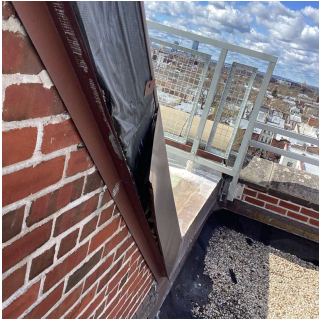
Roof 2 - BH4	
Violations	No violations recorded.	
Deficiency	BUILT-UP: ROOFING: MAJOR ACTIVE ROOF LEAKS IN INSTRUCTIONAL SPACE

Deficiency Quantity	10	
Quantity Uom	L.F.	
Potential Action	REPLACE	
Urgency of Action	PRIORITY 4	
Purpose of Action	LEVEL 2	
Deficiency Photo1

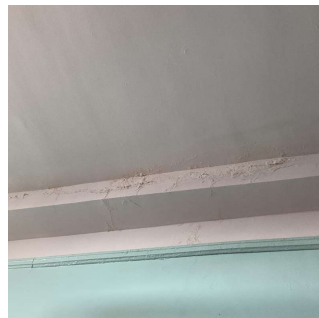
Violations	Roof 2 - Room 515 (shown), Room 516 (similar) No violations recorded.
Instance on Modified Bitumen: Roofs 1,5	Inspected
Instance Condition	1 - Good
Instance Photo

Deficiency Quantity	200
Quantity Uom	S.F.
Potential Action	REPLACE ROOFING WITH MAJOR EQUIPMENT REMOVAL
Urgency of Action	PRIORITY 5
Purpose of Action	LEVEL 2
Deficiency Photo1

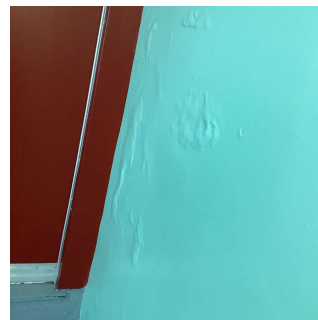
Violations	BH3 No violations recorded.
Deficiency	BULKHEAD/PENTHOUSE WALLS/INTERIOR: PLASTER CRACKS/SPALLING

60
S.F.
REPLACE
PRIORITY 3
LEVEL 2

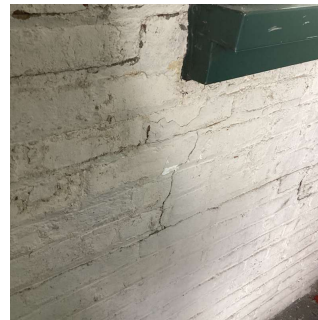
BH4

Question	Response
EXTERIOR	
ROOF	
Specialties	
BULKHEAD/PENTHOUSE	
Deficiency Photo1	 
Violations	BH3 No violations recorded.
Deficiency	BULKHEAD/PENTHOUSE WALLS/EXTERIOR: EFFLORESCENCE
Roof Plan reference	 
Deficiency Quantity	20
Quantity Uom	S.F.
Potential Action	MAINTENANCE
Urgency of Action	PRIORITY 1
Purpose of Action	LEVEL 1
Deficiency Photo1	 
Violations	BH3 No violations recorded.
Deficiency	BULKHEAD/PENTHOUSE WALLS/INTERIOR: BRICK CRACKS/SPALLING

REPLACE

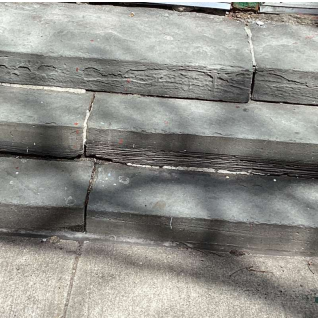
Question	Response
EXTERIOR	
STAIRS/RAMPS: EXTERIOR	
RAILINGS	Inspected
Condition	2 - Between Good and Fair
Deficiency	No deficiencies recorded
STAIRS/RAMPS	Inspected
Condition	5 - Poor
Deficiency	STONE: WORN-OUT TREAD/RISER/NOSING
Roof Plan reference	<p>K205</p>

Violations	<p>Facade H</p> <p>No violations recorded.</p>
Deficiency	CONCRETE: WORN-OUT TREAD/RISER/NOSING
Roof Plan reference	<p>K205</p>

<p>20TH AVENUE</p>
Deficiency Quantity	20
Quantity Uom	S.F.
Potential Action	REPLACE
Urgency of Action	PRIORITY 4
Purpose of Action	LEVEL 2
Deficiency Photo1

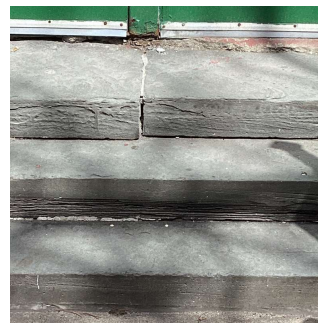
Facade H

STONE: DETERIORATED JOINTS

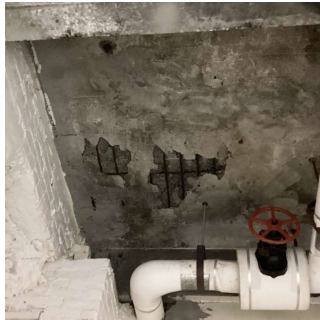
Violations	Basement - Boiler Room No violations recorded.
FLOOR STRUCTURE	Inspected
Condition	3 - Fair
Deficiency	CONCRETE: CRACKS/SPALLED/REINFORCEMENT EXPOSED
Deficiency Location/Instance	Basement - Boiler Room, Rooms B01, B12
Deficiency Quantity	30
Quantity Uom	S.F.
Potential Action	REPAIR
Urgency of Action	PRIORITY 4
Purpose of Action	LEVEL 5
Deficiency Photo1

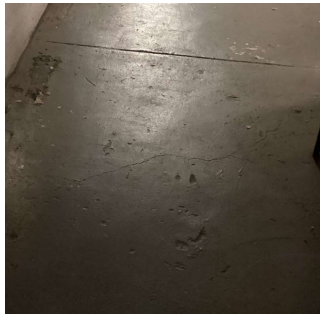
Violations	Basement - Oil Tank Room No violations recorded.
Deficiency	CONCRETE SLAB ON GRADE: THRU CRACKS
Deficiency Location/Instance	Basement - Boiler Room, Rooms B01, B12
Deficiency Quantity	60
Quantity Uom	S.F.
Potential Action	REPAIR
Urgency of Action	PRIORITY 3
Purpose of Action	LEVEL 5
Deficiency Photo1

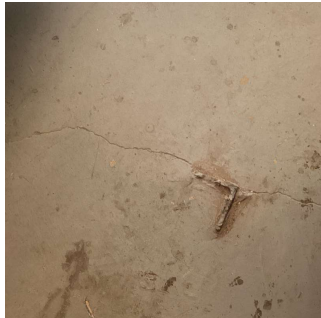
Question	Response
INTERIOR	
STRUCTURAL	
FLOOR STRUCTURE	
Violations	Basement- Room B01 No violations recorded.
Deficiency	CONCRETE: CRACKS/SPALLED/REINFORCEMENT EXPOSED
Deficiency Location/Instance	Roof 1 - PH
Deficiency Quantity	20
Quantity Uom	S.F.
Potential Action	REPAIR
Urgency of Action	PRIORITY 3
Purpose of Action	LEVEL 5
Deficiency Photo1

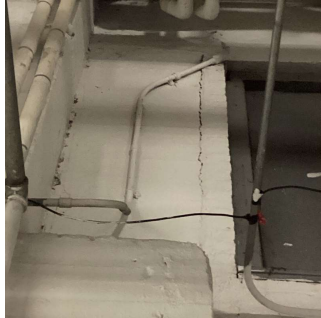
Violations	Roof 1 - PH No violations recorded.
FOUNDATION WALLS	
Material Type(s)	Inspected Concrete
Condition	4 - Between Fair and Poor
Deficiency	CONCRETE: CRACKED/SPALLED/REINFORCEMENT EXPOSED
Deficiency Location/Instance	Basement - Room B12, Boiler Room, Stair C/Basement
Deficiency Quantity	120
Quantity Uom	S.F.
Potential Action	REPAIR
Urgency of Action	PRIORITY 4
Purpose of Action	LEVEL 5
Deficiency Photo1

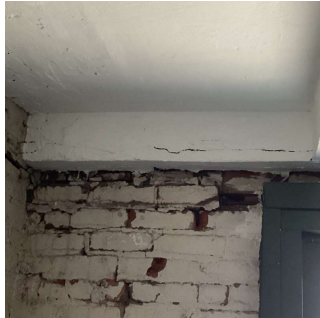
Violations	Basement - Boiler Room No violations recorded.
ROOF STRUCTURE	
Condition	Inspected 3 - Fair
Deficiency	CONCRETE COLUMNS AND BEAMS: CRACKED/SPALLED/REINFORCEMENT EXPOSED

Deficiency Location/Instance	Roof 3 - BH1

Question	Response
INTERIOR	
STRUCTURAL	
ROOF STRUCTURE	
Deficiency Quantity	10
Quantity Uom	S.F.
Potential Action	REPLACE
Urgency of Action	PRIORITY 4
Purpose of Action	LEVEL 5
Deficiency Photo1

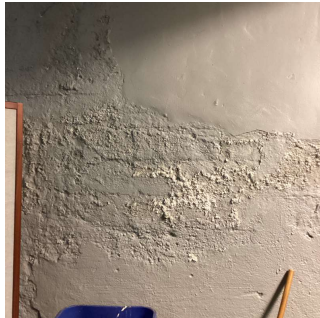
Roof 3 - BH1
Violations	No violations recorded.
VAULTS-BUNKERS	
Foundation Walls	
Condition	Inspected
Condition	4 - Between Fair and Poor
Deficiency	WATER INFILTRATION IN NON- INSTRUCTIONAL SPACE
Deficiency Location/Instance	Basement - Vaults-Bunkers
Deficiency Quantity	100
Quantity Uom	S.F.
Potential Action	INSTALL WATERPROOFING
Urgency of Action	PRIORITY 5
Purpose of Action	LEVEL 5
Deficiency Photo1

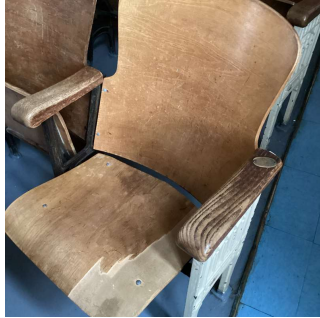
Question	Response
INTERIOR	
AUDITORIUM	
Door(s)	
Deficiency Photo1	 
Violations	Right Side Stage No violations recorded.
Fixed H/C Lift	
Instance on 2nd Floor (688 Seats)	Does not Exist
Fixed Seating	
Instance on 2nd Floor (688 Seats)	Inspected
Condition	5 - Poor
Deficiency	IMPROPERLY ANCHORED
Deficiency Location/Instance	Seat K/1
Deficiency Quantity	1
Quantity Uom	EACH
Potential Action	MAINTENANCE
Urgency of Action	PRIORITY 3
Purpose of Action	LEVEL 2
Deficiency Photo1	No photo recorded
Violations	No violations recorded.
Deficiency	DAMAGED/BROKEN/INOPERABLE
Deficiency Location/Instance	Seats A/15, J/21, K/11, N/1, 15, 11, L/6, M/26, O/14, P/16, 18, Q/23, 25, T/2, 4, U/1, 3, 15, 26, V/6, 19, 21, W/1, 2, X/1, Z/10
Deficiency Quantity	26
Quantity Uom	EACH
Potential Action	REPLACE
Urgency of Action	PRIORITY 5
Purpose of Action	LEVEL 6
Deficiency Photo1	 
Violations	Seats P/16, 18 No violations recorded.
Deficiency	DAMAGED/BROKEN/INOPERABLE

Deficiency Location/Instance	Seats S/22, 24, 26, T/18, 20 and others
Deficiency Quantity	90

Question	Response
INTERIOR	
AUDITORIUM	
Fixed Seating	
Quantity Uom	EACH
Potential Action	REPLACE
Urgency of Action	PRIORITY 3
Purpose of Action	LEVEL 2
Deficiency Photo1

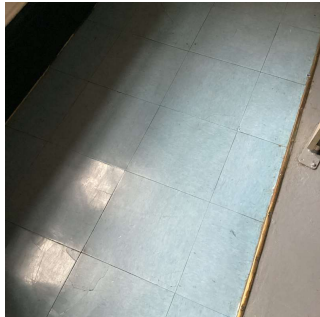
Seat S/26
Violations	No violations recorded.
Floor Finish	
Instance on 2nd Floor (688 Seats)	Inspected
Condition	3 - Fair
Deficiency	VINYL TILES: DETERIORATED SUBSTRATE
Deficiency Location/Instance	Right and Left Side
Deficiency Quantity	80
Quantity Uom	S.F.
Potential Action	REPLACE
Urgency of Action	PRIORITY 3
Purpose of Action	LEVEL 2
Deficiency Photo1

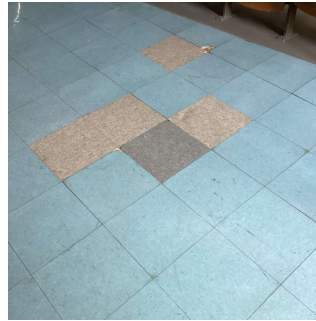
Near Stair C

Right Side
Violations	No violations recorded.
Deficiency	VINYL TILES: BROKEN/DETERIORATED/MISSING TILES
Deficiency Location/Instance	Near Stair C, by Main Entrance, Right Side, next to Stage, Center Aisle and others
Deficiency Quantity	120
Quantity Uom	S.F.
Potential Action	REPLACE
Urgency of Action	PRIORITY 3
Purpose of Action	LEVEL 2

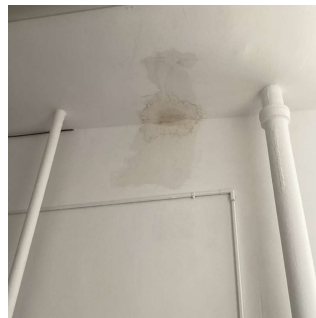
Backstage Room

PLASTER: CRACKS/SPALLING

REPLACE

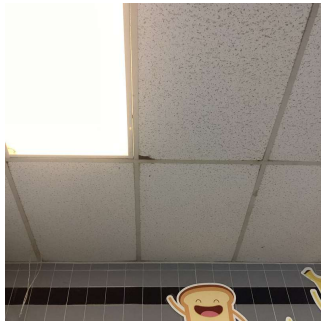
Question	Response
INTERIOR	
AUDITORIUM	
Walls	
Violations	No violations recorded.
Window Curtains/Shades/Blinds	
Instance on 2nd Floor (688 Seats)	Inspected
Condition	2 - Between Good and Fair
Deficiency	No deficiencies recorded
CAFETERIA	
Instance on 1st Floor	Inspected
Ceiling	
Instance on 1st Floor	Inspected
Condition	2 - Between Good and Fair
Deficiency	ACOUSTIC TILES: DAMAGED/MISSING
Deficiency Location/Instance	Near Servery, by Windows
Deficiency Quantity	20
Quantity Uom	S.F.
Potential Action	REPLACE
Urgency of Action	PRIORITY 3
Purpose of Action	LEVEL 2
Deficiency Photo1

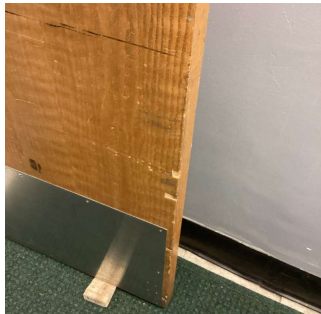
Violations	Near Servery No violations recorded.
Door(s)	
Instance on 1st Floor	Inspected
Condition	5 - Poor
Deficiency	WOOD: DETERIORATED DOOR
Deficiency Location/Instance	Near Elevator A/1, Exit 8 - Vestibule(2x)
Deficiency Quantity	3
Quantity Uom	EACH
Potential Action	MAINTENANCE
Urgency of Action	PRIORITY 3
Purpose of Action	LEVEL 2
Deficiency Photo1

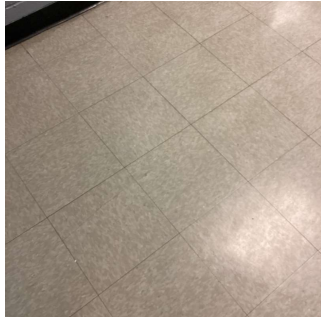
Question	Response
INTERIOR	
CAFETERIA	
Door(s)	
	Near Elevator A/1
Violations	No violations recorded.
Fixed Equipment	
Instance on 1st Floor	Does not Exist
Floor Finish	
Instance on 1st Floor	Inspected
Condition	2 - Between Good and Fair
Deficiency	VINYL TILES: DETERIORATED SUBSTRATE
Deficiency Location/Instance	Near Main Entrance, by Interior Ramp
Deficiency Quantity	20
Quantity Uom	S.F.
Potential Action	REPLACE
Urgency of Action	PRIORITY 3
Purpose of Action	LEVEL 2
Deficiency Photo1

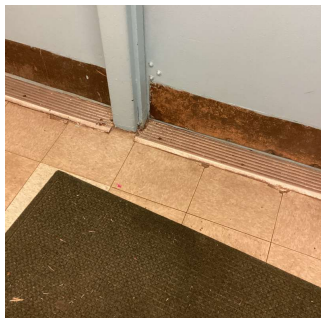
Violations	Near Main Entrance No violations recorded.
Deficiency	VINYL TILES: BROKEN/DETERIORATED/MISSING TILES
Deficiency Location/Instance	Exit 8 - Vestibule, near Exit 2
Deficiency Quantity	20
Quantity Uom	S.F.
Potential Action	REPLACE
Urgency of Action	PRIORITY 3
Purpose of Action	LEVEL 2
Deficiency Photo1

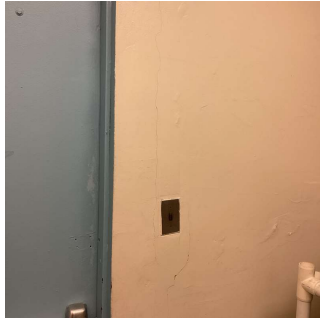
Question	Response
INTERIOR	
CAFETERIA	
Stage	
Instance on 1st Floor	Does not Exist
Walls	
Instance on 1st Floor	Inspected
Condition	2 - Between Good and Fair
Deficiency	PLASTER: CRACKS/SPALLING
Deficiency Location/Instance	Exit 8 - Vestibule, near Exit 8
Deficiency Quantity	30
Quantity Uom	S.F.
Potential Action	REPLACE
Urgency of Action	PRIORITY 3
Purpose of Action	LEVEL 2
Deficiency Photo1

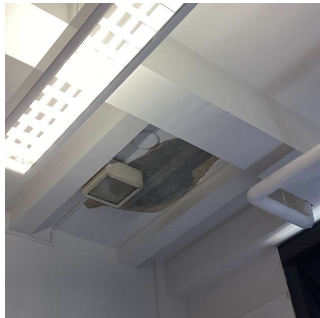
Violations	Exit 8 - Vestibule No violations recorded.
Window Curtains/Shades/Blinds	
Instance on 1st Floor	Does not Exist
CLASSROOMS/CORRIDORS/ADMIN SPACES	
	Inspected
Ceiling	Inspected
Condition	2 - Between Good and Fair
Deficiency	PLASTER: CRACKS/SPALLING
Deficiency Location/Instance	Rooms 546, 419B, 409, Corridor near Room 210A, by Auditorium and others
Deficiency Quantity	80
Quantity Uom	S.F.
Potential Action	REPLACE
Urgency of Action	PRIORITY 3
Purpose of Action	LEVEL 2
Deficiency Photo1

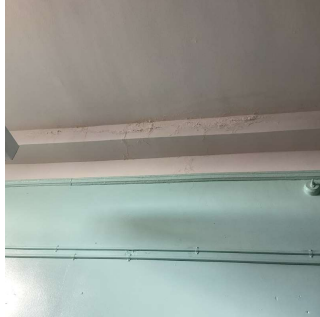
Deficiency	PLASTER: CRACKS/SPALLING - ACTIVE LEAK

Question	Response
INTERIOR	
CLASSROOMS/CORRIDORS/ADMIN SPACES	
Ceiling	
Deficiency Location/Instance	Rooms 515, 516
Deficiency Quantity	40
Quantity Uom	S.F.
Potential Action	REPLACE
Urgency of Action	PRIORITY 5
Purpose of Action	LEVEL 2
Deficiency Photo1

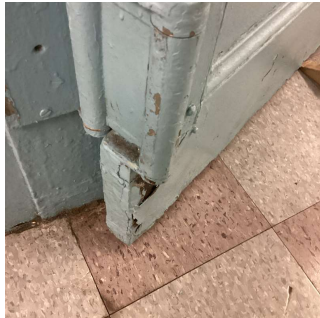
Room 515
Violations	No violations recorded.
Door(s)	Inspected
Condition	5 - Poor
Deficiency	METAL CLAD WOOD: DETERIORATED DOOR
Deficiency Location/Instance	Corridor near Elevator/4
Deficiency Quantity	2
Quantity Uom	EACH
Potential Action	MAINTENANCE
Urgency of Action	PRIORITY 3
Purpose of Action	LEVEL 2
Deficiency Photo1

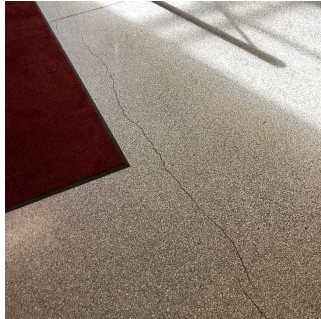
Room 506
Violations	No violations recorded.
Floor Finish	Inspected
Condition	3 - Fair
Deficiency	TERRAZZO: CRACKS
Deficiency Location/Instance	Main Entrance Lobby, Corridor near Rooms 210, 211, 213, by Auditorium and others
Deficiency Quantity	100
Quantity Uom	S.F.
Potential Action	REPLACE
Urgency of Action	PRIORITY 3
Purpose of Action	LEVEL 2
Deficiency Photo1

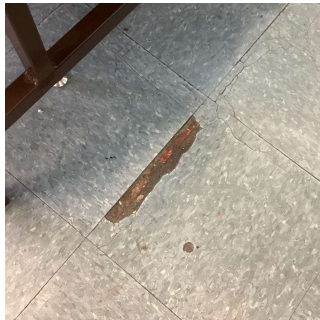
Violations	Corridor near Elevator/2nd Floor No violations recorded.
Deficiency	VINYL TILES: BROKEN/DETERIORATED/MISSING TILES
Deficiency Location/Instance	Rooms 552, 546, 509, Corridor near Rooms 508, 507 and others
Deficiency Quantity	1,200
Quantity Uom	S.F.
Potential Action	REPLACE
Urgency of Action	PRIORITY 3
Purpose of Action	LEVEL 2
Deficiency Photo1

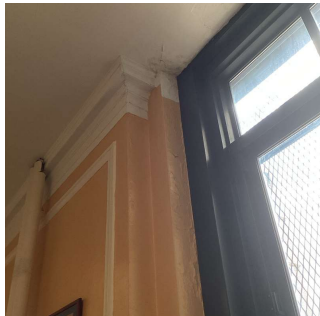
Violations	Room 546 No violations recorded.
Walls	Inspected
Condition	2 - Between Good and Fair
Deficiency	PLASTER: CRACKS/SPALLING
Deficiency Location/Instance	Corridor near Auditorium, Corridor near Rooms 201, 415, by Stair C/3
Deficiency Quantity	40
Quantity Uom	S.F.
Potential Action	REPLACE
Urgency of Action	PRIORITY 3
Purpose of Action	LEVEL 2
Deficiency Photo1

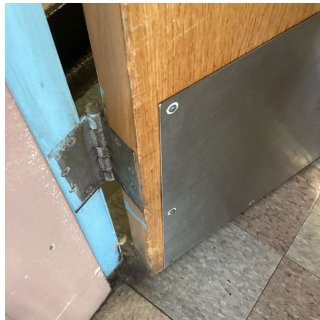
Question	Response
INTERIOR	
CLASSROOMS/CORRIDORS/ADMIN SPACES	
Walls	
Deficiency Photo1	 
Violations	Room 515 No violations recorded.
Specialties	Does not Exist
GYMNASIUM	Inspected
Instance on 5th Floor	Inspected
Instance on Basement	Inspected
Ceiling	
Instance on 5th Floor	Inspected
Condition	2 - Between Good and Fair
Deficiency	No deficiencies recorded
Instance on Basement	Inspected
Condition	2 - Between Good and Fair
Deficiency	No deficiencies recorded
Door(s)	
Instance on Basement	Inspected
Condition	5 - Poor
Deficiency	WOOD: DETERIORATED DOOR
Deficiency Location/Instance	Office Room, Room 122
Deficiency Quantity	3
Quantity Uom	EACH
Potential Action	MAINTENANCE
Urgency of Action	PRIORITY 3
Purpose of Action	LEVEL 2
Deficiency Photo1	 
Violations	Office Room No violations recorded.
Instance on 5th Floor	Inspected
Condition	4 - Between Fair and Poor
Deficiency	WOOD: DETERIORATED DOOR
Deficiency Location/Instance	Main Entrance

Question	Response
INTERIOR	
GYMNASIUM	
Door(s)	
Deficiency Quantity	2
Quantity Uom	EACH
Potential Action	MAINTENANCE
Urgency of Action	PRIORITY 3
Purpose of Action	LEVEL 2
Deficiency Photo1

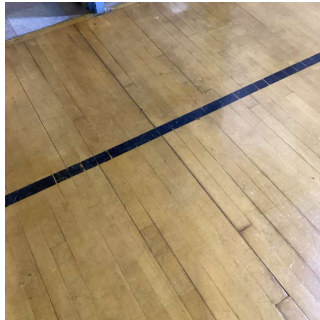
Main Entrance
Violations	No violations recorded.
Fixed Equipment	
Instance on 5th Floor	Inspected
Condition	2 - Between Good and Fair
Deficiency	No deficiencies recorded
Instance on Basement	Inspected
Condition	2 - Between Good and Fair
Deficiency	No deficiencies recorded
Floor Finish	
Instance on Basement	Inspected
Condition	2 - Between Good and Fair
Deficiency	WOOD: DAMAGED/DETERIORATED
Deficiency Location/Instance	Near Stair H
Deficiency Quantity	20
Quantity Uom	S.F.
Potential Action	REPLACE
Urgency of Action	PRIORITY 3
Purpose of Action	LEVEL 2
Deficiency Photo1

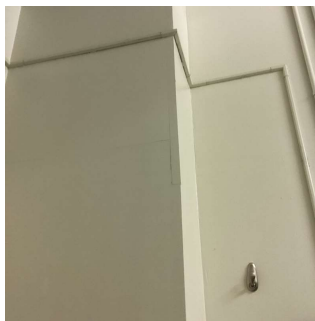
Question	Response
INTERIOR	
GYMNASIUM	
Walls	
Violations	No violations recorded.
Deficiency	GYPSUM BOARD: DETERIORATED
Deficiency Location/Instance	Office Room
Deficiency Quantity	10
Quantity Uom	S.F.
Potential Action	REPLACE
Urgency of Action	PRIORITY 3
Purpose of Action	LEVEL 2
Deficiency Photo1

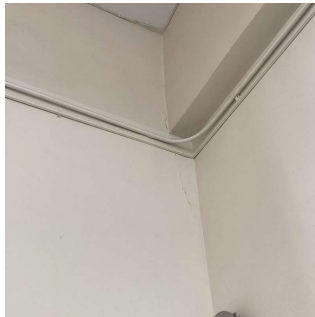
Violations	Office Room No violations recorded.
Instance on 5th Floor	Inspected
Condition	2 - Between Good and Fair
Deficiency	PLASTER: CRACKS/SPALLING
Deficiency Location/Instance	Near Right Side Windows
Deficiency Quantity	10
Quantity Uom	S.F.
Potential Action	REPLACE
Urgency of Action	PRIORITY 3
Purpose of Action	LEVEL 2
Deficiency Photo1

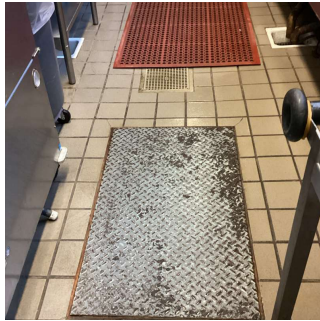
Question	Response
INTERIOR	
KITCHEN	
Ceiling	
Urgency of Action	PRIORITY 3
Purpose of Action	LEVEL 2
Deficiency Photo1	 
	Near Exit Door
Violations	No violations recorded.
Door(s)	
Instance on 1st Floor	Inspected
Condition	2 - Between Good and Fair
Deficiency	No deficiencies recorded
Floor Finish	
Instance on 1st Floor	Inspected
Condition	3 - Fair
Deficiency	VINYL TILES: DETERIORATED SUBSTRATE
Deficiency Location/Instance	Office Room, Storage Room
Deficiency Quantity	30
Quantity Uom	S.F.
Potential Action	REPLACE
Urgency of Action	PRIORITY 3
Purpose of Action	LEVEL 2
Deficiency Photo1	 
	Office Room
Violations	No violations recorded.
Deficiency	QUARRY TILE: BROKEN/MISSING TILES
Deficiency Location/Instance	Sink Room, Servery, Preparation Area
Deficiency Quantity	30
Quantity Uom	S.F.
Potential Action	REPLACE
Urgency of Action	PRIORITY 3
Purpose of Action	LEVEL 2

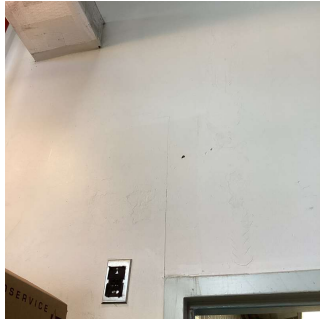
Sink Room
Violations	No violations recorded.
Walls	
Instance on 1st Floor	Inspected
Condition	2 - Between Good and Fair
Deficiency	PLASTER: CRACKS/SPALLING
Deficiency Location/Instance	Storage Room
Deficiency Quantity	10
Quantity Uom	S.F.
Potential Action	REPLACE
Urgency of Action	PRIORITY 3
Purpose of Action	LEVEL 2
Deficiency Photo1

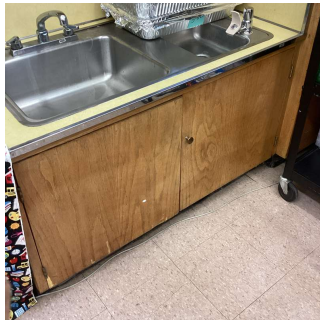
Violations	Preparation Area No violations recorded.
LIBRARY	Inspected
Instance on Room 310	Inspected
Built-in Furnishing	
Instance on Room 310	Inspected
Condition	2 - Between Good and Fair
Deficiency	SINK/STORAGE CABINET - DAMAGED/DETERIORATED
Deficiency Location/Instance	Left Side
Deficiency Quantity	10
Quantity Uom	L.F.
Potential Action	REPLACE
Urgency of Action	PRIORITY 3
Purpose of Action	LEVEL 2
Deficiency Photo1

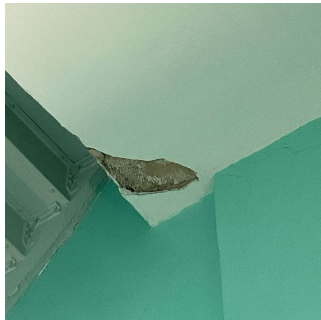
Question	Response
INTERIOR	
MULTI-PURPOSE ROOM	Inspected
Window Curtains/Shades/Blinds	
SCIENCE DEMO ROOM	Does not Exist
SCIENCE LAB	Does not Exist
SCIENCE PREP ROOM	Does not Exist
SHOWER ROOM	Does not Exist
STAIRS/RAMPS: INTERIOR	Inspected
Do Letter Stair Signs Exist?	Yes
Ceiling	Inspected
Condition	2 - Between Good and Fair
Deficiency	PLASTER: CRACKS/SPALLING
Deficiency Location/Instance	Stair E/5
Deficiency Quantity	20
Quantity Uom	S.F.
Potential Action	REPLACE
Urgency of Action	PRIORITY 5
Purpose of Action	LEVEL 6
Deficiency Photo1

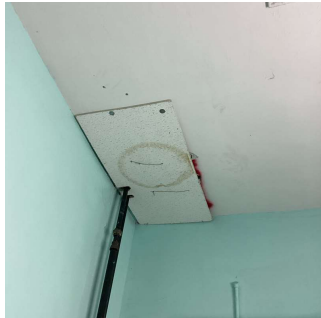
Violations	Stair E/5 No violations recorded.
Deficiency	PLASTER: CRACKS/SPALLING
Deficiency Location/Instance	Stairs B/5, D/5, Exit 5 - Vestibule
Deficiency Quantity	30
Quantity Uom	S.F.
Potential Action	REPLACE
Urgency of Action	PRIORITY 3
Purpose of Action	LEVEL 2
Deficiency Photo1

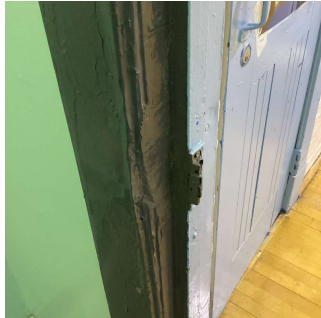
Question	Response
INTERIOR	
STAIRS/RAMPS: INTERIOR	
Door(s)	
Deficiency	WOOD: DETERIORATED DOOR AND FRAME
Deficiency Location/Instance	Stair D/Basement
Deficiency Quantity	1
Quantity Uom	EACH
Potential Action	MAINTENANCE
Urgency of Action	PRIORITY 3
Purpose of Action	LEVEL 2
Deficiency Photo1

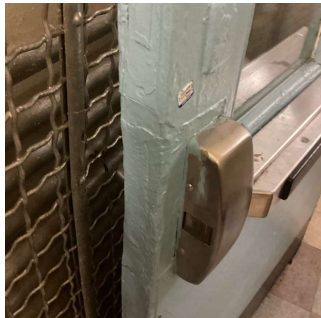
Violations	Stair D/Basement No violations recorded.
Deficiency	METAL: DETERIORATED DOOR
Deficiency Location/Instance	Stair C/1
Deficiency Quantity	1
Quantity Uom	EACH
Potential Action	MAINTENANCE
Urgency of Action	PRIORITY 3
Purpose of Action	LEVEL 2
Deficiency Photo1

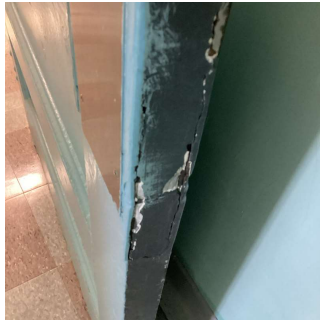
Violations	Stair C/1 No violations recorded.
Deficiency	WOOD: DETERIORATED DOOR
Deficiency Location/Instance	Stair D/3
Deficiency Quantity	1
Quantity Uom	EACH
Potential Action	MAINTENANCE
Urgency of Action	PRIORITY 3
Purpose of Action	LEVEL 2

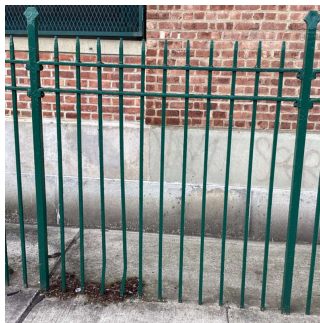
Near Playground
Violations	No violations recorded.
Deficiency	WROUGHT IRON: DAMAGED/DETERIORATED
Deficiency Location/Instance	67th Street, 20th Avenue

Deficiency Quantity	130
Quantity Uom	S.F.
Potential Action	REPLACE
Urgency of Action	PRIORITY 3

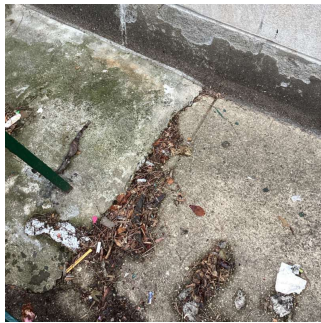
Question	Response
SITE	
IRRIGATION SYSTEM	Does not Exist
PAVING	Inspected
Student Non-Use	Inspected
Gravel Exists?	No
Asphalt	Does not Exist
Concrete	Inspected
Condition	3 - Fair
Deficiency	DAMAGED/DETERIORATED/MISSING SECTIONS
Deficiency Location/Instance	68th Street
Deficiency Quantity	75
Quantity Uom	S.F.
Potential Action	REPLACE
Urgency of Action	PRIORITY 3
Purpose of Action	LEVEL 2
Deficiency Photo1

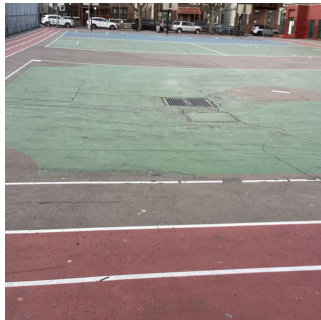
68th Street
Violations	No violations recorded.
Pavers	Does not Exist
Student Use	Inspected
Gravel Exists?	No
Asphalt	Inspected
Condition	4 - Between Fair and Poor
Deficiency	CRACKS - MAJOR
Deficiency Location/Instance	Schoolyard
Deficiency Quantity	850
Quantity Uom	S.F.
Potential Action	REPLACE
Urgency of Action	PRIORITY 3
Purpose of Action	LEVEL 2
Deficiency Photo1

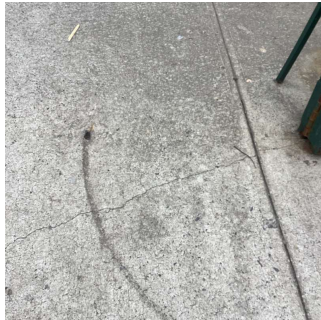
Question	Response
SITE	
PAVING	
Student Use	Inspected
Concrete	Does not Exist
Pavers	Does not Exist
Site Sidewalks & Walkways	Inspected
Asphalt	Does not Exist
Concrete	Inspected
Condition	3 - Fair
Deficiency	DAMAGED/DETERIORATED/MISSING SECTIONS
Deficiency Location/Instance	20th Avenue
Deficiency Quantity	50
Quantity Uom	S.F.
Potential Action	REPLACE
Urgency of Action	PRIORITY 3
Purpose of Action	LEVEL 2
Deficiency Photo1

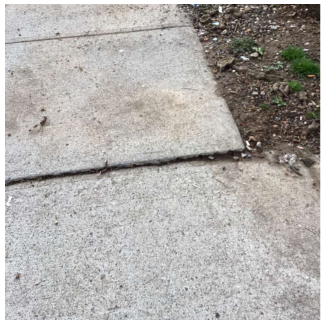
Violations	20th Avenue No violations recorded.
Pavers	Does not Exist
DOT Sidewalk	Inspected
Asphalt	Does not Exist
Concrete	Inspected
Condition	4 - Between Fair and Poor
Deficiency	HEAVING
Deficiency Location/Instance	68th Street, 20th Avenue
Deficiency Quantity	125
Quantity Uom	S.F.
Potential Action	REPLACE
Urgency of Action	PRIORITY 3
Purpose of Action	LEVEL 2
Deficiency Photo1

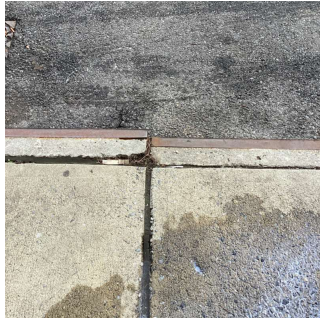
Question	Response
SITE	
PAVING	
DOT Sidewalk	
Concrete	
Violations	No violations recorded.
Deficiency	DAMAGED CURBS
Deficiency Location/Instance	67th Street, 68th Street, 20th Avenue
Deficiency Quantity	100
Quantity Uom	L.F.
Potential Action	REPLACE
Urgency of Action	PRIORITY 3
Purpose of Action	LEVEL 2
Deficiency Photo1

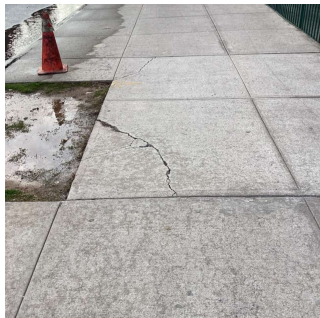
Violations	67th Street No violations recorded.
Deficiency	DAMAGED/DETERIORATED/MISSING SECTIONS
Deficiency Location/Instance	20th Avenue, 67th Street, 68th Street
Deficiency Quantity	525
Quantity Uom	S.F.
Potential Action	REPLACE
Urgency of Action	PRIORITY 3
Purpose of Action	LEVEL 2
Deficiency Photo1

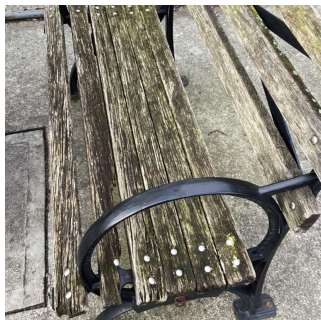
Violations	67th Street No violations recorded.
Pavers	Does not Exist
PLAYGROUNDS	Inspected
Instance on Schoolyard	Inspected
Benches	
Instance on Schoolyard	Inspected
Condition	5 - Poor
Deficiency	DAMAGED/DETERIORATED
Deficiency Location/Instance	Near Fences

Question	Response
SITE	
PLAYGROUNDS	
Benches	
Deficiency Quantity	4
Quantity Uom	EACH
Potential Action	REPLACE
Urgency of Action	PRIORITY 5
Purpose of Action	LEVEL 6
Deficiency Photo1

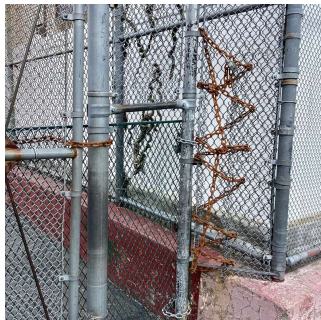
Near Fences
Violations	No violations recorded.
Fence	
Instance on Schoolyard	Inspected
Condition	3 - Fair
Deficiency	CHAIN LINK: DAMAGED/DETERIORATED
Deficiency Location/Instance	Near Schoolyard
Deficiency Quantity	100
Quantity Uom	S.F.
Potential Action	REPLACE
Urgency of Action	PRIORITY 3
Purpose of Action	LEVEL 2
Deficiency Photo1

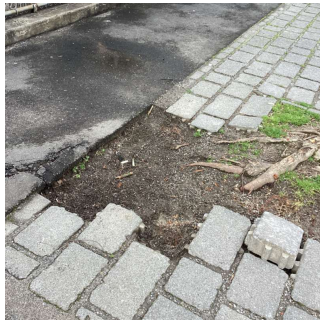
Question	Response
SITE	
PLAYGROUNDS	
Pavement	
Deficiency Photo1	 
Violations	Left Side No violations recorded.
Deficiency	ASPHALT: HEAVING
Deficiency Location/Instance	Left Side
Deficiency Quantity	10
Quantity Uom	S.F.
Potential Action	REPLACE
Urgency of Action	PRIORITY 3
Purpose of Action	LEVEL 2
Deficiency Photo1	 
Violations	Left Side No violations recorded.
Deficiency	PAVERS: DAMAGED/MISSING
Deficiency Location/Instance	Left Side
Deficiency Quantity	20
Quantity Uom	S.F.
Potential Action	REPLACE
Urgency of Action	PRIORITY 3
Purpose of Action	LEVEL 2
Deficiency Photo1

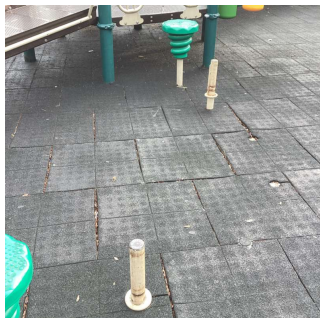
Question	Response
SITE	
PLAYGROUNDS	
Pavement	
Deficiency	ASPHALT: CRACKS - MAJOR
Deficiency Location/Instance	Near Main Entrance, by Schoolyard
Deficiency Quantity	100
Quantity Uom	S.F.
Potential Action	REPLACE
Urgency of Action	PRIORITY 3
Purpose of Action	LEVEL 2
Deficiency Photo1	 
	Near Main Entrance
Violations	No violations recorded.
Play Equipment	
Instance on Schoolyard	Inspected
Condition	5 - Poor
Deficiency	BROKEN/DETERIORATED/MISSING
Deficiency Location/Instance	Center
Deficiency Quantity	2
Quantity Uom	EACH
Potential Action	REPLACE
Urgency of Action	PRIORITY 5
Purpose of Action	LEVEL 6
Deficiency Photo1

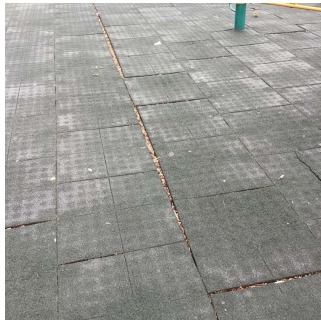
Center
Violations	No violations recorded.
Safety Surfacing	
Instance on Schoolyard	Inspected
Condition	4 - Between Fair and Poor
Deficiency	DETERIORATED/MISSING
Deficiency Location/Instance	Center
Deficiency Quantity	200
Quantity Uom	S.F.
Potential Action	REPLACE

Question	Response
SITE	
PLAYGROUNDS	
Safety Surfacing	
Urgency of Action	PRIORITY 5
Purpose of Action	LEVEL 6
Deficiency Photo1

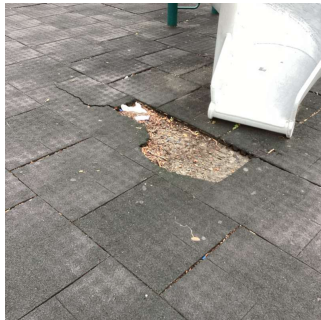
Violations	Center No violations recorded.
Deficiency	DETERIORATED/MISSING
Deficiency Location/Instance	Near Slide, Right Side
Deficiency Quantity	80
Quantity Uom	S.F.
Potential Action	REPLACE
Urgency of Action	PRIORITY 3
Purpose of Action	LEVEL 2
Deficiency Photo1

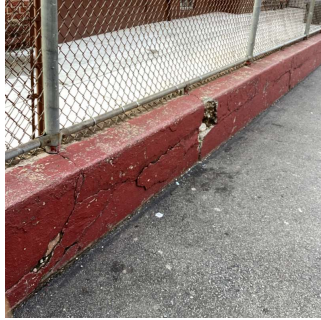
Violations	Near Slide No violations recorded.
Unpaved Area	
Instance on Schoolyard	Inspected
Condition	2 - Between Good and Fair
Deficiency	No deficiencies recorded
PLAYING SURFACE	Does not Exist
RETAINING WALLS	Inspected
Are there any Retaining Walls 6' OR higher facing public street/sidewalk?	No
Condition	3 - Fair
Deficiency	CAST IN PLACE CONCRETE: CRACKS/SPALLING - MAJOR
Deficiency Location/Instance	Schoolyard, near Playground
Deficiency Quantity	80
Quantity Uom	S.F.
Potential Action	REPLACE
Urgency of Action	PRIORITY 3

Purpose of Action	LEVEL 2
