**NYC Department of Education**  
**Building Condition Assessment Survey 2023 - 2024**

Architectural Inspection

**Asset: I.S. 211 - BROOKLYN, 1001 EAST 100 STREET, New York, 11236**

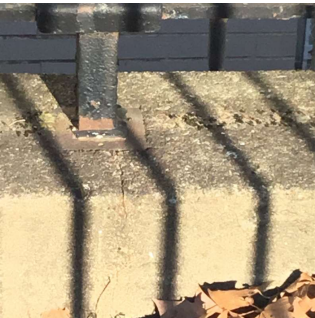
Violations	AW1 No violations recorded.
Deficiency	AREAWAY SLAB: CRACKS AND SPALLING
Roof Plan reference

Question	Response
<b>Architectural</b>	
<b>EXTERIOR</b>	Inspected
<b>AREAWAY</b>	Inspected
Instance on AW1-AW5	Inspected
Instance Condition	3 - Fair
Instance Quantity	5
Instance Quantity Uom	EACH
Deficiency	AREAWAY WALLS: CRACKS AND SPALLING
Roof Plan reference

Deficiency Quantity	25
Quantity Uom	S.F.
Potential Action	REPAIR
Urgency of Action	PRIORITY 3
Purpose of Action	LEVEL 2
Deficiency Photo1

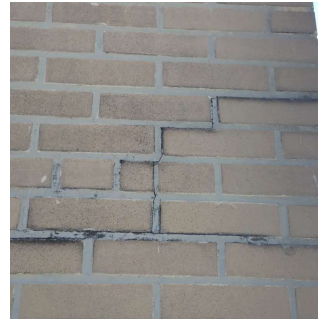
Question	Response
<b>EXTERIOR</b>	
<b>AREAWAY</b>	
Purpose of Action	LEVEL 2
Deficiency Photo1	 
Violations	AW3 No violations recorded.
<b>AWNINGS AND CANOPIES</b>	Inspected
Condition	2 - Between Good and Fair
Deficiency	No deficiencies recorded
<b>CHIMNEY</b>	Inspected
Material Type(s)	Masonry
Condition	3 - Fair
Deficiency	BRICK: DETERIORATED CAP
Roof Plan reference	 
Deficiency Quantity	10
Quantity Uom	L.F.
Potential Action	REPLACE
Urgency of Action	PRIORITY 3
Purpose of Action	LEVEL 2
Deficiency Photo1	 
Violations	Chimney No violations recorded.
Deficiency	BRICK: MINOR CRACKS AND SPALLING

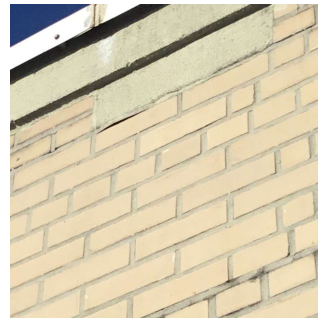
Chimney

BRICK: DETERIORATED JOINTS

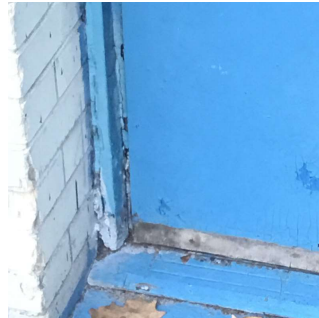
Question	Response
<b>EXTERIOR</b>	
<b>COPING</b>	Inspected
Condition	2 - Between Good and Fair
Deficiency	No deficiencies recorded
<b>CORNICE</b>	Does not Exist
<b>DOORS</b>	Inspected
<b>DOORS AND FRAMES</b>	Inspected
Condition	5 - Poor
Deficiency	WOOD: DETERIORATED DOOR AND FRAME - MAJOR DETERIORATION
Roof Plan reference

Deficiency Quantity	4
Quantity Uom	EACH
Potential Action	REPLACE
Urgency of Action	PRIORITY 4
Purpose of Action	LEVEL 2
Deficiency Photo1

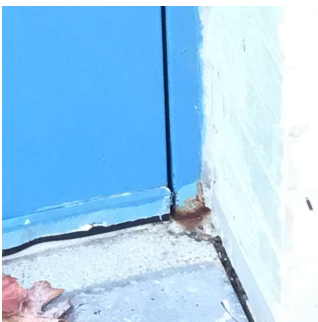
### Facade C

METAL: DETERIORATED DOOR AND FRAME - MINOR  
DETERIORATION

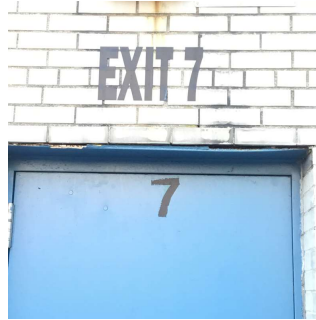
Facade C

STEEL: MAJOR RUSTING

REPLACE

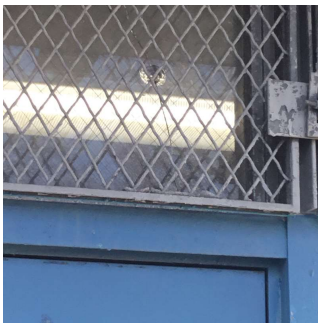
METAL: BROKEN GLASS

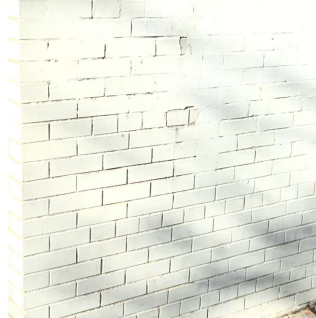
Facade F

Violations	<p>Facade D</p> <p>No violations recorded.</p>
<b>EXTERIOR WALLS</b>	Inspected
Material Type(s)	Masonry
Replacement Quantity	33,000
Replacement Uom	S.F.
Instance on All Facades	Inspected
Instance Condition	3 - Fair
Instance Quantity	33,000
Instance Quantity Uom	S.F.
Deficiency	BRICK: DETERIORATED JOINTS
Roof Plan reference

Deficiency Quantity	75
Quantity Uom	S.F.
Potential Action	REPOINT
Urgency of Action	PRIORITY 3
Purpose of Action	LEVEL 2

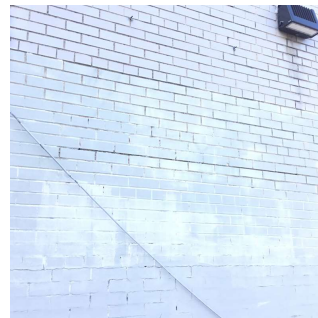
Facade F

**BRICK: DETERIORATED JOINTS**

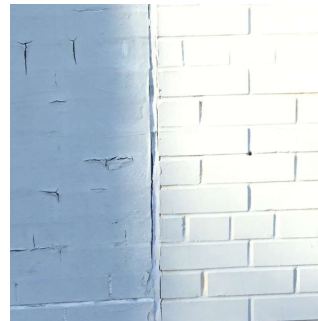
Facade F

**BRICK: DETERIORATED CONTROL/EXPANSION JOINTS**

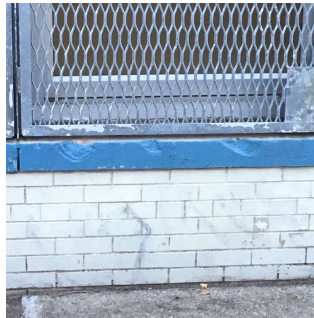
Facade C

BRICK: DETERIORATED MASONRY SILLS - MAJOR

REMOVE AND REPLACE

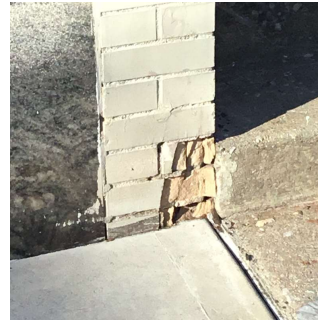
Facade C

BRICK: MAJOR / THRU CRACKS

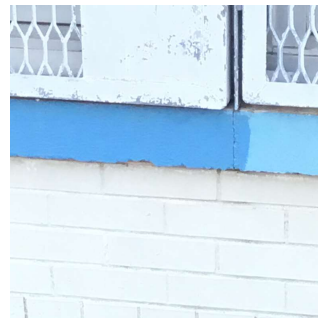
Facade C

BRICK: DETERIORATED MASONRY SILLS - MINOR

REPAIR

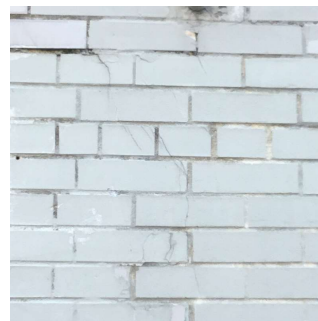
Facade C

BRICK: MINOR CRACKS AND SPALLING

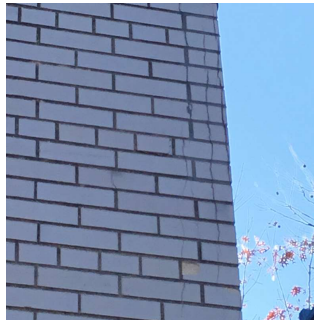
Facade C

BRICK: CRACKS/DISPLACED/SPALLED BRICK AT BUILDING CORNERS

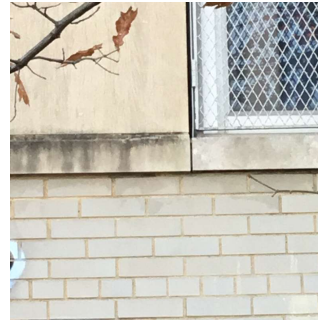
Facade B

BRICK: MASONRY SILLS - DETERIORATED JOINTS

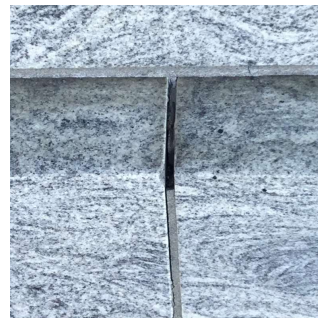
Facade B

STONE: DETERIORATED JOINTS

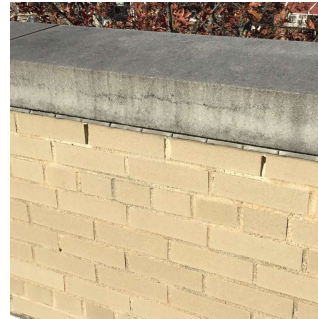
Roof 2

Question	Response
<b>EXTERIOR</b>	
<b>LOADING DOCK</b>	Does not Exist
<b>LOUVER</b>	Inspected
Condition	3 - Fair
Deficiency	BROKEN/ DENTED BLADES
Roof Plan reference	 
Elevation	 
Deficiency Quantity	10
Quantity Uom	S.F.
Potential Action	REPLACE
Urgency of Action	PRIORITY 4
Purpose of Action	LEVEL 2
Deficiency Photo1	 
Violations	<p>Facade A</p> <p>No violations recorded.</p>
<b>PARAPETS</b>	Inspected
Material Type(s)	Masonry
Replacement Quantity	2,000
Replacement Uom	C.F.
Instance on Roofs 1, 2	Inspected
Instance Condition	3 - Fair
Instance Quantity	2,000
Instance Quantity Uom	C.F.
Deficiency	BRICK: DETERIORATED JOINTS

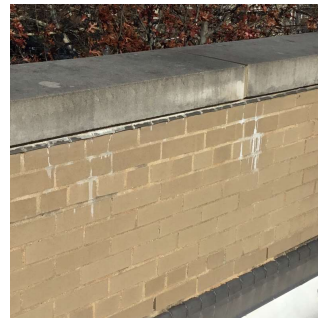
Roof 2

BRICK: EFFLORESCENCE

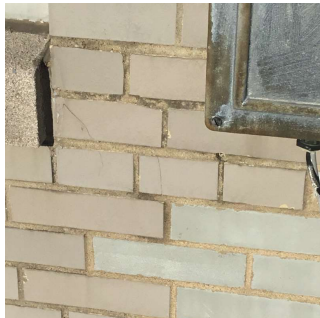
Violations	Roof 1 No violations recorded.
<b>ROOFING DRAINS</b>	Inspected
Condition	2 - Between Good and Fair
Deficiency	No deficiencies recorded
<b>Specialties</b>	Inspected
<b>BULKHEAD/PENTHOUSE</b>	Inspected
Condition	3 - Fair
Deficiency	BULKHEAD/PENTHOUSE WALLS/EXTERIOR: CRACKS/SPALLING - MINOR
Roof Plan reference

Deficiency Quantity	50
Quantity Uom	S.F.
Potential Action	REPAIR
Urgency of Action	PRIORITY 3
Purpose of Action	LEVEL 2
Deficiency Photo1

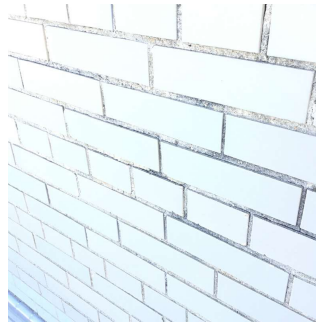
BH3  
No violations recorded.

Violations	BH2 No violations recorded.
Deficiency	BULKHEAD/PENTHOUSE WALLS/EXTERIOR: DETERIORATED JOINTS

180  
S.F.  
REPOINT  
PRIORITY 3  
LEVEL 2

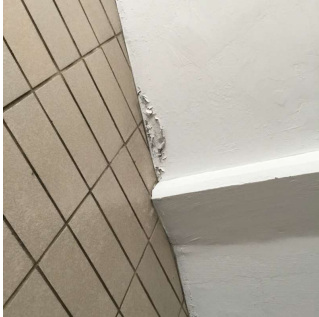
Question	Response
<b>EXTERIOR</b>	
<b>ROOF</b>	
<b>Specialties</b>	
<b>BULKHEAD/PENTHOUSE</b>	
Deficiency Quantity	10
Quantity Uom	S.F.
Potential Action	REPLACE
Urgency of Action	PRIORITY 3
Purpose of Action	LEVEL 2
Deficiency Photo1

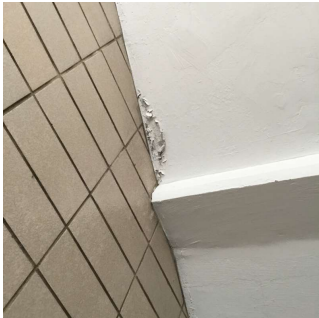
Violations	BH3 No violations recorded.
Deficiency	BULKHEAD/PENTHOUSE ROOF: MINOR LEAKAGE
Roof Plan reference

Deficiency Quantity	50
Quantity Uom	S.F.
Potential Action	MAINTENANCE
Urgency of Action	PRIORITY 3
Purpose of Action	LEVEL 2
Deficiency Photo1

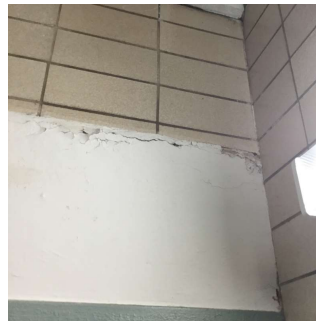
Violations	BH3 No violations recorded.
Deficiency	BULKHEAD/PENTHOUSE WALLS/INTERIOR: PLASTER CRACKS/SPALLING

15  
S.F.  
REPLACE  
PRIORITY 4  
LEVEL 2

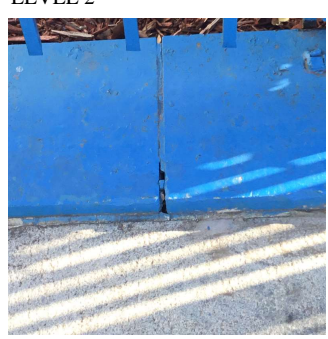
Question	Response
<b>EXTERIOR</b>	
<b>STAIRS/RAMPS: EXTERIOR</b>	
<b>BUILDING CHEEK/FLANK WALLS</b>	Inspected
Condition	4 - Between Fair and Poor
Deficiency	STONE: DETERIORATED JOINTS
Roof Plan reference

Deficiency Quantity	10
Quantity Uom	S.F.
Potential Action	REPOINT
Urgency of Action	PRIORITY 3
Purpose of Action	LEVEL 2
Deficiency Photo1

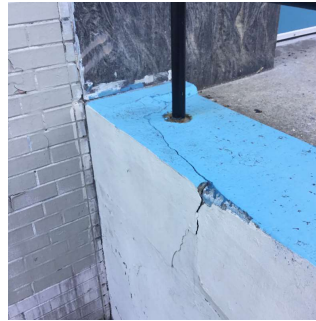
Facade E

Deficiency Quantity	20
Quantity Uom	S.F.
Potential Action	REPLACE
Urgency of Action	PRIORITY 4
Purpose of Action	LEVEL 2

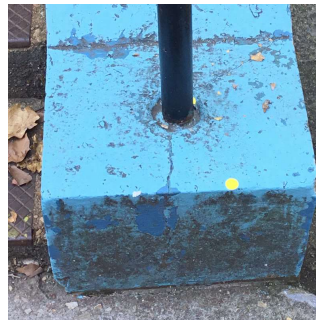
Facade E

**STONE: CRACKS/SPALLING - MINOR**

REPAIR

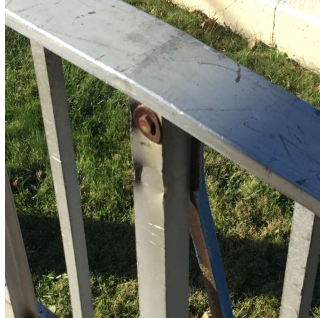
Question	Response
<b>EXTERIOR</b>	
<b>STAIRS/RAMPS: EXTERIOR</b>	
<b>RAILINGS</b>	
Quantity Uom	L.F.
Potential Action	REPLACE
Urgency of Action	PRIORITY 4
Purpose of Action	LEVEL 2
Deficiency Photo1

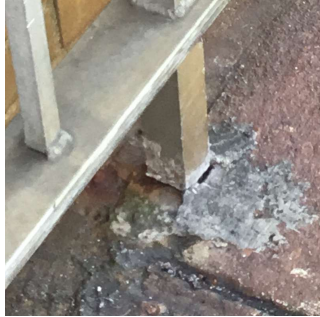
Violations	<p>Facade B</p> <p>No violations recorded.</p>
Deficiency	RUST - MAJOR
Roof Plan reference

Deficiency Quantity	30
Quantity Uom	L.F.
Potential Action	REPLACE
Urgency of Action	PRIORITY 4
Purpose of Action	LEVEL 2
Deficiency Photo1

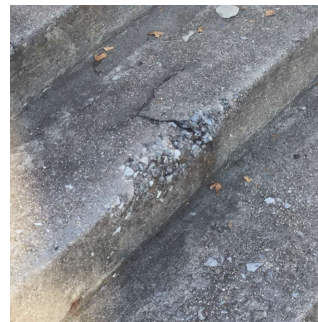
Facade C

Violations	<p>Facade B</p> <p>No violations recorded.</p>
<b>STAIRS/RAMPS</b>	Inspected
Condition	5 - Poor
Deficiency	CONCRETE: CRACKS/SPALLING - MAJOR

25

REPLACE

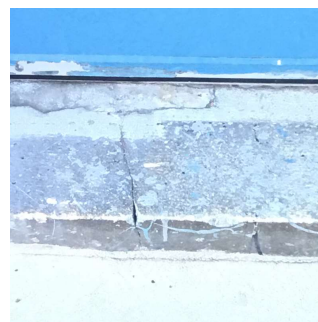
Facade C

STONE: CRACKS/SPALLING - MINOR

10

REPAIR

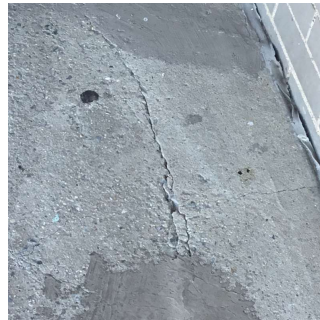
Question	Response
<b>EXTERIOR</b>	
<b>STAIRS/RAMPS: EXTERIOR</b>	
<b>STAIRS/RAMPS</b>	
Violations	No violations recorded.
Deficiency	CONCRETE: CRACKS/SPALLING - MINOR
Roof Plan reference

Deficiency Quantity	20
Quantity Uom	S.F.
Potential Action	REPAIR
Urgency of Action	PRIORITY 3
Purpose of Action	LEVEL 2
Deficiency Photo1

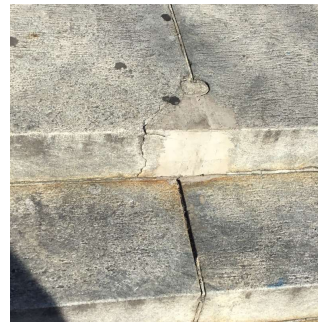
Facade A

Violations	Facade B
Deficiency	STONE: DETERIORATED JOINTS
Roof Plan reference

Deficiency Quantity	25
Quantity Uom	L.F.
Potential Action	REPOINT
Urgency of Action	PRIORITY 4
Purpose of Action	LEVEL 2

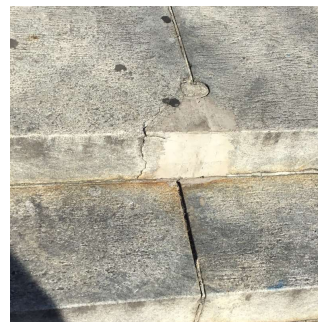
Facade A

STONE: CRACKS/SPALLING - MAJOR

15

REPLACE

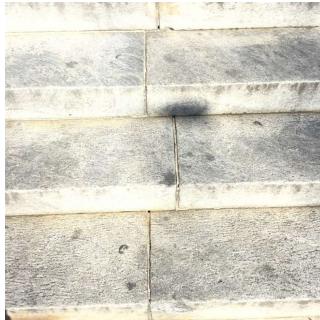
STONE: DETERIORATED JOINTS

35

Question	Response
<b>EXTERIOR</b>	
<b>STAIRS/RAMPS: EXTERIOR</b>	
<b>STAIRS/RAMPS</b>	
Urgency of Action	PRIORITY 3
Purpose of Action	LEVEL 2
Deficiency Photo1

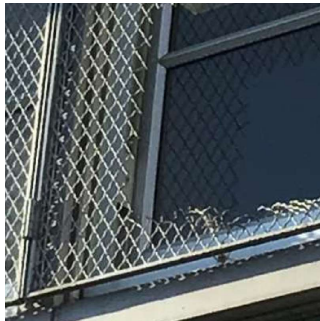
Violations	<p>Facade A</p> <p>No violations recorded.</p>
<b>WINDOWS</b>	Inspected
Replacement Quantity	12,000
Replacement Uom	S.F.
<b>EXTERIOR GUARDS</b>	Inspected
Condition	3 - Fair
Deficiency	DETERIORATED/TORN-OUT/MISSING
Roof Plan reference

Deficiency Quantity	120
Quantity Uom	S.F.
Potential Action	REPLACE
Urgency of Action	PRIORITY 4
Purpose of Action	LEVEL 2

Question	Response
<b>EXTERIOR</b>	
<b>WINDOWS</b>	
<b>EXTERIOR GUARDS</b>	
Deficiency Photo1

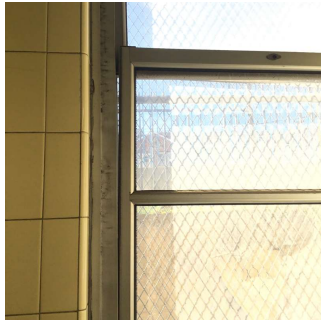
Violations	<p>Facade E</p> <p>No violations recorded.</p>
<b>LINTELS</b>	Inspected
Condition	2 - Between Good and Fair
Deficiency	No deficiencies recorded
<b>WINDOWS</b>	Inspected
Material Type(s)	Aluminum
Instance on Aluminum - Double Hung: All Facades	Inspected
Instance Condition	3 - Fair
Instance Quantity	12,000
Instance Quantity Uom	S.F.
Are these windows insulated	No
Installation Year	1996
Source of Installation	Custodial Staff
Deficiency	ALUMINUM - DOUBLE HUNG: INOPERABLE BALANCE
Roof Plan reference

Deficiency Quantity	120
Quantity Uom	EACH
Potential Action	REPLACE BALANCES
Urgency of Action	PRIORITY 3
Purpose of Action	LEVEL 2

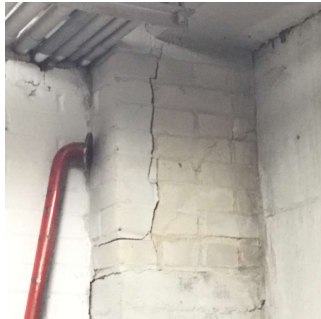
Violations	Facade A No violations recorded.
<b>INTERIOR</b>	Inspected
<b>POOLS</b>	Does not Exist
<b>STRUCTURAL</b>	Inspected
<b>COLUMNS/BEAMS/BEARING WALLS</b>	Inspected
Condition	3 - Fair
Deficiency	STEEL COLUMNS/BEAMS: DETERIORATED MASONRY FIREPROOFING
Deficiency Location/Instance	Basement
Deficiency Quantity	20
Quantity Uom	S.F.
Potential Action	REPLACE
Urgency of Action	PRIORITY 4
Purpose of Action	LEVEL 5
Deficiency Photo1

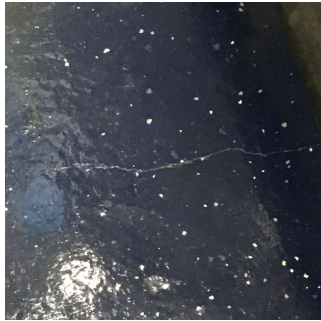
Question	Response
<b>INTERIOR</b>	
<b>STRUCTURAL</b>	
<b>COLUMNS/BEAMS/BEARING WALLS</b>	
Deficiency Photo1	 
Violations	Boiler Room No violations recorded.
Deficiency	STEEL COLUMNS/BEAMS: DETERIORATED CONCRETE FIREPROOFING
Deficiency Location/Instance	Basement
Deficiency Quantity	35
Quantity Uom	S.F.
Potential Action	REPLACE
Urgency of Action	PRIORITY 4
Purpose of Action	LEVEL 5
Deficiency Photo1	 
Violations	Boiler Room No violations recorded.
<b>FLOOR STRUCTURE</b>	Inspected
Condition	3 - Fair
Deficiency	CONCRETE SLAB ON GRADE: THRU CRACKS
Deficiency Location/Instance	Basement
Deficiency Quantity	55
Quantity Uom	S.F.
Potential Action	REPAIR
Urgency of Action	PRIORITY 3
Purpose of Action	LEVEL 5

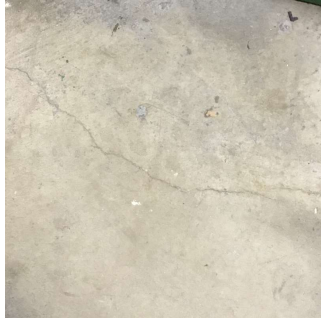
Violations	Boiler Room (Gas Meter Room, Electrical Panel Room similar) No violations recorded.
Deficiency	CONCRETE: CRACKS/SPALLED/REINFORCEMENT EXPOSED
Deficiency Location/Instance	Basement, 2nd Floor
Deficiency Quantity	100
Quantity Uom	S.F.
Potential Action	REPAIR
Urgency of Action	PRIORITY 3
Purpose of Action	LEVEL 5
Deficiency Photo1

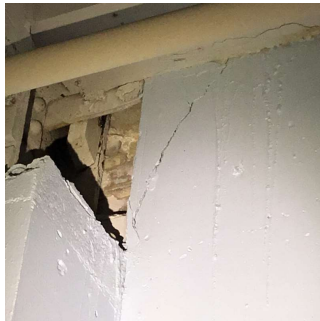
Violations	Room B23 (Rooms B3, 240 similar) No violations recorded.
<b>FOUNDATION WALLS</b>	
Material Type(s)	Inspected Concrete, Masonry
Condition	4 - Between Fair and Poor
Deficiency	CONCRETE: CRACKED/SPALLED/REINFORCEMENT EXPOSED
Deficiency Location/Instance	Basement
Deficiency Quantity	10
Quantity Uom	S.F.
Potential Action	REPAIR
Urgency of Action	PRIORITY 3
Purpose of Action	LEVEL 5

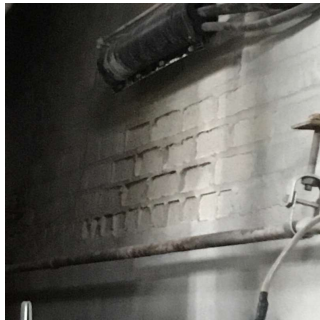
Violations	Room B29 No violations recorded.
Deficiency	BRICK: CRACKED/SPALLED
Deficiency Location/Instance	Basement
Deficiency Quantity	35
Quantity Uom	S.F.
Potential Action	RESTITCH
Urgency of Action	PRIORITY 4
Purpose of Action	LEVEL 5
Deficiency Photo1

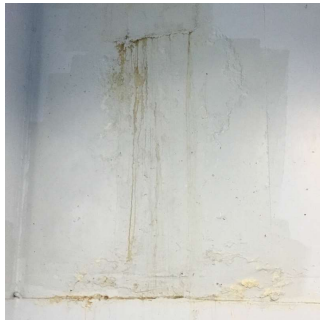
Room B29A (Cafeteria Fan Room similar)

Violations	Cafeteria Fan Room No violations recorded.
Deficiency	CONCRETE: WATER INFILTRATION IN NON- INSTRUCTIONAL SPACE
Deficiency Location/Instance	Basement
Deficiency Quantity	300
Quantity Uom	S.F.
Potential Action	INSTALL WATERPROOFING
Urgency of Action	PRIORITY 5
Purpose of Action	LEVEL 5
Deficiency Photo1

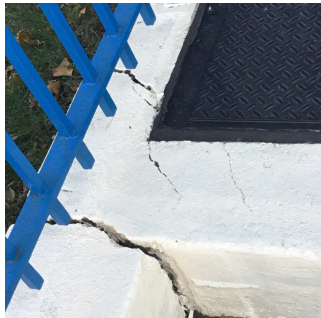
Question	Response
<b>INTERIOR</b>	
<b>STRUCTURAL</b>	
<b>FOUNDATION WALLS</b>	Inspected
Violations	No violations recorded.
<b>ROOF STRUCTURE</b>	Inspected
Condition	2 - Between Good and Fair
Deficiency	No deficiencies recorded
<b>VAULTS-BUNKERS</b>	Inspected
<b>Foundation Walls</b>	Inspected
Condition	2 - Between Good and Fair
Deficiency	CRACKS, SPALLING
Deficiency Location/Instance	Vault
Deficiency Quantity	10
Quantity Uom	S.F.
Potential Action	REPAIR
Urgency of Action	PRIORITY 3
Purpose of Action	LEVEL 5
Deficiency Photo1	 
Violations	Vault No violations recorded.
<b>Slab Structure</b>	Inspected
Condition	3 - Fair
Deficiency	CONCRETE: CRACKS/SPALLED/REINFORCEMENT EXPOSED
Deficiency Location/Instance	Vault
Deficiency Quantity	25
Quantity Uom	S.F.
Potential Action	REPAIR
Urgency of Action	PRIORITY 4
Purpose of Action	LEVEL 5
Deficiency Photo1

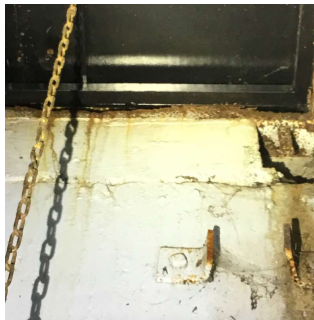
Violations	Vault No violations recorded.
Deficiency	STEEL COLUMNS/BEAMS: MAJOR RUSTING

Question	Response
<b>INTERIOR</b>	
<b>STRUCTURAL</b>	
<b>VAULTS-BUNKERS</b>	
<b>Slab Structure</b>	
Deficiency Location/Instance	Vault
Deficiency Quantity	10
Quantity Uom	S.F.
Potential Action	REPLACE
Urgency of Action	PRIORITY 4
Purpose of Action	LEVEL 5
Deficiency Photo1

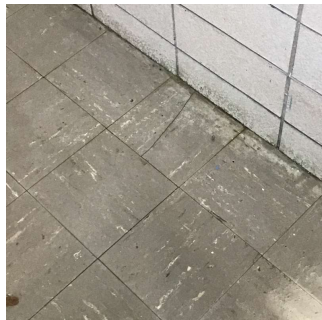
Question	Response
<b>INTERIOR</b>	
<b>AUDITORIUM</b>	
<b>Door(s)</b>	
Deficiency	No deficiencies recorded
<b>Fixed H/C Lift</b>	
Instance on 1st Floor (506 seats)	Does not Exist
<b>Fixed Seating</b>	
Instance on 1st Floor (506 seats)	Inspected
Condition	1 - Good
Deficiency	No deficiencies recorded
<b>Floor Finish</b>	
Instance on 1st Floor (506 seats)	Inspected
Condition	2 - Between Good and Fair
Deficiency	VINYL TILES: BROKEN/DETERIORATED/MISSING TILES
Deficiency Location/Instance	Right side Exit Vestibule, left side exit Vestibule
Deficiency Quantity	20
Quantity Uom	S.F.
Potential Action	REPLACE
Urgency of Action	PRIORITY 3
Purpose of Action	LEVEL 2
Deficiency Photo1

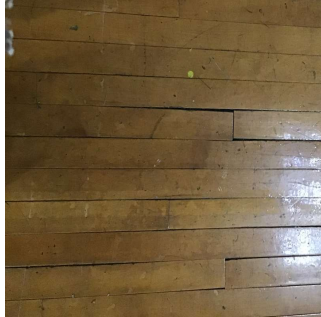
Condition	3 - Fair
Deficiency	DAMAGED FLOOR
Deficiency Location/Instance	Center
Deficiency Quantity	10
Quantity Uom	S.F.
Potential Action	REPLACE
Urgency of Action	PRIORITY 3
Purpose of Action	LEVEL 2

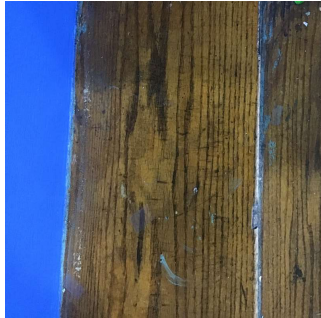
Center	Center
Violations	No violations recorded.
Deficiency	DAMAGED STEPS
Deficiency Location/Instance	Right side, left side
Deficiency Quantity	20
Quantity Uom	S.F.
Potential Action	REPLACE
Urgency of Action	PRIORITY 3
Purpose of Action	LEVEL 2
Deficiency Photo1

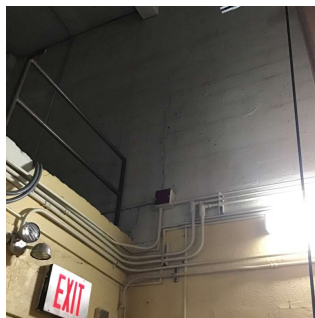
Left side
Violations	No violations recorded.
<b>Walls</b>	
Instance on 1st Floor (506 seats)	Inspected
Condition	2 - Between Good and Fair
Deficiency	MASONRY: CRACKS/SPALLING
Deficiency Location/Instance	Stage
Deficiency Quantity	10
Quantity Uom	S.F.
Potential Action	REPLACE
Urgency of Action	PRIORITY 3
Purpose of Action	LEVEL 2
Deficiency Photo1

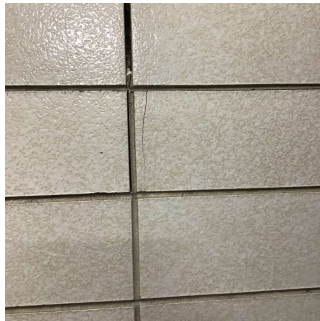
Stage
Violations	No violations recorded.
Deficiency	GLAZED BLOCK: CRACKS/SPALLING
Deficiency Location/Instance	Right side exit Vestibule
Deficiency Quantity	10
Quantity Uom	S.F.
Potential Action	REPLACE
Urgency of Action	PRIORITY 3
Purpose of Action	LEVEL 2

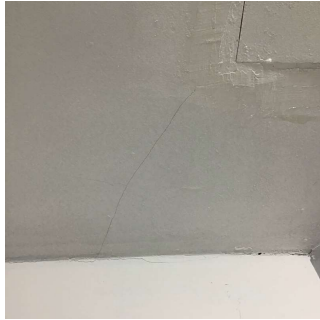
Violations	Right side exit Vestibule No violations recorded.
<b>Window Curtains/Shades/Blinds</b>	
Instance on 1st Floor (506 seats)	Inspected
Condition	2 - Between Good and Fair
Deficiency	No deficiencies recorded
<b>CAFETERIA</b>	
Instance on Basement - Staff	Inspected
Instance on Basement - Student	Inspected
<b>Ceiling</b>	
Instance on Basement - Student	Inspected
Condition	2 - Between Good and Fair
Deficiency	PLASTER: CRACKS/SPALLING
Deficiency Location/Instance	Near elevator/Basement
Deficiency Quantity	10
Quantity Uom	S.F.
Potential Action	REPLACE
Urgency of Action	PRIORITY 3
Purpose of Action	LEVEL 2
Deficiency Photo1

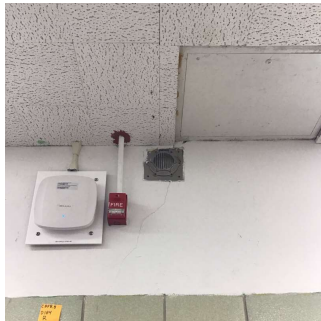
<b>Walls</b>	
Instance on Basement - Student	Inspected
Condition	2 - Between Good and Fair
Deficiency	PLASTER: CRACKS/SPALLING
Deficiency Location/Instance	Near Windows
Deficiency Quantity	10
Quantity Uom	S.F.
Potential Action	REPLACE
Urgency of Action	PRIORITY 3
Purpose of Action	LEVEL 2

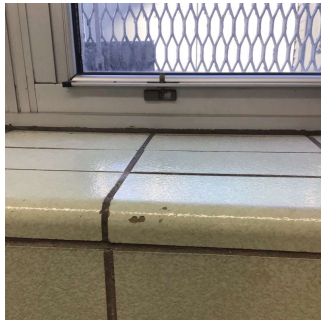
Violations	Near Windows No violations recorded.
Deficiency	GLAZED BLOCK: CRACKS/SPALLING
Deficiency Location/Instance	Near Windows, mechanical room, kitchen
Deficiency Quantity	20
Quantity Uom	S.F.
Potential Action	REPLACE
Urgency of Action	PRIORITY 3
Purpose of Action	LEVEL 2
Deficiency Photo1

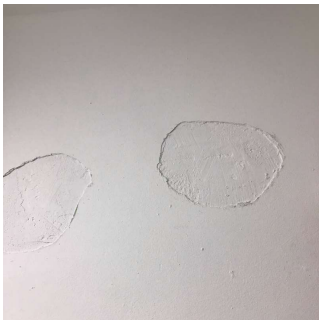
Violations	Near Windows No violations recorded.
<b>Window Curtains/Shades/Blinds</b>	
Instance on Basement - Student	Does not Exist
Instance on Basement - Staff	Does not Exist
<b>CLASSROOMS/CORRIDORS/ADMIN SPACES</b>	
Inspected	Inspected
<b>Ceiling</b>	
Condition	2 - Between Good and Fair
Deficiency	PLASTER: CRACKS/SPALLING
Deficiency Location/Instance	Room 332, Corridor near Room 232
Deficiency Quantity	20
Quantity Uom	S.F.
Potential Action	REPLACE
Urgency of Action	PRIORITY 3
Purpose of Action	LEVEL 2

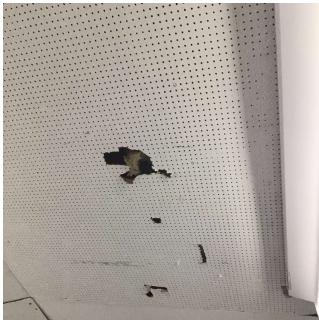
Violations	Room 332 No violations recorded.
Deficiency	ACOUSTIC TILES ON PLASTER: DAMAGED/MISSING - ACTIVE LEAK
Deficiency Location/Instance	Room B38
Deficiency Quantity	20
Quantity Uom	S.F.
Potential Action	REPLACE
Urgency of Action	PRIORITY 5
Purpose of Action	LEVEL 2
Deficiency Photo1

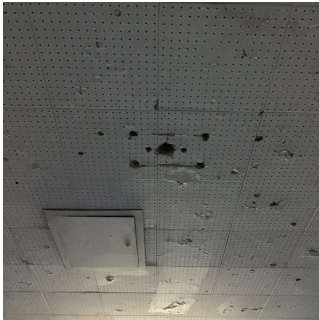
Corridor near Stair B/2

Violations	Room B38 No violations recorded.
Deficiency	ACOUSTIC TILES ON PLASTER: DAMAGED/MISSING
Deficiency Location/Instance	Corridor near Rooms 236,234,230, Stair B/5,2, and others
Deficiency Quantity	150
Quantity Uom	S.F.
Potential Action	REPLACE
Urgency of Action	PRIORITY 3
Purpose of Action	LEVEL 2
Deficiency Photo1

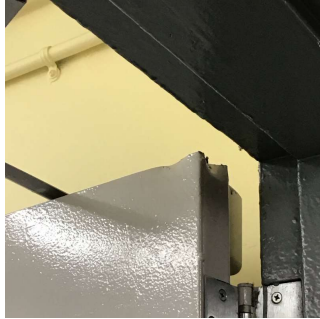
Question	Response
<b>INTERIOR</b>	
<b>CLASSROOMS/CORRIDORS/ADMIN SPACES</b>	
<b>Ceiling</b>	Inspected
Violations	No violations recorded.
<b>Door(s)</b>	Inspected
Condition	5 - Poor
Deficiency	METAL: DETERIORATED DOOR
Deficiency Location/Instance	Rooms 312,307
Deficiency Quantity	2
Quantity Uom	EACH
Potential Action	MAINTENANCE
Urgency of Action	PRIORITY 3
Purpose of Action	LEVEL 2
Deficiency Photo1

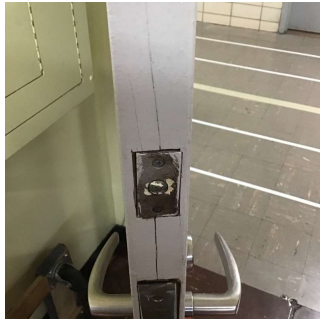
Room 310
Violations	No violations recorded.
<b>Floor Finish</b>	Inspected
Condition	2 - Between Good and Fair
Deficiency	TERRAZZO: CRACKS
Deficiency Location/Instance	Exits 7,5,4,3,2, and others
Deficiency Quantity	100
Quantity Uom	S.F.

Room 307
Violations	No violations recorded.
Deficiency	WOOD: DETERIORATED DOOR
Deficiency Location/Instance	Room 329A,328,323,310,223, and others
Deficiency Quantity	20
Quantity Uom	EACH
Potential Action	MAINTENANCE
Urgency of Action	PRIORITY 3
Purpose of Action	LEVEL 2
Deficiency Photo1

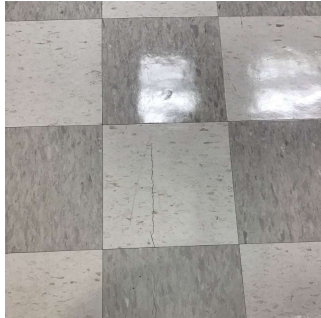
Violations	Exit 7 No violations recorded.
Deficiency	VINYL TILES: BROKEN/DETERIORATED/MISSING TILES
Deficiency Location/Instance	Corridor near Room 324,312,310,309, Elevator/3, and others
Deficiency Quantity	200
Quantity Uom	S.F.
Potential Action	REPLACE
Urgency of Action	PRIORITY 3
Purpose of Action	LEVEL 2
Deficiency Photo1

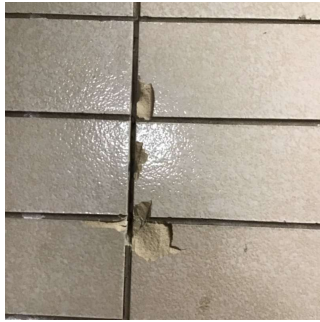
Question	Response
<b>INTERIOR</b>	
<b>CLASSROOMS/CORRIDORS/ADMIN SPACES</b>	
<b>Walls</b>	
Deficiency Photo1	 
Violations	Main Lobby No violations recorded.
Deficiency	GLAZED BLOCK: CRACKS/SPALLING
Deficiency Location/Instance	Corridor near Room 324,320,218, Room B32, Exit 4, and others
Deficiency Quantity	80
Quantity Uom	S.F.
Potential Action	REPLACE
Urgency of Action	PRIORITY 3
Purpose of Action	LEVEL 2
Deficiency Photo1

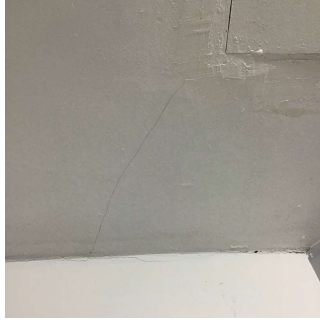
Violations	Corridor near Room 225 No violations recorded.

Violations	Exit 4 No violations recorded.
Deficiency	PLASTER: CRACKS/SPALLING
Deficiency Location/Instance	Corridor near Room 225,217, Rooms B44,B32, 110, and others
Deficiency Quantity	80
Quantity Uom	S.F.
Potential Action	REPLACE
Urgency of Action	PRIORITY 3
Purpose of Action	LEVEL 2
Deficiency Photo1

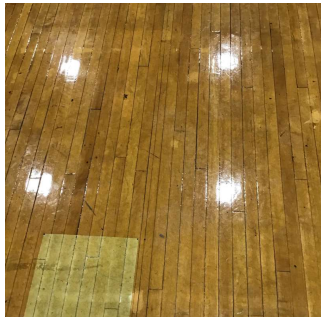
Violations	Near Entrance No violations recorded.
<b>Seating</b>	
Instance on 1st Floor	Does not Exist

Question	Response
<b>INTERIOR</b>	
<b>CLASSROOMS/CORRIDORS/ADMIN SPACES</b>	Inspected
Specialties	Does not Exist
<b>GYMNASIUM</b>	Inspected
Instance on 1st Floor	Inspected
<b>Ceiling</b>	
Instance on 1st Floor	Inspected
Condition	2 - Between Good and Fair
Deficiency	No deficiencies recorded
<b>Door(s)</b>	
Instance on 1st Floor	Inspected
Condition	2 - Between Good and Fair
Deficiency	No deficiencies recorded
<b>Fixed Equipment</b>	
Instance on 1st Floor	Inspected
Condition	2 - Between Good and Fair
Deficiency	No deficiencies recorded
<b>Floor Finish</b>	
Instance on 1st Floor	Inspected
Condition	3 - Fair
Deficiency	WOOD: DAMAGED/DETERIORATED
Deficiency Location/Instance	Near Entrance, sink, storage
Deficiency Quantity	200
Quantity Uom	S.F.
Potential Action	REPLACE
Urgency of Action	PRIORITY 3
Purpose of Action	LEVEL 2
Deficiency Photo1

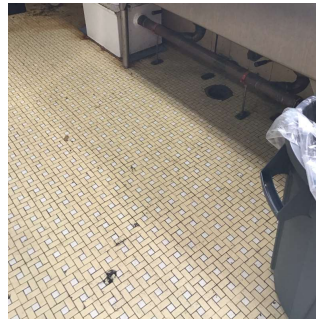
Near sink

Instance on Basement	Inspected
Condition	2 - Between Good and Fair
Deficiency	CERAMIC TILE: BROKEN/MISSING TILES
Deficiency Location/Instance	Near entrance, center, windows, sink
Deficiency Quantity	20
Quantity Uom	S.F.
Potential Action	REPLACE
Urgency of Action	PRIORITY 3
Purpose of Action	LEVEL 2
Deficiency Photo1

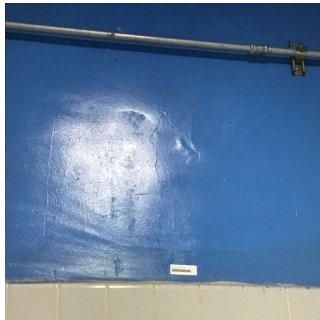
Violations	Storage No violations recorded.
Deficiency	CERAMIC TILE: BROKEN/ MISSING
Deficiency Location/Instance	Near Entrance, storage
Deficiency Quantity	10
Quantity Uom	S.F.
Potential Action	REPLACE
Urgency of Action	PRIORITY 3
Purpose of Action	LEVEL 2
Deficiency Photo1

Question	Response
<b>INTERIOR</b>	
<b>KITCHEN</b>	
<b>Walls</b>	
Deficiency Photo1	 
Violations	Area near storage No violations recorded.
Deficiency	PLASTER: CRACKS/SPALLING
Deficiency Location/Instance	Storage
Deficiency Quantity	10
Quantity Uom	S.F.
Potential Action	REPLACE
Urgency of Action	PRIORITY 3
Purpose of Action	LEVEL 2
Deficiency Photo1

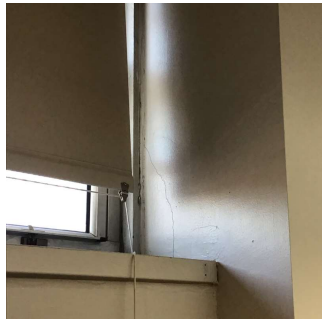
Near Windows
Violations	No violations recorded.
<b>LOCKER ROOM</b>	Does not Exist
<b>MULTI-PURPOSE ROOM</b>	Does not Exist

Question	Response
<b>INTERIOR</b>	
<b>LIBRARY</b>	Inspected
Instance on 2nd Floor	Inspected
<b>Built-in Furnishing</b>	
Instance on 2nd Floor	Does not Exist
<b>Ceiling</b>	
Instance on 2nd Floor	Inspected
Condition	2 - Between Good and Fair
Deficiency	No deficiencies recorded
<b>Door(s)</b>	
Instance on 2nd Floor	Inspected
Condition	2 - Between Good and Fair
Deficiency	No deficiencies recorded
<b>Floor Finish</b>	
Instance on 2nd Floor	Inspected
Condition	2 - Between Good and Fair
Deficiency	No deficiencies recorded
<b>Walls</b>	
Instance on 2nd Floor	Inspected
Condition	2 - Between Good and Fair
Deficiency	GYPSUM BOARD: DETERIORATED
Deficiency Location/Instance	Near Windows
Deficiency Quantity	10
Quantity Uom	S.F.
Potential Action	REPLACE
Urgency of Action	PRIORITY 3
Purpose of Action	LEVEL 2
Deficiency Photo1

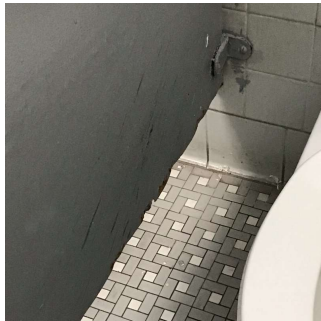
Question	Response
<b>INTERIOR</b>	
<b>TOILET ROOMS - STAFF</b>	
<b>Stalls</b>	
Deficiency Photo1

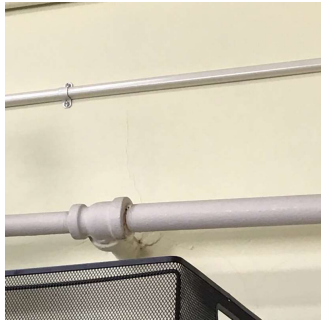
Room 222
Violations	No violations recorded.
Deficiency	CERAMIC TILE: BROKEN/ MISSING
Deficiency Location/Instance	Room 332,138,137,124,Gymnasium, and others
Deficiency Quantity	50
Quantity Uom	S.F.
Potential Action	REPLACE
Urgency of Action	PRIORITY 3
Purpose of Action	LEVEL 2
Deficiency Photo1

Room 332
Violations	No violations recorded.
<b>Walls</b>	Inspected
Condition	2 - Between Good and Fair
Deficiency	PLASTER: CRACKS/SPALLING
Deficiency Location/Instance	Rooms 222,138
Deficiency Quantity	20
Quantity Uom	S.F.
Potential Action	REPLACE
Urgency of Action	PRIORITY 3
Purpose of Action	LEVEL 2
Deficiency Photo1

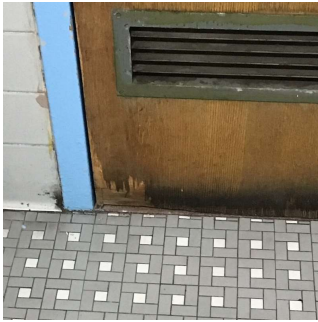
Violations	Room 128 No violations recorded.
Deficiency	WOOD: DAMAGED LOUVER
Deficiency Location/Instance	Rooms 320,316
Deficiency Quantity	2
Quantity Uom	EACH
Potential Action	MAINTENANCE
Urgency of Action	PRIORITY 3
Purpose of Action	LEVEL 2
Deficiency Photo1

Question	Response
<b>INTERIOR</b>	
<b>TOILET ROOMS - STAFF</b>	Inspected
Walls	Inspected
Violations	Room 332 No violations recorded.
<b>TOILET ROOMS - STUDENTS</b>	Inspected
<b>Ceiling</b>	Inspected
Condition	2 - Between Good and Fair
Deficiency	No deficiencies recorded
<b>Door(s)</b>	Inspected
Condition	5 - Poor
Deficiency	WOOD: DETERIORATED DOOR
Deficiency Location/Instance	Rooms 220,216,128
Deficiency Quantity	3
Quantity Uom	EACH
Potential Action	MAINTENANCE
Urgency of Action	PRIORITY 3
Purpose of Action	LEVEL 2
Deficiency Photo1

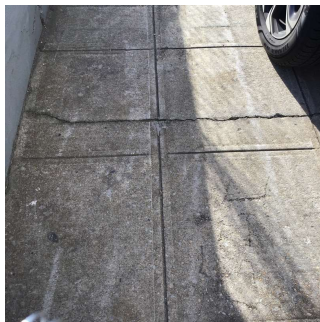
Question	Response
<b>SITE</b>	
<b>PAVING</b>	
<b>Student Non-Use</b>	
<b>Concrete</b>	
Purpose of Action	LEVEL 2
Deficiency Photo1

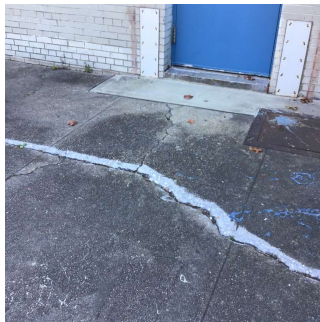
Violations	Near exit 3 No violations recorded.
<b>Pavers</b>	Does not Exist
<b>Student Use</b>	Does not Exist
<b>Site Sidewalks &amp; Walkways</b>	Inspected
<b>Asphalt</b>	Does not Exist
<b>Concrete</b>	Inspected
Condition	4 - Between Fair and Poor
Deficiency	DAMAGED/DETERIORATED/MISSING SECTIONS
Deficiency Location/Instance	Near exit 7, Exit 6
Deficiency Quantity	1,750
Quantity Uom	S.F.
Potential Action	REPLACE
Urgency of Action	PRIORITY 3
Purpose of Action	LEVEL 2
Deficiency Photo1

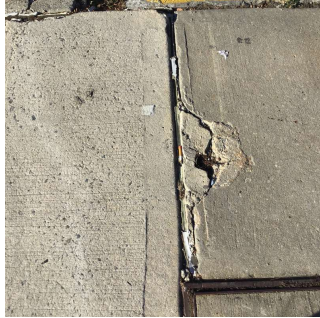
Violations	Near exit 7 No violations recorded.
<b>Pavers</b>	Does not Exist
<b>DOT Sidewalk</b>	Inspected
<b>Asphalt</b>	Does not Exist
<b>Concrete</b>	Inspected
Condition	4 - Between Fair and Poor
Deficiency	DAMAGED/DETERIORATED/MISSING SECTIONS
Deficiency Location/Instance	Along East 100 Street, East 101 Street, Avenue J

Deficiency Quantity	1,000
Quantity Uom	S.F.

Question	Response
<b>SITE</b>	
<b>PAVING</b>	
<b>DOT Sidewalk</b>	
<b>Concrete</b>	
Potential Action	REPLACE
Urgency of Action	PRIORITY 3
Purpose of Action	LEVEL 2
Deficiency Photo1

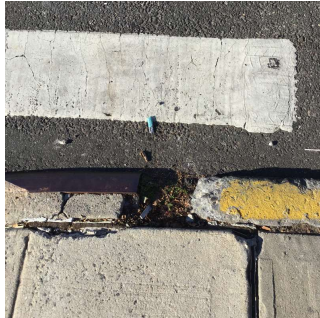
Along Avenue J
Violations	No violations recorded.
<b>Deficiency</b>	<b>DAMAGED CURBS</b>
Deficiency Location/Instance	Along East 100 Street, East 101 Street, Avenue J
Deficiency Quantity	300
Quantity Uom	L.F.
Potential Action	REPLACE
Urgency of Action	PRIORITY 3
Purpose of Action	LEVEL 2
Deficiency Photo1

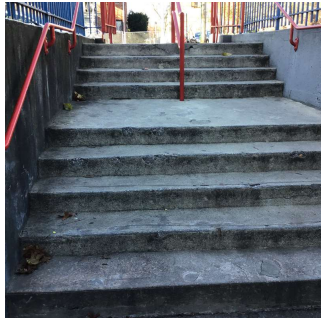
Question	Response
<b>SITE</b>	
<b>RETAINING WALLS</b>	
Purpose of Action	LEVEL 2
Deficiency Photo1	 
	Near exit 7
Violations	No violations recorded.
Deficiency	CAST IN PLACE CONCRETE: CRACKS/SPALLING - MAJOR
Deficiency Location/Instance	Near exit 7, exit 9
Deficiency Quantity	30
Quantity Uom	S.F.
Potential Action	REPLACE
Urgency of Action	PRIORITY 3
Purpose of Action	LEVEL 2
Deficiency Photo1	 
	Near exit 7
Violations	No violations recorded.
<b>SEATING</b>	Does not Exist
<b>SITE WALLS (NOT RETAINING WALLS)</b>	Inspected
Condition	3 - Fair
Deficiency	CAST IN PLACE CONCRETE: CRACKS/SPALLING - MAJOR
Deficiency Location/Instance	East 100th Street
Deficiency Quantity	80
Quantity Uom	S.F.
Potential Action	REPLACE
Urgency of Action	PRIORITY 3
Purpose of Action	LEVEL 2
Deficiency Photo1	No photo recorded
Violations	No violations recorded.
<b>STAIRS/RAMPS: EXTERIOR</b>	Inspected
<b>Railings</b>	Inspected
Condition	3 - Fair
Deficiency	MISSING

Deficiency Location/Instance	Near Exit 7

Question	Response
<b>SITE</b>	
<b>STAIRS/RAMPS: EXTERIOR</b>	
<b>Railings</b>	
Deficiency Quantity	10
Quantity Uom	L.F.
Potential Action	REPLACE
Urgency of Action	PRIORITY 5
Purpose of Action	LEVEL 6
Deficiency Photo1

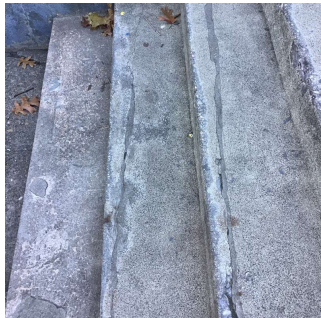
Near exit 7
Violations	No violations recorded.
<b>ARTWORK</b>	Inspected
Instance	Interior - Principal's Office - 71163
Instance Photo

Near exit 7
Violations	No violations recorded.
<b>Site Cheek/flank Walls</b>	Inspected
Condition	2 - Between Good and Fair
Deficiency	No deficiencies recorded
<b>Stairs/ramps</b>	Inspected
Condition	3 - Fair
Deficiency	CAST IN PLACE CONCRETE: CRACKS/SPALLING - MAJOR
Deficiency Location/Instance	Near exit 7
Deficiency Quantity	70
Quantity Uom	S.F.
Potential Action	REPLACE
Urgency of Action	PRIORITY 3
Purpose of Action	LEVEL 2
Deficiency Photo1
