**NYC Department of Education**  
**Building Condition Assessment Survey 2023 - 2024**

Architectural Inspection

**Asset:** P.S. 226 - BROOKLYN, 6006 23 AVENUE, New York, 11204

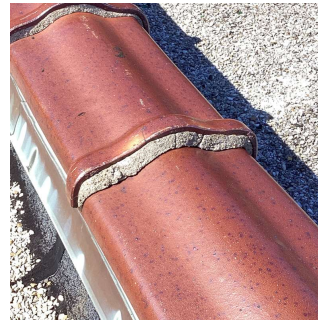
### Roof 1

TERRA COTTA: CRACKED/BROKEN PIECES

REPLACE-IN-KIND

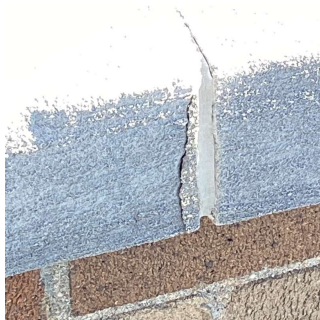
Violations	<p>Roof 3</p> <p>No violations recorded.</p>
Deficiency	<b>CAST STONE: DETERIORATED TRANSVERSE JOINTS</b>

Deficiency Quantity	35
Quantity Uom	L.F.
Potential Action	MAINTENANCE
Urgency of Action	PRIORITY 3
Purpose of Action	LEVEL 2
Deficiency Photo1

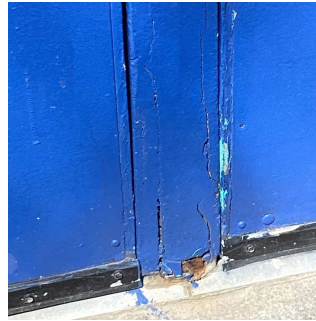
Facade A

Violations	Roof 3 No violations recorded.
<b>CORNICE</b>	Inspected
Condition	2 - Between Good and Fair
Deficiency	No deficiencies recorded
<b>DOORS</b>	Inspected
<b>DOORS AND FRAMES</b>	Inspected
Condition	5 - Poor
Deficiency	METAL CLAD: DETERIORATED DOOR AND FRAME - MAJOR DETERIORATION
Roof Plan reference

Deficiency Quantity	9
Quantity Uom	EACH
Potential Action	REPLACE
Urgency of Action	PRIORITY 4
Purpose of Action	LEVEL 2

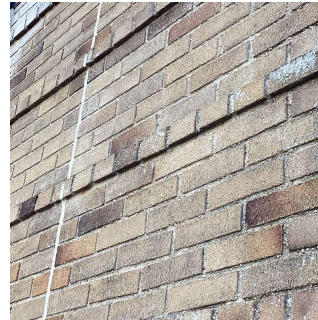
Facade D

STONE: DETERIORATED JOINTS

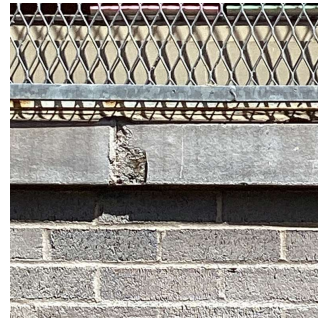
Facade B

BRICK: DETERIORATED JOINTS

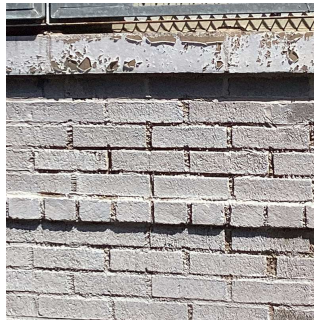
Facade B

BRICK: DETERIORATED MASONRY SILLS - MINOR

REPAIR

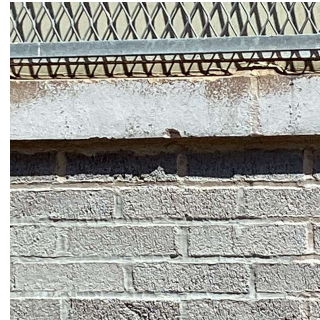
Facade B

STONE: DETERIORATED JOINTS

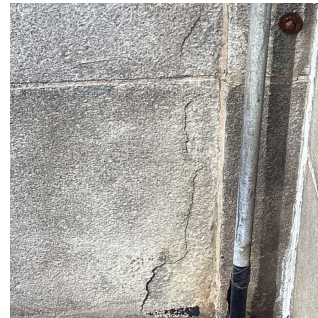
Facade A

STONE: CHIPPED/SPALLED/BROKEN PIECES - MINOR

REPAIR

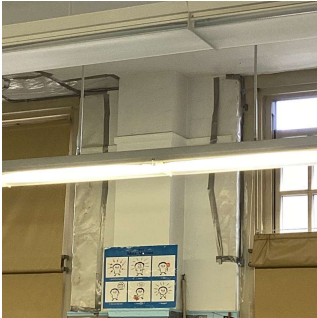
BRICK: WATER INFILTRATION IN INSTRUCTIONAL SPACE

Violations	Facade D - Room 426 (Facade B - Room 427, Facade F - Auditorium similar) No violations recorded.
<b>EXTERIOR SOFFITS</b>	Does not Exist
<b>LOADING DOCK</b>	Does not Exist
<b>LOUVER</b>	Inspected
Condition	2 - Between Good and Fair
Deficiency	No deficiencies recorded
<b>PARAPETS</b>	Inspected
Material Type(s)	Masonry
Replacement Quantity	6,500
Replacement Uom	C.F.
Instance on All Roofs	Inspected
Instance Condition	4 - Between Fair and Poor
Instance Quantity	6,500
Instance Quantity Uom	C.F.
Deficiency	BRICK: DETERIORATED JOINTS

Deficiency Quantity	300
Quantity Uom	S.F.
Potential Action	REPAIR
Urgency of Action	PRIORITY 5
Purpose of Action	LEVEL 2
Deficiency Photo1

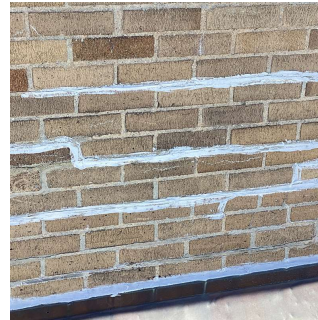
Roof 3

BRICK: DETERIORATED JOINTS

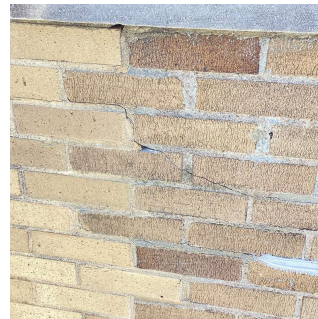
Roof 3

BRICK: MINOR CRACKS, SPALLING

REPAIR

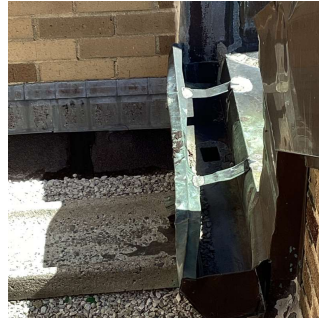
Question	Response
<b>EXTERIOR</b>	
<b>ROOF</b>	
<b>Roofing</b>	
<b>ROOF HATCH/SMOKE HATCH</b>	Does not Exist
<b>LEADERS, GUTTERS, DOWNSPOUTS, SCUPPERS</b>	Inspected
Condition	3 - Fair
Deficiency	DAMAGED/MISSING
Roof Plan reference

Violations	BH2 No violations recorded.
<b>ROOF BARRIER/FENCE</b>	Does not Exist
<b>ROOF CAGE</b>	Does not Exist
<b>ROOFING</b>	Inspected
Instance on Built-Up: All Roods except Roof 8	Inspected
Instance Condition	4 - Between Fair and Poor
Instance Photo

Deficiency Quantity	35
Quantity Uom	L.F.
Potential Action	REPLACE
Urgency of Action	PRIORITY 4
Purpose of Action	LEVEL 2
Deficiency Photo1

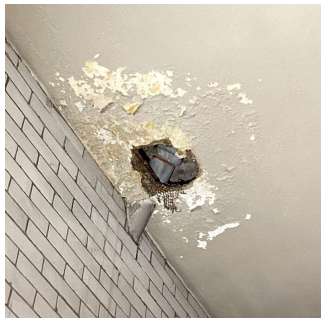
Violations	Roof 1 No violations recorded.
Deficiency	BUILT-UP: ROOFING: MAJOR ACTIVE ROOF LEAKS IN NON-INSTRUCTIONAL SPACE
Roof Plan reference

Violations	Roof 4 - Room 435 No violations recorded.
Deficiency	BUILT-UP: ROOFING: MAJOR ACTIVE ROOF LEAKS IN INSTRUCTIONAL SPACE
Roof Plan reference

Question	Response
<b>EXTERIOR</b>	
<b>ROOF</b>	
<b>Roofing</b>	
<b>ROOFING</b>	
Potential Action	REPLACE ROOFING WITHOUT MAJOR EQUIPMENT REMOVAL
Urgency of Action	PRIORITY 5
Purpose of Action	LEVEL 2
Deficiency Photo1

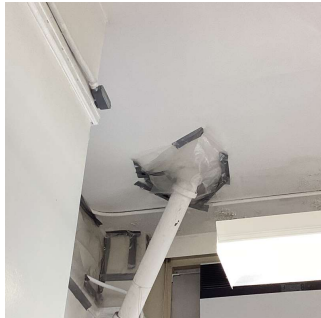
Violations	Roof 3 - Room 423 (Roof 1 - Room 419 similar) No violations recorded.
Instance on Modified Bitumen: Roof. 8	Inspected
Instance Condition	3 - Fair

Deficiency Quantity	300
Quantity Uom	S.F.
Potential Action	REPLACE ROOFING WITHOUT MAJOR EQUIPMENT REMOVAL
Urgency of Action	PRIORITY 5
Purpose of Action	LEVEL 2
Deficiency Photo1

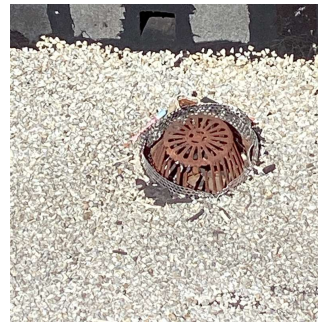
Roof 4

DETERIORATED

REPLACE

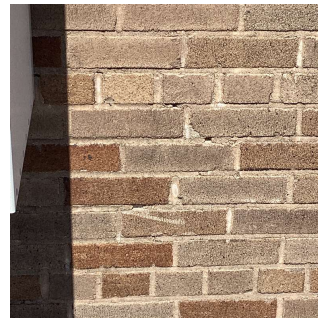
BH1

BULKHEAD/PENTHOUSE WALLS/EXTERIOR: DETERIORATED JOINTS

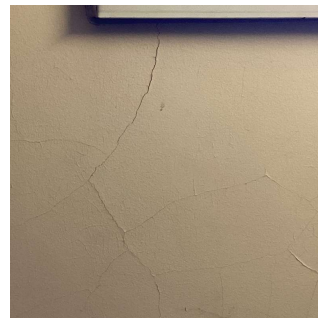
BH1

**BULKHEAD/PENTHOUSE WALLS/INTERIOR: PLASTER CRACKS/SPALLING**

REPLACE

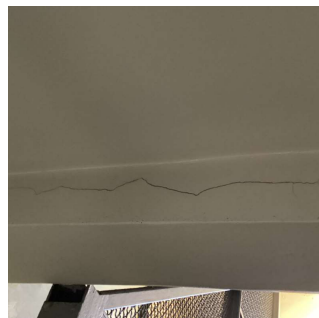
**BULKHEAD/PENTHOUSE CEILING: PLASTER DAMAGED/DETERIORATED**

Violations	BH1 No violations recorded.
<b>CUPOLA/ SPIRES/ TOWERS</b>	Does not Exist
<b>DORMER</b>	Does not Exist
<b>DUNNAGE STEEL</b>	Does not Exist
<b>SKYLIGHT/ROOF VENT</b>	Inspected
Material Type(s)	Glass
Condition	3 - Fair
Deficiency	DAMAGED GUARDS
Roof Plan reference

Deficiency Quantity	25
Quantity Uom	S.F.
Potential Action	REPLACE
Urgency of Action	PRIORITY 3
Purpose of Action	LEVEL 2
Deficiency Photo1

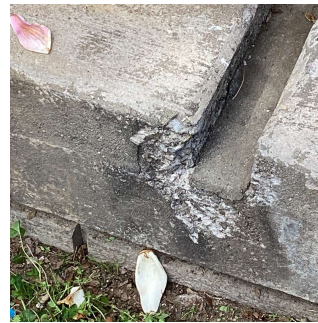
Facade A

CAST IN PLACE CONCRETE: CRACKS/SPALLING - MINOR

REPAIR

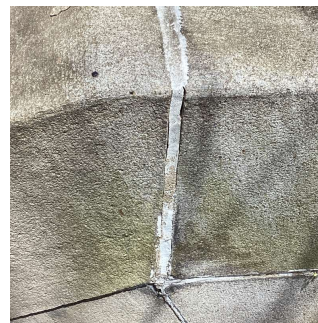
Facade A

**STONE: DETERIORATED JOINTS**

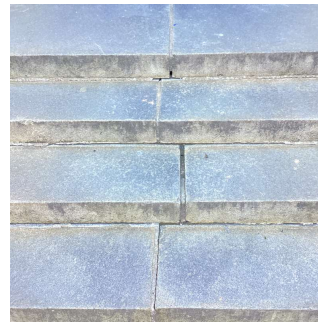
Facade H

STONE: CRACKS/SPALLING - MAJOR

REPLACE

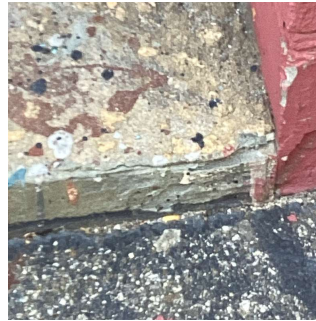
Facade F

**CONCRETE: CRACKS/SPALLING - MINOR**

REPAIR

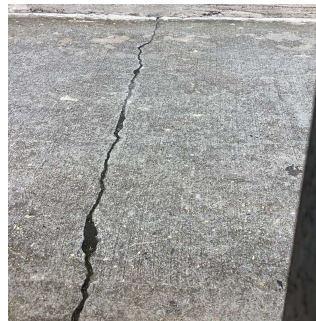
Facade C

**CONCRETE: CRACKS/SPALLING - MAJOR**

30  
S.F.  
REPLACE  
PRIORITY 4  
LEVEL 2

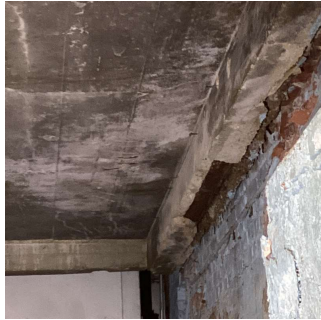
Violations	Basement Fan Area (Boiler Room, Basement Storage Area, Auditorium Crawl Space similar) No violations recorded.
<b>FLOOR STRUCTURE</b>	Inspected
Condition	3 - Fair
Deficiency	CONCRETE SLAB ON GRADE: THRU CRACKS
Deficiency Location/Instance	Basement
Deficiency Quantity	20
Quantity Uom	S.F.
Potential Action	REPLACE
Urgency of Action	PRIORITY 4
Purpose of Action	LEVEL 5

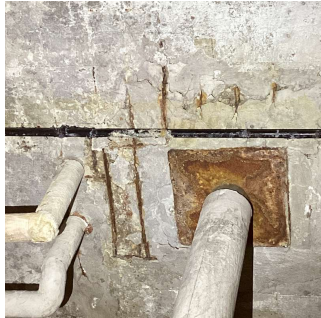
Violations	Basement Storage Area (Basement Fan Area similar) No violations recorded.
Deficiency	CONCRETE SLAB ON GRADE: THRU CRACKS
Deficiency Location/Instance	Basement
Deficiency Quantity	140
Quantity Uom	S.F.
Potential Action	REPAIR
Urgency of Action	PRIORITY 3
Purpose of Action	LEVEL 5
Deficiency Photo1

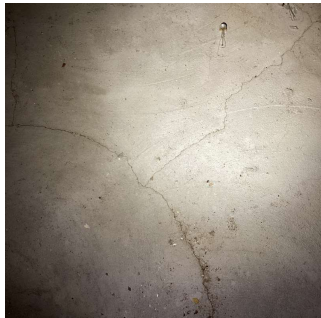
Addition Crawl Space (Auditorium Crawl Space Boiler Room, Basement Corridor similar)

Question	Response
<b>INTERIOR</b>	
<b>STRUCTURAL</b>	
<b>FLOOR STRUCTURE</b>	
Violations	No violations recorded.
Deficiency	CONCRETE: CRACKS/SPALLED/REINFORCEMENT EXPOSED
Deficiency Location/Instance	Basement
Deficiency Quantity	20
Quantity Uom	S.F.
Potential Action	REPAIR
Urgency of Action	PRIORITY 3
Purpose of Action	LEVEL 5
Deficiency Photo1

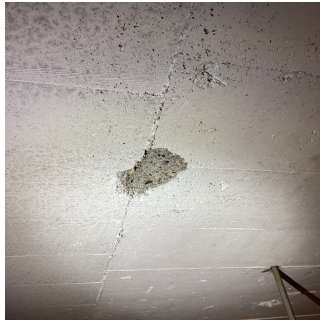
Violations	Addition Crawl Space (Basement Storage Area similar) No violations recorded.
<b>FOUNDATION WALLS</b>	Inspected
Material Type(s)	Concrete
Condition	5 - Poor
Deficiency	CONCRETE: CRACKED/SPALLED/REINFORCEMENT EXPOSED
Deficiency Location/Instance	Basement
Deficiency Quantity	40
Quantity Uom	S.F.
Potential Action	REPAIR
Urgency of Action	PRIORITY 3
Purpose of Action	LEVEL 5
Deficiency Photo1

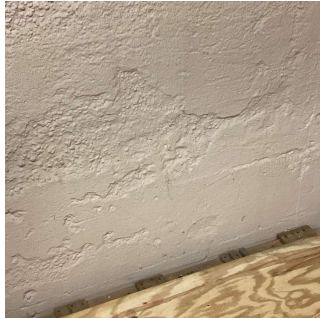
Violations	Basement Storage Area No violations recorded.
Deficiency	CONCRETE: CRACKED/SPALLED/REINFORCEMENT EXPOSED
Deficiency Location/Instance	Basement
Deficiency Quantity	80

Quantity Uom	S.F.
Potential Action	REPAIR

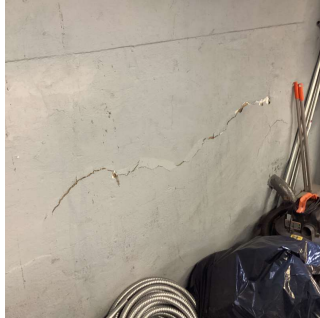
Boiler Room (Basement Fan Area, Basement Storage Area similar)
Violations	No violations recorded.
Deficiency	CONCRETE: WATER INFILTRATION IN NON- INSTRUCTIONAL SPACE
Deficiency Location/Instance	Basement
Deficiency Quantity	500
Quantity Uom	S.F.
Potential Action	INSTALL WATERPROOFING
Urgency of Action	PRIORITY 5
Purpose of Action	LEVEL 5
Deficiency Photo1

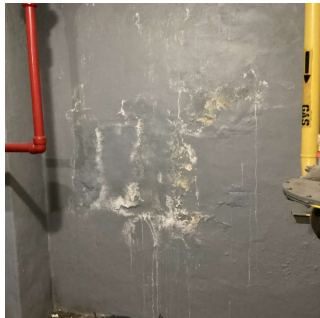
Gas Meter Room (Boiler Room, Basement Fan Area, Oil Tank Room, Custodian Shop similar)
Violations	No violations recorded.
<b>ROOF STRUCTURE</b>	Inspected
Condition	2 - Between Good and Fair
Deficiency	No deficiencies recorded
<b>VAULTS-BUNKERS</b>	Inspected
<b>Foundation Walls</b>	Inspected
Condition	2 - Between Good and Fair
Deficiency	No deficiencies recorded
<b>Slab Structure</b>	Inspected
Condition	3 - Fair

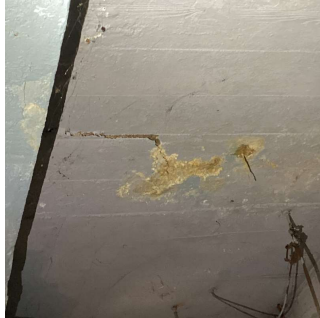
Violations	Vault No violations recorded.
Deficiency	CONCRETE: CRACKS/SPALLED/REINFORCEMENT EXPOSED
Deficiency Location/Instance	Vault
Deficiency Quantity	25
Quantity Uom	S.F.
Potential Action	REPAIR
Urgency of Action	PRIORITY 4
Purpose of Action	LEVEL 5
Deficiency Photo1

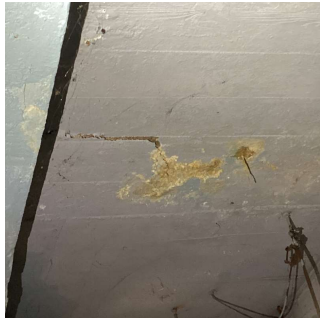
Violations	Vault No violations recorded.
<b>Vault/Ash Hoist Doors and Framing</b>	Inspected
Condition	5 - Poor
Deficiency	DETERIORATED/DAMAGED VAULT/ASH HOIST DOORS AND FRAMING
Deficiency Location/Instance	Vault
Deficiency Quantity	3
Quantity Uom	EACH
Potential Action	REPLACE
Urgency of Action	PRIORITY 4
Purpose of Action	LEVEL 2

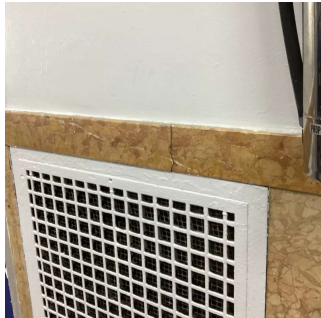
Violations	Near Main Entrance No violations recorded.
Deficiency	PLASTER: CRACKS/SPALLING - ACTIVE LEAK
Deficiency Location/Instance	Right Side
Deficiency Quantity	50
Quantity Uom	S.F.
Potential Action	REPLACE
Urgency of Action	PRIORITY 5

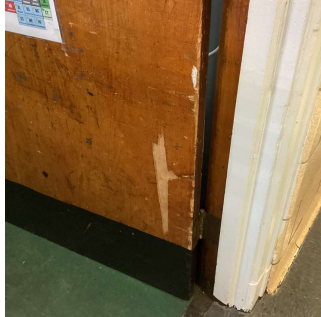
Question	Response
<b>INTERIOR</b>	
<b>CLASSROOMS/CORRIDORS/ADMIN SPACES</b>	
<b>Door(s)</b>	
Deficiency Location/Instance	Main Entrance Vestibule, Rooms 123, 222, 324, 424, and others
Deficiency Quantity	17
Quantity Uom	EACH
Potential Action	MAINTENANCE
Urgency of Action	PRIORITY 3
Purpose of Action	LEVEL 2
Deficiency Photo1

Room 424
Violations	No violations recorded.
<b>Floor Finish</b>	Inspected
Condition	3 - Fair
Deficiency	TERRAZZO: CRACKS
Deficiency Location/Instance	Corridor near Room 101
Deficiency Quantity	20
Quantity Uom	S.F.
Potential Action	REPLACE
Urgency of Action	PRIORITY 3
Purpose of Action	LEVEL 2
Deficiency Photo1

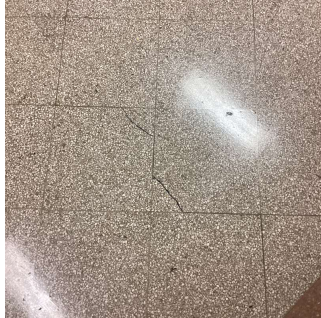
Corridor near Room 101
Violations	No violations recorded.
Deficiency	CONCRETE: CRACKS
Deficiency Location/Instance	Room 355, Corridor near Room 359
Deficiency Quantity	40
Quantity Uom	S.F.
Potential Action	REPLACE
Urgency of Action	PRIORITY 3
Purpose of Action	LEVEL 2

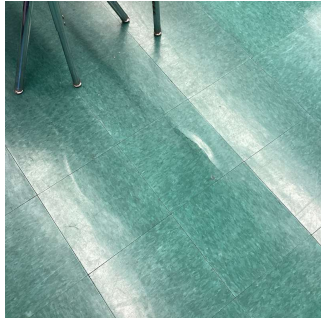
Question	Response
<b>INTERIOR</b>	
<b>CLASSROOMS/CORRIDORS/ADMIN SPACES</b>	
<b>Floor Finish</b>	
Deficiency	VINYL TILES: DETERIORATED SUBSTRATE
Deficiency Location/Instance	Rooms 201, 215, 227, 327, 422, and others
Deficiency Quantity	450
Quantity Uom	S.F.
Potential Action	REPLACE
Urgency of Action	PRIORITY 3
Purpose of Action	LEVEL 2
Deficiency Photo1

Violations	Room 327 No violations recorded.
Deficiency	VINYL TILES: BROKEN/DETERIORATED/MISSING TILES
Deficiency Location/Instance	Rooms 224, 260, 326, 360, 422, and others
Deficiency Quantity	840
Quantity Uom	S.F.
Potential Action	REPLACE
Urgency of Action	PRIORITY 3
Purpose of Action	LEVEL 2
Deficiency Photo1

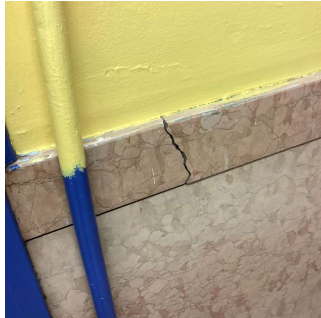
Question	Response
<b>INTERIOR</b>	
<b>CLASSROOMS/CORRIDORS/ADMIN SPACES</b>	
<b>Walls</b>	
Deficiency	STONE MOLDINGS: CRACKS/SPALLING
Deficiency Location/Instance	Auditorium Lobby
Deficiency Quantity	10
Quantity Uom	L.F.
Potential Action	REPLACE
Urgency of Action	PRIORITY 3
Purpose of Action	LEVEL 2
Deficiency Photo1

Auditorium Lobby
Violations	No violations recorded.
<b>Specialties</b>	Does not Exist
<b>GYMNASIUM</b>	
Instance on 3rd Floor	Inspected
	Inspected
<b>Ceiling</b>	
Instance on 3rd Floor	Inspected
Condition	2 - Between Good and Fair
Deficiency	No deficiencies recorded
<b>Door(s)</b>	
Instance on 3rd Floor	Inspected
Condition	4 - Between Fair and Poor
Deficiency	WOOD: DETERIORATED DOOR
Deficiency Location/Instance	Room 354
Deficiency Quantity	2
Quantity Uom	EACH
Potential Action	MAINTENANCE
Urgency of Action	PRIORITY 3
Purpose of Action	LEVEL 2
Deficiency Photo1

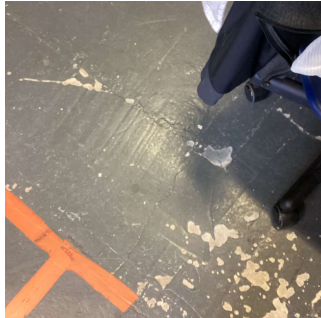
Question	Response
<b>INTERIOR</b>	
<b>GYMNASIUM</b>	
<b>Fixed Equipment</b>	
Instance on 3rd Floor	Inspected
Condition	2 - Between Good and Fair
Deficiency	No deficiencies recorded
<b>Floor Finish</b>	
Instance on 3rd Floor	Inspected
Condition	2 - Between Good and Fair
Deficiency	CONCRETE: CRACKS
Deficiency Location/Instance	Room 354
Deficiency Quantity	10
Quantity Uom	S.F.
Potential Action	REPLACE
Urgency of Action	PRIORITY 3
Purpose of Action	LEVEL 2
Deficiency Photo1

Violations	Room 354 No violations recorded.
Deficiency	WOOD: DAMAGED/DETERIORATED
Deficiency Location/Instance	Right Side, Near Office, Near Main Entrance
Deficiency Quantity	40
Quantity Uom	S.F.
Potential Action	REPLACE
Urgency of Action	PRIORITY 3
Purpose of Action	LEVEL 2
Deficiency Photo1

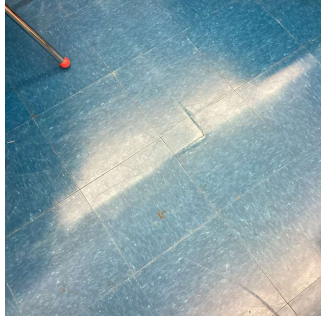
Question	Response
<b>INTERIOR</b>	
<b>LIBRARY</b>	Inspected
<b>Floor Finish</b>	
Deficiency Quantity	20
Quantity Uom	S.F.
Potential Action	REPLACE
Urgency of Action	PRIORITY 3
Purpose of Action	LEVEL 2
Deficiency Photo1

Center
Violations	No violations recorded.
<b>Walls</b>	
Instance on Room 425	Inspected
Condition	2 - Between Good and Fair
Deficiency	No deficiencies recorded
<b>LOCKER ROOM</b>	Does not Exist
<b>MULTI-PURPOSE ROOM</b>	Does not Exist
<b>SCIENCE DEMO ROOM</b>	Inspected
Instance on Room 423	Inspected
Alternative use	No
<b>Fixed Equipment</b>	
Instance on Room 423	Inspected
Condition	2 - Between Good and Fair
Deficiency	No deficiencies recorded
<b>SCIENCE LAB</b>	Does not Exist
<b>SCIENCE PREP ROOM</b>	Does not Exist
<b>SHOWER ROOM</b>	Does not Exist
<b>STAIRS/RAMPS: INTERIOR</b>	Inspected
Do Letter Stair Signs Exist?	Yes
<b>Ceiling</b>	Inspected
Condition	2 - Between Good and Fair
Deficiency	PLASTER: CRACKS/SPALLING

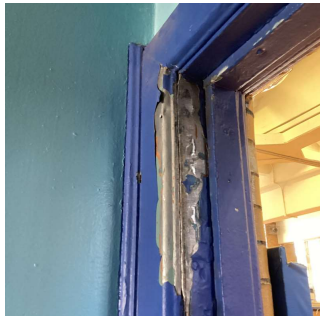
Violations	Stair G/1 No violations recorded.
Deficiency	METAL CLAD WOOD: DETERIORATED DOOR AND FRAME
Deficiency Location/Instance	Stair G/1,3
Deficiency Quantity	2
Quantity Uom	EACH
Potential Action	MAINTENANCE
Urgency of Action	PRIORITY 3
Purpose of Action	LEVEL 2
Deficiency Photo1

Question	Response
<b>INTERIOR</b>	
<b>STAIRS/RAMPS: INTERIOR</b>	
<b>Door(s)</b>	Inspected
	Stair G/3
Violations	No violations recorded.
<b>Partition</b>	Inspected
Condition	2 - Between Good and Fair
Deficiency	GLASS PANEL: DAMAGED/DETERIORATED
Deficiency Location/Instance	Stairs AB/1,4, CD/1,4, EF/1
Deficiency Quantity	35
Quantity Uom	S.F.
Potential Action	REPLACE
Urgency of Action	PRIORITY 3
Purpose of Action	LEVEL 2
Deficiency Photo1

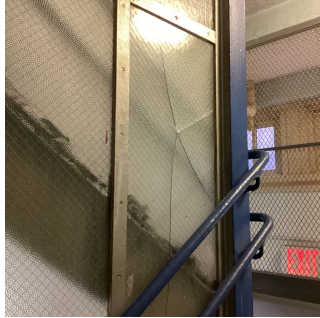
Stair CD/1
Violations	No violations recorded.
<b>Railings</b>	Inspected
Condition	2 - Between Good and Fair
Deficiency	No deficiencies recorded
<b>Stairs and Landings</b>	Inspected
Condition	5 - Poor
Deficiency	VINYL TILES: BROKEN/DETERIORATED/MISSING TILES
Deficiency Location/Instance	Stairs AB/1 Vestibule, CD/1, EF/Bulkhead
Deficiency Quantity	150
Quantity Uom	S.F.
Potential Action	REPLACE
Urgency of Action	PRIORITY 3
Purpose of Action	LEVEL 2
Deficiency Photo1

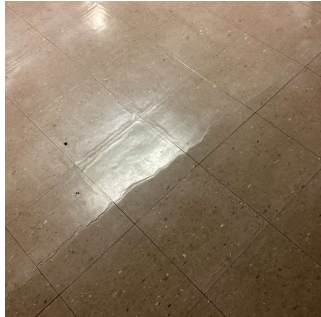
Violations	No violations recorded.
Deficiency	VINYL TILES: DETERIORATED SUBSTRATE
Deficiency Location/Instance	Stairs AB/1 Vestibule, CD/1 Vestibule

Question	Response
<b>INTERIOR</b>	
<b>STAIRS/RAMPS: INTERIOR</b>	
<b>Stairs and Landings</b>	
Deficiency Quantity	100
Quantity Uom	S.F.
Potential Action	REPLACE
Urgency of Action	PRIORITY 3
Purpose of Action	LEVEL 2
Deficiency Photo1

Stair AB/1 Vestibule
Violations	No violations recorded.
Deficiency	STONE: WORN-OUT TREAD/NOSINGS
Deficiency Location/Instance	Stair AB/1
Deficiency Quantity	170
Quantity Uom	S.F.
Potential Action	REPLACE
Urgency of Action	PRIORITY 3
Purpose of Action	LEVEL 2
Deficiency Photo1

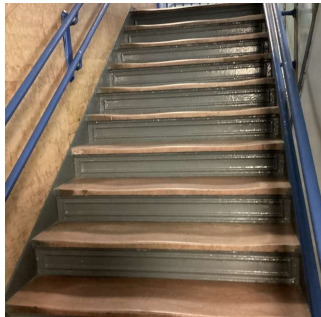
Stair AB/1
Violations	No violations recorded.
Deficiency	TERRAZZO: CRACKS
Deficiency Location/Instance	Stairs AB/1, EF/1
Deficiency Quantity	20
Quantity Uom	S.F.
Potential Action	REPLACE
Urgency of Action	PRIORITY 3
Purpose of Action	LEVEL 2

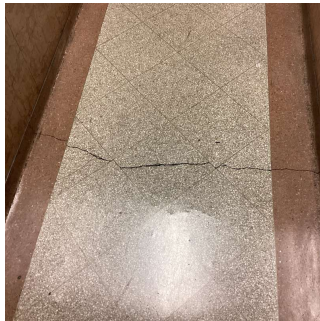
Stair AB/1
Violations	No violations recorded.
Deficiency	CONCRETE: CRACKS/SPALLING - MAJOR
Deficiency Location/Instance	Stair G/1 Vestibule
Deficiency Quantity	25
Quantity Uom	S.F.
Potential Action	REPLACE
Urgency of Action	PRIORITY 3
Purpose of Action	LEVEL 2
Deficiency Photo1

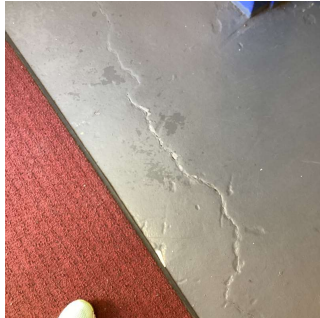
Stair G/1 Vestibule
Violations	No violations recorded.
Deficiency	STONE: BROKEN/MISSING
Deficiency Location/Instance	Exit 6 Vestibule, Exit 7 Vestibule
Deficiency Quantity	60
Quantity Uom	S.F.
Potential Action	REPLACE
Urgency of Action	PRIORITY 3
Purpose of Action	LEVEL 2
Deficiency Photo1

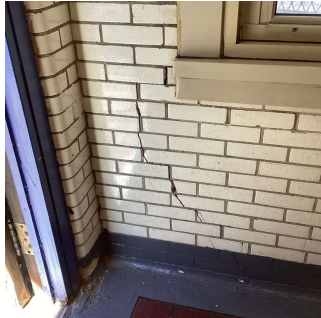
Question	Response
<b>INTERIOR</b>	
<b>STAIRS/RAMPS: INTERIOR</b>	
<b>Walls</b>	
Deficiency	BRICK: CRACKS/SPALLING
Deficiency Location/Instance	Stair G/1 Vestibule
Deficiency Quantity	10
Quantity Uom	S.F.
Potential Action	REPLACE
Urgency of Action	PRIORITY 3
Purpose of Action	LEVEL 2
Deficiency Photo1

Stair G/1 Vestibule
Violations	No violations recorded.
<b>TOILET ROOMS - STAFF</b>	
	Inspected
<b>Ceiling</b>	Inspected
Condition	2 - Between Good and Fair
Deficiency	No deficiencies recorded
<b>Door(s)</b>	Inspected
Condition	5 - Poor
Deficiency	WOOD: DETERIORATED DOOR
Deficiency Location/Instance	Rooms 161A, 257, 356, In Room 422
Deficiency Quantity	4
Quantity Uom	EACH
Potential Action	MAINTENANCE
Urgency of Action	PRIORITY 3
Purpose of Action	LEVEL 2
Deficiency Photo1	 
	Room 356
Violations	No violations recorded.
<b>Floor Finish</b>	
	Inspected
Condition	5 - Poor
Deficiency	CERAMIC TILE: BROKEN/MISSING TILES
Deficiency Location/Instance	Rooms 257, 356, 457, In Room 422

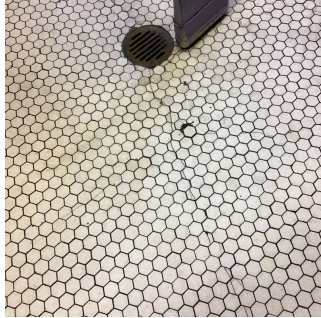
Question	Response
<b>INTERIOR</b>	
<b>TOILET ROOMS - STAFF</b>	
<b>Floor Finish</b>	
Quantity Uom	S.F.
Potential Action	REPLACE
Urgency of Action	PRIORITY 3
Purpose of Action	LEVEL 2
Deficiency Photo1

Room 356
Violations	No violations recorded.
<b>Stalls</b>	Inspected
Condition	5 - Poor
Deficiency	RUST - MAJOR
Deficiency Location/Instance	Rooms 356, 457
Deficiency Quantity	2
Quantity Uom	EACH
Potential Action	REPLACE
Urgency of Action	PRIORITY 3
Purpose of Action	LEVEL 2
Deficiency Photo1

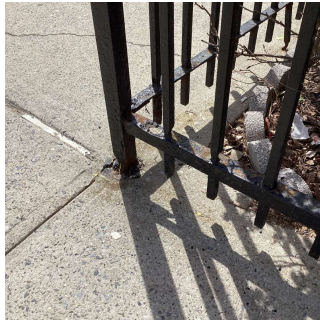
Violations	23rd Avenue No violations recorded.

Question	Response
<b>SITE</b>	
<b>Drainage System for Asphalt</b>	
<b>Catch Basins/Manhole - Surrounded by asphalt</b>	
Potential Action	MAINTENANCE
Urgency of Action	PRIORITY 3
Purpose of Action	LEVEL 2
Deficiency Photo1	No photo recorded
Violations	No violations recorded.
<b>Culverts - Asphalt Covering</b>	Does not Exist
<b>Drainage System for Concrete</b>	Does not Exist
<b>Drainage System for Soil</b>	Inspected
<b>Catch Basins/Manhole - Surrounded by Soil</b>	Inspected
Condition	2 - Between Good and Fair
Deficiency	No deficiencies recorded
<b>Culverts - Soil Covering</b>	Does not Exist
<b>DRINKING FOUNTAINS</b>	Does not Exist
<b>FENCES</b>	Inspected
Condition	4 - Between Fair and Poor
Deficiency	WROUGHT IRON: RUST - MAJOR
Deficiency Location/Instance	23rd Avenue
Deficiency Quantity	40
Quantity Uom	S.F.
Potential Action	REPLACE
Urgency of Action	PRIORITY 3
Purpose of Action	LEVEL 2
Deficiency Photo1

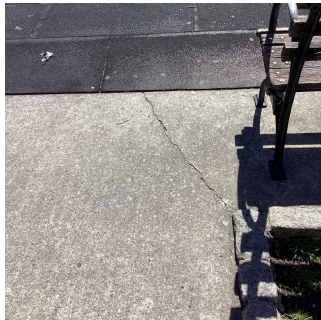
Violations	Schoolyard No violations recorded.
<b>Concrete</b>	Inspected
Condition	3 - Fair
Deficiency	DAMAGED/DETERIORATED/MISSING SECTIONS
Deficiency Location/Instance	Near Playground
Deficiency Quantity	75
Quantity Uom	S.F.
Potential Action	REPLACE
Urgency of Action	PRIORITY 3
Purpose of Action	LEVEL 2
Deficiency Photo1

Violations	Near Playground No violations recorded.
<b>Pavers</b>	Does not Exist
<b>Site Sidewalks &amp; Walkways</b>	Inspected
<b>Asphalt</b>	Inspected
Condition	3 - Fair
Deficiency	LOCALIZED SINK AREA
Deficiency Location/Instance	Near Exit 8
Deficiency Quantity	10
Quantity Uom	S.F.
Potential Action	REPAIR
Urgency of Action	PRIORITY 3
Purpose of Action	LEVEL 2

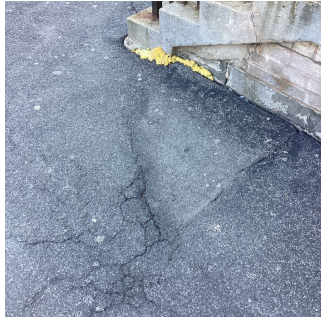
Violations	Near Exit 8 No violations recorded.
Deficiency	CRACKS - MAJOR
Deficiency Location/Instance	Near Schoolyard
Deficiency Quantity	350
Quantity Uom	S.F.
Potential Action	REPLACE
Urgency of Action	PRIORITY 3
Purpose of Action	LEVEL 2
Deficiency Photo1

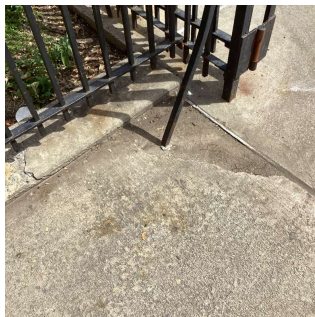
Violations	Near Schoolyard No violations recorded.
<b>Concrete</b>	Inspected
Condition	3 - Fair
Deficiency	DAMAGED/DETERIORATED/MISSING SECTIONS
Deficiency Location/Instance	23rd Avenue
Deficiency Quantity	100
Quantity Uom	S.F.
Potential Action	REPLACE
Urgency of Action	PRIORITY 3
Purpose of Action	LEVEL 2

23rd Avenue
Violations	No violations recorded.
<b>Pavers</b>	Does not Exist
<b>DOT Sidewalk</b>	Inspected
<b>Asphalt</b>	Does not Exist
<b>Concrete</b>	Inspected
Condition	4 - Between Fair and Poor
Deficiency	DAMAGED CURBS
Deficiency Location/Instance	60th Street, 23rd Avenue
Deficiency Quantity	105
Quantity Uom	L.F.
Potential Action	REPLACE
Urgency of Action	PRIORITY 3
Purpose of Action	LEVEL 2
Deficiency Photo1

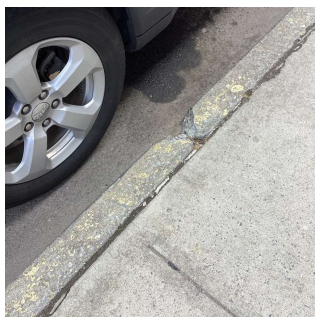
60th Street
Violations	No violations recorded.
Deficiency	DAMAGED/DETERIORATED/MISSING SECTIONS
Deficiency Location/Instance	60th Street, 23rd Avenue, 61st Street
Deficiency Quantity	675
Quantity Uom	S.F.
Potential Action	REPLACE
Urgency of Action	PRIORITY 3
Purpose of Action	LEVEL 2

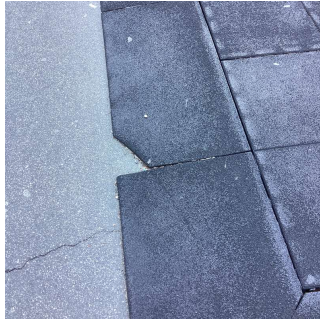
Question	Response
<b>SITE</b>	
<b>PLAYGROUNDS</b>	
<b>Safety Surfacing</b>	
Deficiency Location/Instance	Near Slide, NearGate
Deficiency Quantity	20
Quantity Uom	S.F.
Potential Action	REPLACE
Urgency of Action	PRIORITY 3
Purpose of Action	LEVEL 2
Deficiency Photo1

Violations	Near Gate No violations recorded.
<b>Unpaved Area</b>	
Instance on Schoolyard	Does not Exist
<b>PLAYING SURFACE</b>	Does not Exist
<b>RETAINING WALLS</b>	Inspected
Are there any Retaining Walls 6' OR higher facing public street/sidewalk?	No
Condition	3 - Fair
Deficiency	CAST IN PLACE CONCRETE: CRACKS/SPALLING - MAJOR
Deficiency Location/Instance	Schoolyard
Deficiency Quantity	150
Quantity Uom	S.F.
Potential Action	REPLACE
Urgency of Action	PRIORITY 3
Purpose of Action	LEVEL 2
Deficiency Photo1	 
Violations	Schoolyard No violations recorded.
<b>SEATING</b>	Inspected
<b>Benches</b>	Inspected
<b>Concrete</b>	Does not Exist
<b>Metal/Wood/Plastic</b>	Inspected
