NYC Department of Education
Building Condition Assessment Survey 2023 - 2024

Architectural Inspection

Asset: **P.S. 261 - BROOKLYN, 314 PACIFIC STREET, New York, 11201**

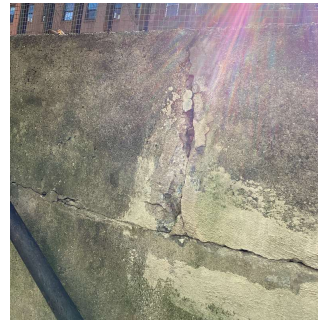
AW2

Deficiency Quantity	10
Quantity Uom	S.F.
Potential Action	REPAIR
Urgency of Action	PRIORITY 3
Purpose of Action	LEVEL 2
Deficiency Photo1	 
Violations	<p>AW2</p> <p>No violations recorded.</p>
Deficiency	AREAWAY WALLS: CRACKS AND SPALLING

REPLACE

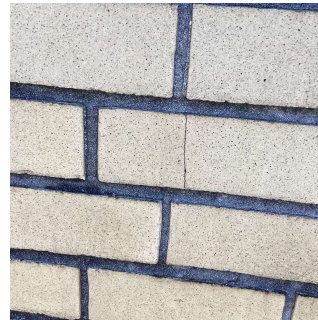
Roof 1 - CH

Violations	AW3 No violations recorded.
AWNINGS AND CANOPIES	Does not Exist
CHIMNEY	Inspected
Material Type(s)	Masonry
Condition	3 - Fair
Deficiency	BRICK: MINOR CRACKS AND SPALLING

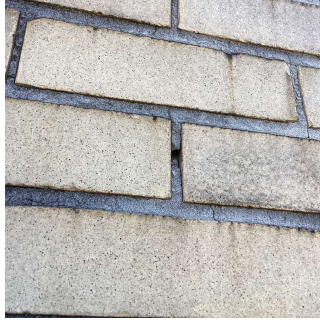
BRICK: DETERIORATED JOINTS

Violations	Roof 1 - CH No violations recorded.
COPING	Inspected
Condition	4 - Between Fair and Poor
Deficiency	CAST STONE: CRACKED/BROKEN PIECES
Roof Plan reference

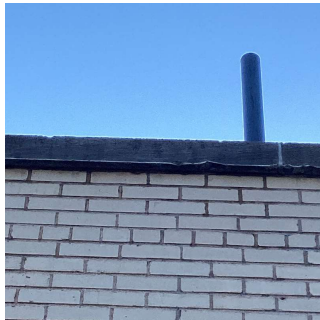
Deficiency Quantity	100
Quantity Uom	L.F.
Potential Action	REPLACE-IN-KIND
Urgency of Action	PRIORITY 4
Purpose of Action	LEVEL 2
Deficiency Photo1

Violations	Facade J No violations recorded.
Deficiency	CAST STONE: DETERIORATED TRANSVERSE JOINTS

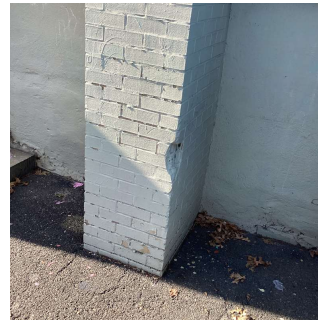
Facade C - Near Exit 7

Question	Response
EXTERIOR	
DOORS	
DOORS AND FRAMES	
Deficiency Photo1	
Violations	<div data-bbox="915 310 1232 630" data-label="Image"> </div> <p>Facade H - Near Exit 3</p> <p>No violations recorded.</p>
DOOR HARDWARE	Inspected
Condition	3 - Fair
Deficiency	No deficiencies recorded
LINTELS	Inspected
Condition	2 - Between Good and Fair
Deficiency	No deficiencies recorded
TRANSOM/SIDE LIGHT	Inspected
Condition	2 - Between Good and Fair
Deficiency	No deficiencies recorded
EXTERIOR WALLS	Inspected
Material Type(s)	Concrete, Masonry, Steel
Replacement Quantity	25,000
Replacement Uom	S.F.
Instance on All Facades	Inspected
Instance Condition	3 - Fair
Instance Quantity	25,000
Instance Quantity Uom	S.F.
Deficiency	BRICK: MAJOR / THRU CRACKS
Roof Plan reference

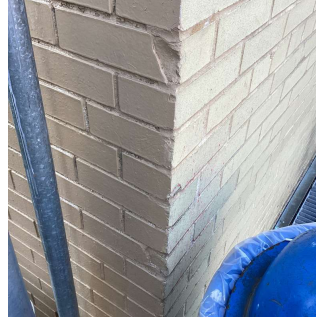
Corner of Facade J and Facade K
 No violations recorded.

BRICK: CRACKS/DISPLACED/SPALLED BRICK AT BUILDING CORNERS

REMOVE AND REBUILD
 PRIORITY 4
 LEVEL 2

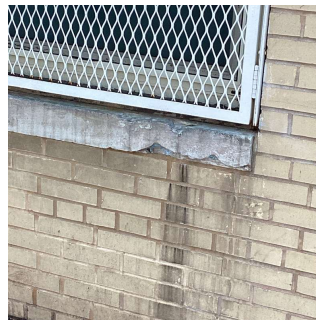
BRICK: DETERIORATED MASONRY SILLS - MAJOR

60
 L.F.
 REMOVE AND REPLACE
 PRIORITY 4
 LEVEL 2

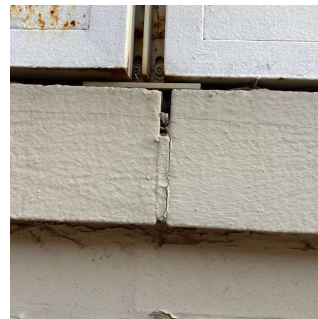
Facade G

BRICK: MASONRY SILLS - DETERIORATED JOINTS

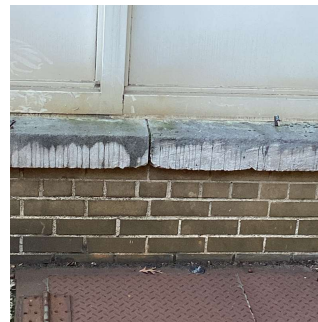
Facade H - Near AW2

BRICK: DETERIORATED MASONRY SILLS - MINOR

REPAIR

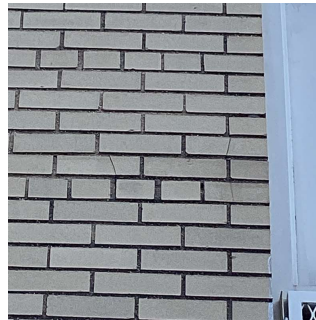
Facade H - Near Exit 3

BRICK: MINOR CRACKS AND SPALLING

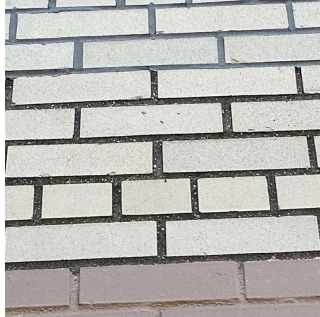
BRICK: DETERIORATED JOINTS

Question	Response
EXTERIOR	
EXTERIOR WALLS	
Urgency of Action	PRIORITY 3
Purpose of Action	LEVEL 2
Deficiency Photo1

Facade B - Near Main Entrance
Violations	No violations recorded.
EXTERIOR SOFFITS	Inspected
Condition	2 - Between Good and Fair
Deficiency	CONCRETE: MINOR CRACKS/SPALLING
Roof Plan reference

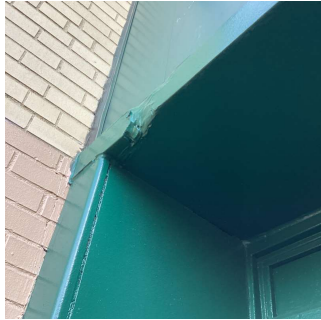
Deficiency Quantity	10
Quantity Uom	S.F.
Potential Action	REPAIR
Urgency of Action	PRIORITY 3
Purpose of Action	LEVEL 2

Violations	<p>Facade A - Main Entrance</p> <p>No violations recorded.</p>
LOADING DOCK	Does not Exist
LOUVER	Inspected
Condition	3 - Fair
Deficiency	MISSING/DAMAGED SCREEN
Roof Plan reference	<p>K261</p>

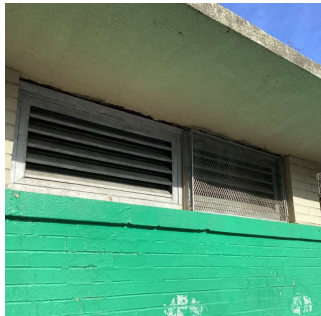
Deficiency Quantity	30
Quantity Uom	S.F.
Potential Action	REPLACE
Urgency of Action	PRIORITY 4
Purpose of Action	LEVEL 2
Deficiency Photo1

Question	Response
EXTERIOR	
LOUVER	Inspected
	Fresh Air In-Take - Small Schoolyard
Violations	No violations recorded.
PARAPETS	Inspected
Material Type(s)	Masonry
Replacement Quantity	7,000
Replacement Uom	C.F.
Instance on All Facades	Inspected
Instance Condition	2 - Between Good and Fair
Instance Quantity	7,000
Instance Quantity Uom	C.F.
Deficiency	No deficiencies recorded
PLAZA DECK	Does not Exist
ROOF	Inspected
Roofing	Inspected
Replacement Quantity	45,000
Replacement Uom	S.F.
ROOF HATCH/SMOKE HATCH	Inspected
Condition	2 - Between Good and Fair
Deficiency	No deficiencies recorded
LEADERS, GUTTERS, DOWNSPOUTS, SCUPPERS	Inspected
Condition	2 - Between Good and Fair
Deficiency	No deficiencies recorded
ROOF BARRIER/FENCE	Does not Exist
ROOF CAGE	Does not Exist
ROOFING	Inspected
Instance on Built-Up: Roof 1	Inspected
Instance Condition	4 - Between Fair and Poor
Instance Photo

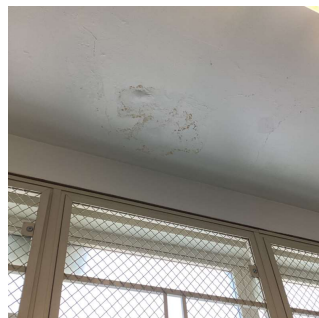
Does the roof have major mechanical equipment sitting on Dunnage Steel less than 18" above the Roofing?	No
Does this roof instance have a Sustainable Roof System?	No
Do solar panels exist on these roofs?	No
Is/Are the roof(s) suitable for Solar Panel installation?	Yes
Installation Year	2006
Source of Installation	Custodial Staff
Deficiency	BUILT-UP: ROOFING: MAJOR ACTIVE ROOF LEAKS IN INSTRUCTIONAL SPACE

Deficiency Quantity	200
Quantity Uom	S.F.
Potential Action	REPLACE ROOFING WITH MAJOR EQUIPMENT REMOVAL
Urgency of Action	PRIORITY 5
Purpose of Action	LEVEL 2
Deficiency Photo1

Violations	Roof 1 - Room 430 (shown), Room 416 (similar) No violations recorded.
Deficiency	BUILT-UP: FLASHING: CAP FLASHING DAMAGED
Roof Plan reference

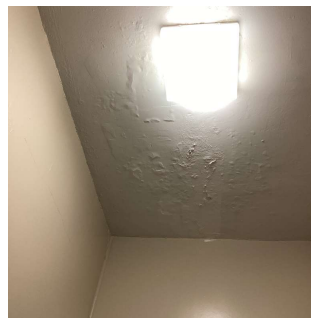
Question	Response
EXTERIOR	
ROOF	
Roofing	
ROOFING	
	Roof 2
Instance Quantity	25,000
Instance Quantity Uom	S.F.
Does the roof have major mechanical equipment sitting on Dunnage Steel less than 18" above the Roofing?	No
Does this roof instance have a Sustainable Roof System?	No
Do solar panels exist on these roofs?	No
Is/Are the roof(s) suitable for Solar Panel installation?	Yes
Installation Year	1997
Source of Installation	Custodial Staff
Deficiency	BUILT-UP: ROOFING: MAJOR ACTIVE ROOF LEAKS IN INSTRUCTIONAL SPACE
Roof Plan reference

Deficiency Quantity	400
Quantity Uom	S.F.
Potential Action	REPLACE ROOFING WITH MAJOR EQUIPMENT REMOVAL
Urgency of Action	PRIORITY 5
Purpose of Action	LEVEL 4
Deficiency Photo1

Violations	35495554R, 35650882N
Deficiency	BUILT-UP: ROOFING: MAJOR ACTIVE ROOF LEAKS IN INSTRUCTIONAL SPACE

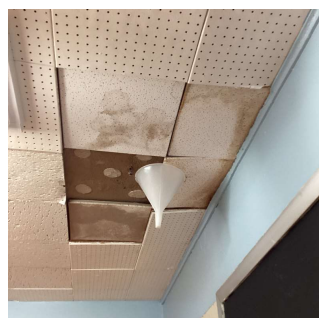
Violations	<p>Roof 2 - Corridor near Room 109 (shown); Roof 2 - 1st Floor Girls Toilet Room, Kitchen Locker Room (similar)</p> <p>No violations recorded.</p>
ROOFING DRAINS	Inspected
Condition	3 - Fair
Deficiency	DETERIORATED
Roof Plan reference

Deficiency Quantity	300
Quantity Uom	S.F.
Potential Action	REPLACE ROOFING WITHOUT MAJOR EQUIPMENT REMOVAL
Urgency of Action	PRIORITY 5
Purpose of Action	LEVEL 2
Deficiency Photo1

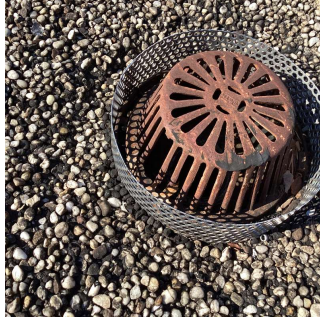
Violations	Roof 2 No violations recorded.
Specialties	Inspected
BULKHEAD/PENTHOUSE	Inspected
Condition	3 - Fair
Deficiency	BULKHEAD/PENTHOUSE WALLS/INTERIOR: GLAZED BLOCK CRACKS/SPALLING
Roof Plan reference

Question	Response
EXTERIOR	
ROOF	
Roofing	
ROOFING DRAINS	
Deficiency Photo1

Deficiency Quantity	1
Quantity Uom	EACH
Potential Action	REPLACE
Urgency of Action	PRIORITY 4
Purpose of Action	LEVEL 2

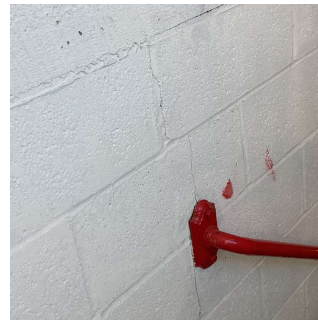
Violations	BH1 No violations recorded.
Deficiency	BULKHEAD/PENTHOUSE WALLS/INTERIOR: CMU CRACKS/SPALLING

20
S.F.
REPLACE
PRIORITY 3
LEVEL 2

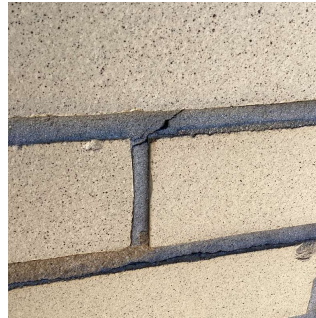
BH1

Deficiency **BULKHEAD/PENTHOUSE WALLS/EXTERIOR: DETERIORATED JOINTS**

20
S.F.
REPOINT
PRIORITY 3
LEVEL 2

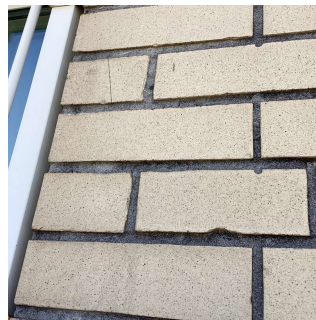
BH2

**BULKHEAD/PENTHOUSE WALLS/EXTERIOR:
CRACKS/SPALLING - MINOR**

REPAIR

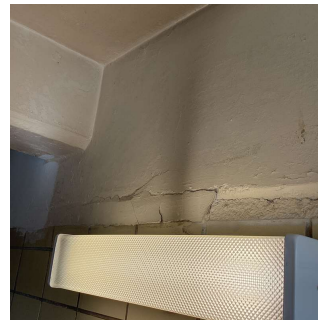
BH2

**BULKHEAD/PENTHOUSE WALLS/INTERIOR: PLASTER
CRACKS/SPALLING**

REPLACE

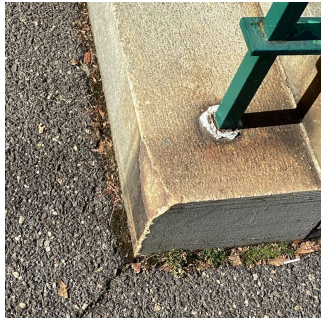
Question	Response
EXTERIOR	
STAIRS/RAMPS: EXTERIOR	
RAILINGS	Inspected
Deficiency	No deficiencies recorded
STAIRS/RAMPS	Inspected
Condition	5 - Poor
Deficiency	STONE: CRACKS/SPALLING - MAJOR
Roof Plan reference

Violations	<p>Facade C - Near Exit 6</p> <p>No violations recorded.</p>
Deficiency	STONE: DETERIORATED JOINTS
Roof Plan reference

Deficiency Quantity	10
Quantity Uom	S.F.
Potential Action	REPLACE
Urgency of Action	PRIORITY 4
Purpose of Action	LEVEL 2
Deficiency Photo1

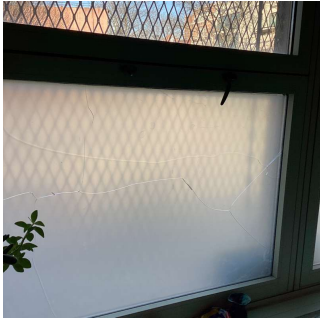
Question	Response
EXTERIOR	
WINDOWS	
WINDOWS	Inspected
Material Type(s)	Aluminum
Instance on Aluminum - Other: All Facades	Inspected
Instance Condition	3 - Fair
Instance Quantity	10,000
Instance Quantity Uom	S.F.
Are these windows insulated	Yes
Installation Year	2006
Source of Installation	Custodial Staff
Deficiency	ALUMINUM - OTHER: BROKEN PANE
Roof Plan reference

Violations	Room 109 (Shown), Rooms 216, 224, Library (similar) No violations recorded.
Deficiency	ALUMINUM - OTHER: INOPERABLE

Deficiency Quantity	300
Quantity Uom	S.F.
Potential Action	MAINTENANCE
Urgency of Action	PRIORITY 3
Purpose of Action	LEVEL 2
Deficiency Photo1

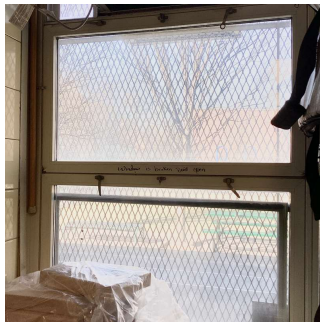
Violations	<p>Facade J - Kitchen</p> <p>No violations recorded.</p>
INTERIOR	Inspected
POOLS	Does not Exist
STRUCTURAL	Inspected
COLUMNS/BEAMS/BEARING WALLS	Inspected
Condition	3 - Fair
Deficiency	STEEL COLUMNS/BEAMS: DETERIORATED CONCRETE FIREPROOFING
Deficiency Location/Instance	Basement - Custodian Supply Room, Storage Room near Auditorium Stage
Deficiency Quantity	30
Quantity Uom	S.F.
Potential Action	REPLACE

Deficiency Quantity	30
Quantity Uom	S.F.
Potential Action	REPLACE WINDOW
Urgency of Action	PRIORITY 4
Purpose of Action	LEVEL 2
Deficiency Photo1

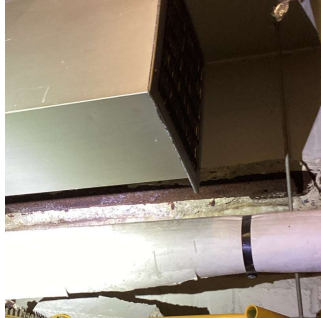
Basement - Custodian Supply Room
Violations	No violations recorded.
FLOOR STRUCTURE	
Condition	Inspected
	3 - Fair
Deficiency	CONCRETE SLAB ON GRADE: THRU CRACKS
Deficiency Location/Instance	Basement - Corridor near Boiler Room, Boiler Room, Crawlspace
Deficiency Quantity	50
Quantity Uom	S.F.
Potential Action	REPAIR
Urgency of Action	PRIORITY 3
Purpose of Action	LEVEL 5
Deficiency Photo1

Question	Response
INTERIOR	
STRUCTURAL	
COLUMNS/BEAMS/BEARING WALLS	
Urgency of Action	PRIORITY 4
Purpose of Action	LEVEL 5
Deficiency Photo1

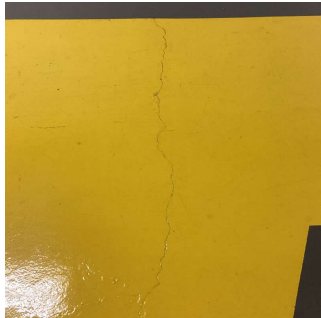
Basement - Corridor near Boiler Room
Violations	No violations recorded.
Deficiency	CONCRETE: CRACKS/SPALLED/REINFORCEMENT EXPOSED
Deficiency Location/Instance	1st Floor - Room 116
Deficiency Quantity	10
Quantity Uom	S.F.
Potential Action	REPAIR
Urgency of Action	PRIORITY 3
Purpose of Action	LEVEL 5

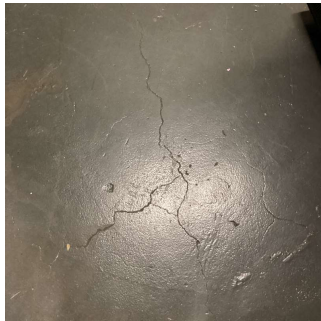
Violations	1st Floor - Room 116 No violations recorded.
FOUNDATION WALLS	Inspected
Material Type(s)	Concrete
Condition	5 - Poor
Deficiency	CONCRETE: WATER INFILTRATION IN INSTRUCTIONAL SPACE
Deficiency Location/Instance	Basement - Auditorium Storage Room, Corridor near Auditorium (left entrance, right entrance)
Deficiency Quantity	300
Quantity Uom	S.F.
Potential Action	INSTALL WATERPROOFING
Urgency of Action	PRIORITY 5
Purpose of Action	LEVEL 5
Deficiency Photo1

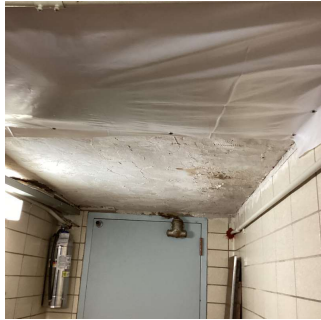
Violations	Corridor near Auditorium (right entrance) 35632039K
Deficiency	CONCRETE: CRACKED/SPALLED/REINFORCEMENT EXPOSED
Deficiency Location/Instance	Basement - Auditorium AC Room, Boiler Room
Deficiency Quantity	40
Quantity Uom	S.F.
Potential Action	REPAIR
Urgency of Action	PRIORITY 4
Purpose of Action	LEVEL 5

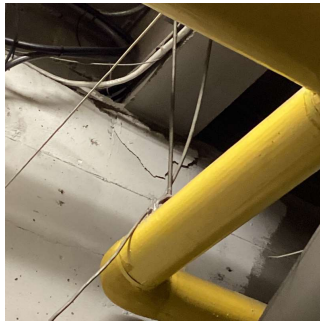
Violations	Basement - Auditorium AC Room No violations recorded.
Deficiency	CONCRETE: WATER INFILTRATION IN NON- INSTRUCTIONAL SPACE
Deficiency Location/Instance	Basement - Auditorium AC Room, Storage Room near entrance to the Auditorium
Deficiency Quantity	200
Quantity Uom	S.F.
Potential Action	INSTALL WATERPROOFING
Urgency of Action	PRIORITY 5
Purpose of Action	LEVEL 5
Deficiency Photo1

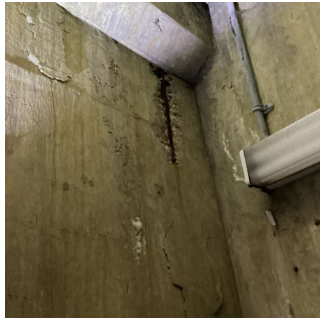
Violations	Facade J - Roof 4 No violations recorded.
VAULTS-BUNKERS	Inspected
Foundation Walls	Inspected
Condition	3 - Fair
Deficiency	CRACKS, SPALLING
Deficiency Location/Instance	Basement - Ash Hoist Vault
Deficiency Quantity	10
Quantity Uom	S.F.
Potential Action	REPAIR
Urgency of Action	PRIORITY 4
Purpose of Action	LEVEL 5
Deficiency Photo1

Violations	Basement - Ash Hoist Vault No violations recorded.
Slab Structure	Inspected
Condition	3 - Fair
Deficiency	CONCRETE BEAMS: CRACKS/SPALLED/REINFORCEMENT EXPOSED
Deficiency Location/Instance	Basement - Ash Hoist Vault
Deficiency Quantity	10
Quantity Uom	S.F.
Potential Action	REPLACE
Urgency of Action	PRIORITY 4
Purpose of Action	LEVEL 5

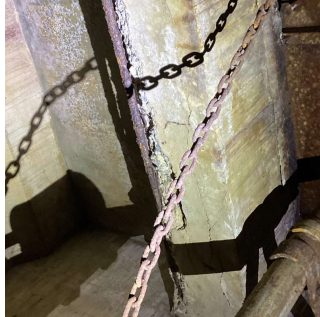
Violations	Basement - Ash Hoist Vault No violations recorded.
Vault/Ash Hoist Doors and Framing	Inspected
Condition	5 - Poor
Deficiency	DETERIORATED/DAMAGED VAULT/ASH HOIST DOORS AND FRAMING
Deficiency Location/Instance	Basement - Ash Hoist Vault
Deficiency Quantity	2
Quantity Uom	EACH
Potential Action	REPLACE
Urgency of Action	PRIORITY 4
Purpose of Action	LEVEL 2
Deficiency Photo1

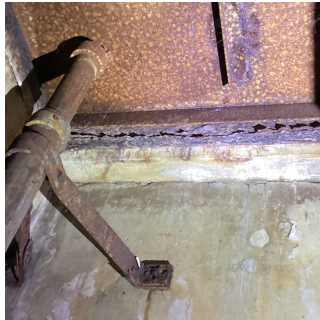
Violations	Basement - Ash Hoist Vault No violations recorded.
Deficiency	WATER INFILTRATION
Deficiency Location/Instance	Basement - Ash Hoist Vault
Deficiency Quantity	10
Quantity Uom	S.F.
Potential Action	REPAIR
Urgency of Action	PRIORITY 5
Purpose of Action	LEVEL 2

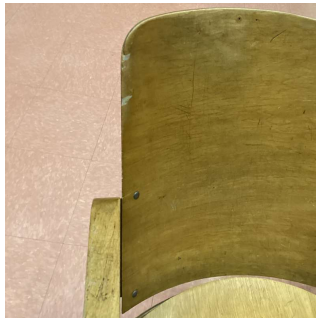
Violations	Basement - Ash Hoist Vault No violations recorded.
AUDITORIUM	Inspected
Instance on Basement (432 Seats)	Inspected
Ceiling	
Instance on Basement (432 Seats)	Inspected
Condition	2 - Between Good and Fair
Deficiency	No deficiencies recorded
Door(s)	
Instance on Basement (432 Seats)	Inspected
Condition	2 - Between Good and Fair
Deficiency	No deficiencies recorded
Fixed H/C Lift	
Instance on Basement (432 Seats)	Does not Exist
Fixed Seating	
Instance on Basement (432 Seats)	Inspected
Condition	5 - Poor
Deficiency	DAMAGED/BROKEN/INOPERABLE
Deficiency Location/Instance	Seat T/101, 102, 103, 104, 105, and others
Deficiency Quantity	42
Quantity Uom	EACH
Potential Action	REPLACE
Urgency of Action	PRIORITY 3
Purpose of Action	LEVEL 2
Deficiency Photo1

Violations	Seat T/101 No violations recorded.
Floor Finish

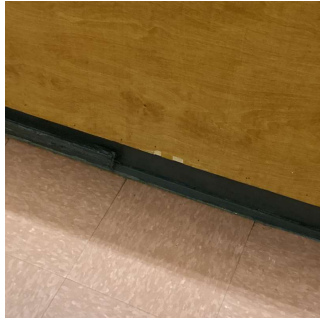
Question	Response
INTERIOR	
AUDITORIUM	
Floor Finish	
Condition	2 - Between Good and Fair
Deficiency	VINYL TILES: BROKEN/DETERIORATED/MISSING TILES
Deficiency Location/Instance	Near Seat T/1, 101, U/1, V/1, W/1, and others
Deficiency Quantity	75
Quantity Uom	S.F.
Potential Action	REPLACE
Urgency of Action	PRIORITY 3
Purpose of Action	LEVEL 2
Deficiency Photo1	 
Violations	Near Seat V/1 No violations recorded.
Sliding-folding Partition	
Instance on Basement (432 Seats)	Does not Exist
Stage	
Instance on Basement (432 Seats)	Inspected
Stage	
Instance on Basement (432 Seats)	Inspected
Condition	3 - Fair
Deficiency	DAMAGED STEPS
Deficiency Location/Instance	Left side, right side
Deficiency Quantity	30
Quantity Uom	S.F.
Potential Action	REPLACE
Urgency of Action	PRIORITY 3
Purpose of Action	LEVEL 2
Deficiency Photo1	 
Violations	Right side No violations recorded.
Deficiency	DAMAGED FASCIA
Deficiency Location/Instance	Near center

Near center
Violations	No violations recorded.
Stage Curtain Rigging	Inspected
Instance on Basement (432 Seats)	Inspected
Condition	5 - Poor
Deficiency	DAMAGED/DETERIORATED
Deficiency Location/Instance	Right side
Deficiency Quantity	1
Quantity Uom	EACH
Potential Action	REPLACE
Urgency of Action	PRIORITY 3
Purpose of Action	LEVEL 2
Deficiency Photo1

Question	Response
INTERIOR	
AUDITORIUM	
Stage	
Stage	
Quantity Uom	S.F.
Potential Action	REPLACE
Urgency of Action	PRIORITY 3
Purpose of Action	LEVEL 2
Deficiency Photo1

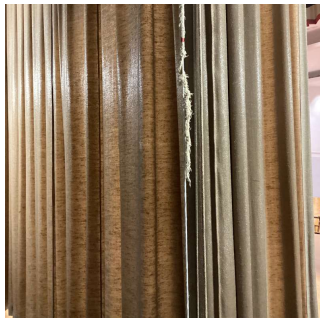
Right side
Violations	No violations recorded.
Deficiency	INOPERABLE
Deficiency Location/Instance	Left side, right side
Deficiency Quantity	2
Quantity Uom	EACH
Potential Action	MAINTENANCE
Urgency of Action	PRIORITY 3
Purpose of Action	LEVEL 2
Deficiency Photo1	No photo recorded
Violations	No violations recorded.
Stage Curtains	Inspected

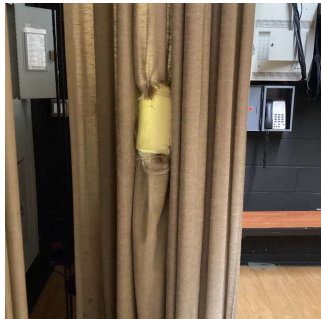
Question	Response
INTERIOR	
AUDITORIUM	
Stage	
Stage Curtains	
Instance on Basement (432 Seats)	Inspected
Condition	4 - Between Fair and Poor
Deficiency	WORN/DETERIORATED
Deficiency Location/Instance	Left side, right side, rear
Deficiency Quantity	800
Quantity Uom	S.F.
Potential Action	REPLACE
Urgency of Action	PRIORITY 3
Purpose of Action	LEVEL 2
Deficiency Photo1

Right side
Violations	No violations recorded.
Walls	
Instance on Basement (432 Seats)	Inspected
Condition	3 - Fair
Deficiency	PLASTER: CRACKS/SPALLING - ACTIVE LEAK
Deficiency Location/Instance	Storage Room
Deficiency Quantity	100
Quantity Uom	S.F.
Potential Action	REPLACE
Urgency of Action	PRIORITY 5
Purpose of Action	LEVEL 6
Deficiency Photo1

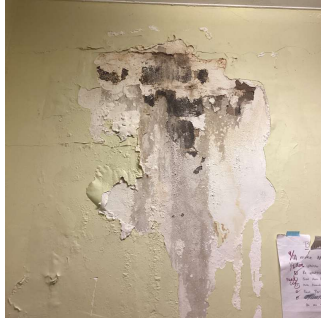
Storage Room
Violations	35495556K, 35632039K, 35650881L, 35650885Z
Deficiency	PLASTER: CRACKS/SPALLING
Deficiency Location/Instance	Rear Stage, Near seat A/6
Deficiency Quantity	60
Quantity Uom	S.F.
Potential Action	REPLACE

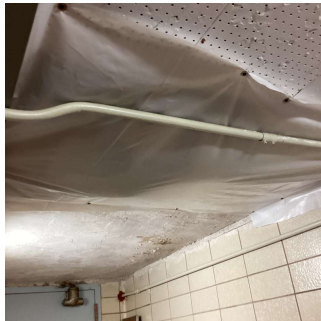
Question	Response
INTERIOR	
CAFETERIA	
Walls	
Deficiency Photo1	 
Violations	Near Windows No violations recorded.
Window Curtains/Shades/Blinds	
Instance on 1st Floor	Does not Exist
CLASSROOMS/CORRIDORS/ADMIN SPACES	
Ceiling	Inspected
Condition	2 - Between Good and Fair
Deficiency	PLASTER: CRACKS/SPALLING - ACTIVE LEAK
Deficiency Location/Instance	Room 408, 419
Deficiency Quantity	50
Quantity Uom	S.F.
Potential Action	REPLACE
Urgency of Action	PRIORITY 5
Purpose of Action	LEVEL 4
Deficiency Photo1	 
Violations	Room 408 35557766J, 35632040H
Deficiency	ACOUSTIC TILES ON PLASTER: DAMAGED/MISSING - ACTIVE LEAK
Deficiency Location/Instance	Corridor near Auditorium
Deficiency Quantity	50
Quantity Uom	S.F.
Potential Action	REPLACE
Urgency of Action	PRIORITY 5
Purpose of Action	LEVEL 6

Violations	Corridor near Auditorium 35632039K
Deficiency	PLASTER: CRACKS/SPALLING - ACTIVE LEAK
Deficiency Location/Instance	Corridor near Auditorium
Deficiency Quantity	50
Quantity Uom	S.F.
Potential Action	REPLACE
Urgency of Action	PRIORITY 5
Purpose of Action	LEVEL 6
Deficiency Photo1

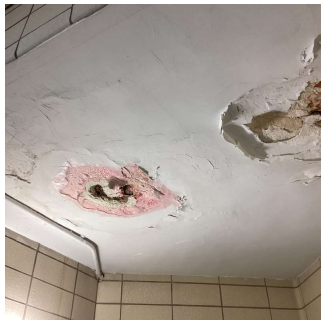
Violations	Corridor near Auditorium 35329501J, 35495556K, 35632039K, 35650882N
Deficiency	PLASTER: CRACKS/SPALLING
Deficiency Location/Instance	Room 111
Deficiency Quantity	20
Quantity Uom	S.F.
Potential Action	REPLACE
Urgency of Action	PRIORITY 3
Purpose of Action	LEVEL 2
Deficiency Photo1

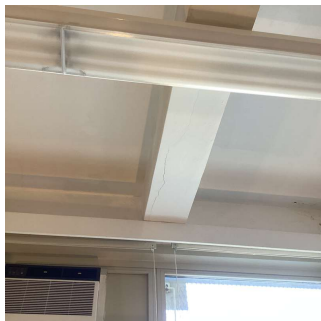
Violations	Room 111 No violations recorded.

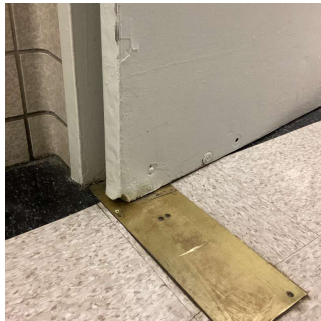
Question	Response
INTERIOR	
CLASSROOMS/CORRIDORS/ADMIN SPACES	
Ceiling	
Deficiency	ACOUSTIC TILES ON PLASTER: DAMAGED/MISSING
Deficiency Location/Instance	Corridor near Room 113, 115, 117, 119, 124, and others
Deficiency Quantity	1,000
Quantity Uom	S.F.
Potential Action	REPLACE
Urgency of Action	PRIORITY 3
Purpose of Action	LEVEL 2
Deficiency Photo1	 
Violations	Corridor near Room 113 No violations recorded.
Deficiency	ACOUSTIC TILES ON PLASTER: DAMAGED/MISSING - ACTIVE LEAK
Deficiency Location/Instance	Corridor near Room 109
Deficiency Quantity	25
Quantity Uom	S.F.
Potential Action	REPLACE
Urgency of Action	PRIORITY 5
Purpose of Action	LEVEL 6
Deficiency Photo1	 
Violations	Corridor near Stair C/1 No violations recorded.
Door(s)	Inspected
Condition	5 - Poor
Deficiency	METAL: DETERIORATED DOOR
Deficiency Location/Instance	Corridor near Room 214
Deficiency Quantity	2
Quantity Uom	EACH
Potential Action	MAINTENANCE
Urgency of Action	PRIORITY 3

Violations	Corridor near Room 214 No violations recorded.
Deficiency	WOOD: DETERIORATED DOOR
Deficiency Location/Instance	Room 109, 111, 113, 115, 117, and others
Deficiency Quantity	34
Quantity Uom	EACH
Potential Action	MAINTENANCE
Urgency of Action	PRIORITY 3
Purpose of Action	LEVEL 2
Deficiency Photo1

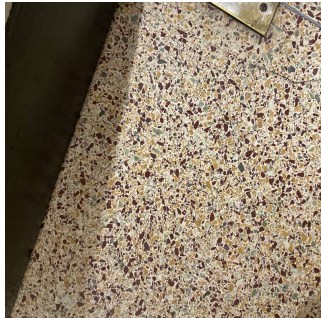
Question	Response
INTERIOR	
CLASSROOMS/CORRIDORS/ADMIN SPACES	
Floor Finish	
Violations	Room 410A No violations recorded.
Deficiency	TERRAZZO: CRACKS
Deficiency Location/Instance	Main Entrance Vestibule
Deficiency Quantity	50
Quantity Uom	S.F.
Potential Action	REPLACE
Urgency of Action	PRIORITY 3
Purpose of Action	LEVEL 2
Deficiency Photo1

Violations	Main Entrance Vestibule No violations recorded.
Deficiency	VINYL TILES: DETERIORATED SUBSTRATE
Deficiency Location/Instance	Room 111, 308, 313, 408, 417
Deficiency Quantity	50
Quantity Uom	S.F.
Potential Action	REPLACE
Urgency of Action	PRIORITY 3
Purpose of Action	LEVEL 2
Deficiency Photo1

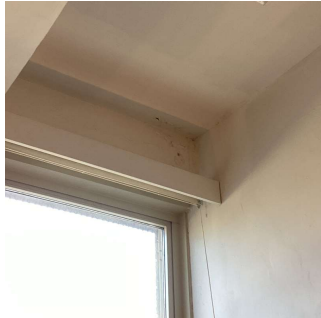
Question	Response
INTERIOR	
CLASSROOMS/CORRIDORS/ADMIN SPACES	
Walls	
Deficiency Photo1	 
Violations	Corridor near Room 409A No violations recorded.
Deficiency	PLASTER: CRACKS/SPALLING
Deficiency Location/Instance	Room 111
Deficiency Quantity	20
Quantity Uom	S.F.
Potential Action	REPLACE
Urgency of Action	PRIORITY 3
Purpose of Action	LEVEL 2
Deficiency Photo1

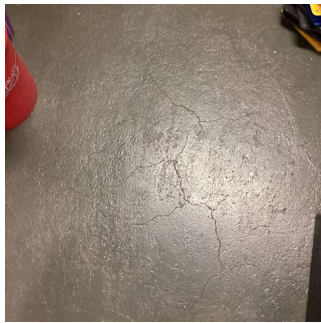
Question	Response
INTERIOR	
GYMNASIUM	
Floor Finish	
Deficiency Photo1

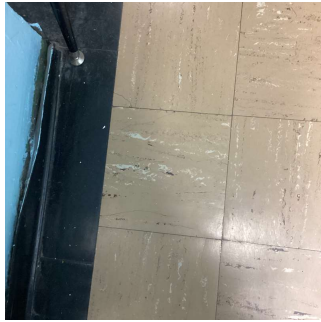
Violations	Storage No violations recorded.
Deficiency	VINYL TILES: BROKEN/DETERIORATED/MISSING TILES
Deficiency Location/Instance	Office
Deficiency Quantity	100
Quantity Uom	S.F.
Potential Action	REPLACE
Urgency of Action	PRIORITY 3
Purpose of Action	LEVEL 2
Deficiency Photo1

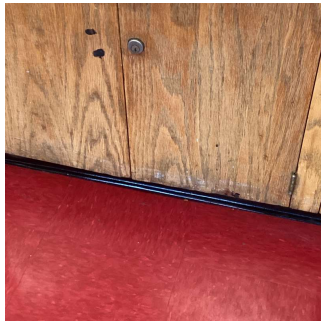
Question	Response
INTERIOR	
LIBRARY	
Built-in Furnishing	
Deficiency Photo1

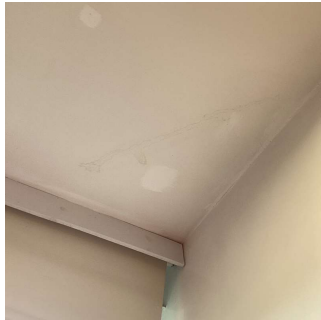
Near center
Violations	No violations recorded.
Ceiling	
Instance on Room 214	Inspected
Condition	2 - Between Good and Fair
Deficiency	PLASTER: CRACKS/SPALLING
Deficiency Location/Instance	Near Windows
Deficiency Quantity	20
Quantity Uom	S.F.
Potential Action	REPLACE
Urgency of Action	PRIORITY 3
Purpose of Action	LEVEL 2
Deficiency Photo1

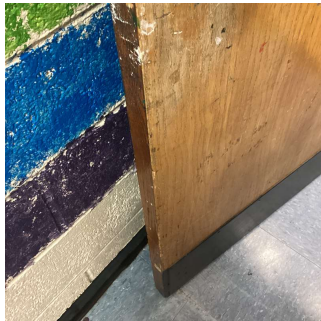
Question	Response
INTERIOR	
LOCKER ROOM	
Door(s)	
Deficiency Photo1

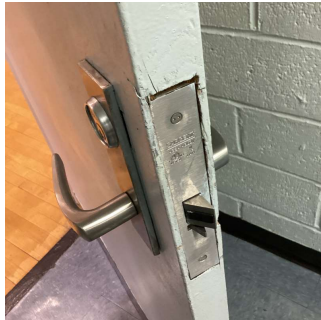
Violations	Entrance No violations recorded.
Instance on Basement - Boys	Inspected
Condition	4 - Between Fair and Poor
Deficiency	WOOD: DETERIORATED DOOR
Deficiency Location/Instance	Entrance
Deficiency Quantity	2
Quantity Uom	EACH
Potential Action	MAINTENANCE
Urgency of Action	PRIORITY 3
Purpose of Action	LEVEL 2
Deficiency Photo1

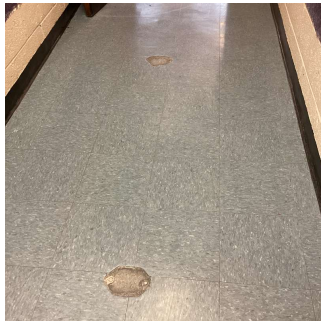
Violations	Entrance No violations recorded.
Floor Finish	
Instance on Basement - Girls (24 Lockers)	Inspected
Condition	2 - Between Good and Fair
Deficiency	VINYL TILES: BROKEN/DETERIORATED/MISSING TILES
Deficiency Location/Instance	Near Entrance, center
Deficiency Quantity	20
Quantity Uom	S.F.
Potential Action	REPLACE
Urgency of Action	PRIORITY 3
Purpose of Action	LEVEL 2

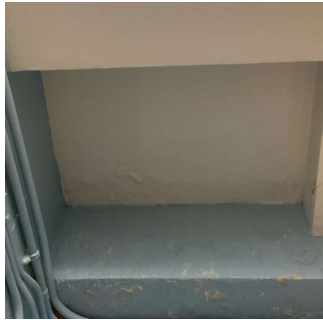
Question	Response
INTERIOR	
SHOWER ROOM	Inspected
Instance on Basement - Boys	Inaccessible
Instance on Basement - Girls	Inaccessible
STAIRS/RAMPS: INTERIOR	Inspected
Do Letter Stair Signs Exist?	Yes
Ceiling	Inspected
Condition	2 - Between Good and Fair
Deficiency	PLASTER: CRACKS/SPALLING - ACTIVE LEAK
Deficiency Location/Instance	Stair C/1 (Exit 2)
Deficiency Quantity	25
Quantity Uom	S.F.
Potential Action	REPLACE
Urgency of Action	PRIORITY 5
Purpose of Action	LEVEL 4
Deficiency Photo1

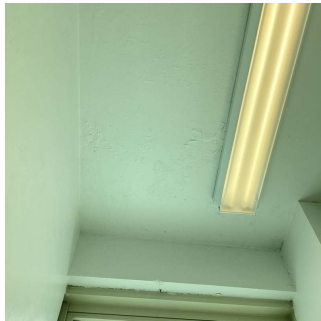
Question	Response
INTERIOR	
TOILET ROOMS - STAFF	
Ceiling	
Deficiency Photo1

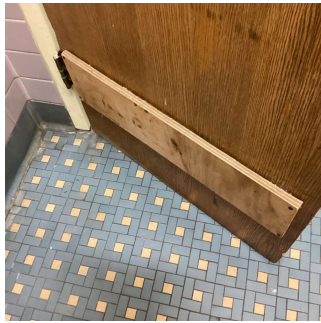
<p>Principals Toilet Room 35495554R</p>
Violations	
Door(s)	Inspected
Condition	5 - Poor
Deficiency	WOOD: DAMAGED LOUVER
Deficiency Location/Instance	Gymnasium Office
Deficiency Quantity	1
Quantity Uom	EACH
Potential Action	MAINTENANCE
Urgency of Action	PRIORITY 3
Purpose of Action	LEVEL 2
Deficiency Photo1

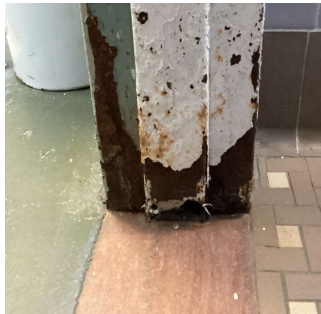
<p>Gymnasium Office No violations recorded.</p>
Violations	
Deficiency	METAL: DETERIORATED DOOR AND FRAME
Deficiency Location/Instance	Kitchen Staff
Deficiency Quantity	1
Quantity Uom	EACH
Potential Action	MAINTENANCE
Urgency of Action	PRIORITY 3
Purpose of Action	LEVEL 2
Deficiency Photo1

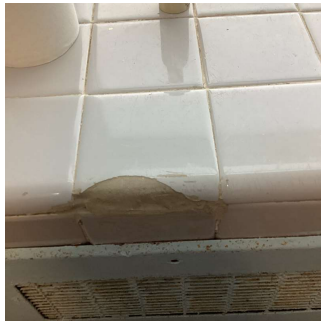
Question	Response
INTERIOR	
TOILET ROOMS - STAFF	
Door(s)	Inspected
	Kitchen Staff
Violations	No violations recorded.
Floor Finish	Inspected
Condition	2 - Between Good and Fair
Deficiency	No deficiencies recorded
Stalls	Inspected
Condition	2 - Between Good and Fair
Deficiency	No deficiencies recorded
Walls	Inspected
Condition	2 - Between Good and Fair
Deficiency	CERAMIC TILE: BROKEN/ MISSING
Deficiency Location/Instance	Kitchen Staff, Principals Toilet Room, Gymnasium Office
Deficiency Quantity	30
Quantity Uom	S.F.
Potential Action	REPLACE
Urgency of Action	PRIORITY 3
Purpose of Action	LEVEL 2
Deficiency Photo1

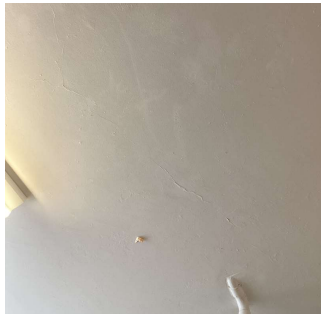
Kitchen Staff
Violations	No violations recorded.
TOILET ROOMS - STUDENTS	
	Inspected
Ceiling	Inspected
Condition	2 - Between Good and Fair
Deficiency	PLASTER: CRACKS/SPALLING
Deficiency Location/Instance	Room 402, 230
Deficiency Quantity	20
Quantity Uom	S.F.
Potential Action	REPLACE
Urgency of Action	PRIORITY 3

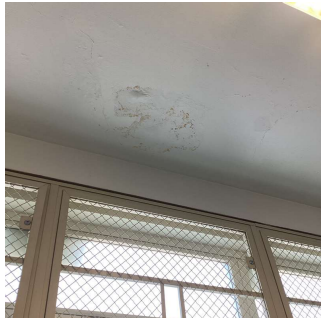
Question	Response
INTERIOR	
TOILET ROOMS - STUDENTS	
Ceiling	
Violations	Room 402 No violations recorded.
Deficiency	PLASTER: CRACKS/SPALLING - ACTIVE LEAK
Deficiency Location/Instance	Room 430, 1st Floor - Girls
Deficiency Quantity	50
Quantity Uom	S.F.
Potential Action	REPLACE
Urgency of Action	PRIORITY 5
Purpose of Action	LEVEL 2
Deficiency Photo1

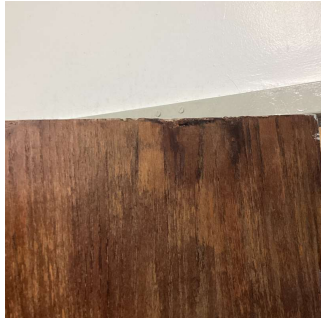
Violations	Room 430 No violations recorded.
Door(s)	Inspected
Condition	5 - Poor
Deficiency	WOOD: DETERIORATED DOOR
Deficiency Location/Instance	Room 430, 402, 330, 316, 302, and others
Deficiency Quantity	9
Quantity Uom	EACH
Potential Action	MAINTENANCE
Urgency of Action	PRIORITY 3
Purpose of Action	LEVEL 2
Deficiency Photo1

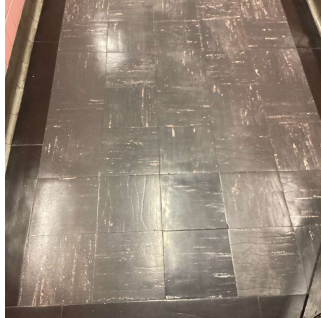
Violations	Room 430 No violations recorded.
Floor Finish	Inspected
Condition	3 - Fair
Deficiency	VINYL TILES: BROKEN/DETERIORATED/MISSING TILES
Deficiency Location/Instance	Room 302
Deficiency Quantity	50
Quantity Uom	S.F.
Potential Action	REPLACE

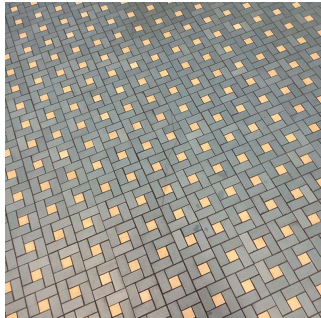
Room 302
Violations	No violations recorded.
Deficiency	CERAMIC TILE: DETERIORATED SUBSTRATE
Deficiency Location/Instance	Room 430, 402, 330, 316, 302, and others
Deficiency Quantity	100
Quantity Uom	S.F.
Potential Action	REPLACE
Urgency of Action	PRIORITY 3
Purpose of Action	LEVEL 2
Deficiency Photo1

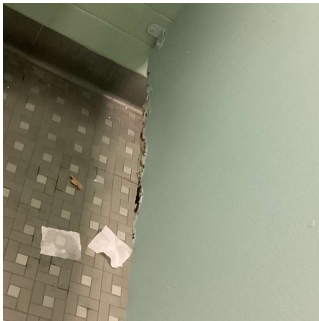
Room 430
Violations	No violations recorded.
Stalls	Inspected
Condition	5 - Poor
Deficiency	RUST - MAJOR
Deficiency Location/Instance	Room 316, 216, B6, B4
Deficiency Quantity	20
Quantity Uom	EACH
Potential Action	REPLACE
Urgency of Action	PRIORITY 3
Purpose of Action	LEVEL 2

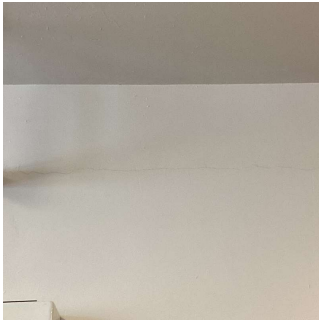
Violations	Room 316 No violations recorded.
Walls	
Condition	Inspected 2 - Between Good and Fair
Deficiency	PLASTER: CRACKS/SPALLING
Deficiency Location/Instance	Room 402, 330, 302
Deficiency Quantity	50
Quantity Uom	S.F.
Potential Action	REPLACE
Urgency of Action	PRIORITY 3
Purpose of Action	LEVEL 2
Deficiency Photo1

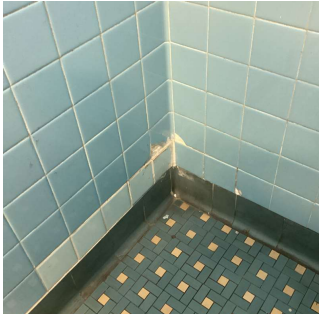
Violations	Room 402 No violations recorded.
Deficiency	CERAMIC TILE: BROKEN/ MISSING
Deficiency Location/Instance	Room 430, 402, 330, 302, 230, and others
Deficiency Quantity	100
Quantity Uom	S.F.
Potential Action	REPLACE
Urgency of Action	PRIORITY 3
Purpose of Action	LEVEL 2
Deficiency Photo1

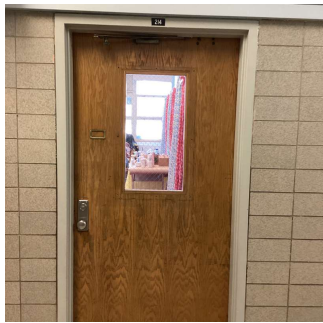
Question	Response
INTERIOR	Inspected
TOILET ROOMS - STUDENTS	Inspected
Walls	
Violations	Room 430 No violations recorded.
LIFE SAFETY	Inspected
F.D. HOLDING AREA	Inspected
Condition	5 - Poor
Deficiency	HOLDING AREAS NOT IDENTIFIED
Deficiency Location/Instance	Rooms 108, 214, 309, 410
Deficiency Quantity	4
Quantity Uom	EACH
Potential Action	PROVIDE IDENTIFICATION AT DOOR
Urgency of Action	PRIORITY 5
Purpose of Action	LEVEL 2
Deficiency Photo1

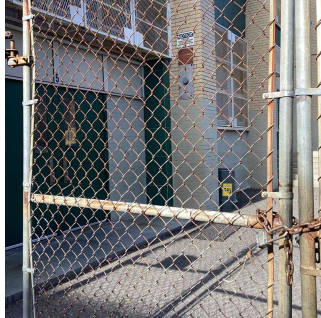
Question	Response
SITE	
FENCES	
Deficiency	CHAIN LINK: RUST - MAJOR
Deficiency Location/Instance	Along Dean Street, East Schoolyard
Deficiency Quantity	2,100
Quantity Uom	S.F.
Potential Action	REPLACE
Urgency of Action	PRIORITY 3
Purpose of Action	LEVEL 2
Deficiency Photo1

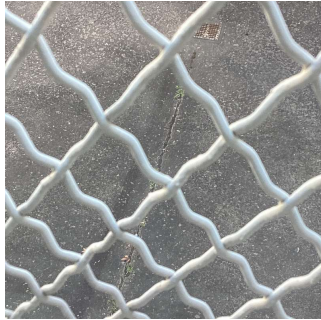
Question	Response
SITE	
IRRIGATION SYSTEM	Does not Exist
PAVING	Inspected
Student Non-Use	Inspected
Gravel Exists?	No
Asphalt	Inspected
Condition	3 - Fair
Deficiency	CRACKS - MAJOR
Deficiency Location/Instance	Near TCU
Deficiency Quantity	200
Quantity Uom	S.F.
Potential Action	REPLACE
Urgency of Action	PRIORITY 3
Purpose of Action	LEVEL 2
Deficiency Photo1	No photo recorded
Violations	No violations recorded.
Concrete	Inspected
Condition	3 - Fair
Deficiency	DAMAGED/DETERIORATED/MISSING SECTIONS
Deficiency Location/Instance	Courtyard, Along Dean Street
Deficiency Quantity	400
Quantity Uom	S.F.
Potential Action	REPLACE
Urgency of Action	PRIORITY 3
Purpose of Action	LEVEL 2
Deficiency Photo1

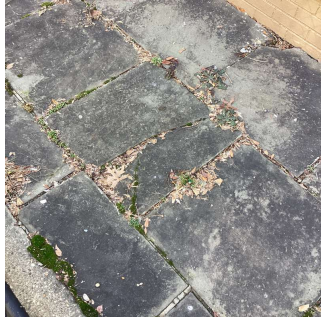
Violations	Courtyard No violations recorded.
Pavers	Inspected
Condition	2 - Between Good and Fair
Deficiency	DAMAGED/MISSING
Deficiency Location/Instance	Near exit 1
Deficiency Quantity	25
Quantity Uom	S.F.
Potential Action	REPLACE
Urgency of Action	PRIORITY 3

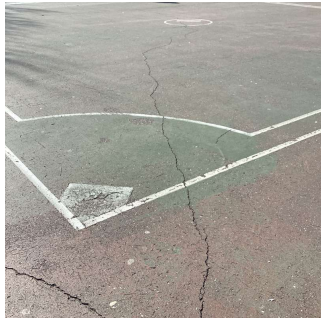
Near exit 1
Violations	No violations recorded.
Student Use	Inspected
Gravel Exists?	No
Asphalt	Inspected
Condition	4 - Between Fair and Poor
Deficiency	CRACKS - MAJOR
Deficiency Location/Instance	Schoolyard
Deficiency Quantity	2,500
Quantity Uom	S.F.
Potential Action	REPLACE
Urgency of Action	PRIORITY 3
Purpose of Action	LEVEL 2
Deficiency Photo1

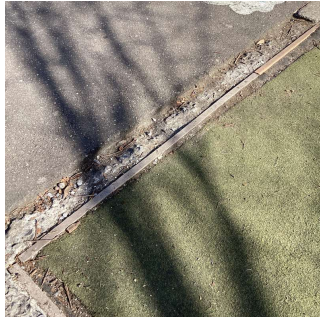
Schoolyard
Violations	No violations recorded.
Concrete	Inspected
Condition	3 - Fair
Deficiency	DAMAGED/DETERIORATED/MISSING SECTIONS
Deficiency Location/Instance	Schoolyard near Playing Surface
Deficiency Quantity	50
Quantity Uom	S.F.
Potential Action	REPLACE
Urgency of Action	PRIORITY 5
Purpose of Action	LEVEL 6

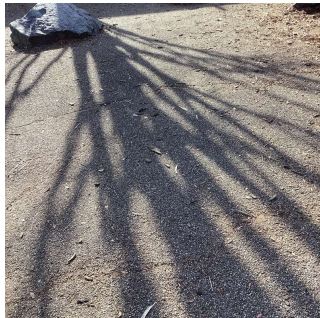
Violations	Schoolyard No violations recorded.
Deficiency	DAMAGED/DETERIORATED/MISSING SECTIONS
Deficiency Location/Instance	Garden near Schoolyard, Schoolyard
Deficiency Quantity	425
Quantity Uom	S.F.
Potential Action	REPLACE
Urgency of Action	PRIORITY 3
Purpose of Action	LEVEL 2
Deficiency Photo1

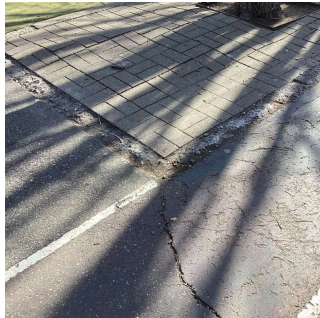
Violations	Garden near Schoolyard No violations recorded.
Pavers	Inspected
Condition	3 - Fair
Deficiency	HEAVING
Deficiency Location/Instance	Schoolyard
Deficiency Quantity	250
Quantity Uom	S.F.
Potential Action	REPLACE
Urgency of Action	PRIORITY 3
Purpose of Action	LEVEL 2

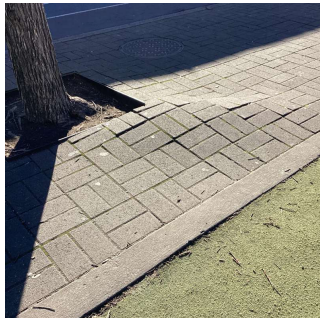
Violations	Schoolyard No violations recorded.
Deficiency	HEAVING
Deficiency Location/Instance	Schoolyard near Playing Surface
Deficiency Quantity	50
Quantity Uom	S.F.
Potential Action	REPLACE
Urgency of Action	PRIORITY 5
Purpose of Action	LEVEL 6
Deficiency Photo1

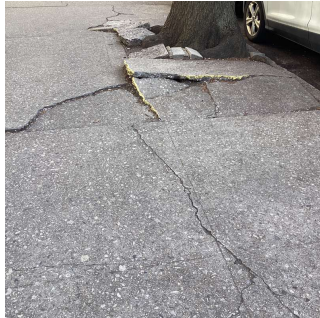
Question	Response
SITE	
PAVING	
DOT Sidewalk	
Concrete	
Deficiency Photo1	 
Violations	Along Dean Street No violations recorded.
Deficiency	HEAVING
Deficiency Location/Instance	Along Dean Street
Deficiency Quantity	400
Quantity Uom	S.F.
Potential Action	REPLACE
Urgency of Action	PRIORITY 5
Purpose of Action	LEVEL 6
Deficiency Photo1

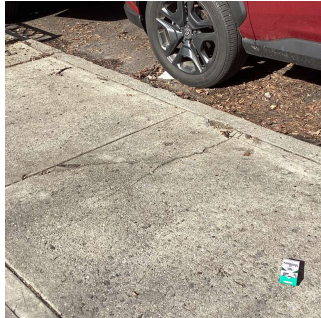
Question	Response
SITE	
PAVING	
DOT Sidewalk	
Concrete	
Violations	No violations recorded.
Deficiency	DAMAGED/DETERIORATED/MISSING SECTIONS
Deficiency Location/Instance	Along Pacific Street, Dean Street
Deficiency Quantity	2,125
Quantity Uom	S.F.
Potential Action	REPLACE
Urgency of Action	PRIORITY 3
Purpose of Action	LEVEL 2
Deficiency Photo1

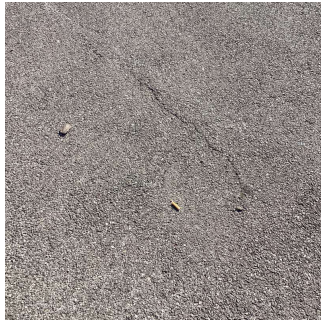
Question	Response
SITE	
PLAYGROUNDS	
Fence	
Deficiency Photo1	 
Violations	Schoolyard No violations recorded.
Pavement	
Instance on West Schoolyard	Inspected
Condition	3 - Fair
Deficiency	ASPHALT: CRACKS - MAJOR
Deficiency Location/Instance	Schoolyard
Deficiency Quantity	200
Quantity Uom	S.F.
Potential Action	REPLACE
Urgency of Action	PRIORITY 3
Purpose of Action	LEVEL 2
Deficiency Photo1

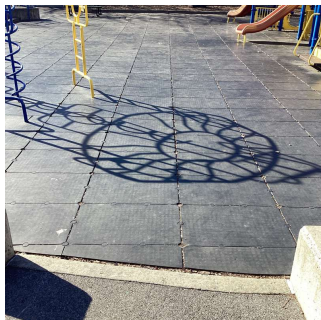
Question	Response
SITE	
PLAYGROUNDS	
Safety Surfacing	
Urgency of Action	PRIORITY 3
Purpose of Action	LEVEL 2
Deficiency Photo1	No photo recorded
Violations	No violations recorded.
Instance on West Schoolyard	Inspected
Condition	3 - Fair
Deficiency	DETERIORATED/MISSING
Deficiency Location/Instance	Schoolyard
Deficiency Quantity	200
Quantity Uom	S.F.
Potential Action	MAINTENANCE
Urgency of Action	PRIORITY 3
Purpose of Action	LEVEL 2
Deficiency Photo1

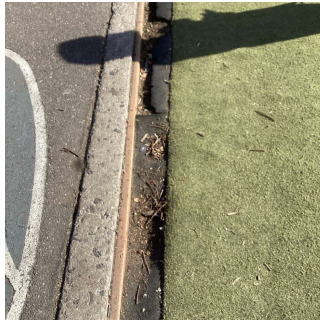
Violations	Schoolyard No violations recorded.
Unpaved Area	
Instance on East Schoolyard	Does not Exist
Instance on West Schoolyard	Inspected
Condition	2 - Between Good and Fair
Deficiency	No deficiencies recorded
PLAYING SURFACE	Inspected
Playing Field	Inspected
Instance on West Schoolyard	Inspected
Instance Condition	3 - Fair
Deficiency	ARTIFICIAL TURF: DAMAGED/WORN OUT
Deficiency Location/Instance	Schoolyard
Deficiency Quantity	200
Quantity Uom	S.F.
Potential Action	REPLACE

Urgency of Action	PRIORITY 5
Purpose of Action	LEVEL 6

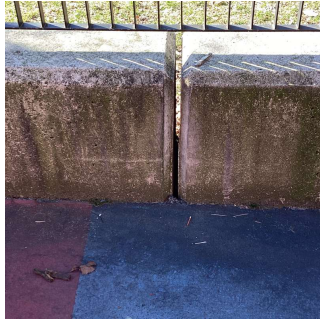
Violations	Schoolyard No violations recorded.
Running Track	Does not Exist
RETAINING WALLS	Inspected
Are there any Retaining Walls 6' OR higher facing public street/sidewalk?	No
Condition	2 - Between Good and Fair
Deficiency	No deficiencies recorded
SEATING	Inspected
Benches	Inspected
Concrete	Does not Exist
Metal/Wood/Plastic	Inspected
Condition	2 - Between Good and Fair
Deficiency	No deficiencies recorded
Bleachers	Does not Exist
SITE WALLS (NOT RETAINING WALLS)	Inspected
Condition	2 - Between Good and Fair
Deficiency	CAST IN PLACE CONCRETE: DETERIORATED CONTROL/EXPANSION JOINT
Deficiency Location/Instance	Near TCU
Deficiency Quantity	10
Quantity Uom	L.F.
Potential Action	REPLACE
Urgency of Action	PRIORITY 3
Purpose of Action	LEVEL 2
Deficiency Photo1
