NYC Department of Education
Building Condition Assessment Survey 2023 - 2024

Architectural Inspection

Asset: **I.S. 292 - BROOKLYN, 300 WYONA STREET, New York, 11207**

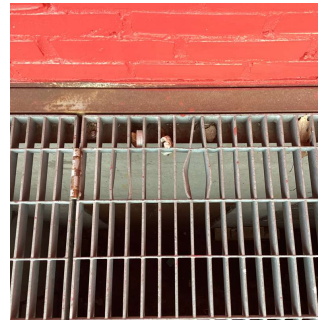
Question	Response
Architectural	
EXTERIOR	Inspected
AREAWAY	Inspected
Instance on AW1	Inspected
Instance Condition	3 - Fair
Instance Quantity	1
Instance Quantity Uom	EACH
Deficiency	AREAWAY GRATINGS: MAJOR RUSTING / OR BROKEN

REPLACE

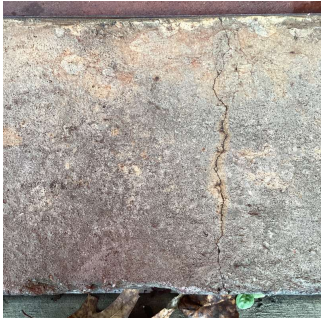
AREAWAY WALLS: CRACKS AND SPALLING

REPLACE

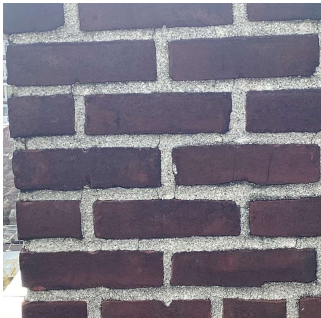
Violations	<p>AW1</p> <p>No violations recorded.</p>
AWNINGS AND CANOPIES	Does not Exist
CHIMNEY	Inspected
Material Type(s)	Masonry
Condition	3 - Fair
Deficiency	BRICK: MINOR CRACKS AND SPALLING
Roof Plan reference	<p>K292</p>

Deficiency Quantity	10
Quantity Uom	S.F.
Potential Action	RESTITCH
Urgency of Action	PRIORITY 3
Purpose of Action	LEVEL 2
Deficiency Photo1

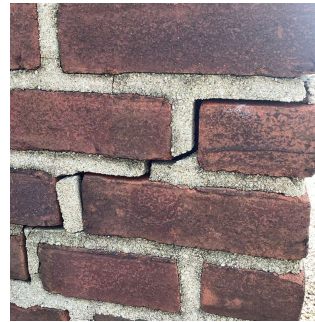
CH

Violations	<p>CH</p> <p>No violations recorded.</p>
Deficiency	BRICK: DETERIORATED JOINTS

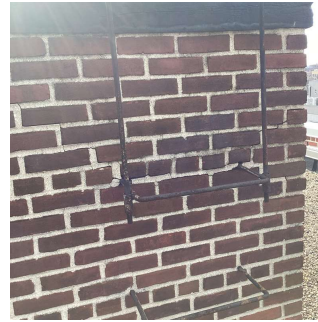
CH

BRICK: DETERIORATED LADDER

REPLACE

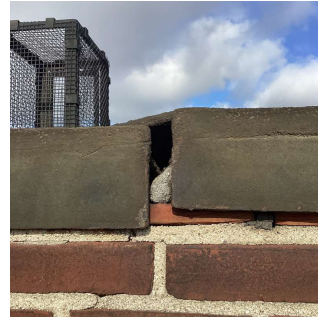
CH

BRICK: DETERIORATED CAP

REPLACE

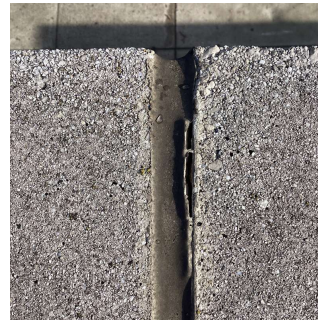
Roof 3b

CAST STONE: DETERIORATED TRANSVERSE JOINTS

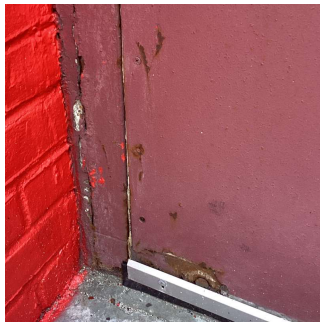
Violations	<p>Facade G - Roof 3B</p> <p>No violations recorded.</p>
Deficiency	<p>METAL CLAD: DETERIORATED DOOR - MINOR DETERIORATION</p>
Roof Plan reference	<p>K292</p>

Deficiency Quantity	4
Quantity Uom	EACH
Potential Action	MAINTENANCE
Urgency of Action	PRIORITY 3
Purpose of Action	LEVEL 2
Deficiency Photo1

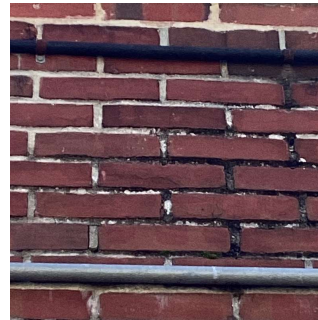
Facade G

Question	Response
EXTERIOR	
DOORS	
DOORS AND FRAMES	
RooF Plan reference	<div> <div> </div> </div>
Deficiency Quantity	13
Quantity Uom	EACH
Potential Action	REPLACE
Urgency of Action	PRIORITY 4
Purpose of Action	LEVEL 2
Deficiency Photo1	<div> </div>
Violations	<div> <div>Facade B</div> <div>No violations recorded.</div> </div>
DOOR HARDWARE	Inspected
Condition	3 - Fair
Deficiency	No deficiencies recorded
LINTELS	Inspected
Condition	2 - Between Good and Fair
Deficiency	No deficiencies recorded
TRANSOM/SIDE LIGHT	Inspected
Condition	2 - Between Good and Fair
Deficiency	No deficiencies recorded
EXTERIOR WALLS	Inspected
Material Type(s)	Masonry
Replacement Quantity	42,000
Replacement Uom	S.F.
Instance on All Facades	Inspected
Instance Condition	3 - Fair
Instance Quantity	42,000
Instance Quantity Uom	S.F.
Deficiency	BRICK: DETERIORATED JOINTS

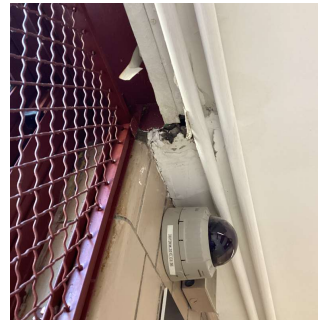
Facade M - Corridor near Room 324

BRICK: WATER INFILTRATION IN INSTRUCTIONAL SPACE

REPAIR

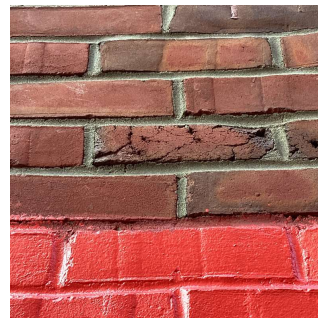
Facade D

BRICK: MINOR CRACKS AND SPALLING

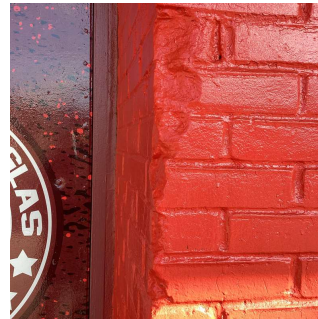
Facade A

BRICK: CRACKS/DISPLACED/SPALLED BRICK AT BUILDING CORNERS

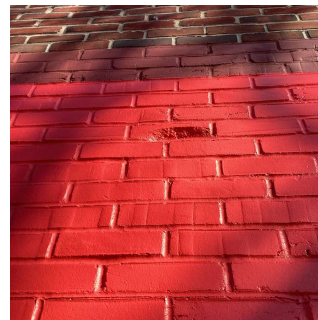
Facade E

BRICK: MAJOR / THRU CRACKS

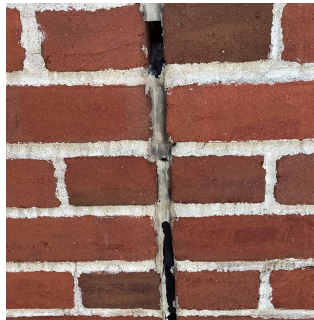
Facade F

BRICK: DETERIORATED CONTROL/EXPANSION JOINTS

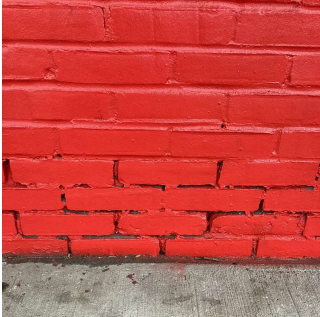
BRICK: DETERIORATED JOINTS

Question	Response
EXTERIOR	
EXTERIOR WALLS	
Urgency of Action	PRIORITY 4
Purpose of Action	LEVEL 2
Deficiency Photo1

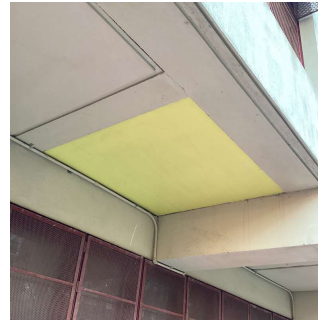
Facade K

Facade A
Violations	No violations recorded.
EXTERIOR SOFFITS	Inspected
Condition	3 - Fair
Deficiency	STUCCO/PLASTER: MAJOR CRACKS/SPALLING
Roof Plan reference	<p>K292</p>

Deficiency Quantity	10
Quantity Uom	S.F.
Potential Action	REPLACE
Urgency of Action	PRIORITY 4
Purpose of Action	LEVEL 2

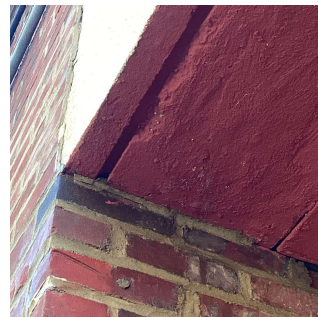
Facade G

CONCRETE: MAJOR CRACKS/SPALLING

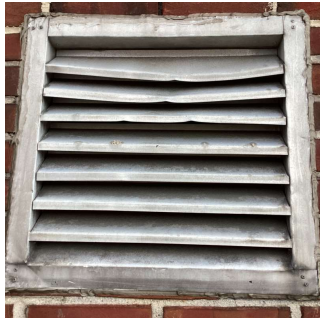
Question	Response
EXTERIOR	
LOUVER	Inspected
Condition	3 - Fair
Deficiency	BROKEN/ DENTED BLADES
Roof Plan reference	K292

Deficiency Quantity	10
Quantity Uom	S.F.
Potential Action	REPLACE
Urgency of Action	PRIORITY 4
Purpose of Action	LEVEL 2
Deficiency Photo1

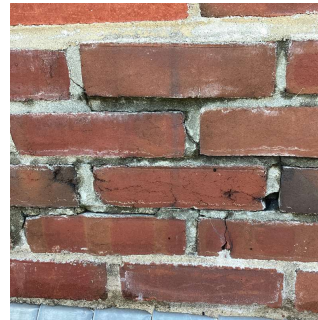
Roof 3a

Violations	BH4 No violations recorded.
PARAPETS	Inspected
Material Type(s)	Masonry
Replacement Quantity	5,000
Replacement Uom	C.F.
Instance on Roofs 3, 3A, 3B	Inspected
Instance Condition	4 - Between Fair and Poor
Instance Quantity	5,000
Instance Quantity Uom	C.F.
Deficiency	BRICK: DETERIORATED JOINTS

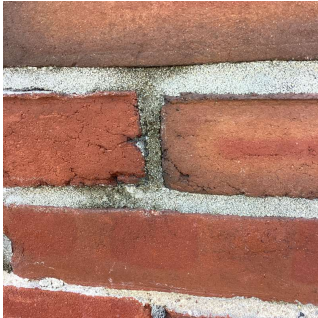
BRICK: MINOR CRACKS, SPALLING

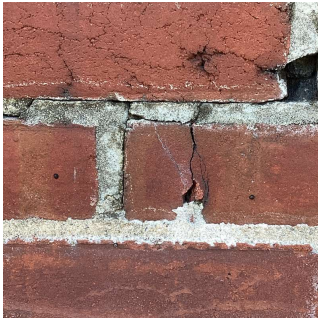
Violations	Roof 3a No violations recorded.
Deficiency	BRICK: MAJOR DETERIORATION/CRACKS
Roof Plan reference	K292

Deficiency Quantity	10
Quantity Uom	S.F.
Potential Action	REMOVE AND REBUILD
Urgency of Action	PRIORITY 4
Purpose of Action	LEVEL 2
Deficiency Photo1

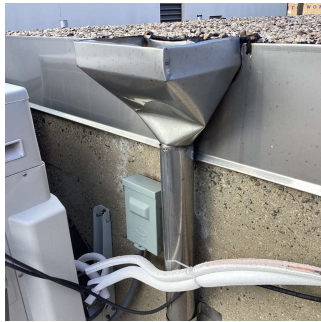
Question	Response
EXTERIOR	
ROOF	
Roofing	
LEADERS, GUTTERS, DOWNSPOUTS, SCUPPERS	
Deficiency Roof Plan reference	DAMAGED/MISSING K292

Deficiency Quantity Quantity Uom Potential Action Urgency of Action Purpose of Action Deficiency Photo1	10 L.F. REPLACE PRIORITY 4 LEVEL 2

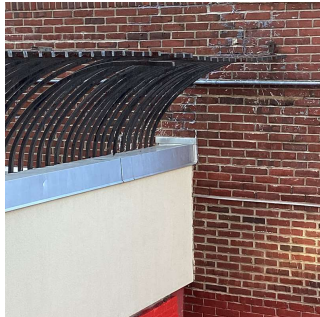
Violations	SK1 No violations recorded.
ROOF BARRIER/FENCE	Inspected
Condition	3 - Fair
Deficiency Roof Plan reference	BEAR CLAW/METAL BAR: DETERIORATED, MAJOR RUSTING K292

Deficiency Quantity Quantity Uom Potential Action Urgency of Action Purpose of Action	30 S.F. REPLACE PRIORITY 4 LEVEL 2

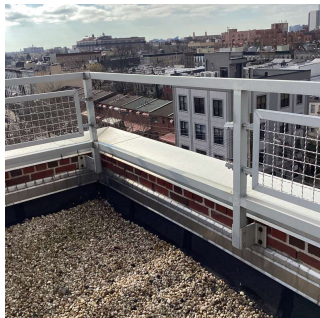
Violations	<p>Facade C</p> <p>No violations recorded.</p>
Deficiency	RAILINGS/PANELS: DETERIORATED, MAJOR RUSTING
Roof Plan reference	<p>K292</p>

Deficiency Quantity	10
Quantity Uom	S.F.
Potential Action	REPLACE
Urgency of Action	PRIORITY 5
Purpose of Action	LEVEL 6
Deficiency Photo1

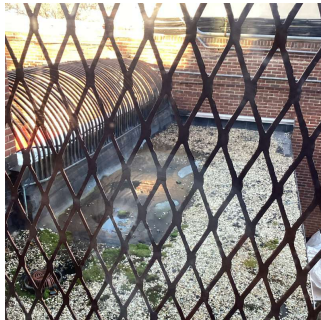
Is/Are the roof(s) suitable for Solar Panel installation?	Yes
Installation Year	2009
Source of Installation	Custodial Staff
Deficiency	BUILT-UP: ROOFING: LOSS OF GRAVEL
Roof Plan reference	<div> <div>K292</div>

Question	Response
EXTERIOR	
ROOF	
Roofing	
ROOFING	
Quantity Uom	S.F.
Potential Action	INSTALL NEW GRAVEL
Urgency of Action	PRIORITY 3
Purpose of Action	LEVEL 2
Deficiency Photo1

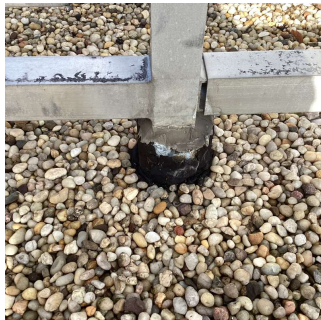
Violations	Roof 4 No violations recorded.
Deficiency	BUILT-UP: FLASHING: PITCH POCKET DETERIORATED - MINOR
Roof Plan reference	K292

Deficiency Quantity	5
Quantity Uom	EACH
Potential Action	REPAIR
Urgency of Action	PRIORITY 3
Purpose of Action	LEVEL 2
Deficiency Photo1

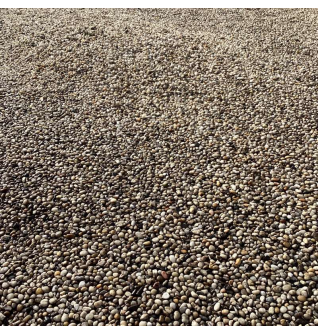
Violations	Roof 1 No violations recorded.
Deficiency	BUILT-UP: ROOFING: DELAMINATION

Deficiency Quantity	100
Quantity Uom	S.F.
Potential Action	REPLACE ROOFING WITHOUT MAJOR EQUIPMENT REMOVAL
Urgency of Action	PRIORITY 4
Purpose of Action	LEVEL 2
Deficiency Photo1

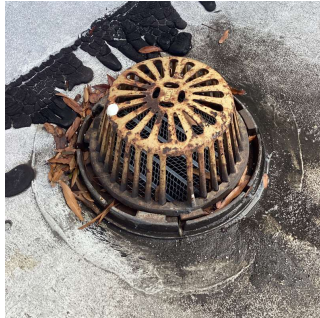
Violations	Roof 3 No violations recorded.
ROOFING DRAINS	Inspected
Condition	3 - Fair
Deficiency	DETERIORATED
Roof Plan reference	K292

Deficiency Quantity	1
Quantity Uom	EACH
Potential Action	REPLACE
Urgency of Action	PRIORITY 4
Purpose of Action	LEVEL 2
Deficiency Photo1

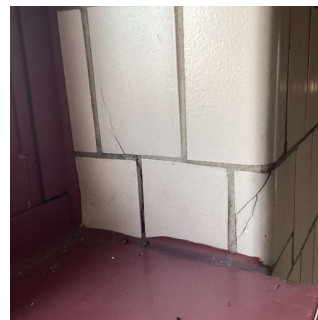
BH1
No violations recorded.

Violations	Roof 3a No violations recorded.
Specialties	Inspected
BULKHEAD/PENTHOUSE	Inspected
Condition	5 - Poor
Deficiency	BULKHEAD/PENTHOUSE WALLS/INTERIOR: GLAZED BLOCK CRACKS/SPALLING

10
S.F.
REPLACE
PRIORITY 3
LEVEL 2

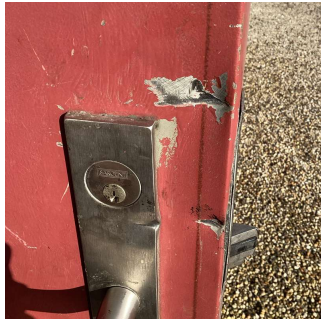
BULKHEAD/PENTHOUSE DOORS: DETERIORATED DOOR

1
EACH
REPLACE DOOR
PRIORITY 4
LEVEL 2

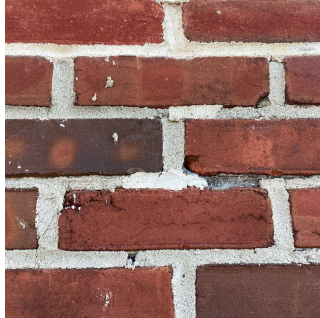
Deficiency Quantity	20
Quantity Uom	S.F.
Potential Action	MAINTENANCE
Urgency of Action	PRIORITY 3
Purpose of Action	LEVEL 2
Deficiency Photo1	No photo recorded
Violations	No violations recorded.
Deficiency	BULKHEAD/PENTHOUSE WALLS/EXTERIOR: CRACKS/SPALLING - MINOR
Roof Plan reference	K292

Deficiency Quantity	80
Quantity Uom	S.F.
Potential Action	REPAIR
Urgency of Action	PRIORITY 3
Purpose of Action	LEVEL 2

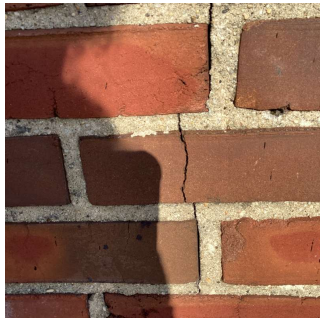
Violations	BH2 No violations recorded.
Deficiency	BULKHEAD/PENTHOUSE WALLS/EXTERIOR: CRACKS/SPALLING - MAJOR
Roof Plan reference	<p>K292</p>

Deficiency Quantity	50
Quantity Uom	S.F.
Potential Action	REPLACE
Urgency of Action	PRIORITY 4
Purpose of Action	LEVEL 2
Deficiency Photo1

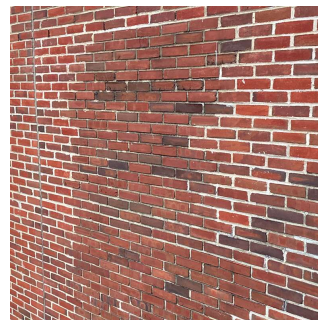
BH4
No violations recorded.

Violations	BH2 No violations recorded.
Deficiency	BULKHEAD/PENTHOUSE WALLS/EXTERIOR: DETERIORATED JOINTS

400
S.F.
REPOINT
PRIORITY 3
LEVEL 2

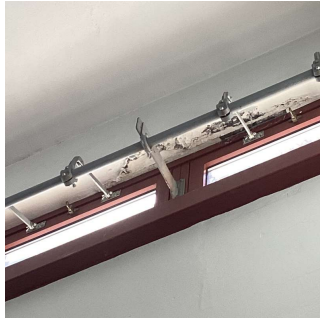
Violations	SK1 - Weight Room SK2 - Room 150 SK3 - 1st Floor Dance Studio SK4, SK5 - Room 130 (Shown) No violations recorded.
ROOF/GRAVITY TANK	Does not Exist
STAIRS/RAMPS: EXTERIOR	Inspected
BUILDING CHEEK/FLANK WALLS	Does not Exist
RAILINGS	Inspected

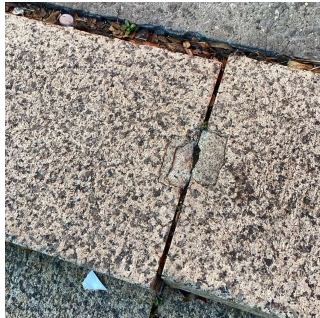
Violations	<p>Facade L</p> <p>No violations recorded.</p>
Deficiency	STONE: CRACKS/SPALLING - MINOR
Roof Plan reference	<p>K292</p>

Deficiency Quantity	10
Quantity Uom	S.F.
Potential Action	REPAIR
Urgency of Action	PRIORITY 3
Purpose of Action	LEVEL 2

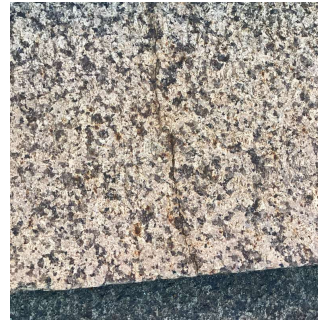
Facade L

STONE: DETERIORATED JOINTS

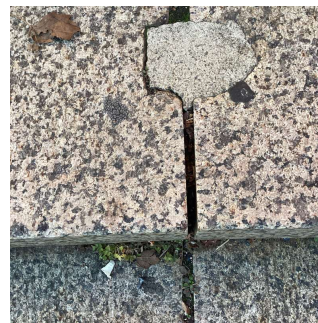
Facade L

STONE: CRACKS/SPALLING - MAJOR

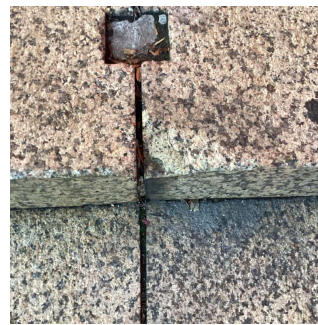
CONCRETE: CRACKS/SPALLING - MAJOR

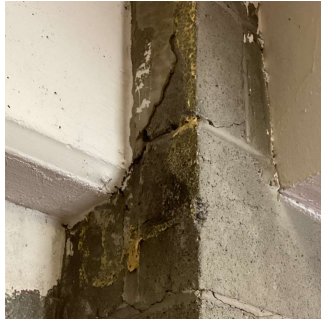
Violations	Basement - Room B2 No violations recorded.
Deficiency	STEEL COLUMNS/BEAMS: DETERIORATED MASONRY FIREPROOFING
Deficiency Location/Instance	BH2
Deficiency Quantity	20
Quantity Uom	S.F.
Potential Action	REPLACE
Urgency of Action	PRIORITY 4
Purpose of Action	LEVEL 5
Deficiency Photo1

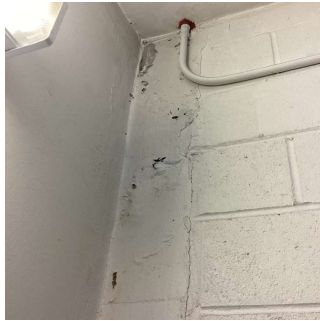
Violations	Basement - Hallway at stair D No violations recorded.
ROOF STRUCTURE	Inspected
Condition	3 - Fair
Deficiency	STEEL COLUMNS/BEAMS: DETERIORATED CONCRETE FIREPROOFING
Deficiency Location/Instance	SK1
Deficiency Quantity	10
Quantity Uom	S.F.
Potential Action	REPLACE
Urgency of Action	PRIORITY 3
Purpose of Action	LEVEL 5
Deficiency Photo1

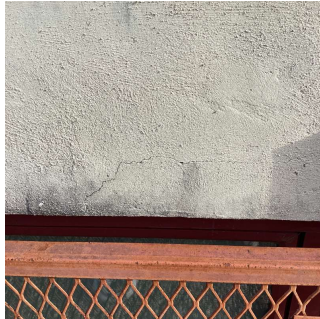
Violations	SK1 No violations recorded.
Deficiency	STEEL COLUMNS/BEAMS: DETERIORATED CONCRETE FIREPROOFING
Deficiency Location/Instance	BH1, BH2, SK4, SK5, SK1
Deficiency Quantity	70
Quantity Uom	S.F.
Potential Action	REPLACE
Urgency of Action	PRIORITY 4
Purpose of Action	LEVEL 5

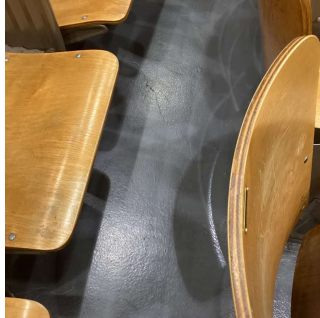
Violations	Near Row F No violations recorded.
Deficiency	SHEET VINYL: BROKEN/DETERIORATED
Deficiency Location/Instance	Near Right and Left Main Entrance, Right, Left and Center Side and others
Deficiency Quantity	200
Quantity Uom	S.F.
Potential Action	REPLACE
Urgency of Action	PRIORITY 3
Purpose of Action	LEVEL 2
Deficiency Photo1

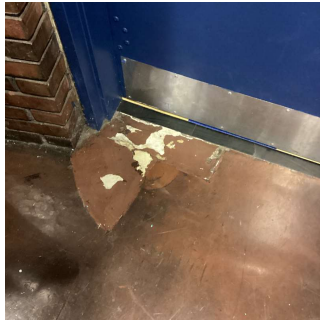
Violations	Near Left Main Entrance No violations recorded.
Sliding-folding Partition	
Instance on 1st Floor (600 Seats)	Does not Exist
Stage	
Instance on 1st Floor (600 Seats)	Inspected
Stage	
Instance on 1st Floor (600 Seats)	Inspected
Condition	3 - Fair
Deficiency	DAMAGED FLOOR
Deficiency Location/Instance	Right, Center and Left Side
Deficiency Quantity	80
Quantity Uom	S.F.
Potential Action	REPLACE
Urgency of Action	PRIORITY 3
Purpose of Action	LEVEL 2

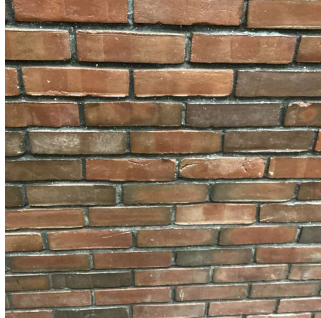
Violations	Left Side No violations recorded.
Deficiency	MASONRY: CRACKS/SPALLING
Deficiency Location/Instance	Right and Left Side Stage
Deficiency Quantity	20
Quantity Uom	S.F.
Potential Action	REPLACE
Urgency of Action	PRIORITY 3
Purpose of Action	LEVEL 2
Deficiency Photo1

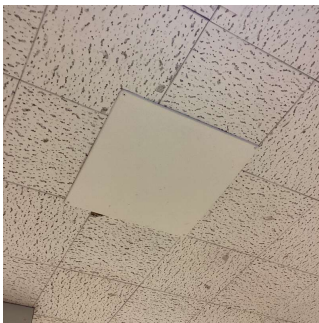
Violations	Center No violations recorded.
Instance on 1st Floor - Staff (800 SF)	Inspected
Condition	3 - Fair
Deficiency	ACOUSTIC TILES ON PLASTER: DAMAGED/MISSING
Deficiency Location/Instance	Near Served, By Main Entrance
Deficiency Quantity	30
Quantity Uom	S.F.
Potential Action	REPLACE
Urgency of Action	PRIORITY 3
Purpose of Action	LEVEL 2
Deficiency Photo1

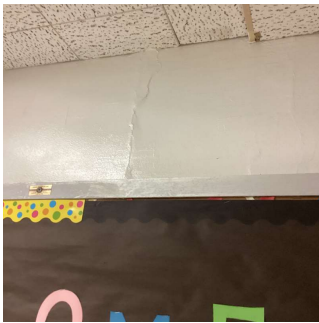
Violations	Near Servery No violations recorded.
Instance on 1st Floor - Students	Inspected
Condition	2 - Between Good and Fair
Deficiency	PLASTER: CRACKS/SPALLING
Deficiency Location/Instance	Near Windows
Deficiency Quantity	10
Quantity Uom	S.F.
Potential Action	REPLACE
Urgency of Action	PRIORITY 3
Purpose of Action	LEVEL 2
Deficiency Photo1

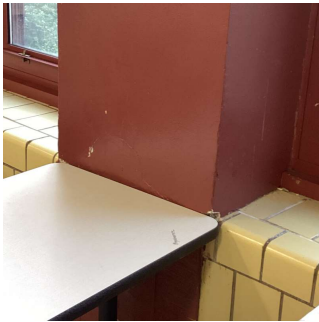
Violations	Near Windows No violations recorded.
Deficiency	GLAZED BLOCK: CRACKS/SPALLING
Deficiency Location/Instance	Columns, Near Right Drinking Fountain, By Windows
Deficiency Quantity	50
Quantity Uom	S.F.
Potential Action	REPLACE
Urgency of Action	PRIORITY 3
Purpose of Action	LEVEL 2
Deficiency Photo1

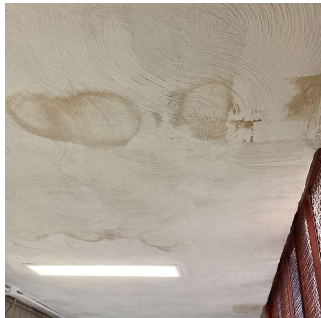
Violations	Corridor near Room 305 No violations recorded.
Deficiency	GYPSON BOARD: DAMAGED/DETERIORATED
Deficiency Location/Instance	Room 421
Deficiency Quantity	10
Quantity Uom	S.F.
Potential Action	REPLACE
Urgency of Action	PRIORITY 3
Purpose of Action	LEVEL 2

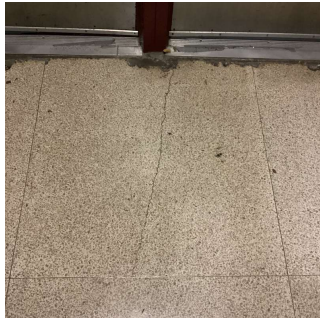
Violations	Exit 7 - Vestibule No violations recorded.
Deficiency	VINYL TILES: DETERIORATED SUBSTRATE
Deficiency Location/Instance	Corridor near Rooms 104, 105, 419, By Exit 1 - Vestibule, next to Stair B/4 and others
Deficiency Quantity	1,500
Quantity Uom	S.F.
Potential Action	REPLACE
Urgency of Action	PRIORITY 3
Purpose of Action	LEVEL 2
Deficiency Photo1	 
Violations	Corridor near Room 104 No violations recorded.
Deficiency	VINYL TILES: BROKEN/DETERIORATED/MISSING TILES
Deficiency Location/Instance	Rooms 419, 326, 319, Corridor near Rooms 333, 331 and others

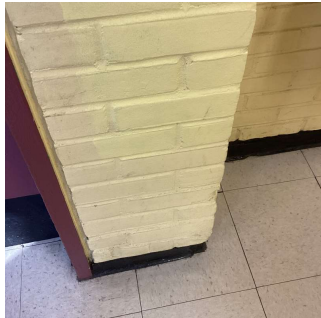
Violations	Corridor near Room 105 No violations recorded.
Deficiency	GLAZED BLOCK: CRACKS/SPALLING
Deficiency Location/Instance	Corridor near Stair C/4, by Rooms 292, 219
Deficiency Quantity	30
Quantity Uom	S.F.
Potential Action	REPLACE
Urgency of Action	PRIORITY 3
Purpose of Action	LEVEL 2
Deficiency Photo1

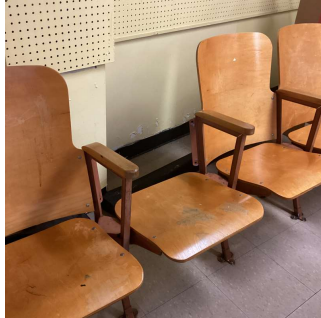
Seat D/5
Violations	No violations recorded.
Deficiency	DAMAGED/BROKEN/INOPERABLE
Deficiency Location/Instance	Seats A/1, 3, 5, 7, B/9 and others (62 Seats)
Deficiency Quantity	19
Quantity Uom	EACH
Potential Action	REPLACE
Urgency of Action	PRIORITY 3
Purpose of Action	LEVEL 2
Deficiency Photo1

Violations	Corridor near Stair C/4 No violations recorded.
Specialties	Inspected
Classroom Locker(s)	Inspected
Condition	2 - Between Good and Fair
Deficiency	No deficiencies recorded
Fixed Seating	Inspected
Condition	5 - Poor
Deficiency	DAMAGED/BROKEN/INOPERABLE

Deficiency Location/Instance	Seats A/2, D/5

Question	Response
INTERIOR	
CLASSROOMS/CORRIDORS/ADMIN SPACES	
Specialties	
Fixed Seating	
Deficiency Quantity	2
Quantity Uom	EACH
Potential Action	REPLACE
Urgency of Action	PRIORITY 5
Purpose of Action	LEVEL 6
Deficiency Photo1

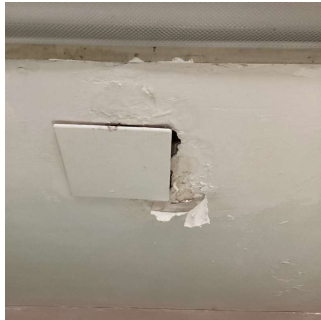
Question	Response
INTERIOR	
KITCHEN	
Ceiling	
Condition	2 - Between Good and Fair
Deficiency	PLASTER: CRACKS/SPALLING
Deficiency Location/Instance	Office Room
Deficiency Quantity	10
Quantity Uom	S.F.
Potential Action	REPLACE
Urgency of Action	PRIORITY 3
Purpose of Action	LEVEL 2
Deficiency Photo1

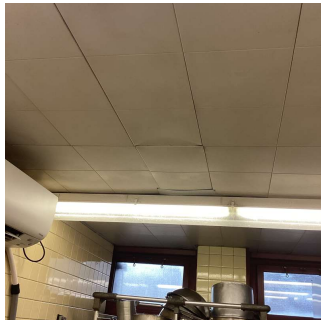
Violations	Office Room No violations recorded.
Deficiency	METAL PAN: DAMAGED/MISSING
Deficiency Location/Instance	Near Sink, close to Office Room
Deficiency Quantity	20
Quantity Uom	S.F.
Potential Action	REPLACE
Urgency of Action	PRIORITY 3
Purpose of Action	LEVEL 2
Deficiency Photo1

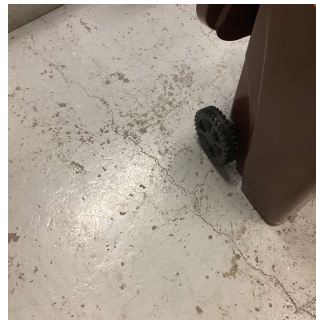
Big Storage Room

Floor Finish

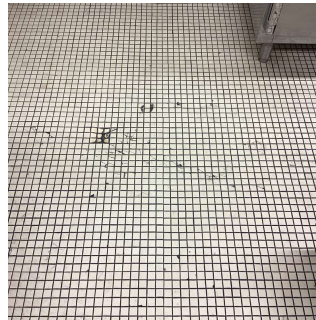
Near Sink

CERAMIC TILE: BROKEN/MISSING TILES

REPLACE

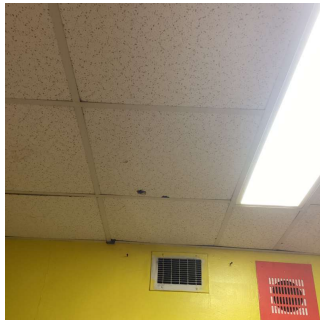
Question	Response
INTERIOR	
KITCHEN	Inspected
Walls	
Violations	No violations recorded.
LIBRARY	Inspected
Instance on Room 112	Inspected
Built-in Furnishing	
Instance on Room 112	Inspected
Condition	2 - Between Good and Fair
Deficiency	SINK/STORAGE CABINET - DAMAGED/DETERIORATED
Deficiency Location/Instance	Room 112B
Deficiency Quantity	12
Quantity Uom	L.F.
Potential Action	REPLACE
Urgency of Action	PRIORITY 3
Purpose of Action	LEVEL 2
Deficiency Photo1	 
Violations	Room 112B No violations recorded.
Ceiling	
Instance on Room 112	Inspected
Condition	2 - Between Good and Fair
Deficiency	ACOUSTIC TILES: DAMAGED/MISSING
Deficiency Location/Instance	Rooms 112A, 112B
Deficiency Quantity	20
Quantity Uom	S.F.
Potential Action	REPLACE
Urgency of Action	PRIORITY 3
Purpose of Action	LEVEL 2
Deficiency Photo1

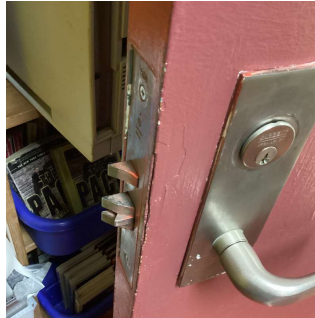
Question	Response
INTERIOR	
LIBRARY	Inspected
Door(s)	
Condition	3 - Fair
Deficiency	WOOD: DETERIORATED DOOR
Deficiency Location/Instance	Room 112A
Deficiency Quantity	1
Quantity Uom	EACH
Potential Action	MAINTENANCE
Urgency of Action	PRIORITY 3
Purpose of Action	LEVEL 2
Deficiency Photo1

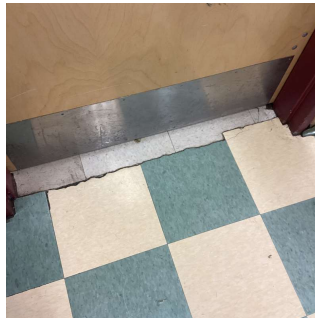
Violations	Room 112A No violations recorded.
Floor Finish	
Instance on Room 112	Inspected
Condition	3 - Fair
Deficiency	VINYL TILES: BROKEN/DETERIORATED/MISSING TILES
Deficiency Location/Instance	Main Entrance, near Room 112A, By Windows
Deficiency Quantity	30
Quantity Uom	S.F.
Potential Action	REPLACE
Urgency of Action	PRIORITY 3
Purpose of Action	LEVEL 2
Deficiency Photo1

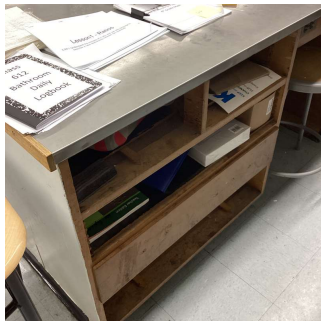
Question	Response
INTERIOR	
LIBRARY	Inspected
Walls	
Deficiency Photo1	 
Violations	Near Room 112B No violations recorded.
LOCKER ROOM	Inspected
Instance on 1st Floor - Boys (44 Lockers)	Inaccessible
Instance on 1st Floor - Girls (130 Lockers)	Inaccessible
MULTI-PURPOSE ROOM	Does not Exist
SCIENCE DEMO ROOM	Inspected
Instance on Rooms 322, 326	Inspected
Alternative use	No
Fixed Equipment	
Instance on Rooms 322, 326	Inspected
Condition	4 - Between Fair and Poor
Deficiency	CABINETRY: MISSING/DAMAGED
Deficiency Location/Instance	Rooms 322, 326
Deficiency Quantity	20
Quantity Uom	L.F.
Potential Action	REPLACE
Urgency of Action	PRIORITY 3
Purpose of Action	LEVEL 2
Deficiency Photo1

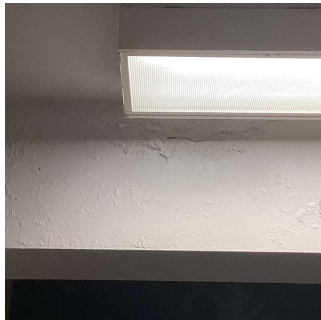
Question	Response
INTERIOR	
SCIENCE LAB	
Fixed Equipment	
Deficiency Location/Instance	Rooms 303, 319
Deficiency Quantity	23
Quantity Uom	L.F.
Potential Action	REPLACE
Urgency of Action	PRIORITY 3
Purpose of Action	LEVEL 2
Deficiency Photo1	No photo recorded
Violations	No violations recorded.
SCIENCE PREP ROOM	
Does not Exist	
SHOWER ROOM	
Does not Exist	
STAIRS/RAMPS: INTERIOR	
Inspected	
Do Letter Stair Signs Exist?	Yes
Ceiling	
Inspected	
Condition	2 - Between Good and Fair
Deficiency	PLASTER: CRACKS/SPALLING - ACTIVE LEAK
Deficiency Location/Instance	Stair C/4
Deficiency Quantity	10
Quantity Uom	S.F.
Potential Action	REPLACE
Urgency of Action	PRIORITY 5
Purpose of Action	LEVEL 2
Deficiency Photo1

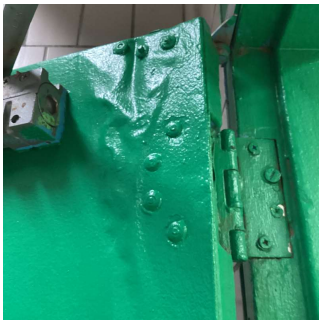
Violations	Stair C/4 No violations recorded.
Door(s)	
Inspected	
Condition	3 - Fair
Deficiency	METAL: DETERIORATED DOOR
Deficiency Location/Instance	Stairs A/4, D/1
Deficiency Quantity	2
Quantity Uom	EACH
Potential Action	MAINTENANCE

Urgency of Action	PRIORITY 3
Purpose of Action	LEVEL 2

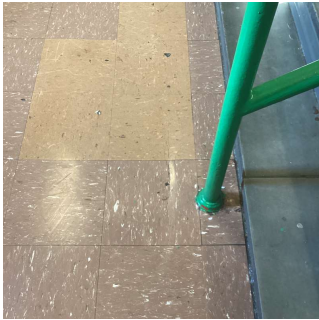
Violations	Stair D/1 No violations recorded.
Partition	Does not Exist
Railings	Inspected
Condition	2 - Between Good and Fair
Deficiency	No deficiencies recorded
Stairs and Landings	Inspected
Condition	3 - Fair
Deficiency	VINYL TILES: BROKEN/DETERIORATED/MISSING TILES
Deficiency Location/Instance	Stairs A/Bulkhead, 4, B/4, C/4, D/4 and others
Deficiency Quantity	120
Quantity Uom	S.F.
Potential Action	REPLACE
Urgency of Action	PRIORITY 3
Purpose of Action	LEVEL 2
Deficiency Photo1

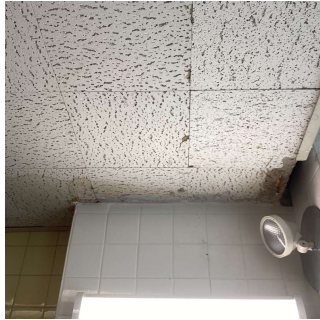
Question	Response
INTERIOR	
STAIRS/RAMPS: INTERIOR	Inspected
Walls	Inspected
	Stair D/4
Violations	No violations recorded.
TOILET ROOMS - STAFF	Inspected
Ceiling	Inspected
Condition	3 - Fair
Deficiency	ACOUSTIC TILES ON PLASTER: DAMAGED/MISSING
Deficiency Location/Instance	Woman Toilet Room - 2nd Floor
Deficiency Quantity	20
Quantity Uom	S.F.
Potential Action	REPLACE
Urgency of Action	PRIORITY 3
Purpose of Action	LEVEL 2
Deficiency Photo1

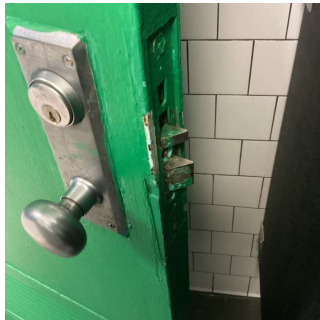
Room 425
Violations	No violations recorded.
Floor Finish	Inspected
Condition	5 - Poor

Woman Toilet Room - 2nd Floor
Violations	No violations recorded.
Door(s)	Inspected
Condition	5 - Poor
Deficiency	WOOD: DETERIORATED DOOR
Deficiency Location/Instance	Rooms 424, 425, In Kitchen Locker Room, Men Toilet Room - 1st Floor, Women Toilet Room - 1st Floor
Deficiency Quantity	5
Quantity Uom	EACH
Potential Action	MAINTENANCE
Urgency of Action	PRIORITY 3
Purpose of Action	LEVEL 2
Deficiency Photo1

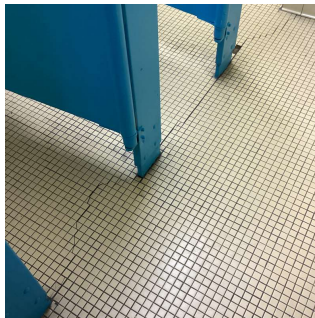
Deficiency	CERAMIC TILE: DETERIORATED SUBSTRATE

Question	Response
INTERIOR	
TOILET ROOMS - STAFF	Inspected
Floor Finish	
Deficiency Location/Instance	In Kitchen Locker Room, Rooms 324, 325, Women Toilet Room - 2nd Floor
Deficiency Quantity	60
Quantity Uom	S.F.
Potential Action	REPLACE
Urgency of Action	PRIORITY 3
Purpose of Action	LEVEL 2
Deficiency Photo1

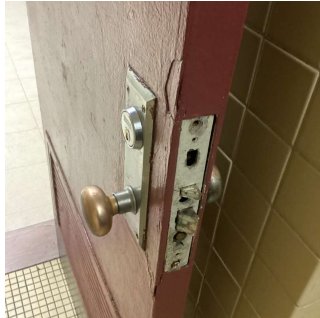
Question	Response
INTERIOR	
TOILET ROOMS - STUDENTS	
Door(s)	
	Room 420
Violations	No violations recorded.
Deficiency	WOOD: DETERIORATED DOOR
Deficiency Location/Instance	Rooms 306, 218, 208, 102, 104
Deficiency Quantity	5
Quantity Uom	EACH
Potential Action	MAINTENANCE
Urgency of Action	PRIORITY 3
Purpose of Action	LEVEL 2
Deficiency Photo1

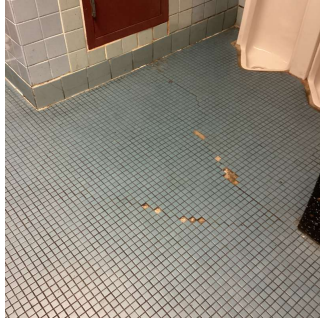
Room 102
Violations	No violations recorded.
Floor Finish	Inspected
Condition	2 - Between Good and Fair
Deficiency	CERAMIC TILE: DETERIORATED SUBSTRATE
Deficiency Location/Instance	Rooms 320, 316, 218, 208, 102 and others
Deficiency Quantity	70
Quantity Uom	S.F.
Potential Action	REPLACE
Urgency of Action	PRIORITY 3
Purpose of Action	LEVEL 2
Deficiency Photo1

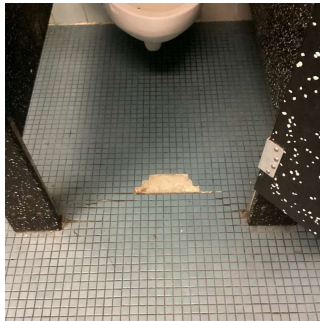
Room 102
Violations	No violations recorded.
Deficiency	CERAMIC TILE: BROKEN/MISSING TILES
Deficiency Location/Instance	Rooms 102, 104
Deficiency Quantity	20
Quantity Uom	S.F.
Potential Action	REPLACE
Urgency of Action	PRIORITY 3

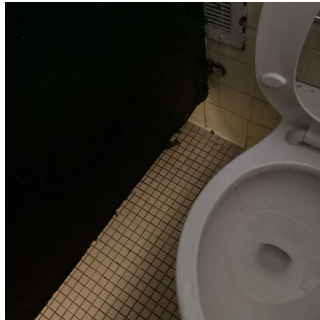
Room 104
Violations	No violations recorded.
Stalls	Inspected
Condition	5 - Poor
Deficiency	RUST - MAJOR
Deficiency Location/Instance	Rooms 102, 320
Deficiency Quantity	8
Quantity Uom	EACH
Potential Action	REPLACE
Urgency of Action	PRIORITY 3
Purpose of Action	LEVEL 2
Deficiency Photo1

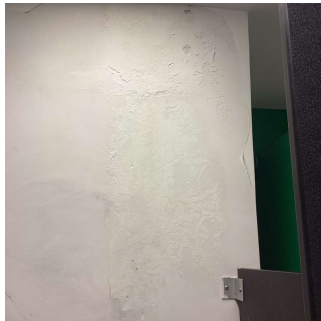
Room 102
Violations	No violations recorded.
Walls	Inspected
Condition	2 - Between Good and Fair
Deficiency	PLASTER: CRACKS/SPALLING
Deficiency Location/Instance	Room 418
Deficiency Quantity	10
Quantity Uom	S.F.
Potential Action	REPLACE
Urgency of Action	PRIORITY 3
Purpose of Action	LEVEL 2

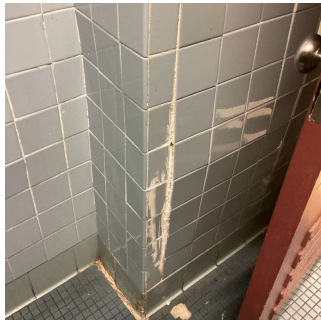
Violations	Room 418 No violations recorded.
Deficiency	CERAMIC TILE: BROKEN/ MISSING
Deficiency Location/Instance	Rooms 102, 104, 306, 316, 320 and others
Deficiency Quantity	90
Quantity Uom	S.F.
Potential Action	REPLACE
Urgency of Action	PRIORITY 3
Purpose of Action	LEVEL 2
Deficiency Photo1

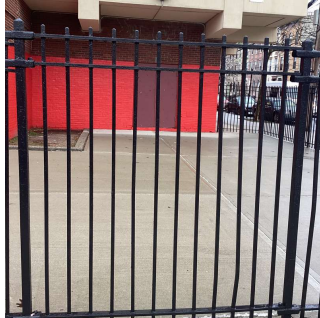
Deficiency	WROUGHT IRON: DAMAGED/DETERIORATED
Deficiency Location/Instance	Belmont Avenue, Wyona Street, Vermont Street

Question	Response
SITE	
FENCES	
Deficiency Quantity	440
Quantity Uom	S.F.
Potential Action	REPLACE
Urgency of Action	PRIORITY 3
Purpose of Action	LEVEL 2
Deficiency Photo1

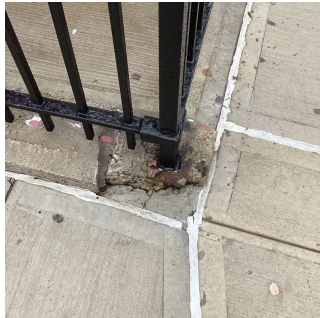
Belmont Avenue
Violations	No violations recorded.
Deficiency	CONCRETE CURB: DAMAGED/DETERIORATED
Deficiency Location/Instance	Belmont Avenue, Vermont Street
Deficiency Quantity	50
Quantity Uom	S.F.
Potential Action	REPLACE
Urgency of Action	PRIORITY 3
Purpose of Action	LEVEL 2
Deficiency Photo1

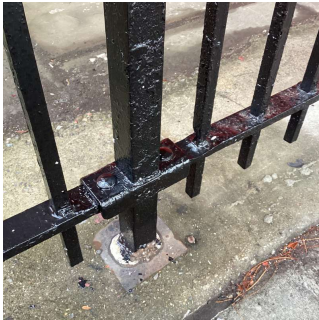
Belmont Avenue
Violations	No violations recorded.
Deficiency	WROUGHT IRON: RUST - MAJOR
Deficiency Location/Instance	Vermont Street
Deficiency Quantity	40
Quantity Uom	S.F.
Potential Action	REPLACE
Urgency of Action	PRIORITY 3
Purpose of Action	LEVEL 2

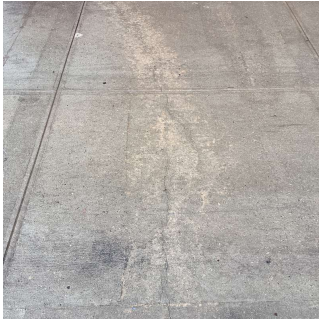
Violations	Vermont Street No violations recorded.
IRRIGATION SYSTEM	Does not Exist
PAVING	Inspected
Student Non-Use	Inspected
Gravel Exists?	No
Asphalt	Does not Exist
Concrete	Inspected
Condition	3 - Fair
Deficiency	CRACKS - MINOR
Deficiency Location/Instance	Vermont Street
Deficiency Quantity	50
Quantity Uom	S.F.
Potential Action	MAINTENANCE
Urgency of Action	PRIORITY 3
Purpose of Action	LEVEL 2
Deficiency Photo1

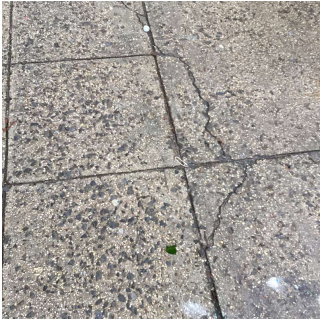
Violations	Vermont Street No violations recorded.
Deficiency	CRACKS - MAJOR
Deficiency Location/Instance	Vermont Street
Deficiency Quantity	150
Quantity Uom	S.F.
Potential Action	REPLACE
Urgency of Action	PRIORITY 3
Purpose of Action	LEVEL 2

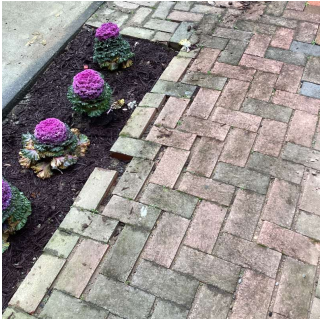
Violations	Vermont Street No violations recorded.
Pavers	Inspected
Condition	3 - Fair
Deficiency	DAMAGED/MISSING
Deficiency Location/Instance	North Courtyard
Deficiency Quantity	50
Quantity Uom	S.F.
Potential Action	REPLACE
Urgency of Action	PRIORITY 3
Purpose of Action	LEVEL 2
Deficiency Photo1

Violations	North Courtyard No violations recorded.
Student Use	Inspected
Gravel Exists?	No
Asphalt	Does not Exist
Concrete	Inspected
Condition	4 - Between Fair and Poor
Deficiency	CRACKS - MAJOR
Deficiency Location/Instance	South Courtyard
Deficiency Quantity	200
Quantity Uom	S.F.
Potential Action	REPLACE
Urgency of Action	PRIORITY 3
Purpose of Action	LEVEL 2

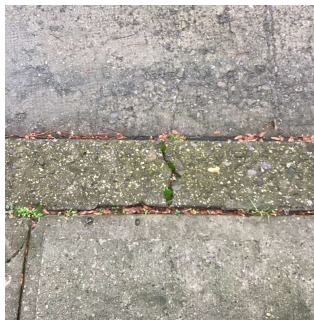
Question	Response
SITE	
PAVING	
Student Use	Inspected
Concrete	Inspected
Violations	No violations recorded.
Pavers	Does not Exist
Site Sidewalks & Walkways	Inspected
Asphalt	Does not Exist
Concrete	Inspected
Condition	3 - Fair
Deficiency	DAMAGED CURBS
Deficiency Location/Instance	Vermont Street
Deficiency Quantity	20
Quantity Uom	L.F.
Potential Action	REPLACE
Urgency of Action	PRIORITY 3
Purpose of Action	LEVEL 2
Deficiency Photo1

Violations	Vermont Street No violations recorded.
Deficiency	DAMAGED/DETERIORATED/MISSING SECTIONS
Deficiency Location/Instance	Belmont Avenue, Vermont Street
Deficiency Quantity	175
Quantity Uom	S.F.
Potential Action	REPLACE
Urgency of Action	PRIORITY 3
Purpose of Action	LEVEL 2
Deficiency Photo1

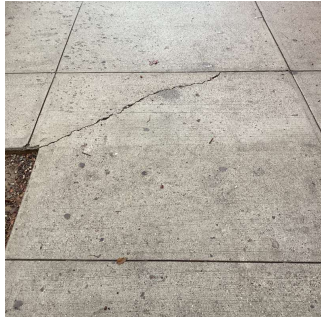
Question	Response
SITE	
PAVING	
DOT Sidewalk	
Concrete	
Deficiency Photo1

Violations	Belmont Avenue No violations recorded.
Deficiency	DAMAGED CURBS
Deficiency Location/Instance	Wyona Street, Vermont Street, Pitkin Avenue
Deficiency Quantity	100
Quantity Uom	L.F.
Potential Action	REPLACE
Urgency of Action	PRIORITY 3
Purpose of Action	LEVEL 2
Deficiency Photo1
