NYC Department of Education
Building Condition Assessment Survey 2023 - 2024

Architectural Inspection

Asset: **P.S. 308 - BROOKLYN, 616 QUINCY STREET, New York, 11221**

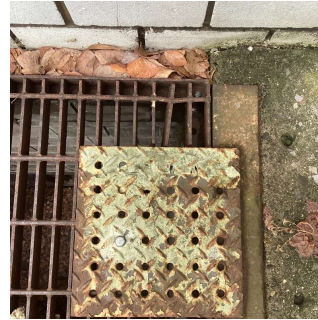
AW1

Question	Response
Architectural	
EXTERIOR	Inspected
AREAWAY	Inspected
Instance on AW1, AW2	Inspected
Instance Condition	3 - Fair
Instance Quantity	2
Instance Quantity Uom	EACH
Deficiency	AREAWAY GRATINGS: MAJOR RUSTING / OR BROKEN

REPLACE

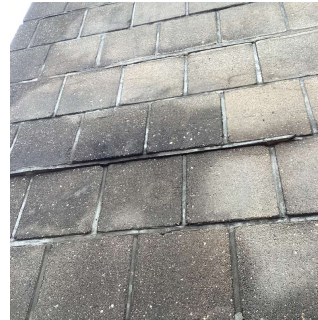
CH

CONCRETE MASONRY UNIT: DETERIORATED JOINTS

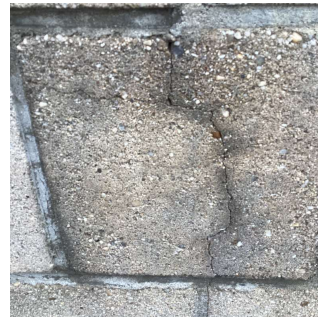
CH

CONCRETE MASONRY UNIT: MINOR CRACKS, SPALLING

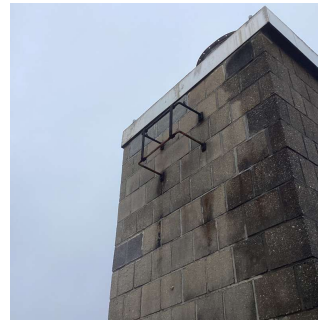
CH

CONCRETE MASONRY UNIT: DETERIORATED LADDER

REPLACE

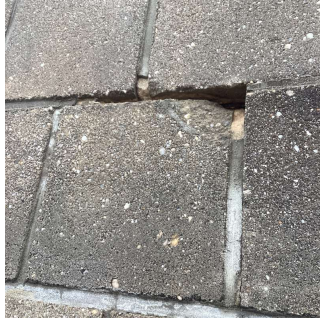
CONCRETE MASONRY UNIT: MAJOR / THRU CRACKS

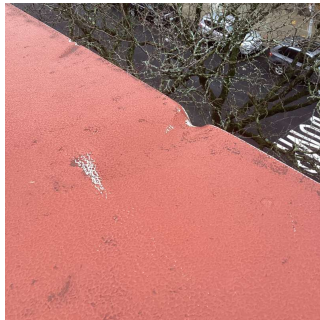
Violations	CH No violations recorded.
COPING	Inspected
Condition	4 - Between Fair and Poor
Deficiency	METAL: DETERIORATED
Roof Plan reference	K308

Deficiency Quantity	10
Quantity Uom	L.F.
Potential Action	REPLACE-IN-KIND
Urgency of Action	PRIORITY 4
Purpose of Action	LEVEL 2
Deficiency Photo1

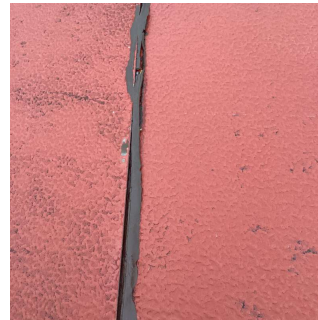
Violations	Roof 1 No violations recorded.
Deficiency	METAL: DETERIORATED TRANSVERSE JOINTS

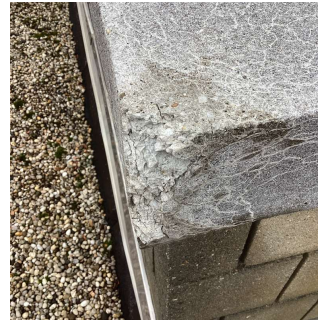
Roof 1

CAST STONE: CRACKED/BROKEN PIECES

REPLACE-IN-KIND

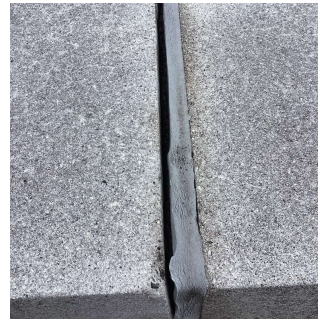
Roof 1

CAST STONE: DETERIORATED TRANSVERSE JOINTS

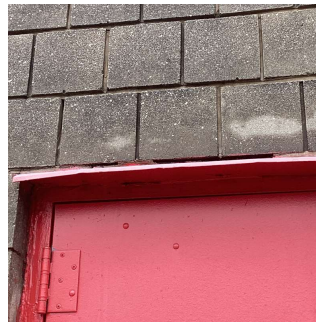
Facade B - Exit 2

Violations	<p>Roof 1</p> <p>No violations recorded.</p>
CORNICE	Does not Exist
DOORS	Inspected
DOORS AND FRAMES	Inspected
Condition	5 - Poor
Deficiency	METAL CLAD: AIR/WATER INFILTRATION, DETERIORATED JOINTS WITH DAMAGED CAULKING
Roof Plan reference

Deficiency Quantity	10
Quantity Uom	L.F.
Potential Action	MAINTENANCE
Urgency of Action	PRIORITY 3
Purpose of Action	LEVEL 2

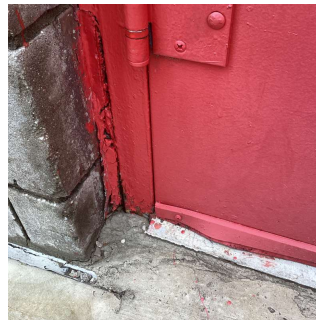
Facade B

METAL CLAD: DETERIORATED DOOR AND FRAME - MINOR DETERIORATION

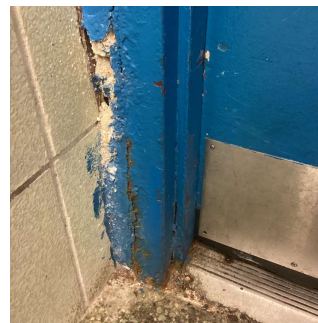
Facade A

METAL CLAD: DETERIORATED DOOR AND FRAME - MAJOR DETERIORATION

REPLACE

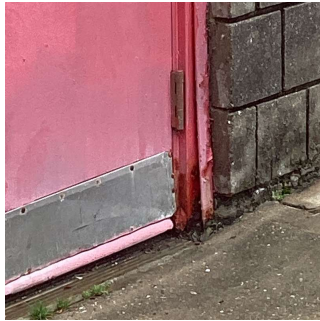
METAL: DETERIORATED DOOR AND FRAME - MAJOR DETERIORATION

REPLACE

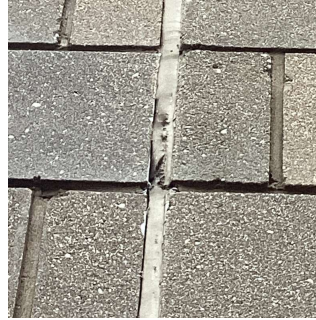
Facade A

CONCRETE MASONRY UNIT: DETERIORATED
CONTROL/EXPANSION JOINTS

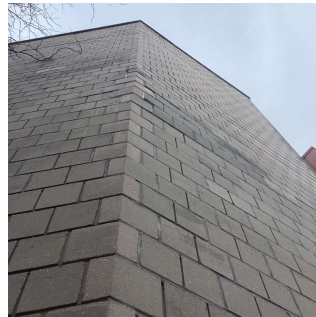
Facade C

CONCRETE MASONRY UNIT: BULGING

REPLACE-IN-KIND

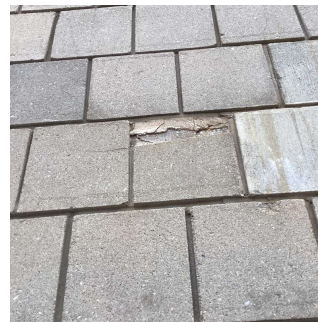
Facade C

CONCRETE MASONRY UNIT: MAJOR / THRU CRACKS

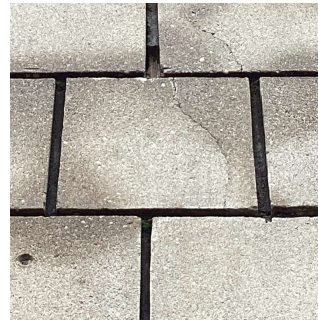
Facade B

CONCRETE MASONRY UNIT: MINOR CRACKS AND SPALLING

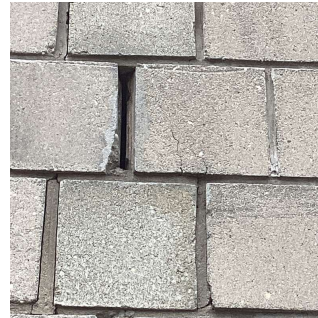
Facade C

CONCRETE MASONRY UNIT: DETERIORATED JOINTS

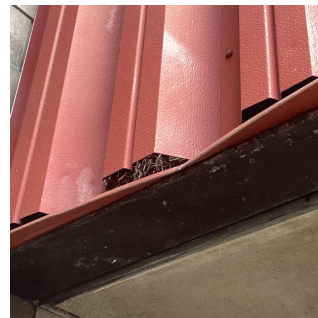
Facade C

METAL PANEL: DAMAGED TRIM

REPLACE

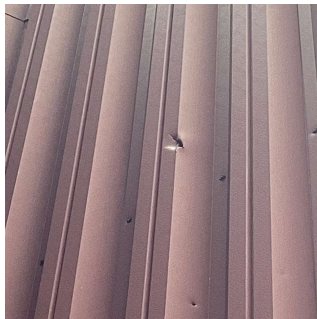
Question	Response
EXTERIOR	
EXTERIOR WALLS	
Violations	No violations recorded.
Deficiency	METAL PANEL: SEVERE DENTS
Roof Plan reference	<p>K308</p>

Deficiency Quantity	20
Quantity Uom	S.F.
Potential Action	REPLACE
Urgency of Action	PRIORITY 4
Purpose of Action	LEVEL 2
Deficiency Photo1

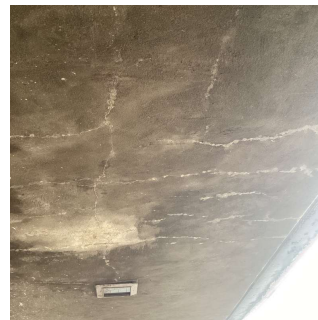
Facade C

<p>Facade C</p>
Violations	No violations recorded.
EXTERIOR SOFFITS	
Condition	Inspected
Deficiency	STUCCO/PLASTER: MINOR CRACKS/SPALLING

REPAIR

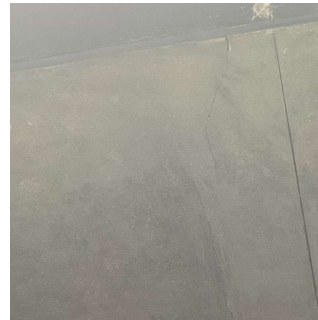
Facade A

STUCCO/PLASTER: MAJOR CRACKS/SPALLING

REPLACE

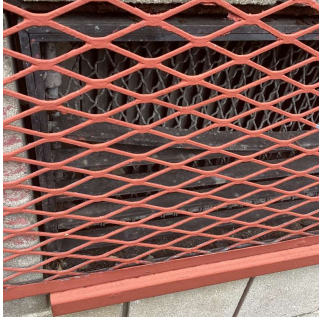
Question	Response
EXTERIOR	
LOUVER	
Deficiency Quantity	20
Quantity Uom	S.F.
Potential Action	REPLACE
Urgency of Action	PRIORITY 4
Purpose of Action	LEVEL 2
Deficiency Photo1

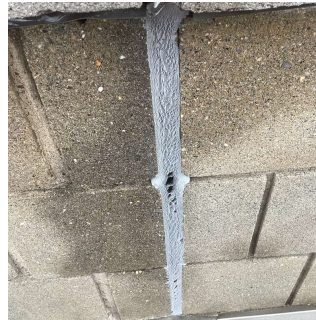
Roof 1

**CONCRETE MASONRY UNITS: MAJOR
 DETERIORATION/CRACKS**

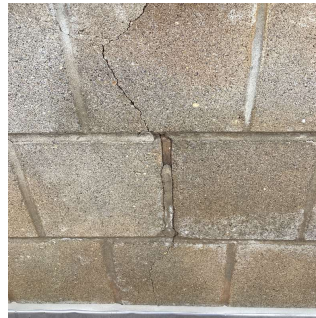
Roof 1

CONCRETE MASONRY UNITS: MINOR CRACKS, SPALLING

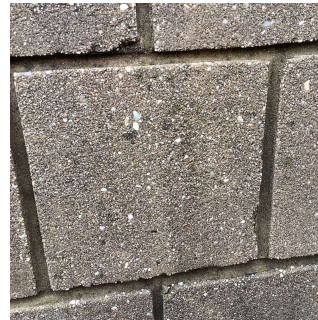
Roof 1

CONCRETE MASONRY UNITS: DETERIORATED JOINTS

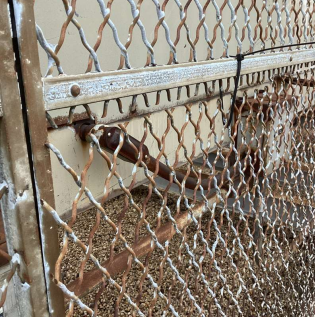
Question	Response
EXTERIOR	
ROOF	
Roofing	
ROOF BARRIER/FENCE	
Deficiency	RAILINGS/PANELS: DETERIORATED, MAJOR RUSTING
Roof Plan reference	<div> <div>K308</div>

</div>
Deficiency Quantity	25
Quantity Uom	S.F.
Potential Action	REPLACE
Urgency of Action	PRIORITY 4
Purpose of Action	LEVEL 2
Deficiency Photo1

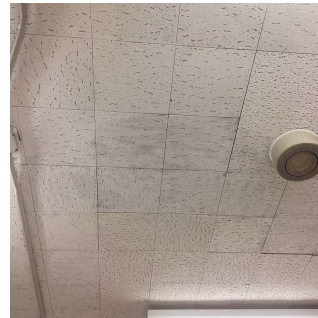
Roof 2 - Corridor near Room 182

BUILT-UP: ROOFING: MAJOR ACTIVE ROOF LEAKS IN INSTRUCTIONAL SPACE

REPLACE ROOFING WITHOUT MAJOR EQUIPMENT REMOVAL

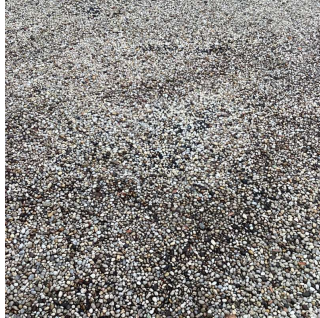
Violations	Roof 1 No violations recorded.
Deficiency	BUILT-UP: ROOFING: LOSS OF GRAVEL
Roof Plan reference	K308

Deficiency Quantity	90
Quantity Uom	S.F.
Potential Action	INSTALL NEW GRAVEL
Urgency of Action	PRIORITY 3
Purpose of Action	LEVEL 2
Deficiency Photo1

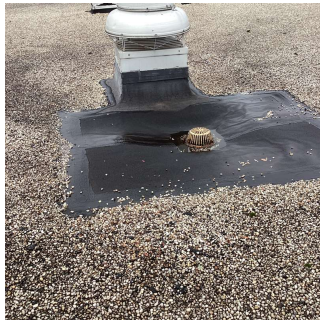
Violations	Roof 1 No violations recorded.
Deficiency	BUILT-UP: FLASHING: PITCH POCKET DETERIORATED - MINOR

Deficiency Quantity	1
Quantity Uom	EACH
Potential Action	REPAIR
Urgency of Action	PRIORITY 3
Purpose of Action	LEVEL 2
Deficiency Photo1

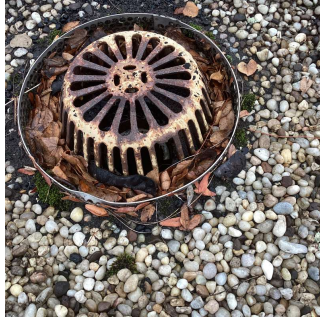
Violations	<p>Roof 3</p> <p>No violations recorded.</p>
ROOFING DRAINS	Inspected
Condition	4 - Between Fair and Poor
Deficiency	DETERIORATED
Roof Plan reference	<p>K308</p>

Deficiency Quantity	2
Quantity Uom	EACH
Potential Action	REPLACE
Urgency of Action	PRIORITY 4
Purpose of Action	LEVEL 2

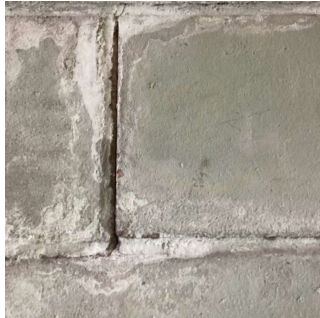
Violations	Roof 1 No violations recorded.
Specialties	Inspected
BULKHEAD/PENTHOUSE	Inspected
Condition	3 - Fair
Deficiency	BULKHEAD/PENTHOUSE WALLS/INTERIOR: CMU DETERIORATED JOINTS
Roof Plan reference	<p>K308</p>

Deficiency Quantity	30
Quantity Uom	S.F.
Potential Action	REPOINT
Urgency of Action	PRIORITY 3
Purpose of Action	LEVEL 2
Deficiency Photo1

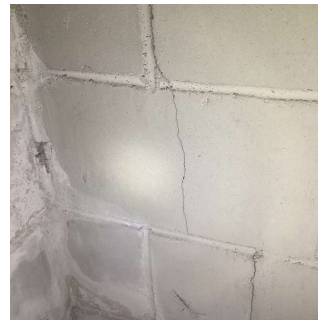
BH2
No violations recorded.

Violations	BH1 No violations recorded.
Deficiency	BULKHEAD/PENTHOUSE WALLS/INTERIOR: CMU CRACKS/SPALLING

20
S.F.
REPLACE
PRIORITY 3
LEVEL 2

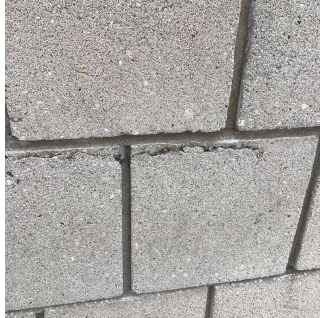
Violations	BH1 No violations recorded.
Deficiency	BULKHEAD/PENTHOUSE WALLS/EXTERIOR: CRACKS/SPALLING - MAJOR
Roof Plan reference	<p>K308 Gates Avenue</p>

<p>Quincy Street</p>
Deficiency Quantity	20
Quantity Uom	S.F.
Potential Action	REPLACE
Urgency of Action	PRIORITY 4
Purpose of Action	LEVEL 2
Deficiency Photo1

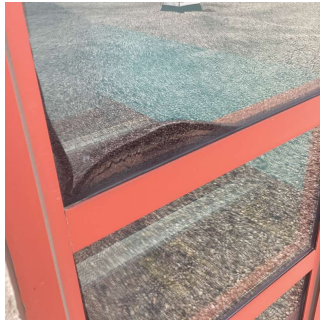
Violations	Roof 5 No violations recorded.
SKYLIGHT/ROOF VENT	Inspected
Material Type(s)	Glass
Condition	3 - Fair
Deficiency	BROKEN FRAMING
Roof Plan reference	<p>K308</p>

Deficiency Quantity	40
Quantity Uom	L.F.
Potential Action	MAINTENANCE
Urgency of Action	PRIORITY 3
Purpose of Action	LEVEL 2
Deficiency Photo1

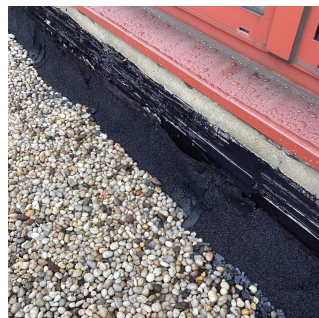
Violations	SK1 No violations recorded.
Deficiency	DAMAGED FLASHING

Deficiency Quantity	10
Quantity Uom	L.F.
Potential Action	MAINTENANCE
Urgency of Action	PRIORITY 3
Purpose of Action	LEVEL 2
Deficiency Photo1

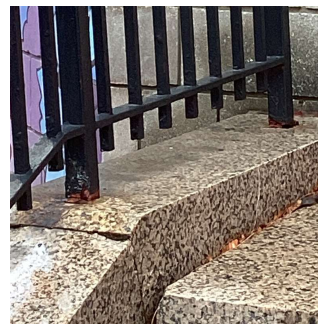
Violations	Facade D No violations recorded.
RAILINGS	Inspected
Condition	5 - Poor
Deficiency	RUST - MAJOR

10
L.F.
REPLACE
PRIORITY 4
LEVEL 2

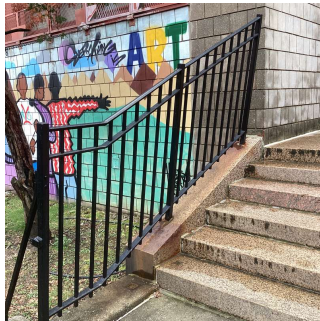
Deficiency	DAMAGED
------------	---------

25
L.F.
REPLACE
PRIORITY 4
LEVEL 2

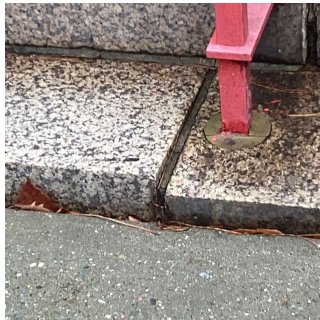
<p>Facade A</p> <p>No violations recorded.</p>
Violations	No violations recorded.
STAIRS/RAMPS	Inspected
Condition	4 - Between Fair and Poor
Deficiency	STONE: DETERIORATED SUBSTRATE
Roof Plan reference	<p>K308</p>

<p>10</p> <p>S.F.</p> <p>REPLACE SUBSTRATE AND RESET</p> <p>PRIORITY 4</p> <p>LEVEL 2</p>

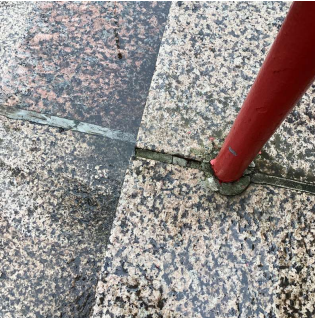
<p>Facade D</p> <p>No violations recorded.</p>
Deficiency Quantity	10
Quantity Uom	S.F.
Potential Action	REPLACE SUBSTRATE AND RESET
Urgency of Action	PRIORITY 4
Purpose of Action	LEVEL 2
Deficiency Photo1	  <p>Facade D</p> <p>No violations recorded.</p>
Violations	No violations recorded.
Deficiency	STONE: DETERIORATED JOINTS

Deficiency Quantity	10
Quantity Uom	L.F.
Potential Action	REPOINT
Urgency of Action	PRIORITY 4
Purpose of Action	LEVEL 2
Deficiency Photo1

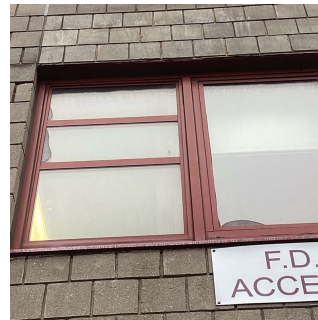
Facade C

Question	Response
EXTERIOR	
WINDOWS	
WINDOWS	
Roof Plan reference	<p>K308</p>   <p>Gates Avenue</p> <p>Quincy Street</p> <p>Lewis Avenue</p>
Elevation	 
Deficiency Quantity	30
Quantity Uom	S.F.
Potential Action	MAINTENANCE
Urgency of Action	PRIORITY 3
Purpose of Action	LEVEL 2
Deficiency Photo1	 
Violations	<p>Facade H</p> <p>No violations recorded.</p>
Instance on Aluminum - Other: All Facades	Inspected
Instance Condition	4 - Between Fair and Poor
Instance Quantity	1,000
Instance Quantity Uom	S.F.
Are these windows insulated	Yes
Installation Year	2009
Source of Installation	Custodial Staff
Deficiency	ALUMINUM - OTHER: DETERIORATED

REPLACE WINDOW

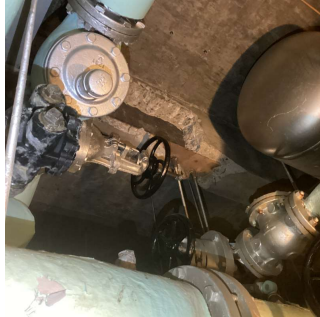
STEEL COLUMNS/BEAMS: DETERIORATED CONCRETE
FIREPROOFING

Basement - Room B13
Violations	No violations recorded.
FLOOR STRUCTURE	
Condition	Inspected
Deficiency	3 - Fair
Deficiency Location/Instance	CONCRETE SLAB ON GRADE: THRU CRACKS
	Basement - Gas Meters Room, Corridor near Room B15, Room B15, Room B13, Room B12, Room B5, Crawlspace
Deficiency Quantity	80
Quantity Uom	S.F.
Potential Action	REPLACE
Urgency of Action	PRIORITY 4
Purpose of Action	LEVEL 5
Deficiency Photo1

REPLACE

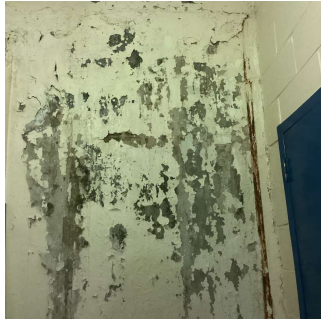
Question	Response
INTERIOR	
STRUCTURAL	
FOUNDATION WALLS	
Deficiency Photo1	 
Violations	Basement - Corridor near Electrical Equipment Room No violations recorded.
Deficiency	CONCRETE: CRACKED/SPALLED/REINFORCEMENT EXPOSED
Deficiency Location/Instance	Basement - Corridor near Stair A, Boiler Room
Deficiency Quantity	70
Quantity Uom	S.F.
Potential Action	REPAIR
Urgency of Action	PRIORITY 4
Purpose of Action	LEVEL 5
Deficiency Photo1

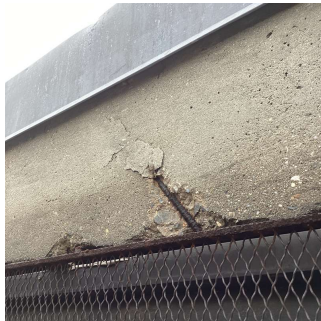
Violations	Basement - Corridor near Stair A No violations recorded.
ROOF STRUCTURE	Inspected
Condition	3 - Fair
Deficiency	CONCRETE: CRACKED/SPALLED/REINFORCEMENT EXPOSED
Deficiency Location/Instance	Roof 2 - PH
Deficiency Quantity	15
Quantity Uom	S.F.
Potential Action	REPAIR
Urgency of Action	PRIORITY 4
Purpose of Action	LEVEL 5

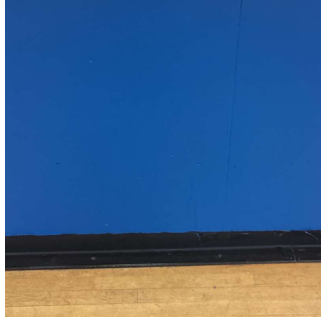
Violations	Front No violations recorded.
Stage Curtain Rigging	Inspected
Instance on 1st Floor (275 Seats)	Inspected
Condition	3 - Fair
Deficiency	DAMAGED/DETERIORATED
Deficiency Location/Instance	Right Side
Deficiency Quantity	1
Quantity Uom	EACH
Potential Action	REPLACE
Urgency of Action	PRIORITY 3
Purpose of Action	LEVEL 2
Deficiency Photo1

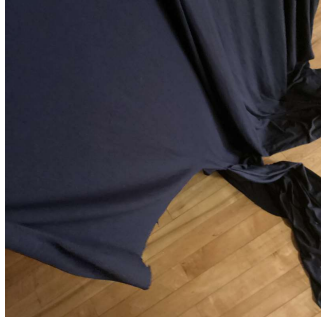
Violations	Right Side No violations recorded.
Stage Curtains	Inspected
Instance on 1st Floor (275 Seats)	Inspected
Condition	4 - Between Fair and Poor
Deficiency	WORN/DETERIORATED
Deficiency Location/Instance	Right and Left Side
Deficiency Quantity	400
Quantity Uom	S.F.
Potential Action	REPLACE
Urgency of Action	PRIORITY 3
Purpose of Action	LEVEL 2

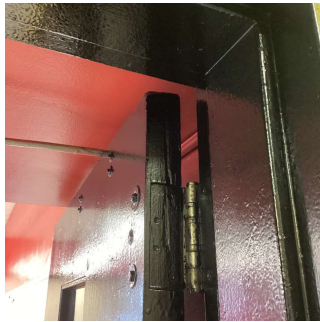
Violations	Room 321 No violations recorded.
Deficiency	WOOD: DETERIORATED DOOR
Deficiency Location/Instance	Rooms 385, 383, 380, 377, 300 and others
Deficiency Quantity	11
Quantity Uom	EACH
Potential Action	MAINTENANCE
Urgency of Action	PRIORITY 3
Purpose of Action	LEVEL 2
Deficiency Photo1

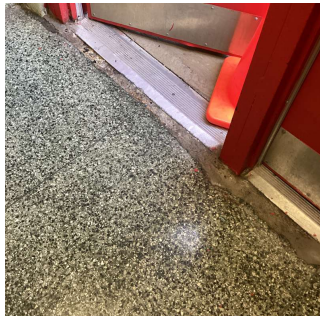
Violations	Room 385 No violations recorded.
Floor Finish	Inspected
Condition	3 - Fair
Deficiency	TERRAZZO: CRACKS
Deficiency Location/Instance	Exit 2 - Vestibule
Deficiency Quantity	10
Quantity Uom	S.F.
Potential Action	REPLACE
Urgency of Action	PRIORITY 3
Purpose of Action	LEVEL 2
Deficiency Photo1

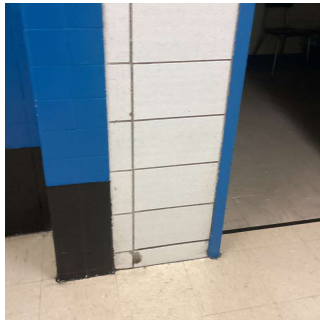
Violations	Main Entrance Lobby No violations recorded.
Deficiency	GLAZED BLOCK: CRACKS/SPALLING
Deficiency Location/Instance	Corridor near Rooms 378, 283, 279, 187, 170 and others
Deficiency Quantity	200
Quantity Uom	S.F.
Potential Action	REPLACE
Urgency of Action	PRIORITY 3
Purpose of Action	LEVEL 2
Deficiency Photo1

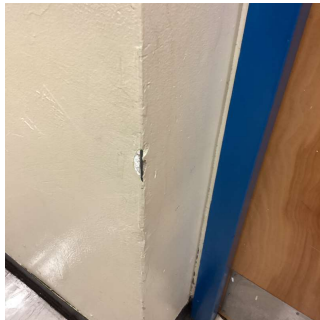
Violations	Corridor near Room 187 No violations recorded.
Deficiency	PLASTER: CRACKS/SPALLING
Deficiency Location/Instance	Rooms 122, 142, 166, Corridor near Rooms 308, 109 and others
Deficiency Quantity	80
Quantity Uom	S.F.
Potential Action	REPLACE
Urgency of Action	PRIORITY 3
Purpose of Action	LEVEL 2
Deficiency Photo1

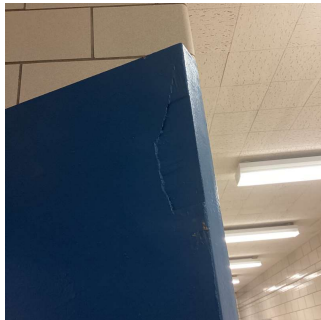
Violations	Center No violations recorded.
Door(s)	
Instance on 1st Floor	Inspected
Condition	5 - Poor
Deficiency	WOOD: DETERIORATED DOOR
Deficiency Location/Instance	Main Entrance
Deficiency Quantity	3
Quantity Uom	EACH
Potential Action	MAINTENANCE
Urgency of Action	PRIORITY 3
Purpose of Action	LEVEL 2
Deficiency Photo1

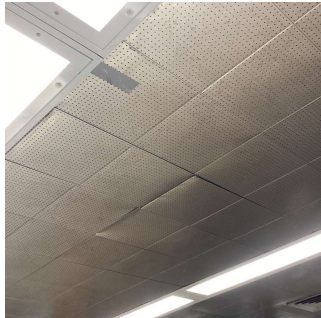
Violations	Center No violations recorded.
Instance on 1st Floor - Main	Inspected
Condition	2 - Between Good and Fair
Deficiency	METAL PAN: DAMAGED/MISSING
Deficiency Location/Instance	Preparation Area, Office Area
Deficiency Quantity	30
Quantity Uom	S.F.
Potential Action	REPLACE
Urgency of Action	PRIORITY 3
Purpose of Action	LEVEL 2
Deficiency Photo1

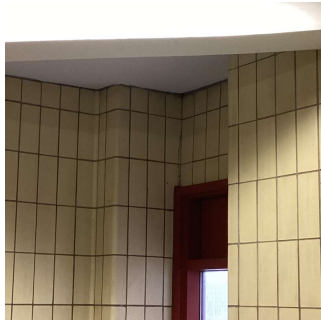
Question	Response
INTERIOR	
STAIRS/RAMPS: INTERIOR	
Walls	Inspected
Condition	2 - Between Good and Fair
Deficiency	GLAZED BLOCK: CRACKS/SPALLING
Deficiency Location/Instance	Stairs D/3, 1
Deficiency Quantity	20
Quantity Uom	S.F.
Potential Action	REPLACE
Urgency of Action	PRIORITY 3
Purpose of Action	LEVEL 2
Deficiency Photo1

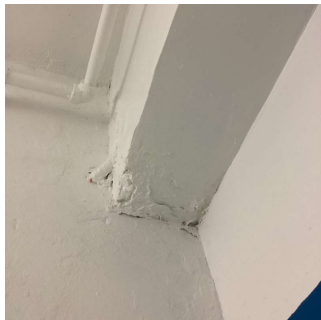
Violations	Stair D/3 No violations recorded.
TOILET ROOMS - STAFF	
Ceiling	Inspected
Condition	2 - Between Good and Fair
Deficiency	PLASTER: CRACKS/SPALLING
Deficiency Location/Instance	Room 250
Deficiency Quantity	10
Quantity Uom	S.F.
Potential Action	REPLACE
Urgency of Action	PRIORITY 3
Purpose of Action	LEVEL 2
Deficiency Photo1

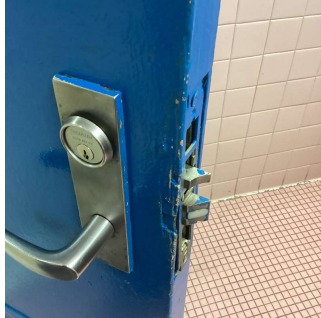
Violations	Room 250 No violations recorded.
Door(s)	Inspected
Condition	5 - Poor
Deficiency	WOOD: DETERIORATED DOOR
Deficiency Location/Instance	Rooms 181, 183, In Kitchen Locker Room
Deficiency Quantity	3
Quantity Uom	EACH
Potential Action	MAINTENANCE

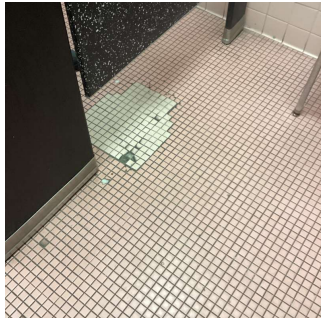
Room 183
Violations	No violations recorded.
Floor Finish	Inspected
Condition	2 - Between Good and Fair
Deficiency	CERAMIC TILE: BROKEN/MISSING TILES
Deficiency Location/Instance	Room 183
Deficiency Quantity	10
Quantity Uom	S.F.
Potential Action	REPLACE
Urgency of Action	PRIORITY 3
Purpose of Action	LEVEL 2
Deficiency Photo1

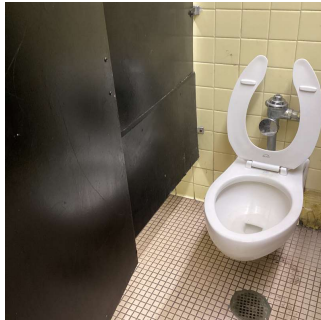
Room 387
Violations	No violations recorded.
Stalls	Inspected
Condition	4 - Between Fair and Poor
Deficiency	RUST - MAJOR
Deficiency Location/Instance	Rooms 387, 365, 325, 305
Deficiency Quantity	8
Quantity Uom	EACH
Potential Action	REPLACE
Urgency of Action	PRIORITY 3
Purpose of Action	LEVEL 2
Deficiency Photo1

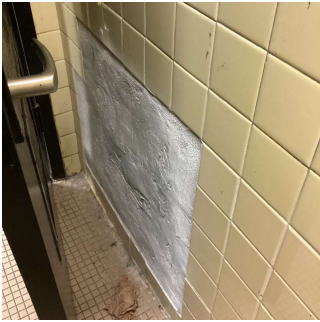
In Room 122
Violations	No violations recorded.
Deficiency	CERAMIC TILE: BROKEN/ MISSING
Deficiency Location/Instance	Rooms 387, 373, 303, 247, 245 and others
Deficiency Quantity	220
Quantity Uom	S.F.
Potential Action	REPLACE
Urgency of Action	PRIORITY 3
Purpose of Action	LEVEL 2
Deficiency Photo1

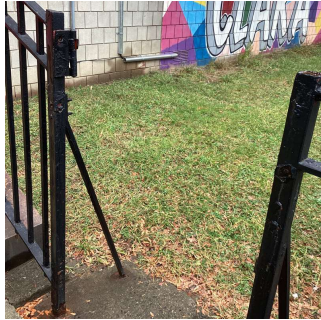
Question	Response
SITE	
FENCES	
Violations	No violations recorded.
Deficiency	WROUGHT IRON: MISSING SECTIONS
Deficiency Location/Instance	Lewis Avenue
Deficiency Quantity	40
Quantity Uom	S.F.
Potential Action	REPLACE
Urgency of Action	PRIORITY 3
Purpose of Action	LEVEL 2
Deficiency Photo1

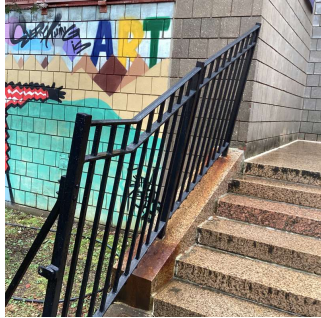
Violations	Lewis Avenue No violations recorded.
Deficiency	WROUGHT IRON: DAMAGED/DETERIORATED
Deficiency Location/Instance	Near Main Entrance, Lewis Avenue, Gates Avenue
Deficiency Quantity	40
Quantity Uom	S.F.
Potential Action	REPLACE
Urgency of Action	PRIORITY 5
Purpose of Action	LEVEL 6
Deficiency Photo1

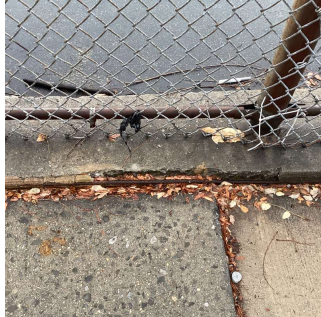
Question	Response
SITE	
FENCES	
Deficiency Location/Instance	Quincy Street, near Containerization, Lewis Avenue, Gates Avenue, Schoolyard
Deficiency Quantity	250
Quantity Uom	S.F.
Potential Action	REPLACE
Urgency of Action	PRIORITY 3
Purpose of Action	LEVEL 2
Deficiency Photo1

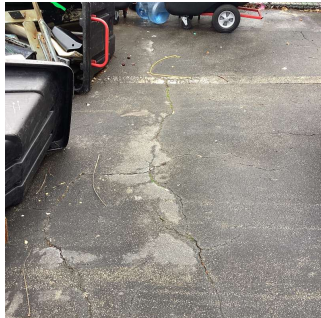
Violations	Quincy Street No violations recorded.
IRRIGATION SYSTEM	Does not Exist
PAVING	Inspected
Student Non-Use	Inspected
Gravel Exists?	No
Asphalt	Inspected
Condition	3 - Fair
Deficiency	CRACKS - MAJOR
Deficiency Location/Instance	Quincy Street
Deficiency Quantity	100
Quantity Uom	S.F.
Potential Action	REPLACE
Urgency of Action	PRIORITY 3
Purpose of Action	LEVEL 2
Deficiency Photo1

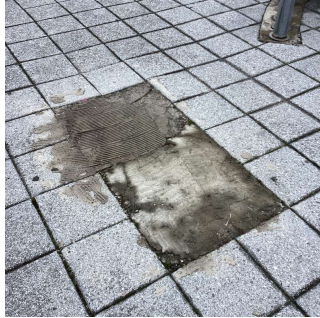
Question	Response
SITE	
PAVING	
Student Non-Use	
Concrete	
Potential Action	REPLACE
Urgency of Action	PRIORITY 3
Purpose of Action	LEVEL 2
Deficiency Photo1	 
Violations	Near Containers No violations recorded.
Pavers	Does not Exist
Student Use	Inspected
Gravel Exists?	No
Asphalt	Inspected
Condition	4 - Between Fair and Poor
Deficiency	CRACKS - MAJOR
Deficiency Location/Instance	Schoolyard
Deficiency Quantity	4,200
Quantity Uom	S.F.
Potential Action	REPLACE
Urgency of Action	PRIORITY 3
Purpose of Action	LEVEL 2
Deficiency Photo1	 
Violations	Schoolyard No violations recorded.
Concrete	Inspected
Condition	2 - Between Good and Fair
Deficiency	No deficiencies recorded
Pavers	Inspected
Condition	3 - Fair
Deficiency	DAMAGED/MISSING
Deficiency Location/Instance	Schoolyard
Deficiency Quantity	150
Quantity Uom	S.F.

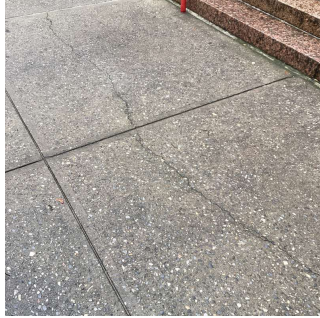
Schoolyard
Violations	No violations recorded.
Site Sidewalks & Walkways	Inspected
Asphalt	Does not Exist
Concrete	Inspected
Condition	3 - Fair
Deficiency	DAMAGED/DETERIORATED/MISSING SECTIONS
Deficiency Location/Instance	Quincy Street, Lewis Avenue, Gates Avenue, near Schoolyard
Deficiency Quantity	450
Quantity Uom	S.F.
Potential Action	REPLACE
Urgency of Action	PRIORITY 3
Purpose of Action	LEVEL 2
Deficiency Photo1

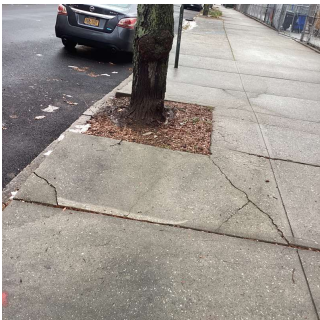
Quincy Street
Violations	No violations recorded.
Pavers	Does not Exist
DOT Sidewalk	Inspected
Asphalt	Does not Exist
Concrete	Inspected
Condition	4 - Between Fair and Poor
Deficiency	HEAVING
Deficiency Location/Instance	Quincy Street
Deficiency Quantity	50
Quantity Uom	S.F.

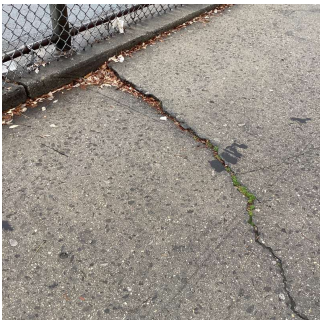
Violations	Quincy Street No violations recorded.
Deficiency	HEAVING
Deficiency Location/Instance	Quincy Street, Lewis Avenue
Deficiency Quantity	325
Quantity Uom	S.F.
Potential Action	REPLACE
Urgency of Action	PRIORITY 3
Purpose of Action	LEVEL 2
Deficiency Photo1

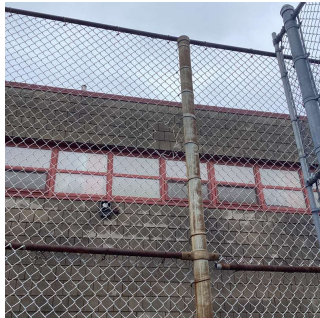
Question	Response
SITE	
PLAYGROUNDS	
Fence	
Purpose of Action	LEVEL 2
Deficiency Photo1

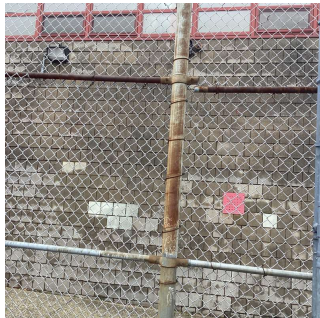
Violations	Near Main Entrance No violations recorded.
Deficiency	CHAIN LINK: DAMAGED POST/RAIL
Deficiency Location/Instance	Near Main Entrance
Deficiency Quantity	10
Quantity Uom	L.F.
Potential Action	REPLACE
Urgency of Action	PRIORITY 3
Purpose of Action	LEVEL 2
Deficiency Photo1

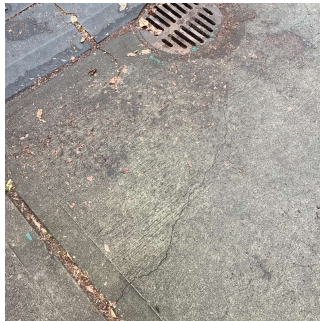
Violations	Near Main Entrance No violations recorded.
Pavement	
Instance on Courtyard	Inspected
Condition	2 - Between Good and Fair
Deficiency	CONCRETE: DAMAGED/DETERIORATED/MISSING SECTIONS
Deficiency Location/Instance	Near Drainage
Deficiency Quantity	25
Quantity Uom	S.F.
Potential Action	REPLACE
Urgency of Action	PRIORITY 3
Purpose of Action	LEVEL 2

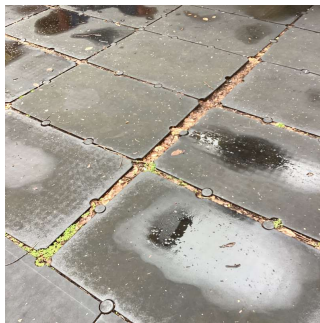
Violations	Near Drainage No violations recorded.
Play Equipment	
Instance on Courtyard	Inspected
Condition	2 - Between Good and Fair
Deficiency	No deficiencies recorded
Instance on Schoolyard	Inspected
Condition	2 - Between Good and Fair
Deficiency	No deficiencies recorded
Safety Surfacing	
Instance on Courtyard	Inspected
Condition	3 - Fair
Deficiency	DETERIORATED/MISSING
Deficiency Location/Instance	Near Slider
Deficiency Quantity	200
Quantity Uom	S.F.
Potential Action	MAINTENANCE
Urgency of Action	PRIORITY 3
Purpose of Action	LEVEL 2
Deficiency Photo1

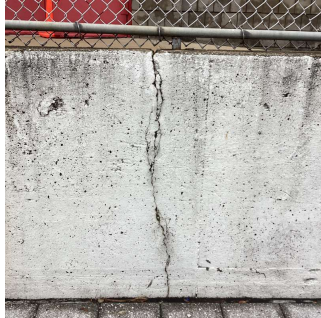
Question	Response
SITE	
RETAINING WALLS	
Deficiency	CAST IN PLACE CONCRETE: CRACKS/SPALLING - MAJOR
Deficiency Location/Instance	Near Exit 2
Deficiency Quantity	20
Quantity Uom	S.F.
Potential Action	REPLACE
Urgency of Action	PRIORITY 3
Purpose of Action	LEVEL 2
Deficiency Photo1

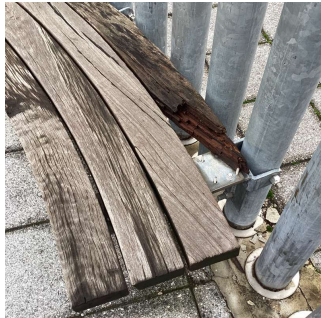
Near Exit 2
Violations	No violations recorded.
SEATING	Inspected
Benches	Inspected
Concrete	Does not Exist
Metal/Wood/Plastic	Inspected
Condition	5 - Poor
Deficiency	DAMAGED/DETERIORATED
Deficiency Location/Instance	Schoolyard
Deficiency Quantity	3
Quantity Uom	EACH
Potential Action	REPLACE
Urgency of Action	PRIORITY 5
Purpose of Action	LEVEL 6
Deficiency Photo1

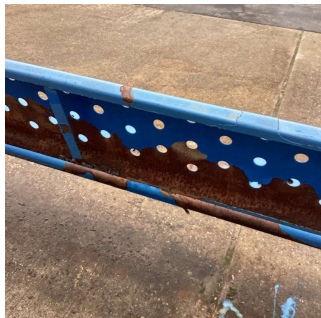
Schoolyard
Violations	No violations recorded.
Deficiency	DAMAGED/DETERIORATED
Deficiency Location/Instance	Schoolyard
Deficiency Quantity	3
Quantity Uom	EACH
Potential Action	REPLACE
Urgency of Action	PRIORITY 3
Purpose of Action	LEVEL 2
