NYC Department of Education
Building Condition Assessment Survey 2023 - 2024

Architectural Inspection

K335

Asset: P.S. 335 - BROOKLYN, 130 ROCHESTER AVENUE, New York, 11213

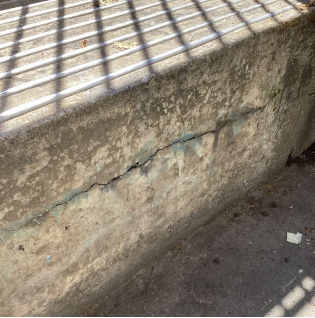
Question	Response
Architectural	
EXTERIOR	Inspected
AREAWAY	Inspected
Instance on AW1	Inspected
Instance Condition	5 - Poor
Instance Quantity	1
Instance Quantity Uom	EACH
Deficiency	AREAWAY WALLS: CRACKS AND SPALLING
Roof Plan reference	K335

Deficiency Quantity	20
Quantity Uom	S.F.
Potential Action	REPAIR
Urgency of Action	PRIORITY 3
Purpose of Action	LEVEL 2
Deficiency Photo1

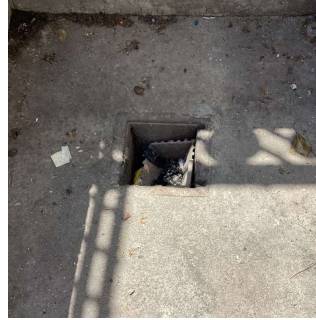
Violations	AW1
	No violations recorded.
Deficiency	AREAWAY DRAINS: DETERIORATED
Roof Plan reference	K335

Deficiency Quantity	1
Quantity Uom	EACH
Potential Action	REPLACE
Urgency of Action	PRIORITY 4
Purpose of Action	LEVEL 2

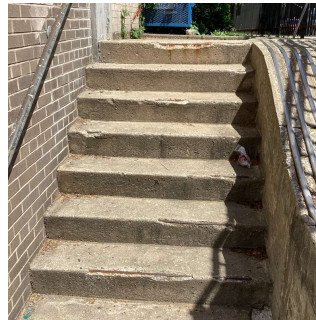
AW1

AREAWAY STAIRS: DETERIORATED
TREADS/RISERS/NOSINGS

REPLACE

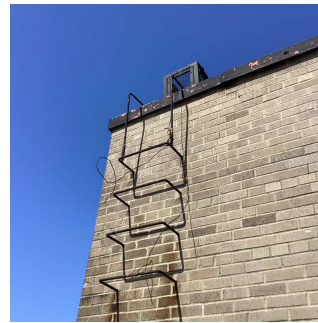
BRICK: DETERIORATED LADDER

REPLACE

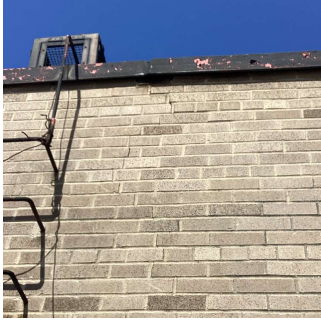
BRICK: MINOR CRACKS AND SPALLING

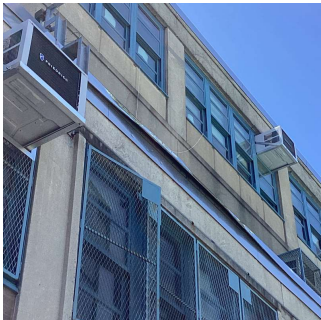
Violations	CH No violations recorded.
COPING	Inspected
Condition	3 - Fair
Deficiency	METAL: DETERIORATED
Roof Plan reference	K335

Deficiency Quantity	20
Quantity Uom	L.F.
Potential Action	REPLACE-IN-KIND
Urgency of Action	PRIORITY 4
Purpose of Action	LEVEL 2
Deficiency Photo1

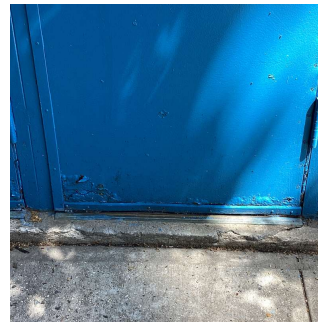
Facade B - Exit 9

Violations	Roof 4 - Facade D No violations recorded.
CORNICE	Does not Exist
DOORS	Inspected
DOORS AND FRAMES	Inspected
Condition	5 - Poor
Deficiency	METAL CLAD: DETERIORATED DOOR - MAJOR DETERIORATION

REPLACE

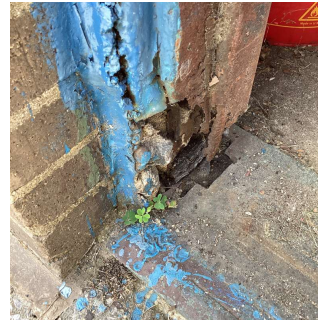
Facade A - Sump Pump Room Exit

METAL: DETERIORATED DOOR AND FRAME - MAJOR DETERIORATION

REPLACE

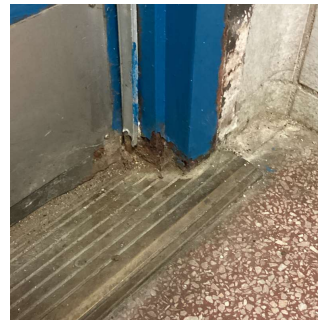
Facade C - Exit 6

METAL CLAD: DETERIORATED DOOR AND FRAME - MAJOR DETERIORATION

REPLACE

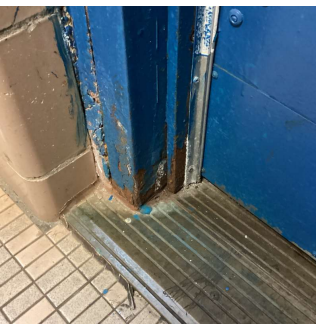
METAL: DETERIORATED DOOR AND FRAME - MINOR DETERIORATION

Deficiency Quantity	1
Quantity Uom	EACH
Potential Action	MAINTENANCE
Urgency of Action	PRIORITY 3
Purpose of Action	LEVEL 2
Deficiency Photo1

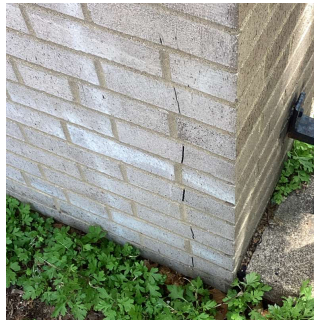
Facade B - Exit 8

BRICK: CRACKS/DISPLACED/SPALLED BRICK AT BUILDING CORNERS

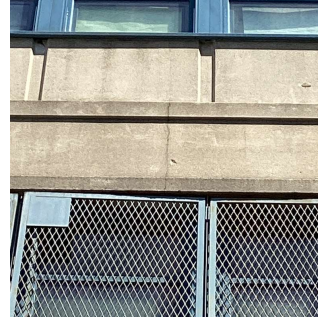
Facade B

CAST IN PLACE / PRE-CAST CONCRETE: MINOR
CRACKS/SPALLING

REPAIR
PRIORITY 3
LEVEL 2

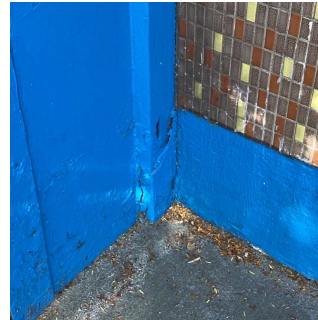
Facade A

CAST IN PLACE / PRE-CAST CONCRETE: MAJOR CRACKS/SPALLING

10
S.F.
REPLACE
PRIORITY 4
LEVEL 2

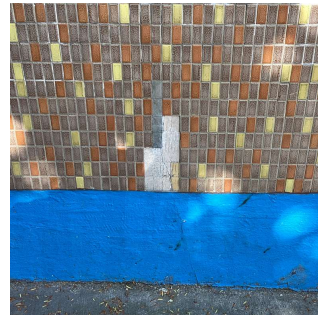
Facade A

CERAMIC TILE: CHIPPED, SPALLED, BROKEN PIECES

REPLACE

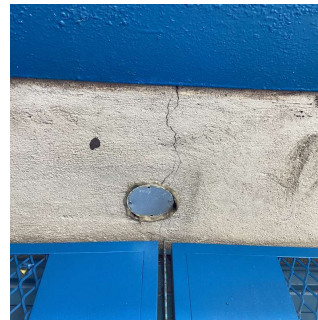
Facade A

STUCCO/PLASTER: MINOR CRACKS/SPALLING

REPAIR

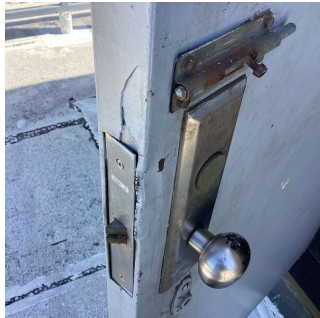
Roof 1
Instance Quantity	39,000
Instance Quantity Uom	S.F.
Does the roof have major mechanical equipment sitting on Dunnage Steel less than 18" above the Roofing?	No
Does this roof instance have a Sustainable Roof System?	Yes
Sustainable Roof Type	White Roof
Sustainable Roof Location (Roof Number)	Roofs 1 - 6
Do solar panels exist on these roofs?	Yes
Solar Panel Location (Roof Number)	Roofs 1, 5, 6
Installation Year	2014
Source of Installation	Custodial Staff
Deficiency	No deficiencies recorded
ROOFING DRAINS	Inspected
Condition	2 - Between Good and Fair
Deficiency	No deficiencies recorded
Specialties	Inspected
BULKHEAD/PENTHOUSE	Inspected
Condition	3 - Fair
Deficiency	BULKHEAD/PENTHOUSE DOORS: DETERIORATED DOOR
Roof Plan reference	<div> <div>K335</div>

</div>
Deficiency Quantity	1
Quantity Uom	EACH
Potential Action	REPLACE DOOR
Urgency of Action	PRIORITY 4

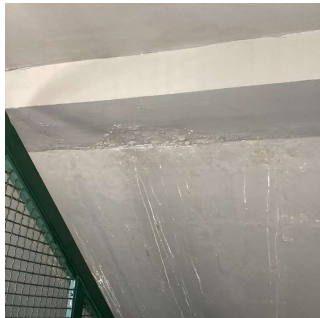
Violations	BH3 No violations recorded.
Deficiency	BULKHEAD/PENTHOUSE CEILING: PLASTER DAMAGED/DETERIORATED
Roof Plan reference	K335

Deficiency Quantity	10
Quantity Uom	S.F.
Potential Action	REPLACE
Urgency of Action	PRIORITY 3
Purpose of Action	LEVEL 2
Deficiency Photo1

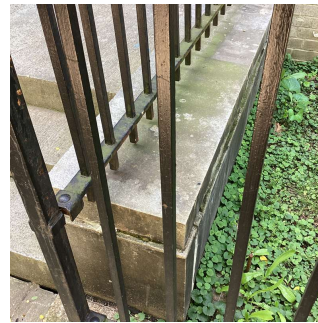
Facade F - Exit 2

Violations	BH1 No violations recorded.
CUPOLA/ SPIRES/ TOWERS	Does not Exist
DORMER	Does not Exist
DUNNAGE STEEL	Does not Exist
SKYLIGHT/ROOF VENT	Inspected
Material Type(s)	Glass
Condition	2 - Between Good and Fair
Deficiency	No deficiencies recorded
ROOF/GRAVITY TANK	Does not Exist
STAIRS/RAMPS: EXTERIOR	Inspected
BUILDING CHEEK/FLANK WALLS	Inspected
Condition	4 - Between Fair and Poor
Deficiency	STONE: BULGING/DISPLACED

REPLACE

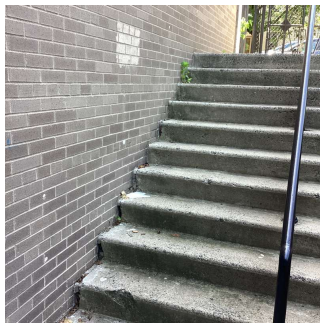
MISSING RAILING

REPLACE

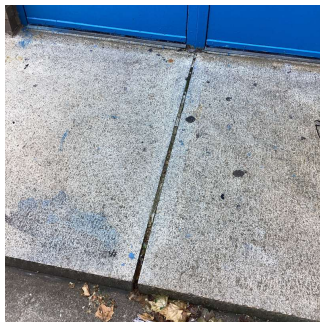
<p>Facade C - Near Exit 6</p> <p>No violations recorded.</p>
Violations	
STAIRS/RAMPS	Inspected
Condition	5 - Poor
Deficiency	STONE: DETERIORATED JOINTS
Roof Plan reference	<p>K335</p>

Deficiency Quantity	10
Quantity Uom	L.F.
Potential Action	REPOINT
Urgency of Action	PRIORITY 3
Purpose of Action	LEVEL 2
Deficiency Photo1

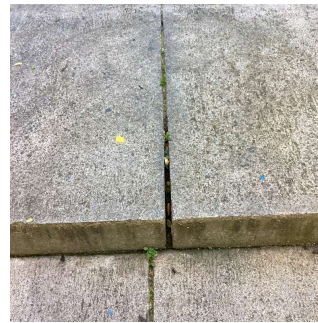
Facade F - Exit 2

<p>Facade E - Exit 5</p> <p>No violations recorded.</p>
Violations	
Deficiency	STONE: DETERIORATED JOINTS

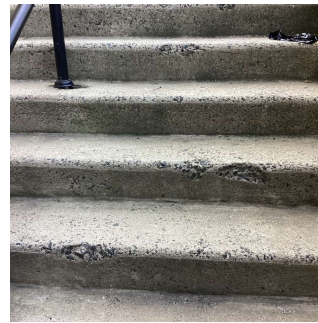
Facade C - Near Exit 6

LEVEL 2

CONCRETE: WORN-OUT TREAD/RISER/NOSING

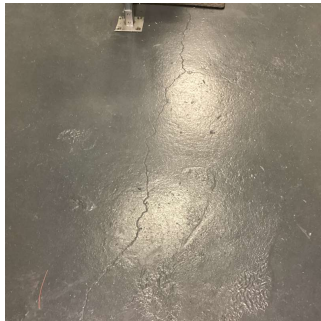
Question	Response
INTERIOR	
STRUCTURAL	
FLOOR STRUCTURE	
Deficiency Photo1

Violations	Electrical Room 25 No violations recorded.
FOUNDATION WALLS	Inspected
Material Type(s)	Concrete
Condition	2 - Between Good and Fair
Deficiency	CONCRETE: CRACKED/SPALLED/REINFORCEMENT EXPOSED
Deficiency Location/Instance	Ground Floor - Sprinkler Valve Main Control Room 27
Deficiency Quantity	20
Quantity Uom	S.F.
Potential Action	REPAIR
Urgency of Action	PRIORITY 3
Purpose of Action	LEVEL 5
Deficiency Photo1

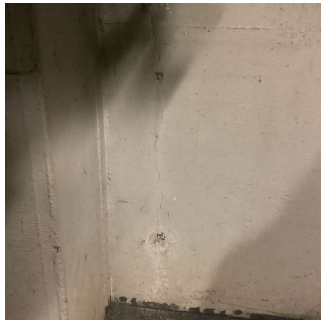
Violations	Sprinkler Valve Main Control Room 27 No violations recorded.
ROOF STRUCTURE	Inspected
Condition	2 - Between Good and Fair
Deficiency	No deficiencies recorded
VAULTS-BUNKERS	Inspected
Foundation Walls	Inspected
Condition	2 - Between Good and Fair
Deficiency	No deficiencies recorded
Slab Structure	Inspected
Condition	2 - Between Good and Fair
Deficiency	No deficiencies recorded
Vault/Ash Hoist Doors and Framing	Inspected

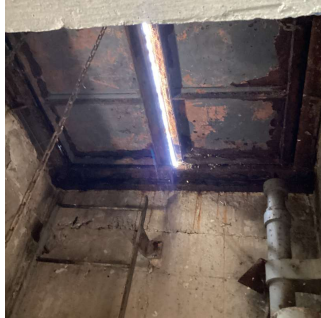
Condition	5 - Poor
Deficiency	WATER INFILTRATION
Deficiency Location/Instance	Basement - Ash Hoist Vault

Question	Response
INTERIOR	
STRUCTURAL	
VAULTS-BUNKERS	
Vault/Ash Hoist Doors and Framing	
Deficiency Quantity	10
Quantity Uom	S.F.
Potential Action	REPAIR
Urgency of Action	PRIORITY 5
Purpose of Action	LEVEL 2
Deficiency Photo1

Ash Hoist Vault
Violations	No violations recorded.
AUDITORIUM	Inspected
Instance on Ground Floor (210 Seats)	Inspected
Ceiling	
Instance on Ground Floor (210 Seats)	Inspected
Condition	2 - Between Good and Fair
Deficiency	GYPSUM BOARD: DAMAGED/DETERIORATED
Deficiency Location/Instance	Right Side Room near Stage
Deficiency Quantity	30
Quantity Uom	S.F.
Potential Action	REPLACE
Urgency of Action	PRIORITY 3
Purpose of Action	LEVEL 2
Deficiency Photo1

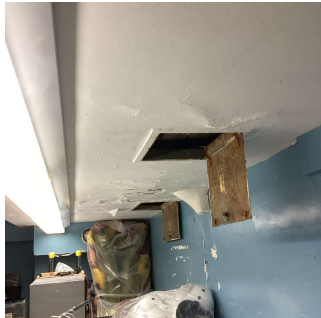
Right Side Room near Stage
Violations	No violations recorded.
Deficiency	ACOUSTIC TILES ON PLASTER: DAMAGED/MISSING
Deficiency Location/Instance	Near Stage
Deficiency Quantity	10
Quantity Uom	S.F.
Potential Action	REPLACE
Urgency of Action	PRIORITY 3

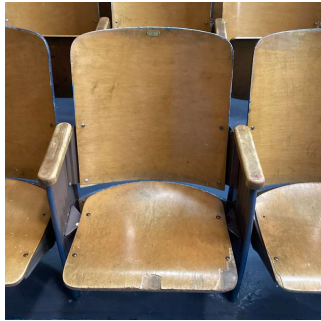
Question	Response
INTERIOR	
AUDITORIUM	
Fixed Seating	
Deficiency Photo1

Violations	Seat B/6 No violations recorded.
Floor Finish	
Instance on Ground Floor (210 Seats)	Inspected
Condition	2 - Between Good and Fair
Deficiency	CONCRETE: CRACKS
Deficiency Location/Instance	Back Room near Stage, by Row F
Deficiency Quantity	30
Quantity Uom	S.F.
Potential Action	REPLACE
Urgency of Action	PRIORITY 3
Purpose of Action	LEVEL 2
Deficiency Photo1

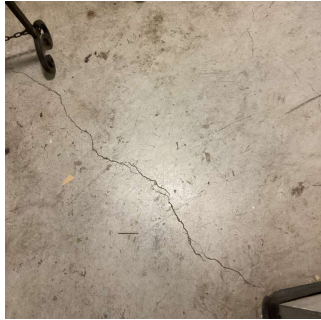
Violations	Back Room near Stage No violations recorded.
Deficiency	VINYL TILES: TRIPPING HAZARD - ELECTRICAL OUTLET
Deficiency Location/Instance	Center Side near Sliding Folding Partition
Deficiency Quantity	10
Quantity Uom	S.F.
Potential Action	REMOVE
Urgency of Action	PRIORITY 5
Purpose of Action	LEVEL 6

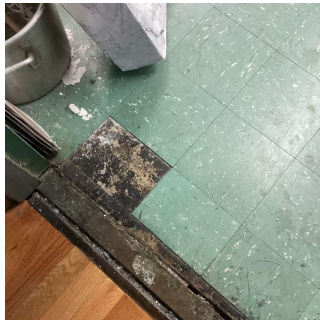
Question	Response
INTERIOR	
AUDITORIUM	
Floor Finish	
Deficiency Photo1	 
Violations	Center Side near Sliding Folding Partition No violations recorded.
Deficiency	VINYL TILES: BROKEN/DETERIORATED/MISSING TILES
Deficiency Location/Instance	Near Stage, by Exit 5, Right Side Room near Stage
Deficiency Quantity	30
Quantity Uom	S.F.
Potential Action	REPLACE
Urgency of Action	PRIORITY 3
Purpose of Action	LEVEL 2
Deficiency Photo1

Violations	Right Side Room near Stage No violations recorded.
Deficiency	VINYL TILES: DETERIORATED SUBSTRATE
Deficiency Location/Instance	Near Sliding Folding Partition, Right, Center and Left Side Aisle
Deficiency Quantity	60
Quantity Uom	S.F.
Potential Action	REPLACE
Urgency of Action	PRIORITY 3
Purpose of Action	LEVEL 2
Deficiency Photo1

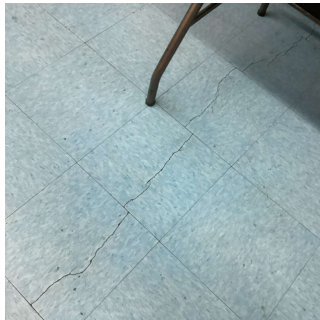
Violations	Near Sliding Folding Partition No violations recorded.

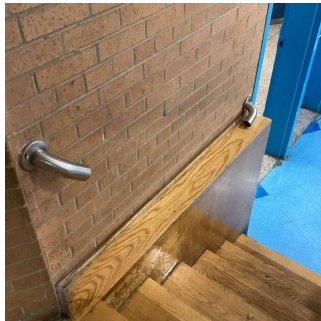
Question	Response
INTERIOR	
AUDITORIUM	
Sliding-folding Partition	
Instance on Ground Floor (210 Seats)	Inspected
Condition	3 - Fair
Deficiency	MOVABLE PANELS: DAMAGED
Deficiency Location/Instance	Near Main Entrance, by Windows, Near Door
Deficiency Quantity	200
Quantity Uom	S.F.
Potential Action	REPLACE
Urgency of Action	PRIORITY 3
Purpose of Action	LEVEL 2
Deficiency Photo1	 
Violations	Near Door No violations recorded.
Stage	
Instance on Ground Floor (210 Seats)	Inspected
Stage	Inspected
Instance on Ground Floor (210 Seats)	Inspected
Condition	3 - Fair
Deficiency	RAILINGS/MISSING
Deficiency Location/Instance	Left Side
Deficiency Quantity	10
Quantity Uom	L.F.
Potential Action	REPLACE
Urgency of Action	PRIORITY 5
Purpose of Action	LEVEL 6
Deficiency Photo1

Violations	Left Side No violations recorded.
Stage Curtain Rigging	
Instance on Ground Floor (210 Seats)	Inspected
Condition	3 - Fair
Deficiency	DAMAGED/DETERIORATED

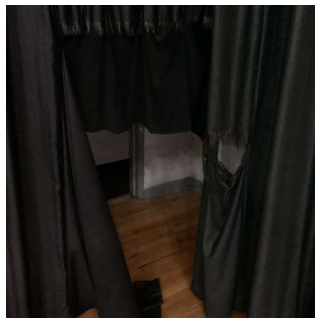
Question	Response
INTERIOR	
AUDITORIUM	
Stage	
Stage Curtain Rigging	
Deficiency Location/Instance	Right Side
Deficiency Quantity	1
Quantity Uom	EACH
Potential Action	REPLACE
Urgency of Action	PRIORITY 3
Purpose of Action	LEVEL 2
Deficiency Photo1	 
Violations	Right Side No violations recorded.
Stage Curtains	
Instance on Ground Floor (210 Seats)	Inspected
Condition	4 - Between Fair and Poor
Deficiency	WORN/DETERIORATED
Deficiency Location/Instance	Right and Left Side
Deficiency Quantity	700
Quantity Uom	S.F.
Potential Action	REPLACE
Urgency of Action	PRIORITY 3
Purpose of Action	LEVEL 2
Deficiency Photo1

Violations	Left Side No violations recorded.
Walls	
Instance on Ground Floor (210 Seats)	Inspected
Condition	2 - Between Good and Fair
Deficiency	GLAZED BLOCK: CRACKS/SPALLING
Deficiency Location/Instance	Exit F - Vestibule
Deficiency Quantity	20
Quantity Uom	S.F.
Potential Action	REPLACE

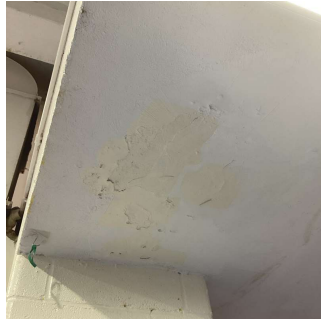
Question	Response
INTERIOR	
AUDITORIUM	
Walls	
Violations	Left Side No violations recorded.
Window Curtains/Shades/Blinds	
Instance on Ground Floor (210 Seats)	Inspected
Condition	2 - Between Good and Fair
Deficiency	No deficiencies recorded
CAFETERIA	
Instance on Ground Floor - Staff (800 SF)	Inspected
Instance on Ground Floor - Students	Inspected
Ceiling	
Instance on Ground Floor - Students	Inspected
Condition	2 - Between Good and Fair
Deficiency	PLASTER: CRACKS/SPALLING
Deficiency Location/Instance	Left Side, near Exit F
Deficiency Quantity	30
Quantity Uom	S.F.
Potential Action	REPLACE
Urgency of Action	PRIORITY 3
Purpose of Action	LEVEL 2
Deficiency Photo1

Violations	Left Side No violations recorded.
Instance on Ground Floor - Staff (800 SF)	Inspected
Condition	3 - Fair
Deficiency	METAL PAN: DAMAGED/MISSING
Deficiency Location/Instance	Near Main Entrance, by Kitchen Door, close to Windows
Deficiency Quantity	50

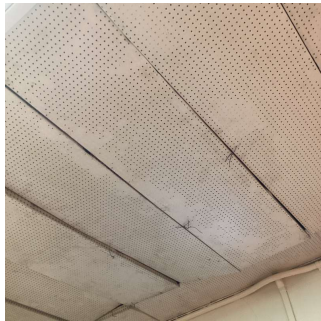
Quantity Uom	S.F.
Potential Action	REPLACE
Urgency of Action	PRIORITY 3
Purpose of Action	LEVEL 2

Near Main Entrance
Violations	No violations recorded.
Door(s)	
Instance on Ground Floor - Staff (800 SF)	Inspected
Condition	3 - Fair
Deficiency	WOOD: DETERIORATED DOOR
Deficiency Location/Instance	Main Entrance
Deficiency Quantity	1
Quantity Uom	EACH
Potential Action	MAINTENANCE
Urgency of Action	PRIORITY 3
Purpose of Action	LEVEL 2
Deficiency Photo1

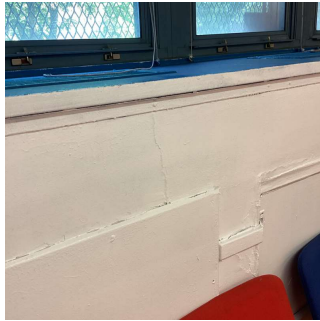
Question	Response
INTERIOR	
CAFETERIA	
Walls	
Violations	No violations recorded.
Instance on Ground Floor - Staff (800 SF)	Inspected
Condition	2 - Between Good and Fair
Deficiency	PLASTER: CRACKS/SPALLING
Deficiency Location/Instance	Near Windows, by Main Entrance
Deficiency Quantity	20
Quantity Uom	S.F.
Potential Action	REPLACE
Urgency of Action	PRIORITY 3
Purpose of Action	LEVEL 2
Deficiency Photo1

Violations	Near Windows No violations recorded.
Instance on Ground Floor - Students	Inspected
Condition	2 - Between Good and Fair
Deficiency	PLASTER: CRACKS/SPALLING
Deficiency Location/Instance	Near Sliding Folding Partition
Deficiency Quantity	20
Quantity Uom	S.F.
Potential Action	REPLACE
Urgency of Action	PRIORITY 3
Purpose of Action	LEVEL 2
Deficiency Photo1

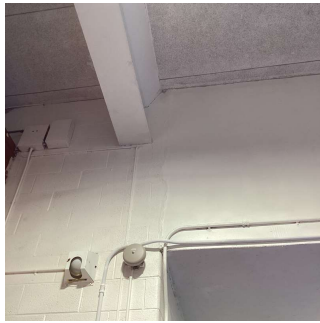
Violations	Near Sliding Folding Partition No violations recorded.
Deficiency	GLAZED BLOCK: CRACKS/SPALLING
Deficiency Location/Instance	Right Side
Deficiency Quantity	10

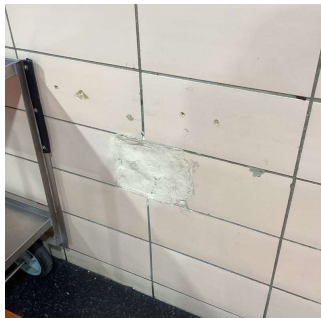
Quantity Uom	S.F.
Potential Action	REPLACE
Urgency of Action	PRIORITY 3

Question	Response
INTERIOR	
CAFETERIA	
Walls	
Purpose of Action	LEVEL 2
Deficiency Photo1

Right Side
Violations	No violations recorded.
Window Curtains/Shades/Blinds	
Instance on Ground Floor - Staff (800 SF)	Does not Exist
Instance on Ground Floor - Students	Does not Exist
CLASSROOMS/CORRIDORS/ADMIN SPACES	Inspected
Ceiling	Inspected
Condition	2 - Between Good and Fair
Deficiency	ACOUSTIC TILES ON PLASTER: DAMAGED/MISSING
Deficiency Location/Instance	Room 37, Corridor near Rooms 302, 305, 114, by Stair A/1 and others
Deficiency Quantity	240
Quantity Uom	S.F.
Potential Action	REPLACE
Urgency of Action	PRIORITY 3
Purpose of Action	LEVEL 2
Deficiency Photo1

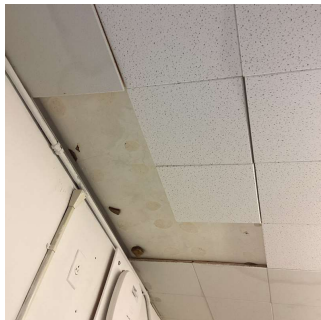
Room 37
Violations	No violations recorded.
Door(s)	Inspected
Condition	5 - Poor
Deficiency	WOOD: DETERIORATED DOOR
Deficiency Location/Instance	Rooms 333, 301, 254, 251, 147 and others
Deficiency Quantity	10
Quantity Uom	EACH
Potential Action	MAINTENANCE
Urgency of Action	PRIORITY 3

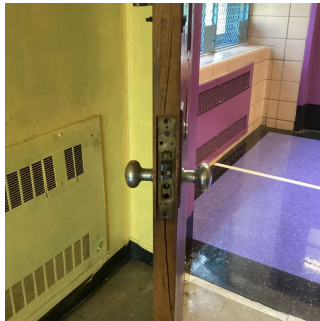
Violations	Room 254 No violations recorded.
Floor Finish	Inspected
Condition	2 - Between Good and Fair
Deficiency	VINYL TILES: DETERIORATED SUBSTRATE
Deficiency Location/Instance	Room 104
Deficiency Quantity	20
Quantity Uom	S.F.
Potential Action	REPLACE
Urgency of Action	PRIORITY 3
Purpose of Action	LEVEL 2
Deficiency Photo1

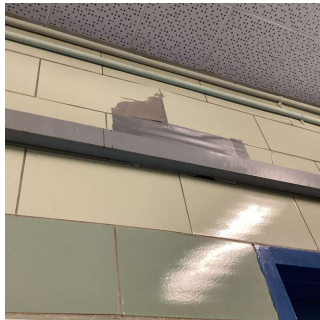
Violations	Room 135 No violations recorded.
Deficiency	GLAZED BLOCK: CRACKS/SPALLING
Deficiency Location/Instance	Corridor near Room 152
Deficiency Quantity	20
Quantity Uom	S.F.
Potential Action	REPLACE
Urgency of Action	PRIORITY 5
Purpose of Action	LEVEL 6
Deficiency Photo1

Violations	Corridor near Room 152 No violations recorded.
Deficiency	GLAZED BLOCK: CRACKS/SPALLING
Deficiency Location/Instance	Main Entrance - Lobby, Corridor near Rooms 43, 239, 241, Exit 6 - Vestibule and others
Deficiency Quantity	340
Quantity Uom	S.F.
Potential Action	REPLACE
Urgency of Action	PRIORITY 3
Purpose of Action	LEVEL 2
Deficiency Photo1

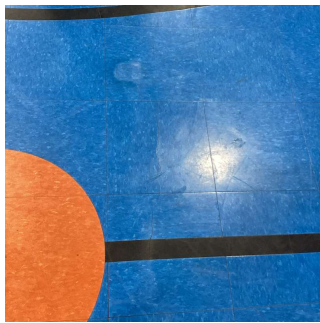
Question	Response
INTERIOR	
GYMNASIUM	
Fixed Equipment	
Instance on Ground Floor	Inspected
Condition	2 - Between Good and Fair
Deficiency	No deficiencies recorded
Floor Finish	
Instance on Ground Floor	Inspected
Condition	2 - Between Good and Fair
Deficiency	VINYL TILES: DETERIORATED SUBSTRATE
Deficiency Location/Instance	Center
Deficiency Quantity	10
Quantity Uom	S.F.
Potential Action	REPLACE
Urgency of Action	PRIORITY 3
Purpose of Action	LEVEL 2
Deficiency Photo1

Violations	Center No violations recorded.
Deficiency	VINYL TILES: BROKEN/DETERIORATED/MISSING TILES
Deficiency Location/Instance	Near Right Side Sliding Folding Partition
Deficiency Quantity	10
Quantity Uom	S.F.
Potential Action	REPLACE
Urgency of Action	PRIORITY 3
Purpose of Action	LEVEL 2
Deficiency Photo1

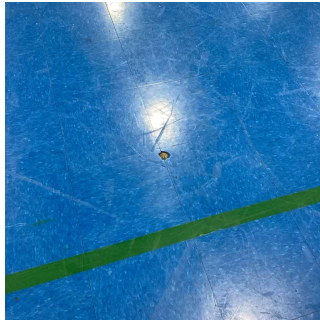
Violations	Near Right Side Sliding Folding Partition No violations recorded.
Seating	
Instance on Ground Floor	Does not Exist
Sliding-folding Partition

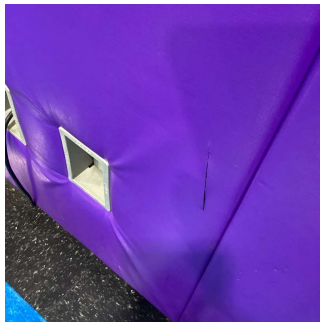
Question	Response
INTERIOR	
GYMNASIUM	
Stage	
Instance on Ground Floor	Does not Exist
Walls	
Instance on Ground Floor	Inspected
Condition	2 - Between Good and Fair
Deficiency	WALL PADDING: DETERIORATED
Deficiency Location/Instance	Near Main Entrance, by Exit F
Deficiency Quantity	40
Quantity Uom	S.F.
Potential Action	REPLACE
Urgency of Action	PRIORITY 3
Purpose of Action	LEVEL 2
Deficiency Photo1

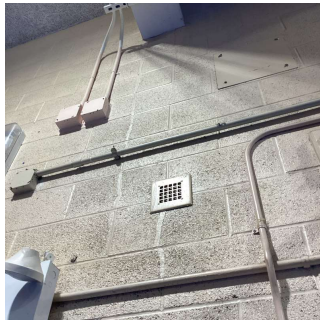
Violations	Near Main Entrance No violations recorded.
Deficiency	MASONRY: CRACKS/SPALLING
Deficiency Location/Instance	Near Main Entrance
Deficiency Quantity	20
Quantity Uom	S.F.
Potential Action	REPLACE
Urgency of Action	PRIORITY 3
Purpose of Action	LEVEL 2
Deficiency Photo1

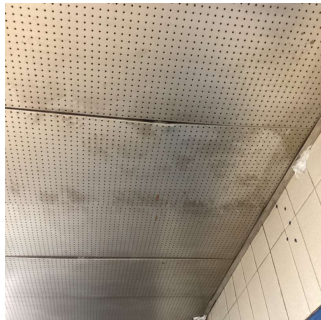
Question	Response
INTERIOR	
INTERIOR GUARDS	Inspected
Deficiency	No deficiencies recorded
KITCHEN	Inspected
Instance on Ground Floor	Inspected
Ceiling	
Instance on Ground Floor	Inspected
Condition	3 - Fair
Deficiency	METAL PAN: DAMAGED/MISSING
Deficiency Location/Instance	Servery, by Sink, Preparation Area
Deficiency Quantity	40
Quantity Uom	S.F.
Potential Action	REPLACE
Urgency of Action	PRIORITY 3
Purpose of Action	LEVEL 2
Deficiency Photo1

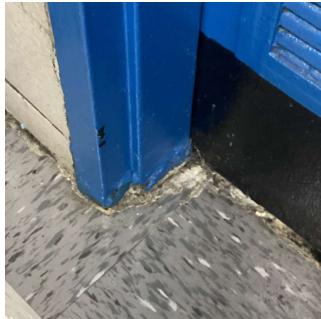
Servery
Violations	No violations recorded.
Door(s)	
Instance on Ground Floor	Inspected
Condition	5 - Poor
Deficiency	WOOD: DETERIORATED DOOR AND FRAME
Deficiency Location/Instance	Room 53
Deficiency Quantity	1
Quantity Uom	EACH
Potential Action	MAINTENANCE
Urgency of Action	PRIORITY 3
Purpose of Action	LEVEL 2
Deficiency Photo1

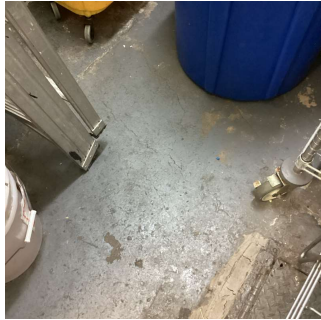
Violations	<p>Servery</p> <p>No violations recorded.</p>
Floor Finish	
Instance on Ground Floor	Inspected
Condition	4 - Between Fair and Poor
Deficiency	CONCRETE: CRACKS
Deficiency Location/Instance	Mop Room
Deficiency Quantity	25
Quantity Uom	S.F.
Potential Action	REPLACE
Urgency of Action	PRIORITY 3
Purpose of Action	LEVEL 2
Deficiency Photo1

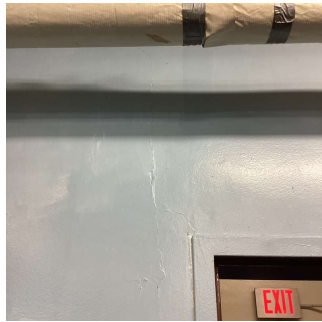
Violations	<p>Servery</p> <p>No violations recorded.</p>
Walls	
Instance on Ground Floor	Inspected
Condition	3 - Fair
Deficiency	PLASTER: CRACKS/SPALLING
Deficiency Location/Instance	Storage Room, Mop Room
Deficiency Quantity	30
Quantity Uom	S.F.
Potential Action	REPLACE
Urgency of Action	PRIORITY 3
Purpose of Action	LEVEL 2
Deficiency Photo1

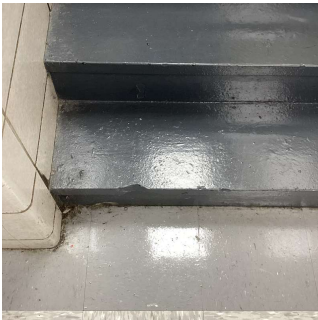
Question	Response
INTERIOR	
STAIRS/RAMPS: INTERIOR	
Stairs and Landings	
Deficiency	STONE: BROKEN/MISSING
Deficiency Location/Instance	Corridor near Exit Stage Right, Stair A/Ground Floor, B/3
Deficiency Quantity	30
Quantity Uom	S.F.
Potential Action	REPLACE
Urgency of Action	PRIORITY 3
Purpose of Action	LEVEL 2
Deficiency Photo1

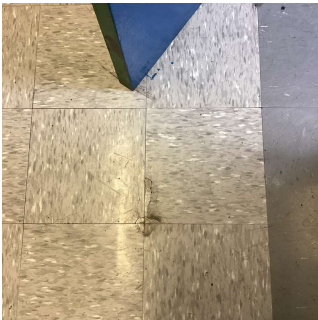
Violations	Corridor near Right Stage Exit No violations recorded.
Deficiency	VINYL TILES: DETERIORATED SUBSTRATE
Deficiency Location/Instance	Stairs A/Ground Floor, B/3
Deficiency Quantity	20
Quantity Uom	S.F.
Potential Action	REPLACE
Urgency of Action	PRIORITY 3
Purpose of Action	LEVEL 2
Deficiency Photo1

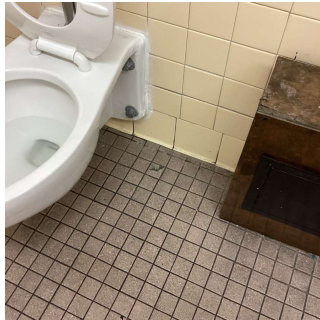
Violations	Room 316 No violations recorded.
Floor Finish	Inspected
Condition	2 - Between Good and Fair
Deficiency	CERAMIC TILE: BROKEN/MISSING TILES
Deficiency Location/Instance	Room 50
Deficiency Quantity	10
Quantity Uom	S.F.
Potential Action	REPLACE
Urgency of Action	PRIORITY 3
Purpose of Action	LEVEL 2
Deficiency Photo1

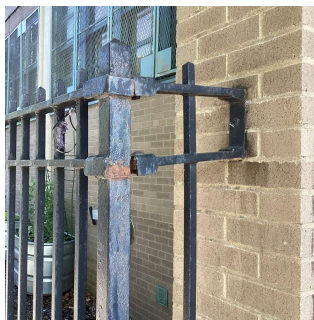
Question	Response
SITE	
Drainage System for Soil	Inspected
Catch Basins/Manhole - Surrounded by Soil	Inspected
Deficiency	No deficiencies recorded
Culverts - Soil Covering	Does not Exist
DRINKING FOUNTAINS	Does not Exist
FENCES	Inspected
Condition	4 - Between Fair and Poor
Deficiency	WROUGHT IRON: RUST - MAJOR
Deficiency Location/Instance	St. Marks Avenue
Deficiency Quantity	40
Quantity Uom	S.F.
Potential Action	REPLACE
Urgency of Action	PRIORITY 3
Purpose of Action	LEVEL 2
Deficiency Photo1

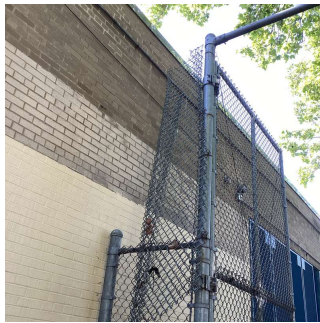
Violations	Rochester Avenue No violations recorded.
Deficiency	CHAIN LINK: DAMAGED/DETERIORATED
Deficiency Location/Instance	Bergen Street, by Exit 6, near Playgrounds

Deficiency Quantity	240
Quantity Uom	S.F.
Potential Action	REPLACE
Urgency of Action	PRIORITY 3

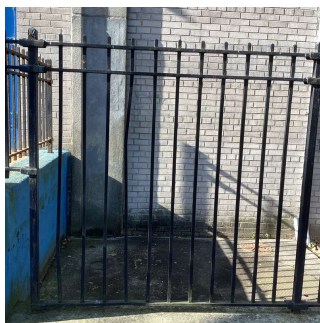
Bergen Street
Violations	No violations recorded.
Deficiency	WROUGHT IRON: DAMAGED/DETERIORATED
Deficiency Location/Instance	Bergen Street, St. Marks Avenue
Deficiency Quantity	160
Quantity Uom	S.F.
Potential Action	REPLACE
Urgency of Action	PRIORITY 3
Purpose of Action	LEVEL 2
Deficiency Photo1

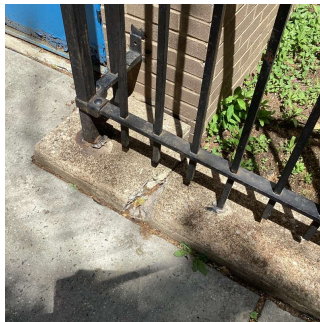
Bergen Street
Violations	No violations recorded.
Deficiency	CONCRETE CURB: DAMAGED/DETERIORATED
Deficiency Location/Instance	Bergen Street, Rochester Avenue, St. Marks Avenue
Deficiency Quantity	140
Quantity Uom	S.F.
Potential Action	REPLACE
Urgency of Action	PRIORITY 3
Purpose of Action	LEVEL 2
Deficiency Photo1

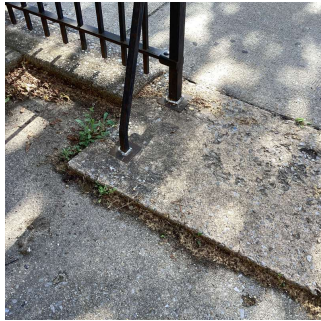
Question	Response
SITE	
IRRIGATION SYSTEM	Does not Exist
PAVING	Inspected
Student Non-Use	Inspected
Gravel Exists?	No
Asphalt	Does not Exist
Concrete	Inspected
Condition	3 - Fair
Deficiency	HEAVING
Deficiency Location/Instance	Rochester Avenue
Deficiency Quantity	25
Quantity Uom	S.F.
Potential Action	REPLACE
Urgency of Action	PRIORITY 3
Purpose of Action	LEVEL 2
Deficiency Photo1

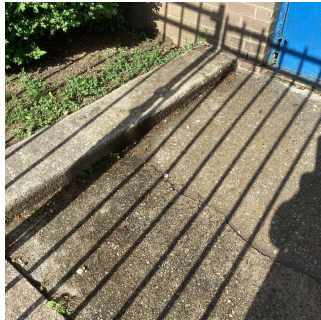
Violations	Rochester Avenue No violations recorded.
Deficiency	DAMAGED/DETERIORATED/MISSING SECTIONS
Deficiency Location/Instance	Rochester Avenue
Deficiency Quantity	25
Quantity Uom	S.F.
Potential Action	REPLACE
Urgency of Action	PRIORITY 3
Purpose of Action	LEVEL 2
Deficiency Photo1

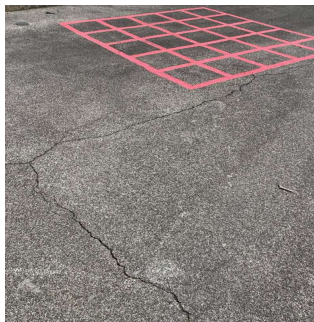
Question	Response
SITE	
PAVING	
Student Use	
Asphalt	
Deficiency	CRACKS - MAJOR
Deficiency Location/Instance	Schoolyard, Bergen Street, Near Exit 7, St. Marks Avenue
Deficiency Quantity	300
Quantity Uom	S.F.
Potential Action	REPLACE
Urgency of Action	PRIORITY 3
Purpose of Action	LEVEL 2
Deficiency Photo1

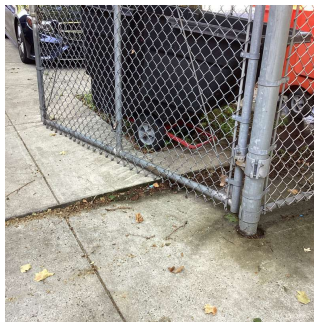
Violations	St. Marks Avenue No violations recorded.
Concrete	Does not Exist
Pavers	Does not Exist
Site Sidewalks & Walkways	Inspected
Asphalt	Does not Exist
Concrete	Inspected
Condition	4 - Between Fair and Poor
Deficiency	HEAVING
Deficiency Location/Instance	Bergen Street, near Exit 4
Deficiency Quantity	100
Quantity Uom	S.F.
Potential Action	REPLACE
Urgency of Action	PRIORITY 3
Purpose of Action	LEVEL 2
Deficiency Photo1

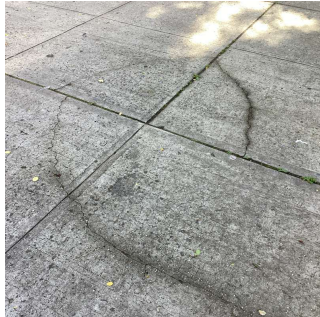
Violations	Bergen Street No violations recorded.
Deficiency	DAMAGED/DETERIORATED/MISSING SECTIONS
Deficiency Location/Instance	Bergen Street, St. Marks Avenue, Rochester Avenue
Deficiency Quantity	2,825
Quantity Uom	S.F.
Potential Action	REPLACE
Urgency of Action	PRIORITY 3
Purpose of Action	LEVEL 2
Deficiency Photo1

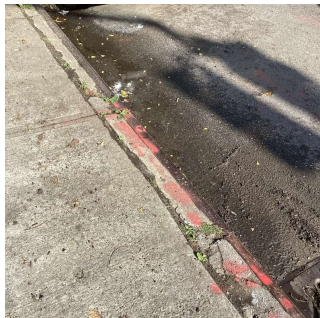
Violations	Bergen Street No violations recorded.
Deficiency	DAMAGED CURBS
Deficiency Location/Instance	Bergen Street, St. Marks Avenue
Deficiency Quantity	80
Quantity Uom	L.F.
Potential Action	REPLACE
Urgency of Action	PRIORITY 3
Purpose of Action	LEVEL 2
Deficiency Photo1

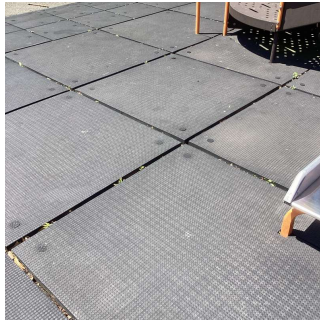
Near Slide
Violations	No violations recorded.
Instance on St. Mark Avenue - West	Inspected
Condition	3 - Fair
Deficiency	DETERIORATED/MISSING
Deficiency Location/Instance	Near Slide
Deficiency Quantity	200
Quantity Uom	S.F.
Potential Action	MAINTENANCE
Urgency of Action	PRIORITY 3
Purpose of Action	LEVEL 2
Deficiency Photo1
