NYC Department of Education
Building Condition Assessment Survey 2023 - 2024

Architectural Inspection

Asset: TILDEN AF - BROOKLYN, 5800 TILDEN AVENUE, New York, 11203

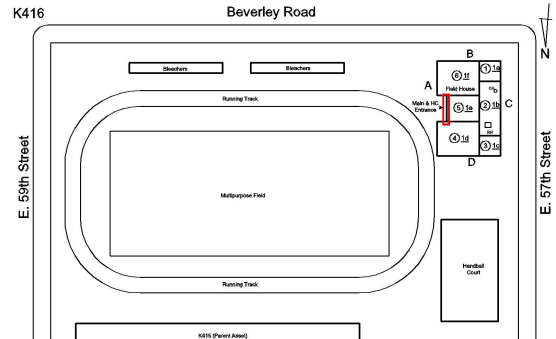
Question	Response
EXTERIOR	
AWNINGS AND CANOPIES	
Deficiency	METAL: WATER PENETRATION
Roof Plan reference

Deficiency Quantity	20
Quantity Uom	S.F.
Potential Action	REPAIR
Urgency of Action	PRIORITY 5
Purpose of Action	LEVEL 2
Deficiency Photo1

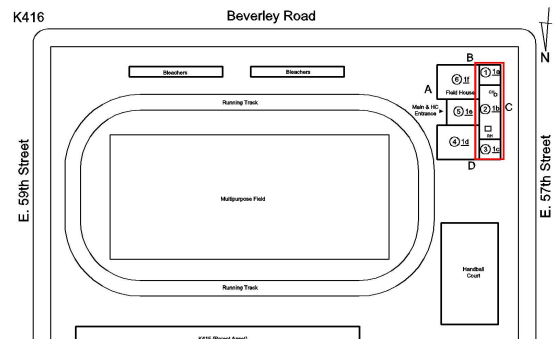
Violations	<p>Facade A</p> <p>No violations recorded.</p>
CHIMNEY	
Material Type(s)	Inspected Metal
Condition	2 - Between Good and Fair
Deficiency	No deficiencies recorded
COPING	
Condition	Inspected 2 - Between Good and Fair
Deficiency	CAST STONE: DETERIORATED TRANSVERSE JOINTS
Roof Plan reference

Deficiency Quantity	40
Quantity Uom	L.F.
Potential Action	MAINTENANCE
Urgency of Action	PRIORITY 3

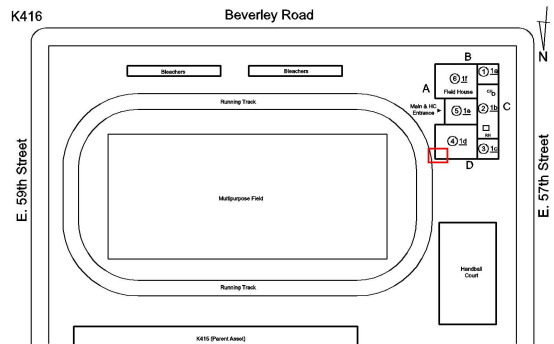
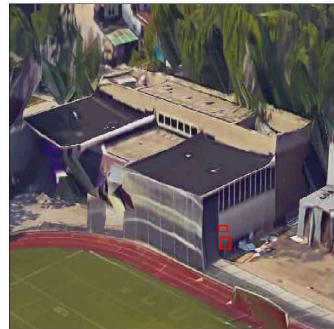
Question	Response
EXTERIOR	
COPING	Inspected
Purpose of Action	LEVEL 2
Deficiency Photo1	No photo recorded
Violations	No violations recorded.
CORNICE	Does not Exist
DOORS	Inspected
DOORS AND FRAMES	Inspected
Condition	2 - Between Good and Fair
Deficiency	No deficiencies recorded
DOOR HARDWARE	Inspected
Condition	2 - Between Good and Fair
Deficiency	No deficiencies recorded
LINTELS	Inspected
Condition	2 - Between Good and Fair
Deficiency	No deficiencies recorded
TRANSOM/SIDE LIGHT	Does not Exist
EXTERIOR WALLS	Inspected
Material Type(s)	Concrete, Masonry
Replacement Quantity	4,000
Replacement Uom	S.F.
Instance on All Facades	Inspected
Instance Condition	3 - Fair
Instance Quantity	4,000
Instance Quantity Uom	S.F.
Deficiency	CAST IN PLACE / PRE-CAST CONCRETE: MINOR CRACKS/SPALLING
Roof Plan reference

Deficiency Quantity	10
Quantity Uom	S.F.
Potential Action	REPAIR
Urgency of Action	PRIORITY 3

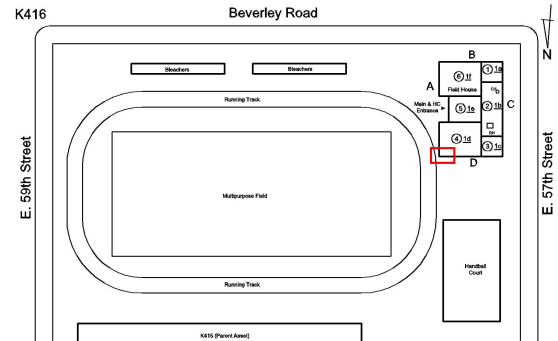
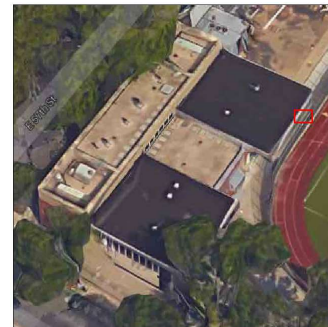
CAST IN PLACE / PRE-CAST CONCRETE: DETERIORATED JOINTS

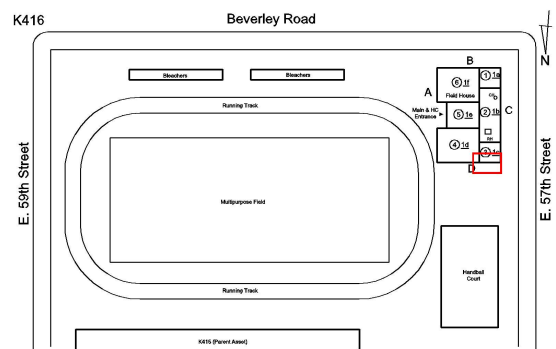
Question	Response
EXTERIOR	
PARAPETS	
Rooftop Plan reference

Deficiency Quantity	30
Quantity Uom	S.F.
Potential Action	MAINTENANCE
Urgency of Action	PRIORITY 1
Purpose of Action	LEVEL 1
Deficiency Photo1	No photo recorded
Violations	No violations recorded.
PLAZA DECK	Does not Exist
ROOF	Inspected
Roofing	Inspected
Replacement Quantity	3,300
Replacement Uom	S.F.
ROOF HATCH/SMOKE HATCH	Inspected
Condition	2 - Between Good and Fair
Deficiency	No deficiencies recorded
LEADERS, GUTTERS, DOWNSPOUTS, SCUPPERS	Does not Exist
ROOFING	Inspected
Instance on Built-Up: Roofs 1, 2, 3, 5	Inspected
Instance Condition	5 - Poor
Instance Photo

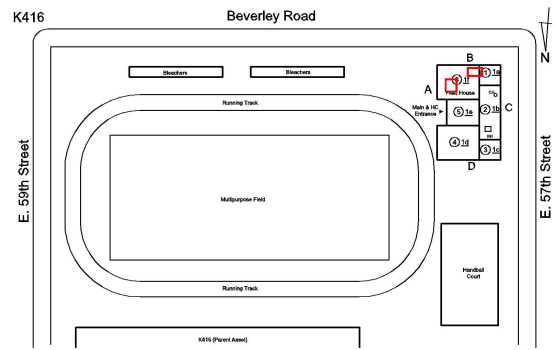
Question	Response
EXTERIOR	
ROOF	
Roofing	
ROOFING	
Roof Plan reference	 
Deficiency Quantity	200
Quantity Uom	S.F.
Potential Action	REPLACE ROOFING WITHOUT MAJOR EQUIPMENT REMOVAL
Urgency of Action	PRIORITY 5
Purpose of Action	LEVEL 2
Deficiency Photo1	 
Violations	Roof 1 - South Shower Room (Roof 2 - Weight Room similar) No violations recorded.
Instance on Modified Bitumen: Roofs 4-6	Inspected
Instance Condition	4 - Between Fair and Poor
Instance Photo	 
	Roof 5
Instance Quantity	1,600
Instance Quantity Uom	S.F.
Does the roof have major mechanical equipment sitting on Dunnage Steel less than 18" above the Roofing?	No
Does this roof instance have a Sustainable Roof System?	No
Do solar panels exist on these roofs?	No
Is/Are the roof(s) suitable for Solar Panel installation?	No
Installation Year	2002
Source of Installation	Custodial Staff
Deficiency	MODIFIED BITUMEN: ROOFING: DELAMINATION

Deficiency Quantity	20
Quantity Uom	S.F.
Potential Action	REPLACE ROOFING WITHOUT MAJOR EQUIPMENT REMOVAL
Urgency of Action	PRIORITY 4
Purpose of Action	LEVEL 2
Deficiency Photo1

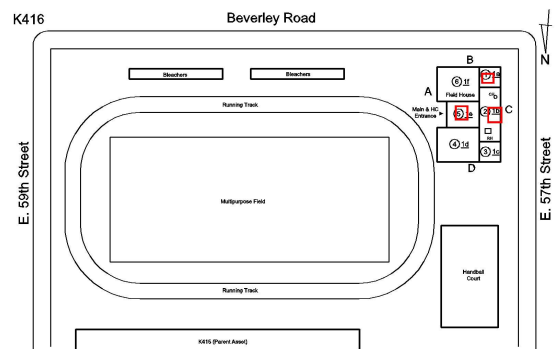
Violations	Roof 6 No violations recorded.
ROOFING DRAINS	Inspected
Condition	5 - Poor
Deficiency	DETERIORATED
Roof Plan reference

Deficiency Quantity	3
Quantity Uom	EACH
Potential Action	REPLACE
Urgency of Action	PRIORITY 4
Purpose of Action	LEVEL 2

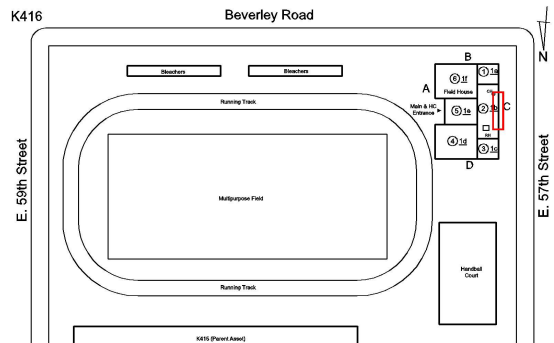
Violations	Roof 2 No violations recorded.
Specialties	Does not Exist
STAIRS/RAMPS: EXTERIOR	Does not Exist
WINDOWS	Inspected
Replacement Quantity	1,000
Replacement Uom	S.F.
EXTERIOR GUARDS	Inspected
Condition	2 - Between Good and Fair
Deficiency	No deficiencies recorded
LINTELS	Inspected
Condition	2 - Between Good and Fair
Deficiency	No deficiencies recorded
WINDOWS	Inspected
Material Type(s)	Aluminum
Instance on Aluminum - Other: All Facades	Inspected
Instance Condition	3 - Fair
Instance Quantity	1,000
Instance Quantity Uom	S.F.
Are these windows insulated	Yes
Installation Year	2002
Source of Installation	Custodial Staff
Deficiency	ALUMINUM - OTHER: BROKEN PANE
Roof Plan reference	K416

Question	Response
EXTERIOR	
WINDOWS	
WINDOWS	
Elevation	 
Deficiency Quantity	20
Quantity Uom	S.F.
Potential Action	MAINTENANCE
Urgency of Action	PRIORITY 3
Purpose of Action	LEVEL 2
Deficiency Photo1	No photo recorded
Violations	No violations recorded.
INTERIOR	Inspected
STRUCTURAL	Inspected
COLUMNS/BEAMS/BEARING WALLS	Inspected
Condition	2 - Between Good and Fair
Deficiency	No deficiencies recorded
FLOOR STRUCTURE	Inspected
Condition	3 - Fair
Deficiency	CONCRETE SLAB ON GRADE: THRU CRACKS
Deficiency Location/Instance	1st Floor - Electrical Panel Room
Deficiency Quantity	80
Quantity Uom	S.F.
Potential Action	REPAIR
Urgency of Action	PRIORITY 3
Purpose of Action	LEVEL 5
Deficiency Photo1	 
Violations	1st Floor - Electrical Panel Room No violations recorded.
FOUNDATION WALLS	Inspected
Material Type(s)	Concrete
Condition	2 - Between Good and Fair
Deficiency	No deficiencies recorded
ROOF STRUCTURE	Inspected

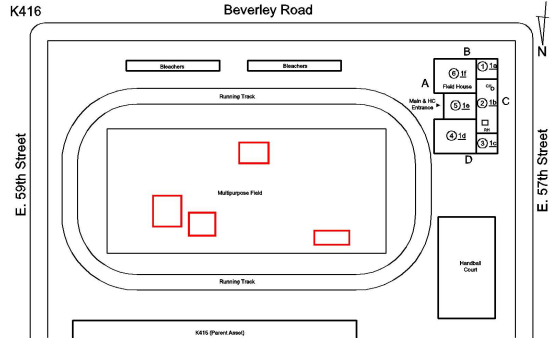
Question	Response
INTERIOR	
TOILET ROOMS - STUDENTS	
Walls	
Deficiency	MASONRY: CRACKS/SPALLING
Deficiency Location/Instance	1st Floor - Girls
Deficiency Quantity	10
Quantity Uom	S.F.
Potential Action	REPLACE
Urgency of Action	PRIORITY 3
Purpose of Action	LEVEL 2
Deficiency Photo1	 
Violations	1st Floor - Girls No violations recorded.
ATHLETIC FIELDS	Inspected
PLAYING SURFACE	Inspected
Synthetic Turf Field exists?	Yes
Year of Installation	2002
Replacement Quantity	81,000
Replacement Uom	S.F.
Instance on Football Field	Inspected
Instance Condition	3 - Fair
Instance Quantity	65,000
Instance Quantity Uom	S.F.
Deficiency	ARTIFICIAL TURF: DAMAGED/WORN OUT
Deficiency Location/Instance	Football Field
Roof Plan reference

Deficiency Quantity	200
Quantity Uom	S.F.
Potential Action	REPLACE
Urgency of Action	PRIORITY 4
Purpose of Action	LEVEL 2
