NYC Department of Education
Building Condition Assessment Survey 2023 - 2024

Architectural Inspection

K874

Asset: I.S. 340 (OLD 249 AX) - BROOKLYN, 227 STERLING PLACE, New York, 11238

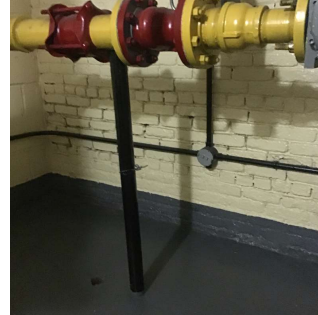
Violations	Stair D/Basement No violations recorded.
Deficiency	BRICK: DETERIORATED JOINTS

Deficiency Location/Instance	Basement - Boiler Room, Gas Meter Room
Deficiency Quantity	60
Quantity Uom	S.F.
Potential Action	REPOINT
