**NYC Department of Education**  
**Building Condition Assessment Survey 2023 - 2024**

Architectural Inspection

**Asset:** P.S. 20 - QUEENS, 142-30 BARCLAY AVENUE, New York, 11355

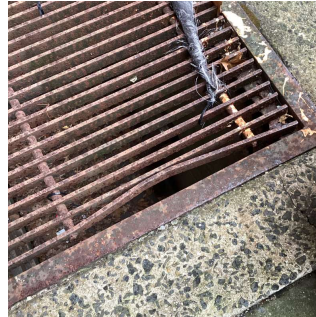
Facade A - AW2

Question	Response
<b>Architectural</b>	
<b>EXTERIOR</b>	Inspected
<b>AREAWAY</b>	Inspected
Instance on AW1-AW8	Inspected
Instance Condition	3 - Fair
Instance Quantity	8
Instance Quantity Uom	EACH
Deficiency	AREAWAY GRATINGS: MAJOR RUSTING / OR BROKEN
Roof Plan reference	
	<p>Q020</p> <p>The diagram is a smaller version of the floor plan shown above, but with a red rectangular box highlighting the area around room AW2, which is located near the Main Entrance and the 1996 Addition.</p>
Deficiency Quantity	30
Quantity Uom	S.F.

REPLACE  
 PRIORITY 4  
 LEVEL 2

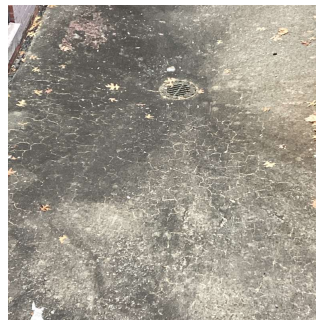
Facade B - AW3

**AREAWAY SLAB: CRACKS AND SPALLING**

200  
 S.F.  
 REPAIR  
 PRIORITY 3  
 LEVEL 2

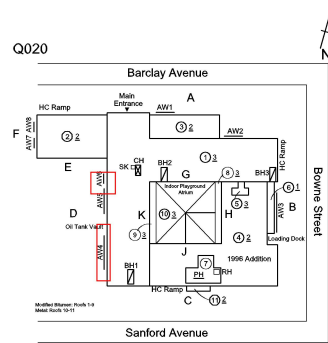
**AREAWAY WALLS: CRACKS AND SPALLING**

REPAIR

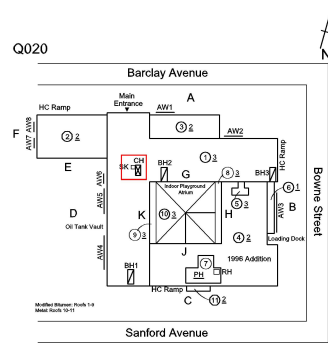
Violations	Roof 1 No violations recorded.
Deficiency	BRICK: DETERIORATED CAP

REPLACE

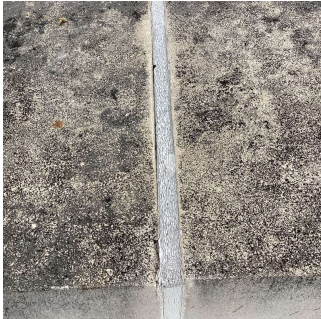
Violations	Roof 1 No violations recorded.
Deficiency	CAST STONE: DETERIORATED TRANSVERSE JOINTS
Roof Plan reference

Deficiency Quantity	50
Quantity Uom	L.F.
Potential Action	MAINTENANCE
Urgency of Action	PRIORITY 3
Purpose of Action	LEVEL 2
Deficiency Photo1

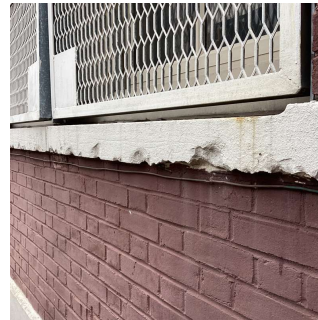
Facade A

BRICK: DETERIORATED MASONRY SILLS - MAJOR

REMOVE AND REPLACE

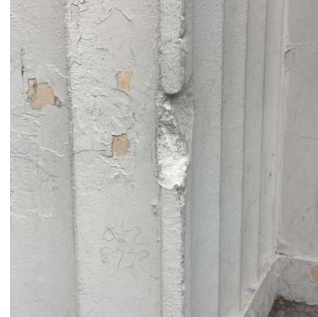
Facade B

STONE: CHIPPED/SPALLED/BROKEN PIECES - MAJOR

REPLACE

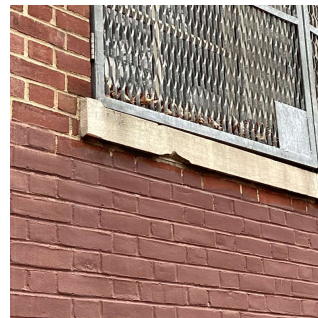
Facade D

BRICK: DETERIORATED MASONRY SILLS - MINOR

REPAIR

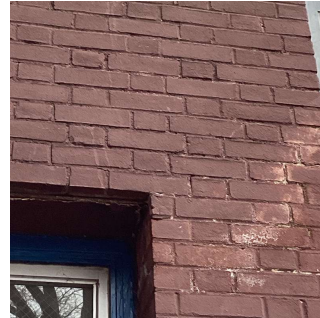
Facade D

BRICK: DETERIORATED JOINTS

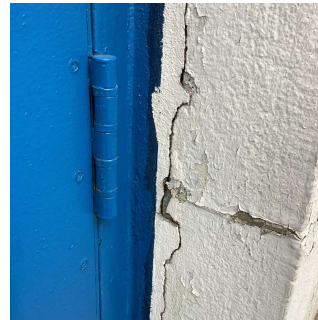
Facade F

STONE: CHIPPED/SPALLED/BROKEN PIECES - MINOR

REPAIR

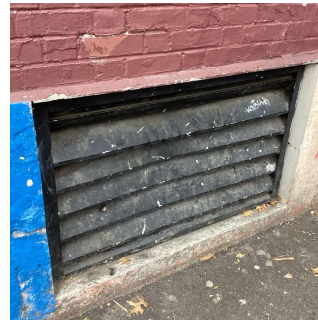
Facade E

BROKEN/ DENTED BLADES

REPLACE

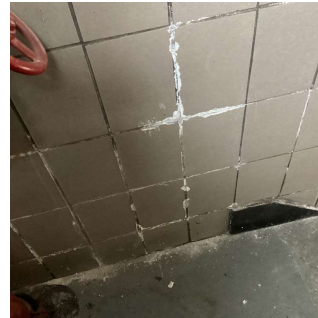
Roof 1 - Bulkhead 1

BULKHEAD/PENTHOUSE WALLS/EXTERIOR: WATER INFILTRATION

100  
S.F.  
REPAIR  
PRIORITY 5  
LEVEL 2

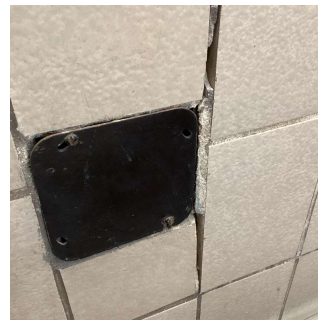
Roof 1 - Bulkhead 2

**BULKHEAD/PENTHOUSE WALLS/INTERIOR: SALT GLAZED BRICK DETERIORATED JOINTS**

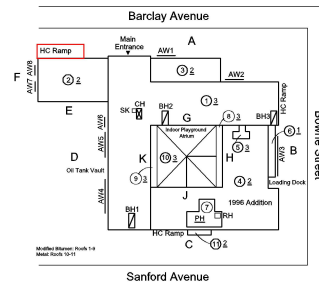
STUCCO CEMENT SURFACE: CRACKS/SPALLING - MINOR

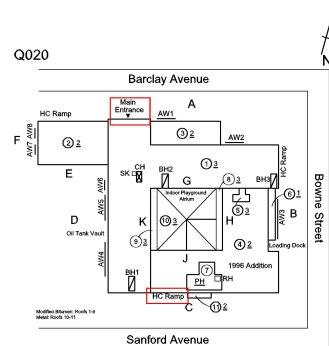
STONE: CRACKS/SPALLING - MINOR

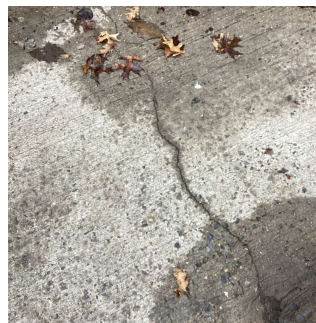
Facade C

**CONCRETE: CRACKS/SPALLING - MINOR**

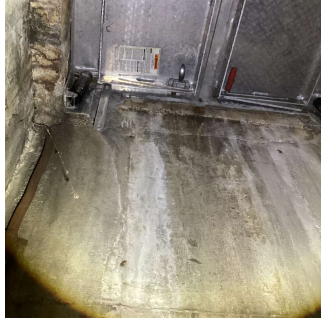
Condition	5 - Poor
Deficiency	WATER INFILTRATION
Deficiency Location/Instance	Basement - Ash Hoist Vault

Question	Response
<b>INTERIOR</b>	
<b>STRUCTURAL</b>	
<b>VAULTS-BUNKERS</b>	
<b>Vault/Ash Hoist Doors and Framing</b>	
Deficiency Quantity	10
Quantity Uom	S.F.
Potential Action	REPAIR
Urgency of Action	PRIORITY 5
Purpose of Action	LEVEL 2
Deficiency Photo1

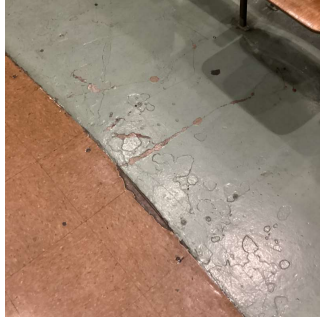
Question	Response
<b>INTERIOR</b>	
<b>AUDITORIUM</b>	
<b>Fixed Seating</b>	
Violations	No violations recorded.
<b>Floor Finish</b>	
Instance on 1st Floor (466 Seats)	Inspected
Condition	3 - Fair
Deficiency	VINYL TILES: BROKEN/DETERIORATED/MISSING TILES
Deficiency Location/Instance	Near Stage
Deficiency Quantity	10
Quantity Uom	S.F.
Potential Action	REPLACE
Urgency of Action	PRIORITY 3
Purpose of Action	LEVEL 2
Deficiency Photo1

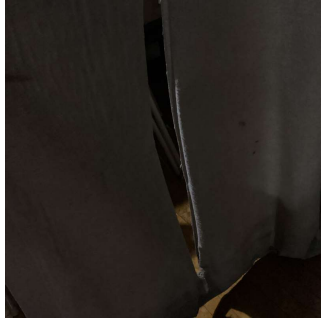
Question	Response
<b>INTERIOR</b>	
<b>AUDITORIUM</b>	
<b>Floor Finish</b>	
Deficiency Photo1	 
	Near Seat J/1
Violations	No violations recorded.
<b>Sliding-folding Partition</b>	
Instance on 1st Floor (466 Seats)	Does not Exist
<b>Stage</b>	
Instance on 1st Floor (466 Seats)	Inspected
<b>Stage</b>	Inspected
Instance on 1st Floor (466 Seats)	Inspected
Condition	3 - Fair
Deficiency	DAMAGED STEPS
Deficiency Location/Instance	Right and Left Side
Deficiency Quantity	30
Quantity Uom	S.F.
Potential Action	REPLACE
Urgency of Action	PRIORITY 3
Purpose of Action	LEVEL 2
Deficiency Photo1	 
	Right Side
Violations	No violations recorded.
<b>Stage Curtain Rigging</b>	
Instance on 1st Floor (466 Seats)	Inspected
Condition	2 - Between Good and Fair
Deficiency	No deficiencies recorded
<b>Stage Curtains</b>	
Instance on 1st Floor (466 Seats)	Inspected
Condition	4 - Between Fair and Poor
Deficiency	WORN/DETERIORATED
Deficiency Location/Instance	Lateral Right and Left Side, Back

Question	Response
<b>INTERIOR</b>	
<b>AUDITORIUM</b>	
<b>Stage</b>	
<b>Stage Curtains</b>	
Potential Action	REPLACE
Urgency of Action	PRIORITY 3
Purpose of Action	LEVEL 2
Deficiency Photo1

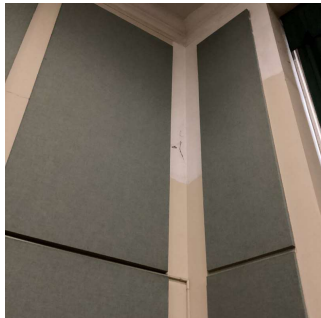
Lateral Right Side
Violations	No violations recorded.
<b>Walls</b>	
Instance on 1st Floor (466 Seats)	Inspected
Condition	2 - Between Good and Fair
Deficiency	PLASTER: CRACKS/SPALLING
Deficiency Location/Instance	Near Windows, Vestibule Exit 2
Deficiency Quantity	30
Quantity Uom	S.F.
Potential Action	REPLACE
Urgency of Action	PRIORITY 3
Purpose of Action	LEVEL 2
Deficiency Photo1

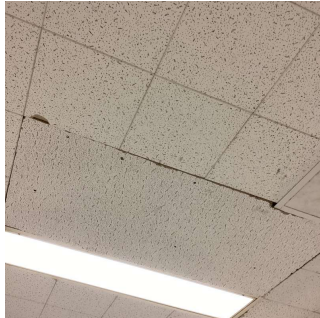
Room 320
Violations	No violations recorded.
Deficiency	ACOUSTIC TILES ON PLASTER: DAMAGED/MISSING
Deficiency Location/Instance	Room 259, Corridor near Rooms 241, 261, 263A, Near Exit 5
Deficiency Quantity	40
Quantity Uom	S.F.
Potential Action	REPLACE
Urgency of Action	PRIORITY 3
Purpose of Action	LEVEL 2
Deficiency Photo1

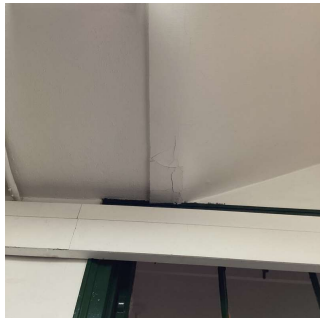
Room 334
Violations	No violations recorded.

Corridor near Room 241
Violations	No violations recorded.
Deficiency	PLASTER: CRACKS/SPALLING
Deficiency Location/Instance	Rooms 204, 301, 334, Corridor near Room 127.
Deficiency Quantity	40
Quantity Uom	S.F.
Potential Action	REPLACE
Urgency of Action	PRIORITY 3
Purpose of Action	LEVEL 2
Deficiency Photo1

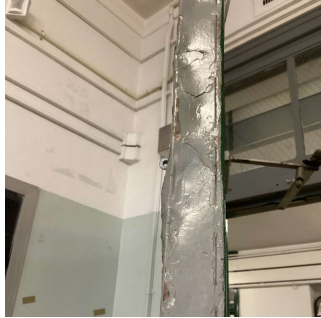
Question	Response
<b>INTERIOR</b>	
<b>CLASSROOMS/CORRIDORS/ADMIN SPACES</b>	
<b>Door(s)</b>	Inspected
Condition	5 - Poor
Deficiency	METAL: DETERIORATED DOOR
Deficiency Location/Instance	Room 306, Corridor near Rooms 228, 330
Deficiency Quantity	4
Quantity Uom	EACH
Potential Action	MAINTENANCE
Urgency of Action	PRIORITY 3
Purpose of Action	LEVEL 2
Deficiency Photo1

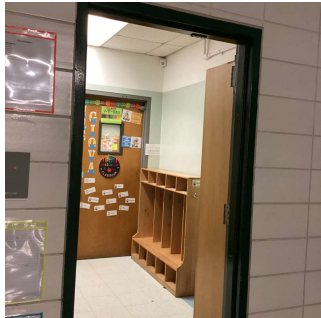
Violations	Room 306 No violations recorded.
Deficiency	METAL: MISSING DOOR
Deficiency Location/Instance	Room 320
Deficiency Quantity	1
Quantity Uom	EACH
Potential Action	MAINTENANCE
Urgency of Action	PRIORITY 3
Purpose of Action	LEVEL 2
Deficiency Photo1

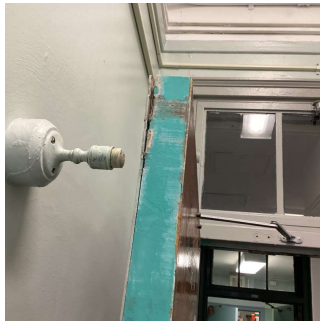
Violations	Room 320 No violations recorded.
Deficiency	WOOD: DETERIORATED DOOR
Deficiency Location/Instance	Rooms 105, 131, 234, 301, 318, and others.
Deficiency Quantity	22
Quantity Uom	EACH
Potential Action	MAINTENANCE
Urgency of Action	PRIORITY 3
Purpose of Action	LEVEL 2

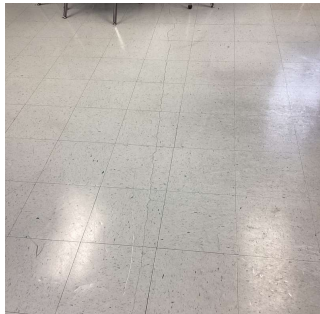
Violations	Room 306 No violations recorded.
Deficiency	VINYL TILES: DETERIORATED SUBSTRATE
Deficiency Location/Instance	Rooms 104, 166, 310, 320, Corridor near Room 241, and others.
Deficiency Quantity	2,000
Quantity Uom	S.F.
Potential Action	REPLACE
Urgency of Action	PRIORITY 3
Purpose of Action	LEVEL 2
Deficiency Photo1

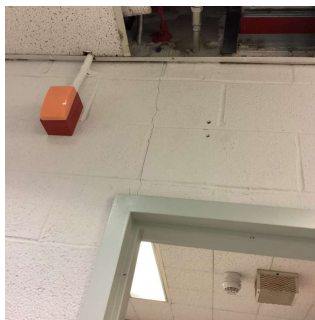
Violations	Room 249 No violations recorded.
Deficiency	MASONRY: CRACKS/SPALLING
Deficiency Location/Instance	Rooms 132, 133, 241, Corridor near Room 033

Deficiency Quantity	40
Quantity Uom	S.F.
Potential Action	REPLACE
Urgency of Action	PRIORITY 3
Purpose of Action	LEVEL 2

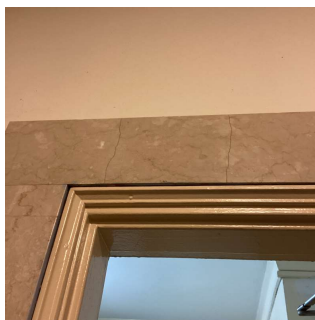
Room 241
Violations	No violations recorded.
Deficiency	STONE MOLDINGS: CRACKS/SPALLING
Deficiency Location/Instance	Corridor near Toilet Room Women - Main Entrance
Deficiency Quantity	10
Quantity Uom	L.F.
Potential Action	REPLACE
Urgency of Action	PRIORITY 3
Purpose of Action	LEVEL 2
Deficiency Photo1

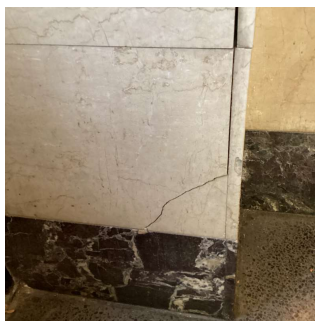
Main Entrance - Vestibule
Violations	No violations recorded.

Corridor near Toilet Room Women - Main Entrance
Violations	No violations recorded.
Deficiency	STONE: CRACKS/SPALLING
Deficiency Location/Instance	Main Entrance - Vestibule
Deficiency Quantity	20
Quantity Uom	S.F.
Potential Action	REPLACE
Urgency of Action	PRIORITY 3
Purpose of Action	LEVEL 2
Deficiency Photo1

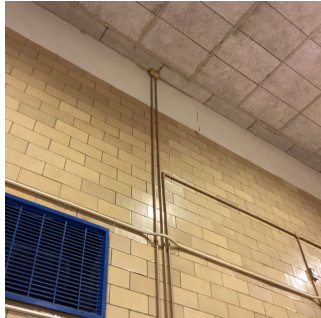
Question	Response
<b>INTERIOR</b>	
<b>GYMNASIUM</b>	
<b>Stage</b>	
Instance on 1st Floor	Does not Exist
<b>Walls</b>	
Instance on 1st Floor	Inspected
Condition	2 - Between Good and Fair
Deficiency	PLASTER: CRACKS/SPALLING
Deficiency Location/Instance	Near Entrances
Deficiency Quantity	20
Quantity Uom	S.F.
Potential Action	REPLACE
Urgency of Action	PRIORITY 3
Purpose of Action	LEVEL 2
Deficiency Photo1

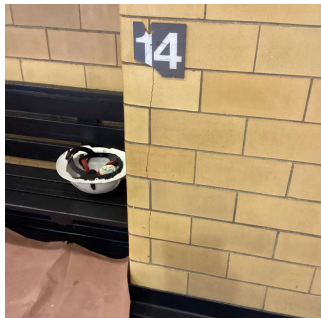
Violations	Near Entrance No violations recorded.
Deficiency	GLAZED BLOCK: CRACKS/SPALLING
Deficiency Location/Instance	Near Windows
Deficiency Quantity	20
Quantity Uom	S.F.
Potential Action	REPLACE
Urgency of Action	PRIORITY 3
Purpose of Action	LEVEL 2
Deficiency Photo1

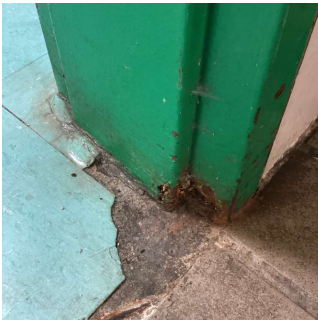
Violations	Serving Area No violations recorded.
<b>Door(s)</b>	
Instance on Basement	Inspected
Condition	4 - Between Fair and Poor
Deficiency	METAL: DETERIORATED DOOR AND FRAME
Deficiency Location/Instance	Serving Area Entrance, Mop Room

Deficiency Quantity	2

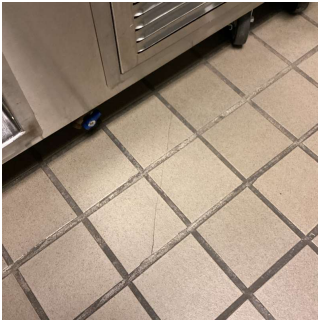
Serving Area Entrance
Violations	No violations recorded.
<b>Floor Finish</b>	
Instance on Basement	Inspected
Condition	3 - Fair
Deficiency	QUARRY TILE: BROKEN/MISSING TILES
Deficiency Location/Instance	Serving Area, Near Fridge Area, Near Walking Fridge, Room 009.
Deficiency Quantity	20
Quantity Uom	S.F.
Potential Action	REPLACE
Urgency of Action	PRIORITY 3
Purpose of Action	LEVEL 2
Deficiency Photo1

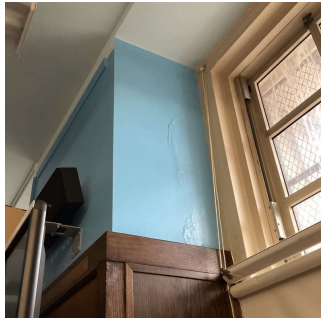
Room 220A
Violations	No violations recorded.
<b>Walls</b>	
Instance on Room 220	Inspected
Condition	2 - Between Good and Fair
Deficiency	PLASTER: CRACKS/SPALLING
Deficiency Location/Instance	Near Windows
Deficiency Quantity	10
Quantity Uom	S.F.
Potential Action	REPLACE
Urgency of Action	PRIORITY 3
Purpose of Action	LEVEL 2
Deficiency Photo1

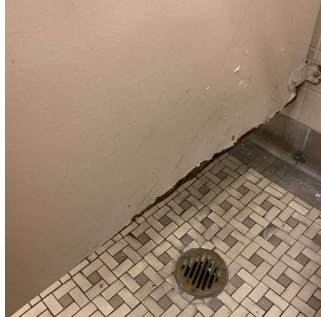
Violations	Room 107A No violations recorded.
<b>Stalls</b>	
Condition	Inspected
Condition	5 - Poor
Deficiency	RUST - MAJOR
Deficiency Location/Instance	Rooms 107A, 216A, 224, Inside Principal Office.

Deficiency Quantity	4
Quantity Uom	EACH
Potential Action	REPLACE
Urgency of Action	PRIORITY 3

Room 107A
Violations	No violations recorded.
<b>Walls</b>	Inspected
Condition	2 - Between Good and Fair
Deficiency	MASONRY: CRACKS/SPALLING
Deficiency Location/Instance	Room 023B, 242
Deficiency Quantity	10
Quantity Uom	S.F.
Potential Action	REPLACE
Urgency of Action	PRIORITY 3
Purpose of Action	LEVEL 2
Deficiency Photo1

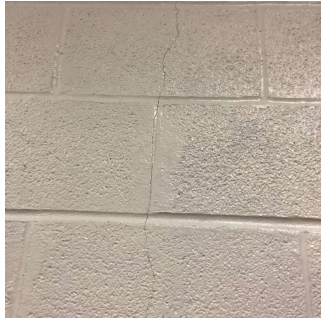
Room 242
Violations	No violations recorded.
Deficiency	PLASTER: CRACKS/SPALLING
Deficiency Location/Instance	Rooms 107A, 216A, Women - Main Entrance, Gymnasium Office.
Deficiency Quantity	30
Quantity Uom	S.F.
Potential Action	REPLACE
Urgency of Action	PRIORITY 3
Purpose of Action	LEVEL 2

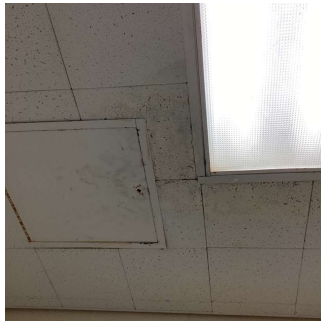
Question	Response
<b>INTERIOR</b>	
<b>TOILET ROOMS - STUDENTS</b>	
<b>Ceiling</b>	Inspected
Deficiency Photo1

Violations	Room 025 No violations recorded.
<b>Door(s)</b>	Inspected
Condition	5 - Poor
Deficiency	METAL: DETERIORATED DOOR AND FRAME
Deficiency Location/Instance	Room 025
Deficiency Quantity	1
Quantity Uom	EACH
Potential Action	MAINTENANCE
Urgency of Action	PRIORITY 3
Purpose of Action	LEVEL 2
Deficiency Photo1

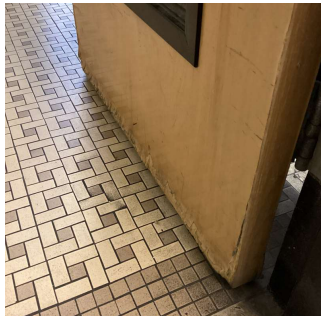
Violations	Room 025 No violations recorded.
Deficiency	WOOD: DETERIORATED DOOR
Deficiency Location/Instance	Rooms 125, 212, 225, 312, 323, and others.
Deficiency Quantity	7
Quantity Uom	EACH
Potential Action	MAINTENANCE
Urgency of Action	PRIORITY 3
Purpose of Action	LEVEL 2
Deficiency Photo1

Question	Response
<b>INTERIOR</b>	
<b>TOILET ROOMS - STUDENTS</b>	
<b>Door(s)</b>	Inspected
	Room 212
Violations	No violations recorded.
<b>Floor Finish</b>	Inspected
Condition	2 - Between Good and Fair
Deficiency	CERAMIC TILE: DETERIORATED SUBSTRATE
Deficiency Location/Instance	Rooms 123, 125, 212, 312
Deficiency Quantity	30
Quantity Uom	S.F.
Potential Action	REPLACE
Urgency of Action	PRIORITY 3
Purpose of Action	LEVEL 2
Deficiency Photo1

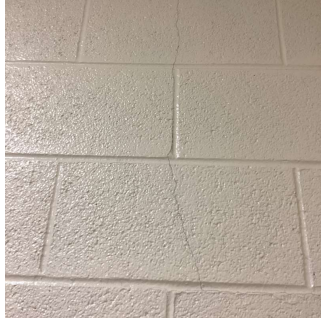
Room 323
Violations	No violations recorded.
<b>Walls</b>	Inspected
Condition	2 - Between Good and Fair
Deficiency	MASONRY: CRACKS/SPALLING
Deficiency Location/Instance	Rooms 024, 025, 143/151

Deficiency Quantity	20

Question	Response
<b>INTERIOR</b>	
<b>TOILET ROOMS - STUDENTS</b>	
<b>Walls</b>	
Quantity Uom	S.F.
Potential Action	REPLACE
Urgency of Action	PRIORITY 3
Purpose of Action	LEVEL 2
Deficiency Photo1

Room 025
Violations	No violations recorded.
Deficiency	PLASTER: CRACKS/SPALLING
Deficiency Location/Instance	Rooms 123, 125, 212
Deficiency Quantity	30
Quantity Uom	S.F.
Potential Action	REPLACE
Urgency of Action	PRIORITY 3
Purpose of Action	LEVEL 2
Deficiency Photo1

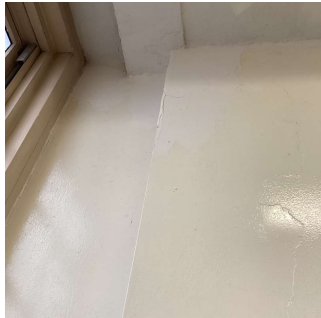
Room 212
Violations	No violations recorded.
Deficiency	CERAMIC TILE: BROKEN/ MISSING
Deficiency Location/Instance	Rooms 125, 212, 225, 312, 323, and others.
Deficiency Quantity	40
Quantity Uom	S.F.
Potential Action	REPLACE
Urgency of Action	PRIORITY 3
Purpose of Action	LEVEL 2

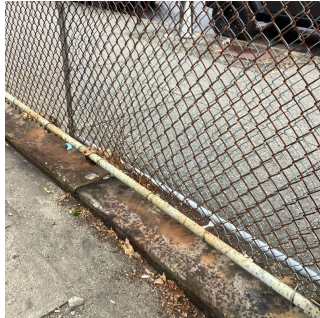
<b>Culverts - Soil Covering</b>	Does not Exist
<b>DRINKING FOUNTAINS</b>	Does not Exist
<b>FENCES</b>	Inspected
Condition	4 - Between Fair and Poor
Deficiency	CHAIN LINK: RUST - MAJOR
Deficiency Location/Instance	Parking Lot
Deficiency Quantity	1,300
Quantity Uom	S.F.
Potential Action	REPLACE
Urgency of Action	PRIORITY 3
Purpose of Action	LEVEL 2

Violations	Parking Lot No violations recorded.
Deficiency	CONCRETE CURB: DAMAGED/DETERIORATED
Deficiency Location/Instance	Barclay Avenue, Browne Street, Sanford Avenue.
Deficiency Quantity	100
Quantity Uom	S.F.
Potential Action	REPLACE
Urgency of Action	PRIORITY 3
Purpose of Action	LEVEL 2
Deficiency Photo1

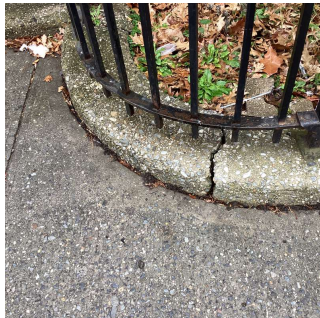
Violations	Barclay Avenue No violations recorded.
Deficiency	WROUGHT IRON: DAMAGED/DETERIORATED
Deficiency Location/Instance	Barclay Avenue, Sanford Avenue.
Deficiency Quantity	80
Quantity Uom	S.F.
Potential Action	REPLACE
Urgency of Action	PRIORITY 3
Purpose of Action	LEVEL 2
Deficiency Photo1

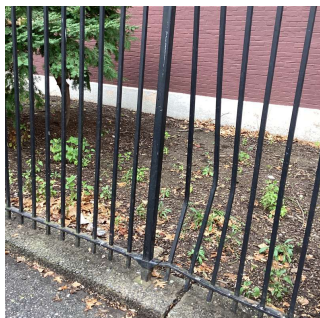
Violations	Barclay Avenue No violations recorded.
<b>IRRIGATION SYSTEM</b>	Inspected

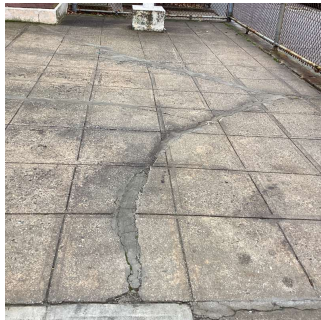
Question	Response
<b>SITE</b>	
<b>IRRIGATION SYSTEM</b>	Inspected
Condition	2 - Between Good and Fair
Deficiency	No deficiencies recorded
<b>PAVING</b>	Inspected
<b>Student Non-Use</b>	Inspected
Gravel Exists?	No
<b>Asphalt</b>	Does not Exist
<b>Concrete</b>	Inspected
Condition	4 - Between Fair and Poor
Deficiency	DAMAGED/DETERIORATED/MISSING SECTIONS
Deficiency Location/Instance	Barclay Avenue, Parking Area.
Deficiency Quantity	600
Quantity Uom	S.F.
Potential Action	REPLACE
Urgency of Action	PRIORITY 3
Purpose of Action	LEVEL 2
Deficiency Photo1

Violations	Parking Area No violations recorded.
<b>Pavers</b>	Does not Exist
<b>Student Use</b>	Does not Exist
<b>Site Sidewalks &amp; Walkways</b>	Inspected
<b>Asphalt</b>	Does not Exist
<b>Concrete</b>	Inspected
Condition	3 - Fair
Deficiency	DAMAGED/DETERIORATED/MISSING SECTIONS
Deficiency Location/Instance	Near Exits 2, 3
Deficiency Quantity	50
Quantity Uom	S.F.
Potential Action	REPLACE

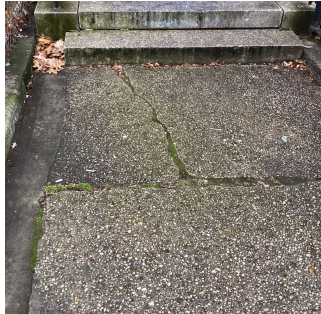
Urgency of Action	PRIORITY 3
Purpose of Action	LEVEL 2
Deficiency Photo1

Question	Response
<b>SITE</b>	
<b>PAVING</b>	Inspected
<b>Site Sidewalks &amp; Walkways</b>	
<b>Concrete</b>	Inspected
Violations	Near Exit 2 No violations recorded.
<b>Pavers</b>	Inspected
Condition	2 - Between Good and Fair
Deficiency	No deficiencies recorded
<b>DOT Sidewalk</b>	Inspected
<b>Asphalt</b>	Does not Exist
<b>Concrete</b>	Inspected
Condition	4 - Between Fair and Poor
Deficiency	HEAVING
Deficiency Location/Instance	Sanford Avenue
Deficiency Quantity	100
Quantity Uom	S.F.
Potential Action	REPLACE
Urgency of Action	PRIORITY 3
Purpose of Action	LEVEL 2
Deficiency Photo1

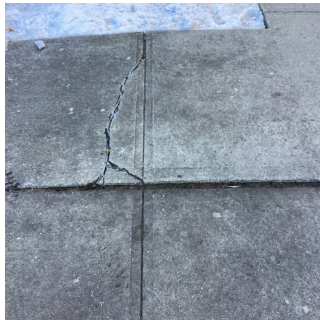
Violations	Sanford Avenue No violations recorded.
<b>Deficiency</b>	<b>DAMAGED/DETERIORATED/MISSING SECTIONS</b>
Deficiency Location/Instance	Barclay Avenue, Browne Street, Sanford Avenue.
Deficiency Quantity	1,600
Quantity Uom	S.F.
Potential Action	REPLACE
Urgency of Action	PRIORITY 3
Purpose of Action	LEVEL 2
Deficiency Photo1

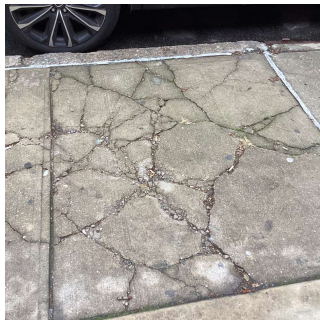
Violations	Barclay Avenue No violations recorded.

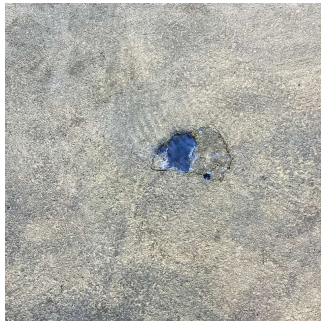
<b>Safety Surfacing</b>	
Instance on Interior Courtyard	Inspected
Condition	2 - Between Good and Fair
Deficiency	DETERIORATED/MISSING
Deficiency Location/Instance	Near Entrance, Center
Deficiency Quantity	20
Quantity Uom	S.F.
Potential Action	REPLACE
Urgency of Action	PRIORITY 3
Purpose of Action	LEVEL 2

Near Entrance
Violations	No violations recorded.
<b>Unpaved Area</b>	
Instance on Interior Courtyard	Inspected
Condition	2 - Between Good and Fair
Deficiency	No deficiencies recorded
<b>PLAYING SURFACE</b>	Does not Exist
<b>RETAINING WALLS</b>	Does not Exist
<b>SEATING</b>	Inspected
<b>Benches</b>	Inspected
<b>Concrete</b>	Does not Exist
<b>Metal/Wood/Plastic</b>	Inspected
Condition	2 - Between Good and Fair
Deficiency	No deficiencies recorded
<b>Bleachers</b>	Does not Exist
<b>SITE WALLS (NOT RETAINING WALLS)</b>	Does not Exist
<b>STAIRS/RAMPS: EXTERIOR</b>	Does not Exist
<b>ARTWORK</b>	Inspected
Instance	Interior - 1st Floor Atrium Lobby - 21603
Instance Photo
