NYC Department of Education
Building Condition Assessment Survey 2023 - 2024

Architectural Inspection

Asset: P.S. 22 - QUEENS, 153-33 SANFORD AVENUE, New York, 11355

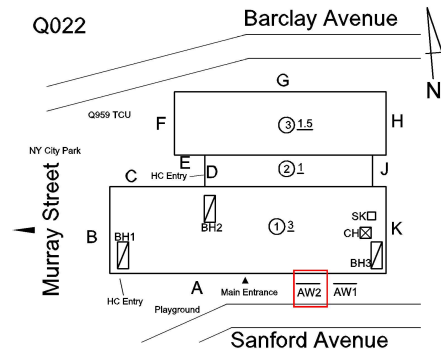
Question	Response
Architectural	
EXTERIOR	Inspected
AREAWAY	Inspected
Instance on AW1, AW2	Inspected
Instance Condition	3 - Fair
Instance Quantity	2
Instance Quantity Uom	EACH
Deficiency	AREAWAY STAIRS: DETERIORATED MATERIAL SLIDE
Roof Plan reference	<p>Q022</p>

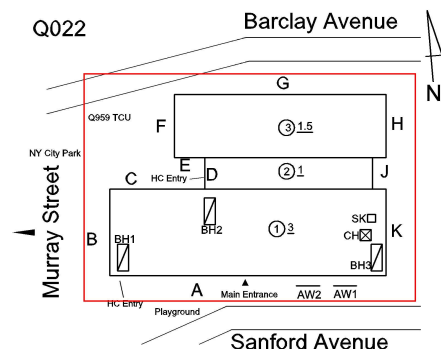
Question	Response
EXTERIOR	
COPING	
Roof Plan reference

Deficiency Quantity	50
Quantity Uom	L.F.
Potential Action	MAINTENANCE
Urgency of Action	PRIORITY 3
Purpose of Action	LEVEL 2
Deficiency Photo1

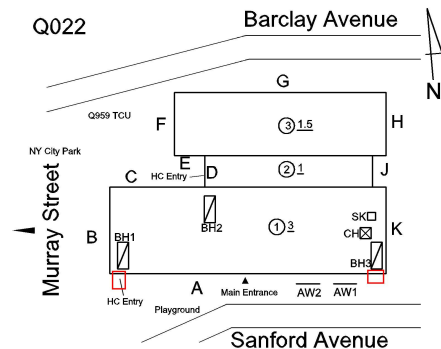
Question	Response
EXTERIOR	
DOORS	
DOORS AND FRAMES	
Violations	No violations recorded.
Deficiency	METAL: DETERIORATED DOOR AND FRAME - MAJOR DETERIORATION
Roof Plan reference	<p>Q022</p>

Deficiency Quantity	4
Quantity Uom	EACH
Potential Action	REPLACE
Urgency of Action	PRIORITY 4
Purpose of Action	LEVEL 2
Deficiency Photo1

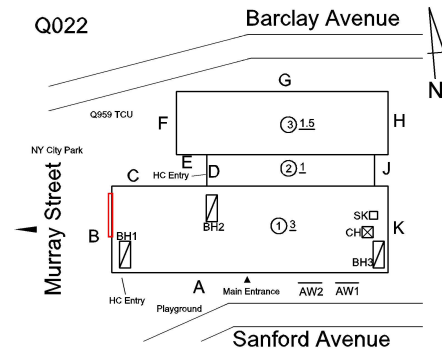
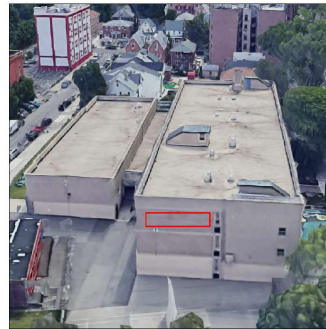
Violations	Facade A No violations recorded.
DOOR HARDWARE	Inspected
Condition	3 - Fair
Deficiency	No deficiencies recorded
LINTELS	Inspected
Condition	2 - Between Good and Fair
Deficiency	No deficiencies recorded
TRANSOM/SIDE LIGHT	Inspected
Condition	2 - Between Good and Fair
Deficiency	No deficiencies recorded
EXTERIOR WALLS	Inspected
Material Type(s)	Concrete, Masonry
Replacement Quantity	25,300
Replacement Uom	S.F.
Instance on All Facades	Inspected
Instance Condition	3 - Fair
Instance Quantity	25,300
Instance Quantity Uom	S.F.
Deficiency	BRICK: DETERIORATED JOINTS

Deficiency Quantity

200

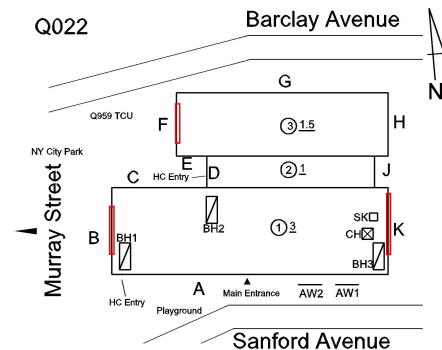
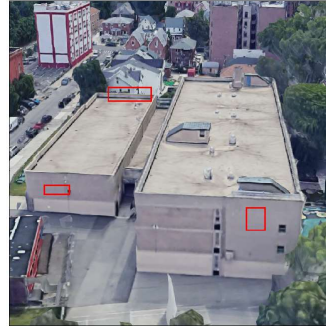
BRICK: EFFLORESCENCE

Deficiency Quantity

200

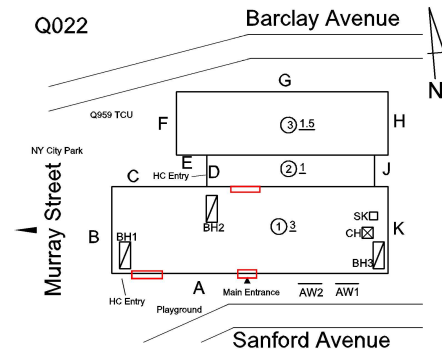
CONCRETE: MAJOR DETERIORATION/CRACKS

Deficiency Quantity

30

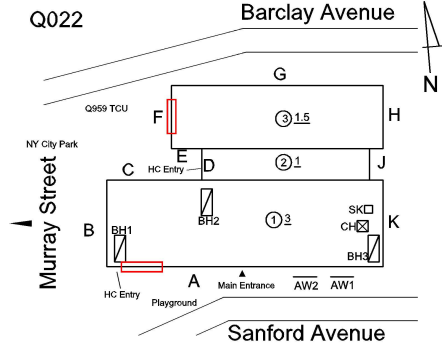
Violations	Roof 1 No violations recorded.
Deficiency	BRICK: EFFLORESCENCE
Roof Plan reference	<p>Q022</p>

Deficiency Quantity	20
Quantity Uom	S.F.
Potential Action	MAINTENANCE
Urgency of Action	PRIORITY 1
Purpose of Action	LEVEL 1
Deficiency Photo1	No photo recorded
Violations	No violations recorded.
PLAZA DECK	Does not Exist
ROOF	Inspected
Roofing	Inspected
Replacement Quantity	28,300
Replacement Uom	S.F.
ROOF HATCH/SMOKE HATCH	Does not Exist
LEADERS, GUTTERS, DOWNSPOUTS, SCUPPERS	Inspected
Condition	2 - Between Good and Fair
Deficiency	No deficiencies recorded
ROOF BARRIER/FENCE	Inspected
Condition	2 - Between Good and Fair
Deficiency	No deficiencies recorded
ROOF CAGE	Does not Exist
ROOFING	Inspected
Instance on Built-Up: All Roofs	Inspected
Instance Condition	3 - Fair

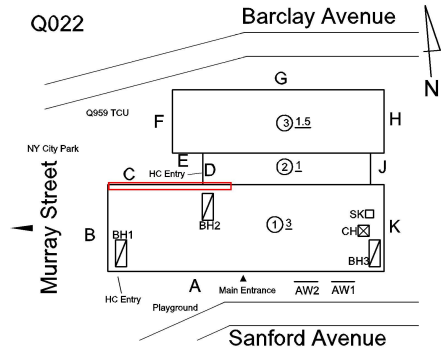
Roof 1
Instance Quantity	28,300
Instance Quantity Uom	S.F.
Does the roof have major mechanical equipment sitting on Dunnage Steel less than 18" above the Roofing?	No
Does this roof instance have a Sustainable Roof System?	No
Do solar panels exist on these roofs?	No
Is/Are the roof(s) suitable for Solar Panel installation?	Yes
Installation Year	2000
Source of Installation	Custodial Staff
Deficiency	BUILT-UP: FLASHING: BASE FLASHING DETERIORATED
Roof Plan reference

Deficiency Quantity	100
Quantity Uom	S.F.
Potential Action	REPAIR
Urgency of Action	PRIORITY 3
Purpose of Action	LEVEL 2
Deficiency Photo1

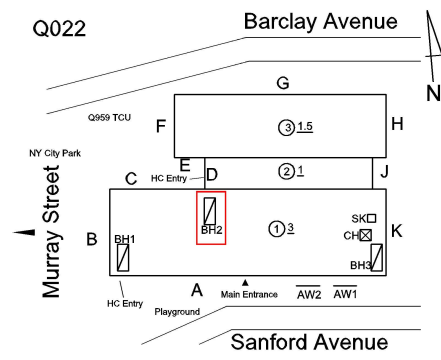
Question	Response
EXTERIOR	
ROOF	
Specialties	
BULKHEAD/PENTHOUSE	Inspected
Condition	3 - Fair
Deficiency	BULKHEAD/PENTHOUSE WALLS/EXTERIOR: DETERIORATED JOINTS
Roof Plan reference

Deficiency Quantity	10
Quantity Uom	S.F.
Potential Action	REPOINT
Urgency of Action	PRIORITY 4
Purpose of Action	LEVEL 2
Deficiency Photo1

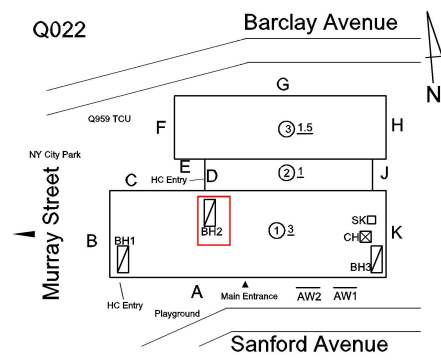
Violations	Roof 1 - Bulkhead 2 No violations recorded.
Deficiency	BULKHEAD/PENTHOUSE ROOF: MINOR LEAKAGE
Roof Plan reference

Deficiency Quantity	50
Quantity Uom	S.F.
Potential Action	MAINTENANCE
Urgency of Action	PRIORITY 3
Purpose of Action	LEVEL 2

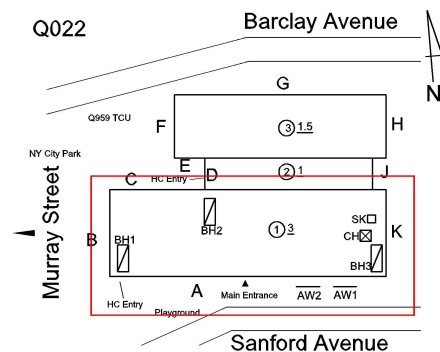
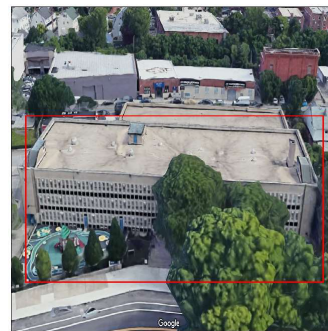
Question	Response
EXTERIOR	
STAIRS/RAMPS: EXTERIOR	
BUILDING CHEEK/FLANK WALLS	Does not Exist
RAILINGS	Inspected
Condition	2 - Between Good and Fair
Deficiency	No deficiencies recorded
STAIRS/RAMPS	Inspected
Condition	2 - Between Good and Fair
Deficiency	No deficiencies recorded
WINDOWS	Inspected
Replacement Quantity	7,000
Replacement Uom	S.F.
EXTERIOR GUARDS	Inspected
Condition	4 - Between Fair and Poor
Deficiency	RUST - MAJOR
Roof Plan reference

300
S.F.
REPLACE
PRIORITY 4
LEVEL 2

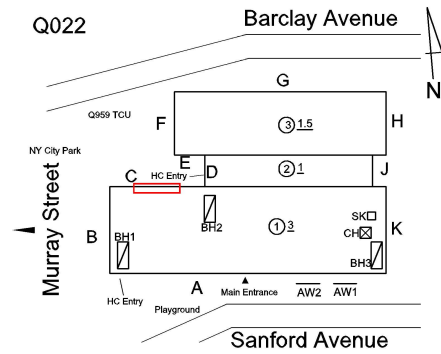
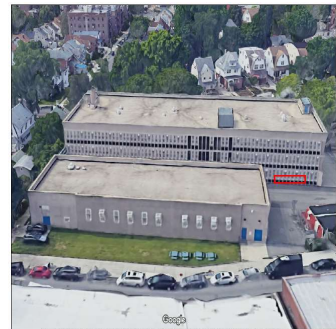
Question	Response
EXTERIOR	
WINDOWS	
LINTELS	Inspected
Condition	2 - Between Good and Fair
Deficiency	No deficiencies recorded
WINDOWS	Inspected
Material Type(s)	Aluminum, Steel
Instance on Aluminum - Double Hung: All Facades	Inspected
Instance Condition	3 - Fair
Instance Quantity	6,700
Instance Quantity Uom	S.F.
Are these windows insulated	No
Installation Year	2000
Source of Installation	Custodial Staff
Deficiency	ALUMINUM - DOUBLE HUNG: AIR/WATER INFILTRATION
Roof Plan reference	<p>Q022</p>

Deficiency Quantity	90
Quantity Uom	L.F.
Potential Action	REPLACE TRIM, SILLS OR WEATHERSTRIPPING
Urgency of Action	PRIORITY 5
Purpose of Action	LEVEL 2
Deficiency Photo1

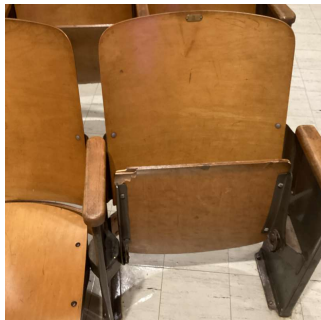
Question	Response
INTERIOR	
AUDITORIUM	
Ceiling	
Deficiency	No deficiencies recorded
Door(s)	
Instance on 1st Floor (218 Seats)	Inspected
Condition	2 - Between Good and Fair
Deficiency	No deficiencies recorded
Fixed H/C Lift	
Instance on 1st Floor (218 Seats)	Does not Exist
Fixed Seating	
Instance on 1st Floor (218 Seats)	Inspected
Condition	3 - Fair
Deficiency	DAMAGED/BROKEN/INOPERABLE
Deficiency Location/Instance	Seats A/2, J/113
Deficiency Quantity	2
Quantity Uom	EACH
Potential Action	REPLACE
Urgency of Action	PRIORITY 5
Purpose of Action	LEVEL 6
Deficiency Photo1

Violations	Seat A/2 No violations recorded.
Deficiency	DAMAGED/BROKEN/INOPERABLE
Deficiency Location/Instance	Seats C/7, D/5, J/4, L/4, M/2, and others
Deficiency Quantity	15
Quantity Uom	EACH
Potential Action	REPLACE
Urgency of Action	PRIORITY 3
Purpose of Action	LEVEL 2
Deficiency Photo1

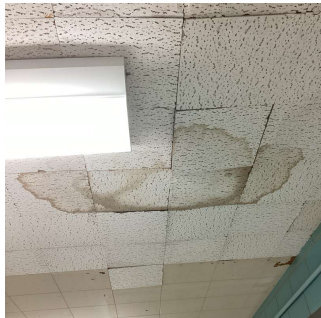
Near Entrance
Violations	No violations recorded.
Window Curtains/Shades/Blinds	
Instance on 1st Floor	Does not Exist
CLASSROOMS/CORRIDORS/ADMIN SPACES	
Ceiling	
Condition	2 - Between Good and Fair
Deficiency	ACOUSTIC TILES ON PLASTER: DAMAGED/MISSING
Deficiency Location/Instance	Corridor near Room 111
Deficiency Quantity	10
Quantity Uom	S.F.
Potential Action	REPLACE
Urgency of Action	PRIORITY 3
Purpose of Action	LEVEL 2
Deficiency Photo1

Corridor near Room 111
Violations	No violations recorded.

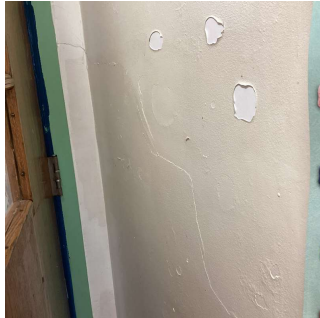
Question	Response
INTERIOR	
CLASSROOMS/CORRIDORS/ADMIN SPACES	
Walls	
Quantity Uom	S.F.
Potential Action	REPLACE
Urgency of Action	PRIORITY 3
Purpose of Action	LEVEL 2
Deficiency Photo1	 
	Near Auditorium
Violations	No violations recorded.
Deficiency	PLASTER: CRACKS/SPALLING
Deficiency Location/Instance	Rooms 123, 220
Deficiency Quantity	20
Quantity Uom	S.F.
Potential Action	REPLACE
Urgency of Action	PRIORITY 3
Purpose of Action	LEVEL 2
Deficiency Photo1

Room 220
Violations	No violations recorded.
Specialties	Inspected
Classroom Locker(s)	Does not Exist
Fixed Seating	Does not Exist
GYMNASIUM	Inspected
Instance on 1st Floor	Inspected
Ceiling	
Instance on 1st Floor	Inspected
Condition	2 - Between Good and Fair
Deficiency	No deficiencies recorded
Door(s)	
Instance on 1st Floor	Inspected
Condition	2 - Between Good and Fair
Deficiency	No deficiencies recorded
Fixed Equipment

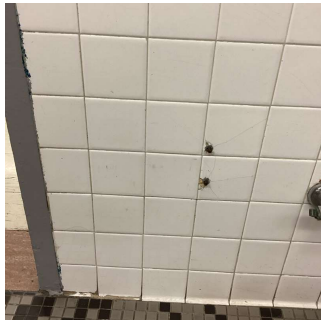
Near Mop Room
Violations	No violations recorded.
Walls	
Instance on 1st Floor	Inspected
Condition	2 - Between Good and Fair
Deficiency	CERAMIC TILE: BROKEN/ MISSING
Deficiency Location/Instance	Near Entrance, Emergency Exit, Windows
Deficiency Quantity	20
Quantity Uom	S.F.
Potential Action	REPLACE
Urgency of Action	PRIORITY 3
Purpose of Action	LEVEL 2
Deficiency Photo1

Near Entrance
Violations	No violations recorded.
LIBRARY	Does not Exist
LOCKER ROOM	Does not Exist
MULTI-PURPOSE ROOM	Does not Exist
SCIENCE DEMO ROOM	Does not Exist
SCIENCE LAB	Does not Exist
SCIENCE PREP ROOM	Does not Exist
SHOWER ROOM	Does not Exist
STAIRS/RAMPS: INTERIOR	Inspected
Do Letter Stair Signs Exist?	Yes

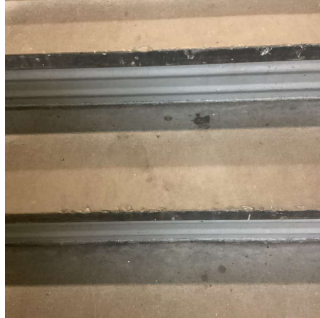
Violations	Stair B/Vestibule No violations recorded.
Door(s)	Inspected
Condition	2 - Between Good and Fair
Deficiency	No deficiencies recorded
Partition	Does not Exist
Railings	Inspected
Condition	2 - Between Good and Fair
Deficiency	No deficiencies recorded
Stairs and Landings	Inspected
Condition	5 - Poor
Deficiency	STONE: BROKEN/MISSING
Deficiency Location/Instance	Stairs A/1, B/1, 2, C/1, 2, and others
Deficiency Quantity	300
Quantity Uom	S.F.
Potential Action	REPLACE
Urgency of Action	PRIORITY 3
Purpose of Action	LEVEL 2
Deficiency Photo1

Violations	Stair C/1 No violations recorded.
Deficiency	VINYL TILES: BROKEN/DETERIORATED/MISSING TILES

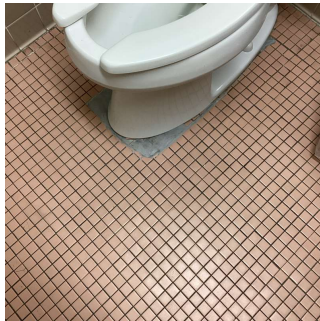
Question	Response
INTERIOR	
TOILET ROOMS - STAFF	
Floor Finish	
Deficiency Photo1

Room 104
Violations	No violations recorded.
Stalls	Inspected
Condition	5 - Poor
Deficiency	RUST - MAJOR
Deficiency Location/Instance	Rooms 107, 213, 315, 317, Kitchen
Deficiency Quantity	5
Quantity Uom	EACH
Potential Action	REPLACE
Urgency of Action	PRIORITY 3
Purpose of Action	LEVEL 2
Deficiency Photo1

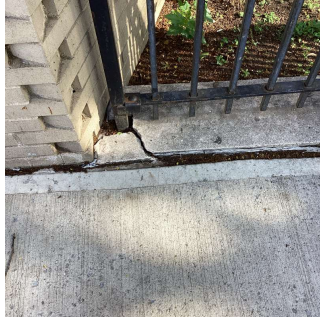
Question	Response
SITE	
FENCES	
Deficiency	CONCRETE CURB: DAMAGED/DETERIORATED
Deficiency Location/Instance	Sanford Avenue
Deficiency Quantity	70
Quantity Uom	S.F.
Potential Action	REPLACE
Urgency of Action	PRIORITY 3
Purpose of Action	LEVEL 2
Deficiency Photo1

Violations	Sanford Avenue No violations recorded.
IRRIGATION SYSTEM	Does not Exist
PAVING	Inspected
Student Non-Use	Inspected
Gravel Exists?	No
Asphalt	Does not Exist
Concrete	Inspected
Condition	3 - Fair
Deficiency	HEAVING
Deficiency Location/Instance	Sanford Avenue
Deficiency Quantity	50
Quantity Uom	S.F.
Potential Action	REPLACE
Urgency of Action	PRIORITY 3
Purpose of Action	LEVEL 2
Deficiency Photo1

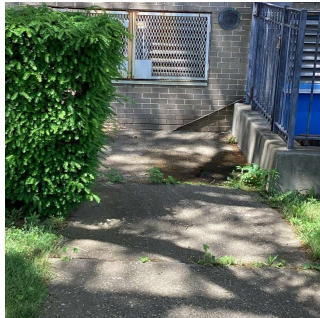
Violations	Sanford Avenue No violations recorded.
Pavers	Does not Exist
Student Use	Inspected
Gravel Exists?	No
Asphalt	Inspected
Condition	1 - Good

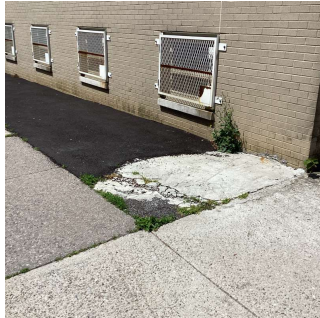
Question	Response
SITE	
PAVING	
Student Use	
Asphalt	Inspected
Deficiency	No deficiencies recorded
Concrete	Inspected
Condition	1 - Good
Deficiency	No deficiencies recorded
Pavers	Does not Exist
Site Sidewalks & Walkways	Inspected
Asphalt	Inspected
Condition	2 - Between Good and Fair
Deficiency	CRACKS - MAJOR
Deficiency Location/Instance	Near Barclays Avenue
Deficiency Quantity	30
Quantity Uom	S.F.
Potential Action	REPLACE
Urgency of Action	PRIORITY 3
Purpose of Action	LEVEL 2
Deficiency Photo1

Violations	Near Barclays Avenue No violations recorded.
Concrete	Inspected
Condition	3 - Fair
Deficiency	DAMAGED/DETERIORATED/MISSING SECTIONS
Deficiency Location/Instance	Main Entrance, Exits to Barclay Avenue playground, Kitchen Entrance
Deficiency Quantity	200
Quantity Uom	S.F.
Potential Action	REPLACE
Urgency of Action	PRIORITY 3
Purpose of Action	LEVEL 2
Deficiency Photo1

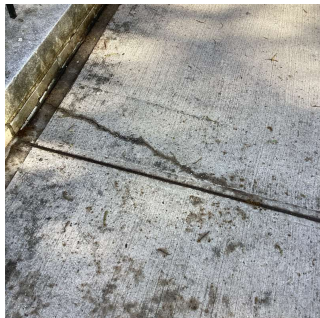
Violations	Main Entrance No violations recorded.

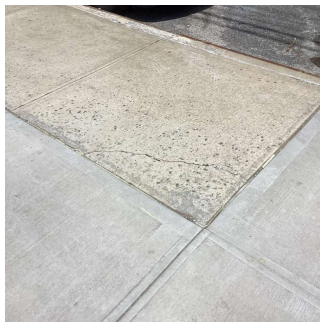
Question	Response
SITE	
PAVING	
Site Sidewalks & Walkways	Inspected
Pavers	Does not Exist
DOT Sidewalk	Inspected
Asphalt	Does not Exist
Concrete	Inspected
Condition	3 - Fair
Deficiency	DAMAGED/DETERIORATED/MISSING SECTIONS
Deficiency Location/Instance	Barclays Avenue
Deficiency Quantity	150
Quantity Uom	S.F.
Potential Action	REPLACE
Urgency of Action	PRIORITY 3
Purpose of Action	LEVEL 2
Deficiency Photo1

Violations	Barclays Avenue No violations recorded.
Deficiency	DAMAGED CURBS
Deficiency Location/Instance	Sanford Avenue, Barclays Avenue
Deficiency Quantity	50
Quantity Uom	L.F.
Potential Action	REPLACE
Urgency of Action	PRIORITY 3
Purpose of Action	LEVEL 2
Deficiency Photo1

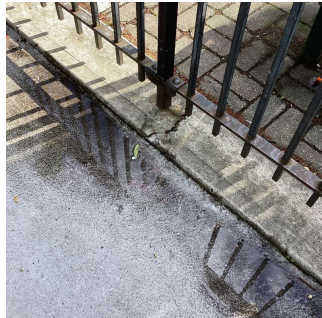
Question	Response
SITE	
PLAYGROUNDS	
Benches	
Instance on Barclay Avenue	Does not Exist
Instance on Sanford Avenue	Inspected
Condition	2 - Between Good and Fair
Deficiency	No deficiencies recorded
Fence	
Instance on Sanford Avenue	Inspected
Condition	2 - Between Good and Fair
Deficiency	CONCRETE CURB: DAMAGED/DETERIORATED
Deficiency Location/Instance	NYC Park
Deficiency Quantity	10
Quantity Uom	S.F.
Potential Action	REPLACE
Urgency of Action	PRIORITY 3
Purpose of Action	LEVEL 2
Deficiency Photo1

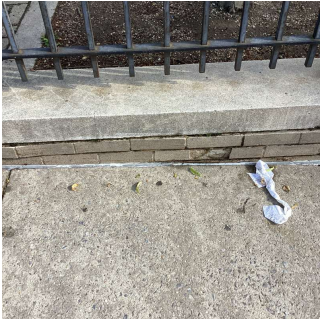
Violations	Sanford Avenue No violations recorded.
SEATING	Does not Exist
SITE WALLS (NOT RETAINING WALLS)	Inspected
Condition	2 - Between Good and Fair
Deficiency	No deficiencies recorded
STAIRS/RAMPS: EXTERIOR	Does not Exist
ARTWORK	Does not Exist

Question	Response
SITE	
RETAINING WALLS	
Deficiency Photo1
