NYC Department of Education
Building Condition Assessment Survey 2023 - 2024

Architectural Inspection

Asset: I.S. 53 - QUEENS, 10-45 NAMEOKE STREET, New York, 11691

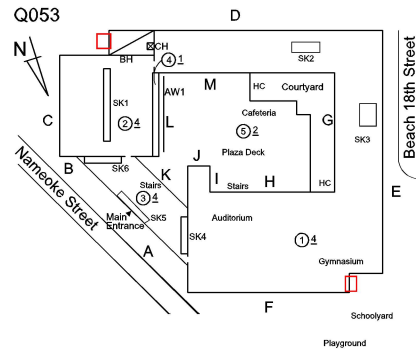
Question	Response
Architectural	
EXTERIOR	Inspected
AREAWAY	Inspected
Instance on AW1	Inspected
Instance Condition	2 - Between Good and Fair
Instance Quantity	1
Instance Quantity Uom	EACH
Deficiency	No deficiencies recorded
AWNINGS AND CANOPIES	Does not Exist
CHIMNEY	Inspected
Material Type(s)	Masonry
Condition	1 - Good
Deficiency	No deficiencies recorded
COPING	Inspected
Condition	1 - Good
Deficiency	No deficiencies recorded
CORNICE	Does not Exist
DOORS	Inspected
DOORS AND FRAMES	Inspected
Condition	5 - Poor
Deficiency	METAL CLAD: DETERIORATED DOOR AND FRAME - MAJOR DETERIORATION

2
EACH
REPLACE
PRIORITY 4
LEVEL 2

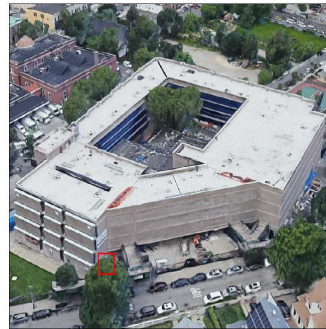
Question	Response
EXTERIOR	
DOORS	
DOORS AND FRAMES	
Roof Plan reference	
Deficiency Quantity	4
Quantity Uom	EACH
Potential Action	REPLACE
Urgency of Action	PRIORITY 4
Purpose of Action	LEVEL 2
Deficiency Photo1	
Violations	Facade A No violations recorded.
DOOR HARDWARE	Inspected
Condition	3 - Fair
Deficiency	No deficiencies recorded
LINTELS	Inspected
Condition	2 - Between Good and Fair
Deficiency	No deficiencies recorded
TRANSOM/SIDE LIGHT	Inspected
Condition	2 - Between Good and Fair
Deficiency	No deficiencies recorded
EXTERIOR WALLS	Inspected
Material Type(s)	Masonry, Wood
Replacement Quantity	72,000
Replacement Uom	S.F.
Instance on All Facades	Inspected
Instance Condition	3 - Fair
Instance Quantity	72,000
Instance Quantity Uom	S.F.
Deficiency	BRICK: WATER INFILTRATION IN INSTRUCTIONAL SPACE

100

REPAIR

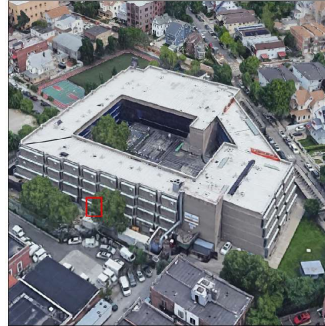
BRICK: CRACKS/DISPLACED/SPALLED BRICK AT BUILDING CORNERS

10

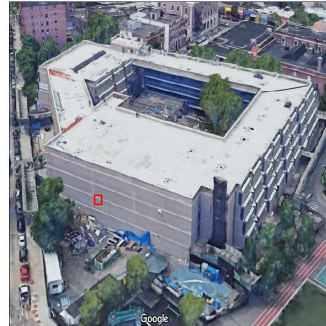
Facade F
No violations recorded.

BRICK: MAJOR / THRU CRACKS

10
S.F.
REMOVE AND REBUILD
PRIORITY 4
LEVEL 2

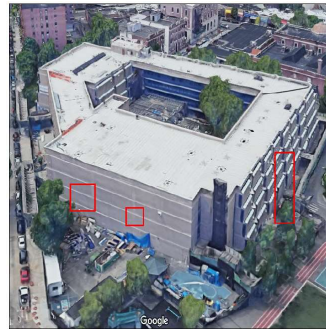
Facade F
No violations recorded.

BRICK: DETERIORATED JOINTS

1,000
S.F.
REPOINT
PRIORITY 3
LEVEL 2

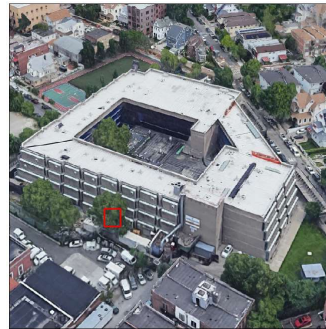
Facade D
No violations recorded.

MAJOR RUSTING

10
S.F.
REPLACE
PRIORITY 4
LEVEL 2

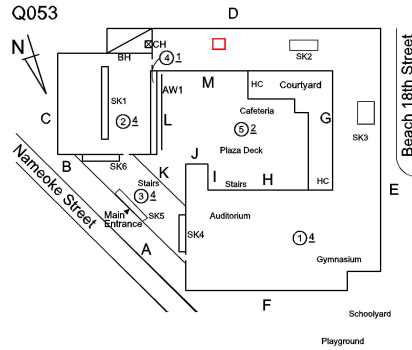
Roof 1
No violations recorded.

Is/Are the roof(s) suitable for Solar Panel installation?	Yes
Installation Year	2021
Source of Installation	Custodial Staff
Deficiency	No deficiencies recorded
ROOFING DRAINS	Inspected
Condition	3 - Fair
Deficiency	DETERIORATED

1
EACH
REPLACE
PRIORITY 4
LEVEL 2

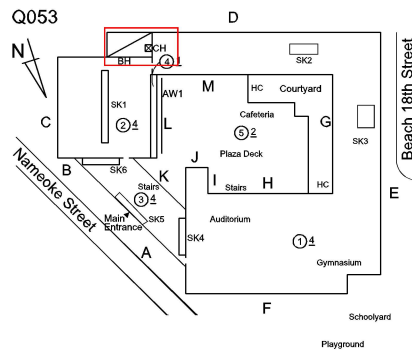
BULKHEAD/PENTHOUSE WALLS/EXTERIOR: DETERIORATED JOINTS

100
S.F.
REPOINT
PRIORITY 3
LEVEL 2

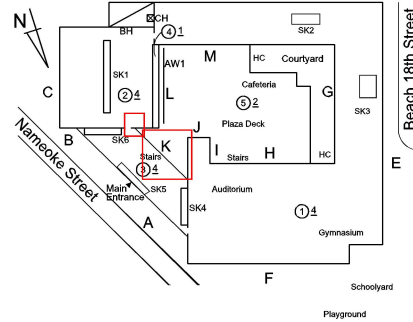
WATER INFILTRATION

200

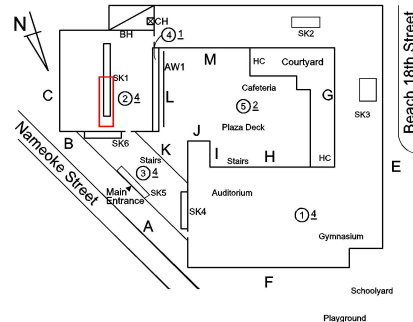
DAMAGED GUARDS

10

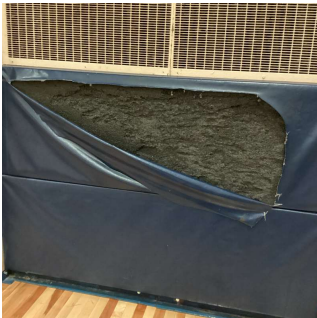
Violations	Office/Storage No violations recorded.
Seating	
Instance on 1st Floor	Does not Exist
Sliding-folding Partition	
Instance on 1st Floor	Inspected
Condition	2 - Between Good and Fair
Deficiency	No deficiencies recorded
Stage	
Instance on 1st Floor	Does not Exist
Walls	
Instance on 1st Floor	Inspected
Condition	2 - Between Good and Fair
Deficiency	WALL PADDING: DETERIORATED
Deficiency Location/Instance	Near Center
Deficiency Quantity	100
Quantity Uom	S.F.
Potential Action	REPLACE
Urgency of Action	PRIORITY 3
Purpose of Action	LEVEL 2
Deficiency Photo1

Violations	Near Center No violations recorded.
Deficiency	MASONRY: CRACKS/SPALLING
Deficiency Location/Instance	Storage Room
Deficiency Quantity	10
Quantity Uom	S.F.
Potential Action	REPLACE
Urgency of Action	PRIORITY 3

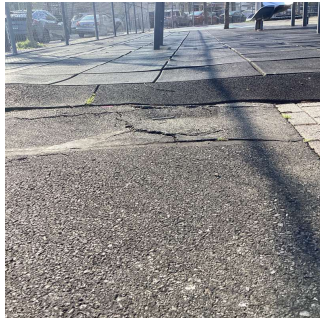
Violations	Near Playground No violations recorded.
Deficiency	CRACKS - MAJOR
Deficiency Location/Instance	Near Playground, Playing Field, basketball Court, School Entrance, Exit 5, Center, and others
Deficiency Quantity	2,500
Quantity Uom	S.F.
Potential Action	REPLACE
Urgency of Action	PRIORITY 3
Purpose of Action	LEVEL 2
Deficiency Photo1

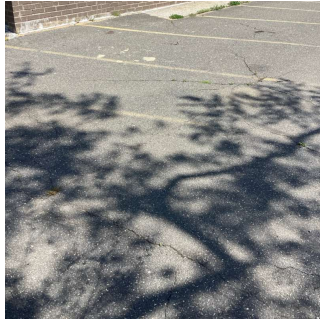
Question	Response
SITE	
PAVING	
Site Sidewalks & Walkways	
Asphalt	
Deficiency Photo1

Violations	Near Beach 18th Street No violations recorded.
Concrete	Inspected
Condition	4 - Between Fair and Poor
Deficiency	DAMAGED CURBS
Deficiency Location/Instance	Containerization Area
Deficiency Quantity	50
Quantity Uom	L.F.
Potential Action	REPLACE
Urgency of Action	PRIORITY 3
Purpose of Action	LEVEL 2
Deficiency Photo1

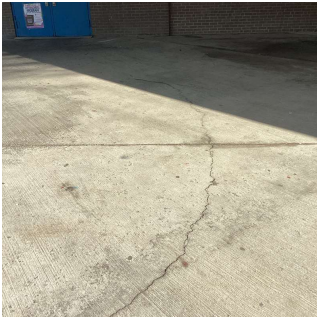
Question	Response
SITE	
PAVING	
Site Sidewalks & Walkways	
Concrete	Inspected
Deficiency Photo1

Near Exit 6
Violations	No violations recorded.
Pavers	Does not Exist
DOT Sidewalk	Inspected
Asphalt	Does not Exist
Concrete	Inspected
Condition	4 - Between Fair and Poor
Deficiency	HEAVING
Deficiency Location/Instance	Beach 18th Street
Deficiency Quantity	30
Quantity Uom	S.F.
Potential Action	REPLACE
Urgency of Action	PRIORITY 5
Purpose of Action	LEVEL 6
Deficiency Photo1	 
	Beach 18th Street
Violations	No violations recorded.
Deficiency	DAMAGED CURBS
Deficiency Location/Instance	Nameoke Street, Bayport Place, Beach 18th Street
Deficiency Quantity	180
Quantity Uom	L.F.
Potential Action	REPLACE
Urgency of Action	PRIORITY 3
Purpose of Action	LEVEL 2
