NYC Department of Education
Building Condition Assessment Survey 2023 - 2024

Architectural Inspection

Asset: P.S. 69 - QUEENS, 77-02 37 AVENUE, New York, 11372

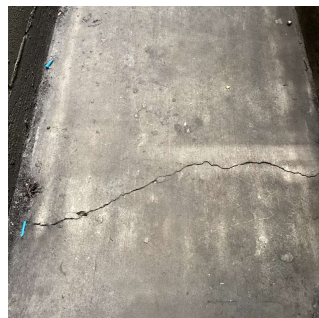
Question	Response
EXTERIOR	
AREAWAY	
Instance Quantity	4
Instance Quantity Uom	EACH
Deficiency	AREAWAY SLAB: CRACKS AND SPALLING
Roof Plan reference

Deficiency Quantity	80
Quantity Uom	S.F.
Potential Action	REPAIR
Urgency of Action	PRIORITY 3
Purpose of Action	LEVEL 2
Deficiency Photo1

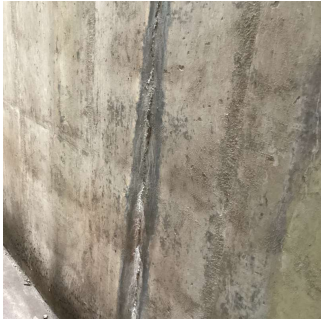
Violations	AW3 No violations recorded.
Deficiency	AREAWAY WALLS: CRACKS AND SPALLING
Roof Plan reference

Deficiency Quantity	40
Quantity Uom	S.F.
Potential Action	REPAIR
Urgency of Action	PRIORITY 3
Purpose of Action	LEVEL 2

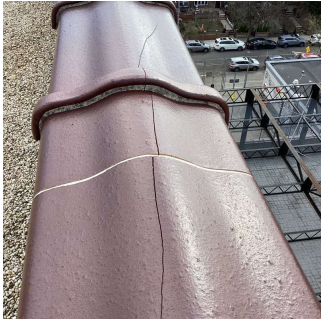
Violations	AW4 No violations recorded.
AWNINGS AND CANOPIES	Does not Exist
CHIMNEY	Inspected
Material Type(s)	Masonry, Metal
Condition	2 - Between Good and Fair
Deficiency	No deficiencies recorded
COPING	Inspected
Condition	3 - Fair
Deficiency	TERRA COTTA: CRACKED/BROKEN PIECES
Roof Plan reference	Q069

Deficiency Quantity	50
Quantity Uom	L.F.
Potential Action	REPLACE-IN-KIND
Urgency of Action	PRIORITY 4
Purpose of Action	LEVEL 2
Deficiency Photo1

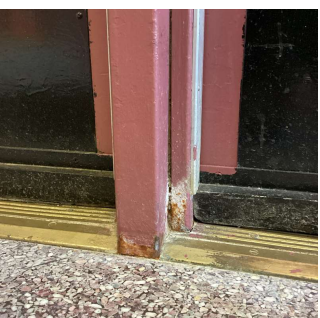
Question	Response
EXTERIOR	
DOORS	Inspected
DOORS AND FRAMES	Inspected
Condition	3 - Fair
Deficiency	METAL: DETERIORATED DOOR AND FRAME - MINOR DETERIORATION
Roof Plan reference	Q069

Deficiency Quantity	3
Quantity Uom	EACH
Potential Action	MAINTENANCE
Urgency of Action	PRIORITY 3
Purpose of Action	LEVEL 2
Deficiency Photo1

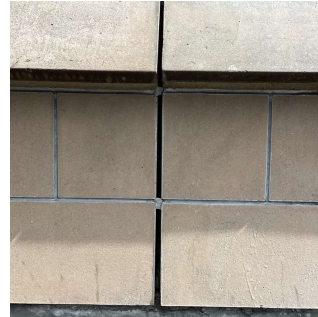
Facade G

CAST IN PLACE / PRE-CAST CONCRETE: DETERIORATED JOINTS

REPOINT
 PRIORITY 4
 LEVEL 2

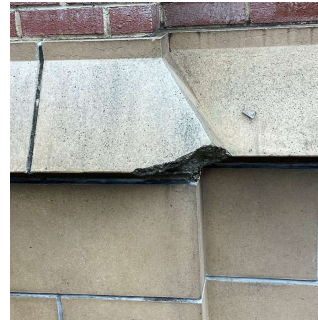
Facade G

CAST IN PLACE / PRE-CAST CONCRETE: MAJOR CRACKS/SPALLING

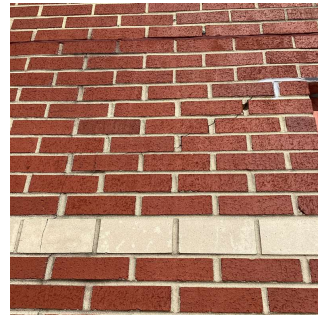
Facade F

BRICK: MINOR CRACKS AND SPALLING

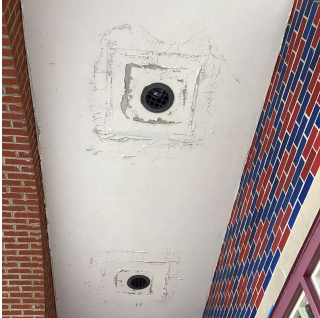
Question	Response
EXTERIOR	
EXTERIOR SOFFITS	
Deficiency Quantity	100
Quantity Uom	S.F.
Potential Action	REPLACE
Urgency of Action	PRIORITY 4
Purpose of Action	LEVEL 2
Deficiency Photo1

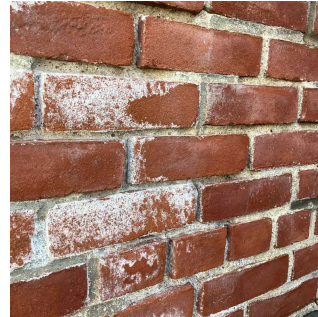
Roof 1

BRICK: DETERIORATED JOINTS

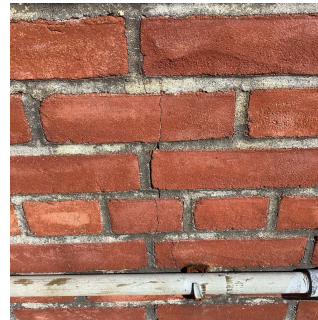
Roof 1

BRICK: MINOR CRACKS, SPALLING

30

S.F.

REPAIR

PRIORITY 3

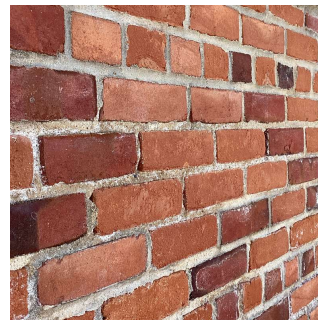
Roof 1

BRICK: DETERIORATED JOINTS

60

S.F.

PRIORITY 3

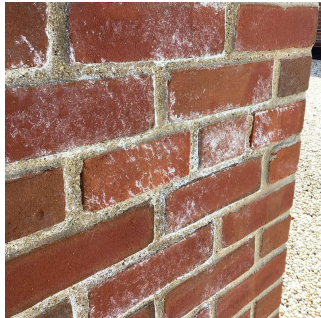
Violations	Roof 8 No violations recorded.
ROOFING DRAINS	Inspected
Condition	2 - Between Good and Fair
Deficiency	No deficiencies recorded
Specialties	Inspected
BULKHEAD/PENTHOUSE	Inspected
Condition	3 - Fair
Deficiency	BULKHEAD/PENTHOUSE WALLS/EXTERIOR: DETERIORATED JOINTS
Roof Plan reference	Q069
Deficiency Quantity	30

Question	Response
EXTERIOR	
ROOF	
Specialties	
BULKHEAD/PENTHOUSE	
Quantity Uom	S.F.
Potential Action	REPOINT
Urgency of Action	PRIORITY 3
Purpose of Action	LEVEL 2
Deficiency Photo1

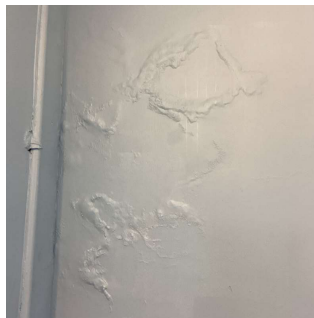
BH1

BULKHEAD/PENTHOUSE WALLS/INTERIOR: PLASTER
CRACKS/SPALLING

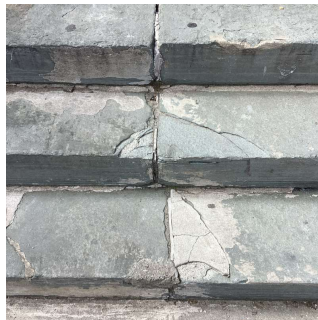
Question	Response
EXTERIOR	
STAIRS/RAMPS: EXTERIOR	
RAILINGS	Inspected
Condition	2 - Between Good and Fair
Deficiency	No deficiencies recorded
STAIRS/RAMPS	Inspected
Condition	4 - Between Fair and Poor
Deficiency	STONE: CRACKS/SPALLING - MAJOR
Roof Plan reference	<p>Q069</p>

<p>10 S.F. REPLACE PRIORITY 4 LEVEL 2</p>

<p>Facade C - Exit 5 No violations recorded.</p>
Deficiency Quantity	
Quantity Uom	
Potential Action	
Urgency of Action	
Purpose of Action	
Deficiency Photo1	
Violations	
Deficiency	STONE: CRACKS/SPALLING - MINOR
Roof Plan reference	<p>Q069</p>

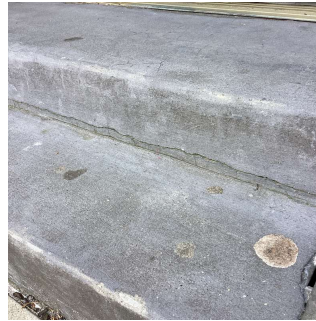
Facade A

<p>10 S.F. REPAIR PRIORITY 3 LEVEL 2</p>
Deficiency Quantity	
Quantity Uom	
Potential Action	
Urgency of Action	
Purpose of Action

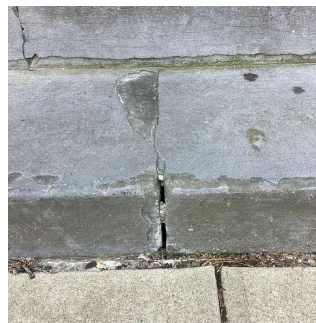
Facade A

STONE: DETERIORATED JOINTS

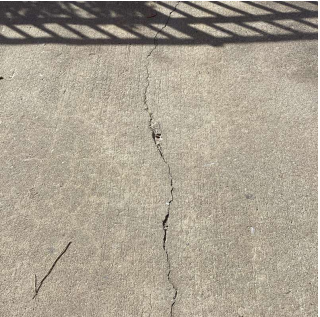
Deficiency Quantity	20
Quantity Uom	S.F.
Potential Action	REPAIR
Urgency of Action	PRIORITY 3
Purpose of Action	LEVEL 2
Deficiency Photo1

Violations	<p>Facade B</p> <p>No violations recorded.</p>
WINDOWS	Inspected
Replacement Quantity	14,000
Replacement Uom	S.F.
EXTERIOR GUARDS	Inspected
Condition	2 - Between Good and Fair
Deficiency	No deficiencies recorded
LINTELS	Inspected
Condition	2 - Between Good and Fair
Deficiency	No deficiencies recorded
WINDOWS	Inspected
Material Type(s)	Aluminum
Instance on Aluminum - Double Hung: All Facades	Inspected
Instance Condition	3 - Fair
Instance Quantity	7,000
Instance Quantity Uom	S.F.
Are these windows insulated	No
Installation Year	2005
Source of Installation	Custodial Staff
Deficiency	No deficiencies recorded
Instance on Aluminum - Double Hung: All Facades - 1994 Addition	Inspected

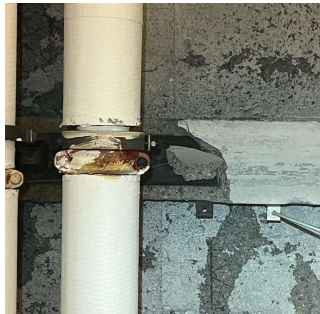
Question	Response
EXTERIOR	
WINDOWS	
WINDOWS	
Instance Quantity	7,000
Instance Quantity Uom	S.F.
Are these windows insulated	No
Installation Year	1994
Source of Installation	Custodial Staff
Deficiency	No deficiencies recorded
INTERIOR	Inspected
POOLS	Does not Exist
STRUCTURAL	Inspected
COLUMNS/BEAMS/BEARING WALLS	Inspected
Condition	3 - Fair
Deficiency	STEEL COLUMNS/BEAMS: DETERIORATED/MISSING SPRAY-ON FIREPROOFING
Deficiency Location/Instance	Basement - Electrical Panel Room 022, Storage Room 032
Deficiency Quantity	40
Quantity Uom	S.F.
Potential Action	REPLACE
Urgency of Action	PRIORITY 4
Purpose of Action	LEVEL 5
Deficiency Photo1	 
Violations	Basement - Electrical Panel Room 022 No violations recorded.
Deficiency	STEEL COLUMNS/BEAMS: DETERIORATED CONCRETE FIREPROOFING
Deficiency Location/Instance	Basement - Boiler Room, Fan Room
Deficiency Quantity	30
Quantity Uom	S.F.
Potential Action	REPLACE
Urgency of Action	PRIORITY 4

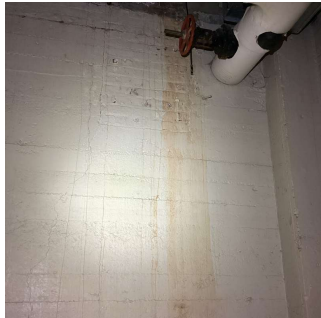
Basement - Fan Room
Violations	No violations recorded.
FOUNDATION WALLS	Inspected
Material Type(s)	Concrete, Masonry
Condition	4 - Between Fair and Poor

Deficiency	BRICK: WATER INFILTRATION IN NON- INSTRUCTIONAL SPACE
Deficiency Location/Instance	Basement - Paint Room, Rooms C01A, C02, C04

Question	Response
INTERIOR	
STRUCTURAL	
FOUNDATION WALLS	
Deficiency Quantity	400
Quantity Uom	S.F.
Potential Action	INSTALL WATERPROOFING
Urgency of Action	PRIORITY 5
Purpose of Action	LEVEL 5
Deficiency Photo1

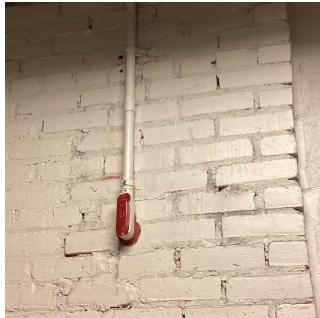
Question	Response
INTERIOR	
STRUCTURAL	
VAULTS-BUNKERS	
Foundation Walls	
Deficiency Photo1

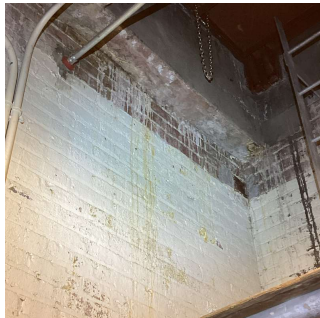
Violations	Ash Hoist Vault No violations recorded.
Slab Structure	Inspected
Condition	3 - Fair
Deficiency	CONCRETE: WATER INFILTRATION IN NON- INSTRUCTIONAL SPACE
Deficiency Location/Instance	Ash Hoist Vault
Deficiency Quantity	50
Quantity Uom	S.F.
Potential Action	INSTALL WATERPROOFING
Urgency of Action	PRIORITY 5
Purpose of Action	LEVEL 5
Deficiency Photo1

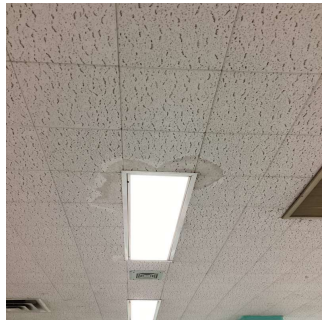
Question	Response
INTERIOR	
AUDITORIUM	
Stage	
Stage Curtain Rigging	Inspected
Violations	No violations recorded.
Stage Curtains	Inspected
Instance on 2nd Floor (402 Seats)	Inspected
Condition	2 - Between Good and Fair
Deficiency	No deficiencies recorded
Walls	
Instance on 2nd Floor (402 Seats)	Inspected
Condition	2 - Between Good and Fair
Deficiency	No deficiencies recorded
Window Curtains/Shades/Blinds	
Instance on 2nd Floor (402 Seats)	Inspected
Condition	2 - Between Good and Fair
Deficiency	No deficiencies recorded
CAFETERIA	
Instance on 1st Floor	Inspected
Ceiling	
Instance on 1st Floor	Inspected
Condition	2 - Between Good and Fair
Deficiency	ACOUSTIC TILES: DAMAGED/MISSING
Deficiency Location/Instance	Center, Near Entrance
Deficiency Quantity	20
Quantity Uom	S.F.
Potential Action	REPLACE
Urgency of Action	PRIORITY 3
Purpose of Action	LEVEL 2
Deficiency Photo1

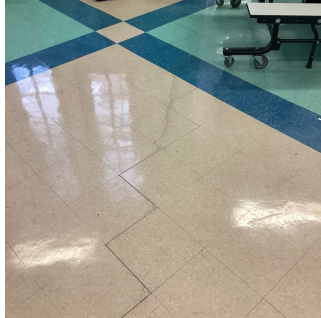
Instance on 1st Floor	Inspected
Condition	2 - Between Good and Fair
Deficiency	No deficiencies recorded
Fixed Equipment	
Instance on 1st Floor	Does not Exist
Floor Finish	
Instance on 1st Floor	Inspected
Condition	4 - Between Fair and Poor
Deficiency	VINYL TILES: DETERIORATED SUBSTRATE

Question	Response
INTERIOR	
CAFETERIA	
Floor Finish	
Deficiency Location/Instance	Near Boys Toilet Room, Center, Near Windows, Near Columns, Near Entrance and others
Deficiency Quantity	300
Quantity Uom	S.F.
Potential Action	REPLACE
Urgency of Action	PRIORITY 3
Purpose of Action	LEVEL 2
Deficiency Photo1

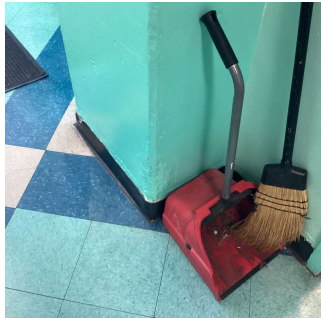
Violations	Near Boys Toilet Room No violations recorded.
Sliding-folding Partition	
Instance on 1st Floor	Does not Exist
Stage	
Instance on 1st Floor	Does not Exist
Walls	
Instance on 1st Floor	Inspected
Condition	2 - Between Good and Fair
Deficiency	PLASTER: CRACKS/SPALLING
Deficiency Location/Instance	Near Kitchen
Deficiency Quantity	10
Quantity Uom	S.F.
Potential Action	REPLACE
Urgency of Action	PRIORITY 3
Purpose of Action	LEVEL 2
Deficiency Photo1

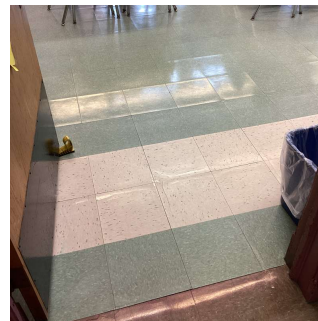
Room 408

VINYL TILES: BROKEN/DETERIORATED/MISSING TILES

REPLACE

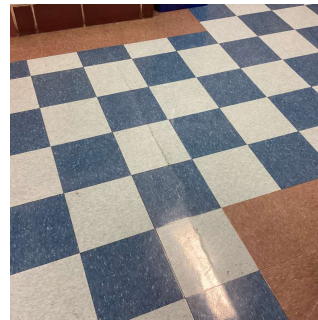
Corridor near Room 518

VINYL TILES: DETERIORATED SUBSTRATE

REPLACE

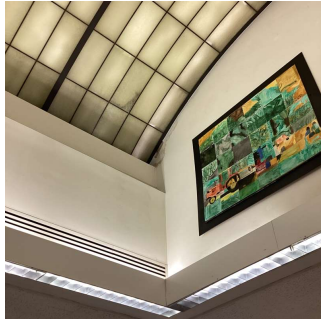
Question	Response
INTERIOR	
CLASSROOMS/CORRIDORS/ADMIN SPACES	
Walls	Inspected
Condition	2 - Between Good and Fair
Deficiency	GYPSUM BOARD: DETERIORATED - ACTIVE LEAK
Deficiency Location/Instance	2nd Floor Atrium
Deficiency Quantity	10
Quantity Uom	S.F.
Potential Action	REPLACE
Urgency of Action	PRIORITY 5
Purpose of Action	LEVEL 2
Deficiency Photo1

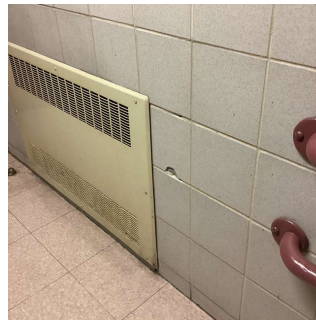
Corridor near Stair D/3

Violations	2nd Floor Atrium No violations recorded.
Deficiency	CERAMIC TILE: BROKEN/ MISSING
Deficiency Location/Instance	Corridor near Stair D/3, Corridor near Room 317
Deficiency Quantity	20
Quantity Uom	S.F.
Potential Action	REPLACE
Urgency of Action	PRIORITY 3
Purpose of Action	LEVEL 2

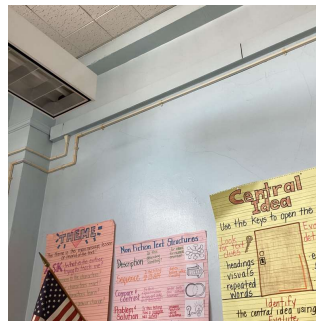
Room 509

PLASTER: CRACKS/SPALLING

REPLACE

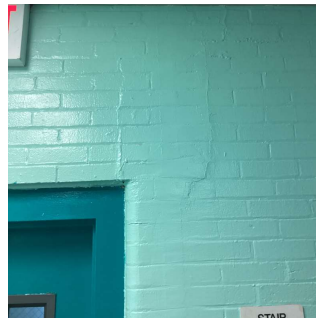
Corridor near Stair AB/1

BRICK: CRACKS/SPALLING

REPLACE

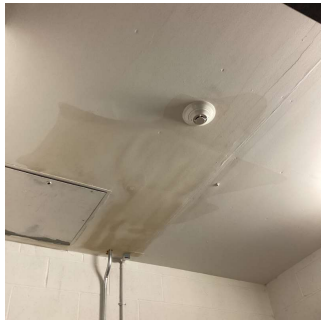
Question	Response
INTERIOR	
CLASSROOMS/CORRIDORS/ADMIN SPACES	Inspected
Specialties	Does not Exist
GYMNASIUM	Inspected
Instance on 3rd Floor	Inspected
Ceiling	
Instance on 3rd Floor	Inspected
Condition	2 - Between Good and Fair
Deficiency	GYPSUM BOARD: DAMAGED/DETERIORATED
Deficiency Location/Instance	Storage Room
Deficiency Quantity	20
Quantity Uom	S.F.
Potential Action	REPLACE
Urgency of Action	PRIORITY 3
Purpose of Action	LEVEL 2
Deficiency Photo1

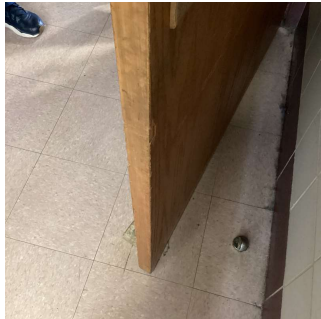
Storage Room
Violations	No violations recorded.
Door(s)	
Instance on 3rd Floor	Inspected
Condition	5 - Poor
Deficiency	WOOD: DETERIORATED DOOR
Deficiency Location/Instance	Entrance near Room 324, Main Entrance
Deficiency Quantity	3
Quantity Uom	EACH
Potential Action	MAINTENANCE
Urgency of Action	PRIORITY 3
Purpose of Action	LEVEL 2
Deficiency Photo1

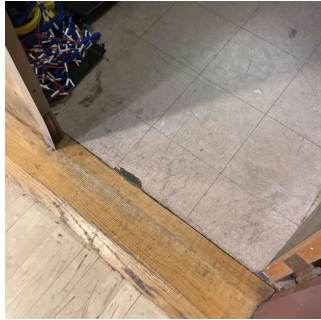
Question	Response
INTERIOR	
GYMNASIUM	Inspected
Fixed Equipment	
Deficiency	No deficiencies recorded
Floor Finish	
Instance on 3rd Floor	Inspected
Condition	2 - Between Good and Fair
Deficiency	VINYL TILES: BROKEN/DETERIORATED/MISSING TILES
Deficiency Location/Instance	Storage Room
Deficiency Quantity	10
Quantity Uom	S.F.
Potential Action	REPLACE
Urgency of Action	PRIORITY 3
Purpose of Action	LEVEL 2
Deficiency Photo1

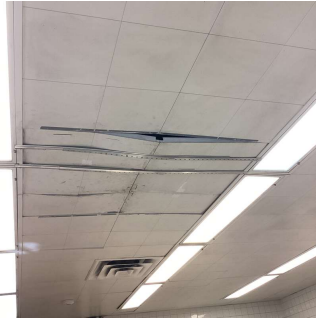
Deficiency	No deficiencies recorded
KITCHEN	Inspected
Instance on 1st Floor	Inspected
Ceiling	
Instance on 1st Floor	Inspected
Condition	2 - Between Good and Fair
Deficiency	METAL PAN: DAMAGED/MISSING
Deficiency Location/Instance	Center

Question	Response
INTERIOR	
KITCHEN	
Ceiling	
Deficiency Quantity	10
Quantity Uom	S.F.
Potential Action	REPLACE
Urgency of Action	PRIORITY 5
Purpose of Action	LEVEL 6
Deficiency Photo1

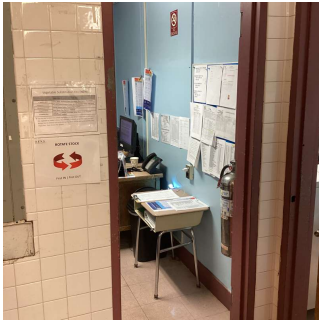
Center
Violations	No violations recorded.
Door(s)	
Instance on 1st Floor	Inspected
Condition	5 - Poor
Deficiency	WOOD: MISSING DOOR
Deficiency Location/Instance	Office
Deficiency Quantity	1
Quantity Uom	EACH
Potential Action	MAINTENANCE
Urgency of Action	PRIORITY 3
Purpose of Action	LEVEL 2
Deficiency Photo1

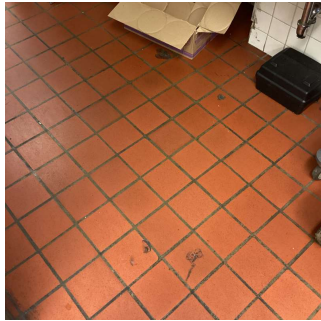
Violations	Large Storage Room No violations recorded.
Deficiency	QUARRY TILE: BROKEN/MISSING TILES
Deficiency Location/Instance	Near Entrance, Near Office, prep area
Deficiency Quantity	30
Quantity Uom	S.F.
Potential Action	REPLACE
Urgency of Action	PRIORITY 3
Purpose of Action	LEVEL 2

Question	Response
INTERIOR	
KITCHEN	
Floor Finish	
Deficiency Photo1

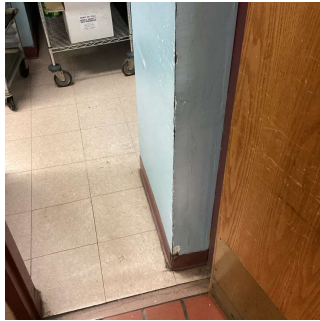
Near Entrance
Violations	No violations recorded.
Deficiency	GYPSUM BOARD: DETERIORATED
Deficiency Location/Instance	Storage Room
Deficiency Quantity	10
Quantity Uom	S.F.
Potential Action	REPLACE
Urgency of Action	PRIORITY 3
Purpose of Action	LEVEL 2

Question	Response
INTERIOR	
KITCHEN	Inspected
Walls	
Deficiency Photo1

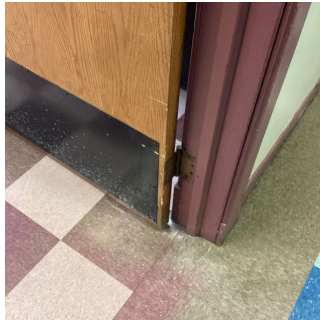
Storage Room
Violations	No violations recorded.
LIBRARY	Inspected
Instance on Room 307	Inspected
Built-in Furnishing	
Instance on Room 307	Inspected
Condition	2 - Between Good and Fair
Deficiency	No deficiencies recorded
Ceiling	
Instance on Room 307	Inspected
Condition	2 - Between Good and Fair
Deficiency	No deficiencies recorded
Door(s)	
Instance on Room 307	Inspected
Condition	3 - Fair
Deficiency	WOOD: DETERIORATED DOOR
Deficiency Location/Instance	Main Entrance
Deficiency Quantity	1
Quantity Uom	EACH
Potential Action	MAINTENANCE
Urgency of Action	PRIORITY 3
Purpose of Action	LEVEL 2
Deficiency Photo1

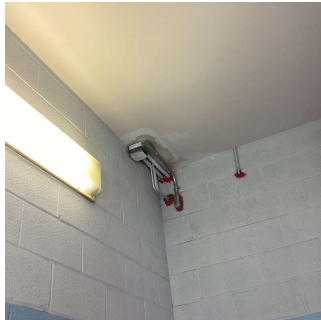
Question	Response
INTERIOR	
STAIRS/RAMPS: INTERIOR	
Ceiling	
Condition	2 - Between Good and Fair
Deficiency	GYPSUM BOARD: DAMAGED/DETERIORATED
Deficiency Location/Instance	Stair D/5
Deficiency Quantity	10
Quantity Uom	S.F.
Potential Action	REPLACE
Urgency of Action	PRIORITY 3
Purpose of Action	LEVEL 2
Deficiency Photo1

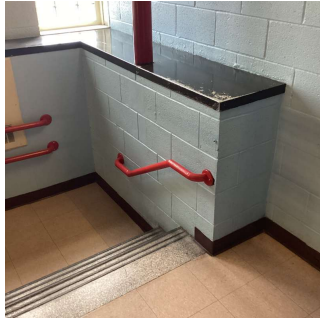
Violations	Stair GH/1 Vestibule No violations recorded.
Door(s)	Inspected
Condition	2 - Between Good and Fair
Deficiency	No deficiencies recorded
Partition	Inspected
Condition	2 - Between Good and Fair
Deficiency	No deficiencies recorded
Railings	Inspected
Condition	3 - Fair
Deficiency	METAL: MISSING
Deficiency Location/Instance	Stair D/3

Question	Response
INTERIOR	
STAIRS/RAMPS: INTERIOR	
Railings	
Deficiency Quantity	10
Quantity Uom	L.F.
Potential Action	REPLACE
Urgency of Action	PRIORITY 5
Purpose of Action	LEVEL 6
Deficiency Photo1

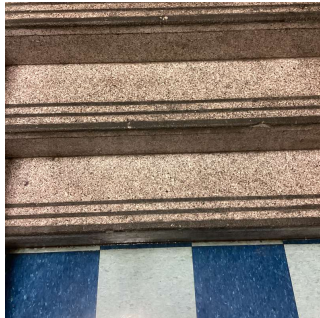
Stair D/3
Violations	No violations recorded.
Stairs and Landings	Inspected
Condition	3 - Fair
Deficiency	TERRAZZO: CRACKS
Deficiency Location/Instance	Near Stair D/3, Corridor near Gymnasium,
Deficiency Quantity	40
Quantity Uom	S.F.
Potential Action	REPLACE
Urgency of Action	PRIORITY 3
Purpose of Action	LEVEL 2
Deficiency Photo1

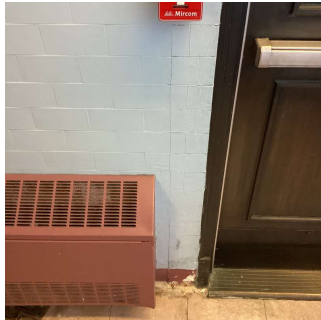
Question	Response
INTERIOR	
STAIRS/RAMPS: INTERIOR	
Walls	Inspected
Condition	2 - Between Good and Fair
Deficiency	CERAMIC TILE: BROKEN/ MISSING
Deficiency Location/Instance	Stair AB/1 Vestibule
Deficiency Quantity	10
Quantity Uom	S.F.
Potential Action	REPLACE
Urgency of Action	PRIORITY 3
Purpose of Action	LEVEL 2
Deficiency Photo1

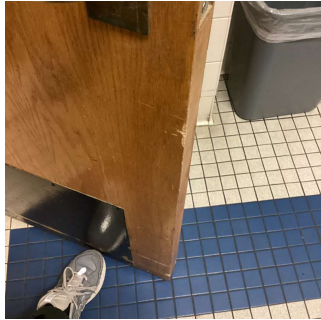
Violations	Stair GH/1 No violations recorded.
TOILET ROOMS - STAFF	
Ceiling	Inspected
Condition	2 - Between Good and Fair
Deficiency	No deficiencies recorded
Door(s)	Inspected
Condition	5 - Poor
Deficiency	WOOD: DETERIORATED DOOR
Deficiency Location/Instance	Inside Kitchen, 1st Floor - Men, Women, Rooms 521, 231

Question	Response
INTERIOR	
TOILET ROOMS - STAFF	
Door(s)	
Potential Action	MAINTENANCE
Urgency of Action	PRIORITY 3
Purpose of Action	LEVEL 2
Deficiency Photo1

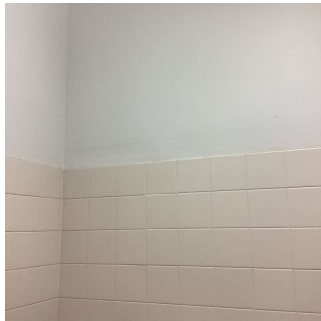
Inside Kitchen
Violations	No violations recorded.
Stalls	Inspected
Condition	2 - Between Good and Fair
Deficiency	No deficiencies recorded
Walls	Inspected
Condition	2 - Between Good and Fair
Deficiency	GYPSUM BOARD: DETERIORATED
Deficiency Location/Instance	Room 513
Deficiency Quantity	10
Quantity Uom	S.F.
Potential Action	REPLACE
Urgency of Action	PRIORITY 3
Purpose of Action	LEVEL 2

Question	Response
INTERIOR	
TOILET ROOMS - STAFF	
Walls	
Deficiency Photo1

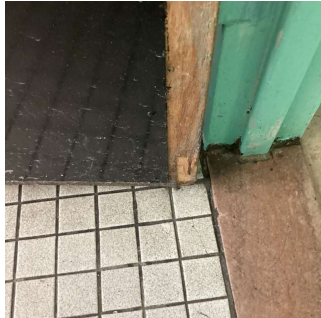
Question	Response
INTERIOR	
TOILET ROOMS - STUDENTS	Inspected
Ceiling	Inspected
Condition	2 - Between Good and Fair
Deficiency	No deficiencies recorded
Door(s)	Inspected
Condition	5 - Poor
Deficiency	WOOD: DETERIORATED DOOR
Deficiency Location/Instance	Rooms 520, 512, 318, 135, 108
Deficiency Quantity	5
Quantity Uom	EACH
Potential Action	MAINTENANCE
Urgency of Action	PRIORITY 3
Purpose of Action	LEVEL 2
Deficiency Photo1

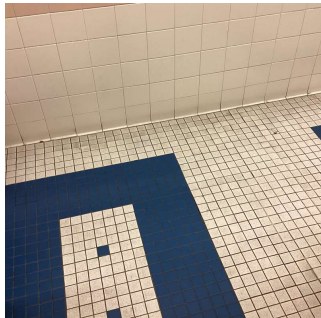
Violations	Room 108 No violations recorded.
Floor Finish	Inspected
Condition	2 - Between Good and Fair
Deficiency	CERAMIC TILE: BROKEN/MISSING TILES
Deficiency Location/Instance	Rooms 224, 135, 108
Deficiency Quantity	30
Quantity Uom	S.F.
Potential Action	REPLACE
Urgency of Action	PRIORITY 3
Purpose of Action	LEVEL 2
Deficiency Photo1

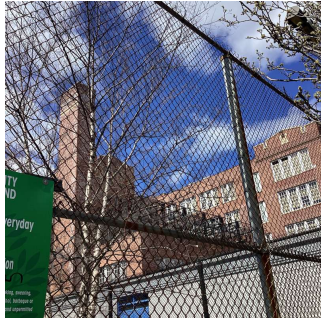
Question	Response
SITE	
FENCES	
Violations	78th Street No violations recorded.
Deficiency	CHAIN LINK: RUST - MAJOR
Deficiency Location/Instance	78th Street
Deficiency Quantity	400
Quantity Uom	S.F.
Potential Action	REPLACE
Urgency of Action	PRIORITY 3
Purpose of Action	LEVEL 2
Deficiency Photo1

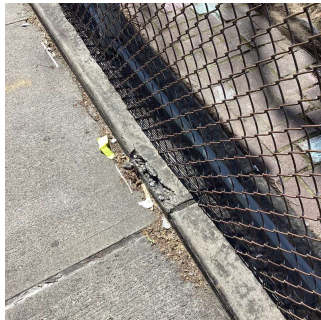
Violations	78th Street No violations recorded.
Deficiency	CONCRETE CURB: DAMAGED/DETERIORATED
Deficiency Location/Instance	78th Street, 77th Street, 37th Avenue
Deficiency Quantity	120
Quantity Uom	S.F.
Potential Action	REPLACE
Urgency of Action	PRIORITY 3
Purpose of Action	LEVEL 2
Deficiency Photo1

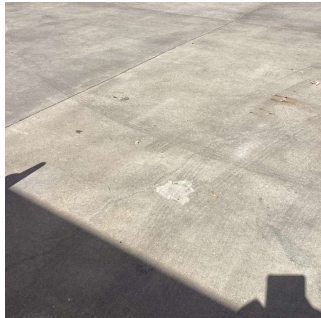
Violations	78th Street No violations recorded.
IRRIGATION SYSTEM	Does not Exist
PAVING	Inspected
Student Non-Use	Inspected
Gravel Exists?	No
Asphalt	Inspected
Condition	2 - Between Good and Fair
Deficiency	No deficiencies recorded
Concrete	Does not Exist
Pavers	Does not Exist
Student Use	Inspected
Gravel Exists?	No
Asphalt	Inspected
Condition	4 - Between Fair and Poor
Deficiency	CRACKS - MAJOR
Deficiency Location/Instance	Schoolyard
Deficiency Quantity	1,800
Quantity Uom	S.F.
Potential Action	REPLACE
Urgency of Action	PRIORITY 3
Purpose of Action	LEVEL 2
Deficiency Photo1	 
Violations	Schoolyard No violations recorded.
Concrete	Inspected
Condition	3 - Fair
Deficiency	CRACKS - MAJOR
Deficiency Location/Instance	Near Exit 5
Deficiency Quantity	200

Question	Response
SITE	
PAVING	
Student Use	
Concrete	
Quantity Uom	S.F.
Potential Action	REPLACE
Urgency of Action	PRIORITY 3
Purpose of Action	LEVEL 2
Deficiency Photo1

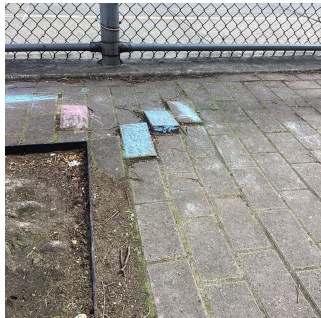
Near Exit 5
Violations	No violations recorded.
Pavers	Inspected
Condition	3 - Fair
Deficiency	HEAVING
Deficiency Location/Instance	Schoolyard near 78th Street
Deficiency Quantity	10
Quantity Uom	S.F.
Potential Action	REPLACE
Urgency of Action	PRIORITY 5
Purpose of Action	LEVEL 6
Deficiency Photo1

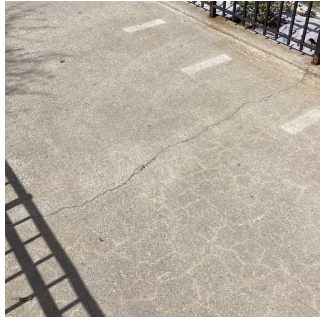
Question	Response
SITE	
PAVING	
Site Sidewalks & Walkways	
Concrete	
Deficiency Photo1

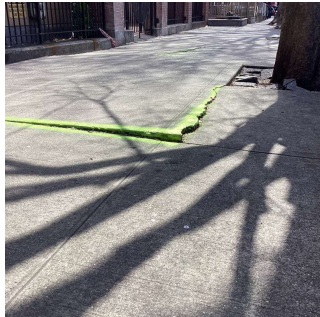
Question	Response
SITE	
PAVING	
DOT Sidewalk	
Concrete	
Deficiency Photo1

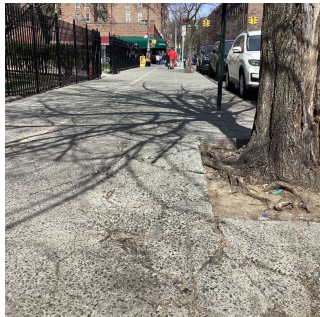
Violations	77th Street No violations recorded.
Deficiency	HEAVING
Deficiency Location/Instance	77th Street, 78th Street
Deficiency Quantity	275
Quantity Uom	S.F.
Potential Action	REPLACE
Urgency of Action	PRIORITY 3
Purpose of Action	LEVEL 2
Deficiency Photo1

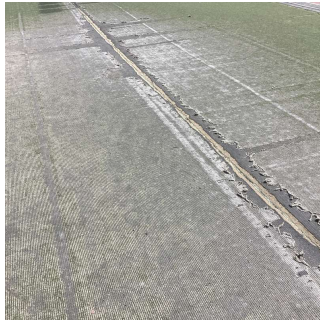
Condition	2 - Between Good and Fair
Deficiency	No deficiencies recorded
Unpaved Area	
Instance on Schoolyard - East	Does not Exist
Instance on Schoolyard - West	Does not Exist
PLAYING SURFACE	Inspected
Playing Field	Inspected
Instance on Schoolyard	Inspected
Instance Condition	5 - Poor
Deficiency	ARTIFICIAL TURF: DAMAGED/WORN OUT
Deficiency Location/Instance	Center, Left and Right Side
Deficiency Quantity	1,000
Quantity Uom	S.F.
Potential Action	REPLACE
Urgency of Action	PRIORITY 3
Purpose of Action	LEVEL 2

Question	Response
SITE	
PLAYING SURFACE	
Playing Field	
Deficiency Photo1

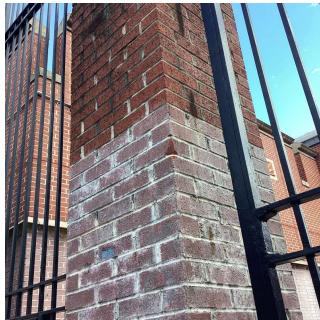
Center	Center
Violations	No violations recorded.
Running Track	Does not Exist
RETAINING WALLS	Inspected
Are there any Retaining Walls 6' OR higher facing public street/sidewalk?	No
Condition	2 - Between Good and Fair
Deficiency	No deficiencies recorded
SEATING	Inspected
Benches	Inspected
Concrete	Does not Exist
Metal/Wood/Plastic	Inspected
Condition	2 - Between Good and Fair
Deficiency	No deficiencies recorded
Bleachers	Does not Exist
SITE WALLS (NOT RETAINING WALLS)	Inspected
Condition	2 - Between Good and Fair
Deficiency	BRICK: CRACKS/SPALLING - MAJOR
Deficiency Location/Instance	77th Street
Deficiency Quantity	10
Quantity Uom	S.F.
Potential Action	REPLACE
Urgency of Action	PRIORITY 3
Purpose of Action	LEVEL 2
Deficiency Photo1
