**NYC Department of Education**  
**Building Condition Assessment Survey 2023 - 2024**

Architectural Inspection

**Asset:**        **P.S. 70 - QUEENS, 30-45 42 STREET, New York, 11103**

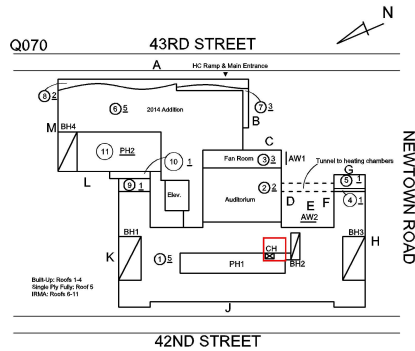
Question	Response
<b>EXTERIOR</b>	
<b>AREAWAY</b>	
Deficiency	No deficiencies recorded
<b>AWNINGS AND CANOPIES</b>	Does not Exist
<b>CHIMNEY</b>	Inspected
Material Type(s)	Masonry
Condition	3 - Fair
Deficiency	BRICK: DETERIORATED JOINTS
Roof Plan reference

Deficiency Quantity	40
Quantity Uom	S.F.
Potential Action	REPOINT
Urgency of Action	PRIORITY 4
Purpose of Action	LEVEL 2
Deficiency Photo1

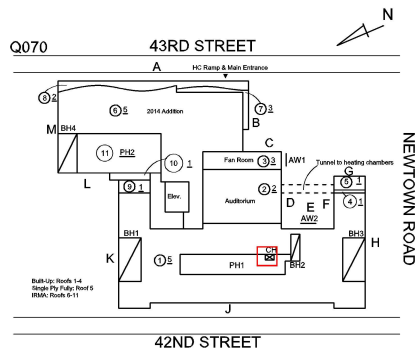
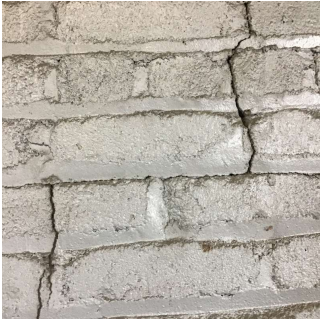
Violations	CH
	No violations recorded.
Deficiency	BRICK: MAJOR / THRU CRACKS
Roof Plan reference

Deficiency Quantity	20
Quantity Uom	S.F.
Potential Action	REMOVE AND REBUILD
Urgency of Action	PRIORITY 4
Purpose of Action	LEVEL 2

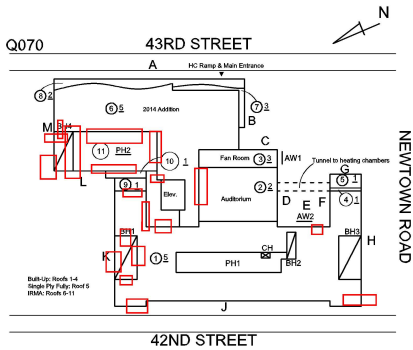
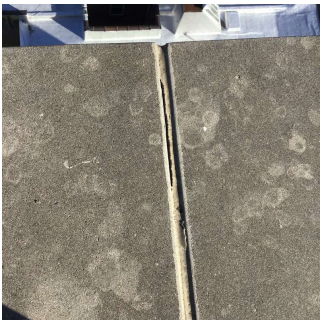
Violations	BH4 Roof No violations recorded.
<b>CORNICE</b>	Inspected
Condition	3 - Fair
Deficiency	STONE: DETERIORATED JOINTS

Violations	CH No violations recorded.
<b>COPING</b>	Inspected
Condition	3 - Fair
Deficiency	CAST STONE: DETERIORATED TRANSVERSE JOINTS
Roof Plan reference

Deficiency Quantity	70
Quantity Uom	L.F.
Potential Action	MAINTENANCE
Urgency of Action	PRIORITY 3
Purpose of Action	LEVEL 2
Deficiency Photo1

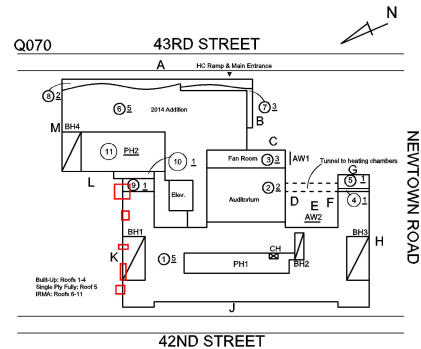
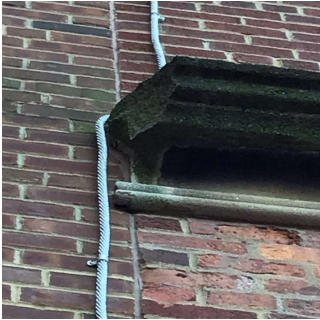
Violations	<p>Facade K</p> <p>No violations recorded.</p>
<b>DOORS</b>	Inspected
<b>DOORS AND FRAMES</b>	Inspected
Condition	5 - Poor
Deficiency	METAL: DETERIORATED DOOR - MINOR DETERIORATION
Roof Plan reference

STONE: MAJOR CRACKS, SPALLING

REPLACE

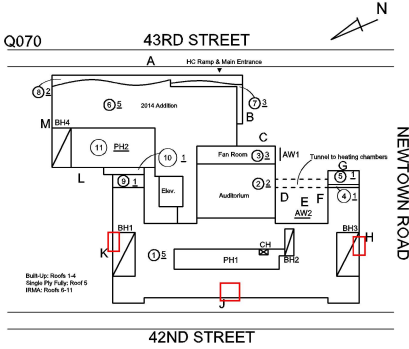
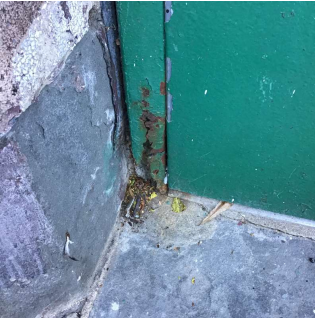
Violations	<p>Facade H</p> <p>No violations recorded.</p>
Deficiency	METAL: DETERIORATED DOOR AND FRAME - MAJOR DETERIORATION

Deficiency Quantity	10
Quantity Uom	EACH
Potential Action	REPLACE
Urgency of Action	PRIORITY 4
Purpose of Action	LEVEL 2
Deficiency Photo1

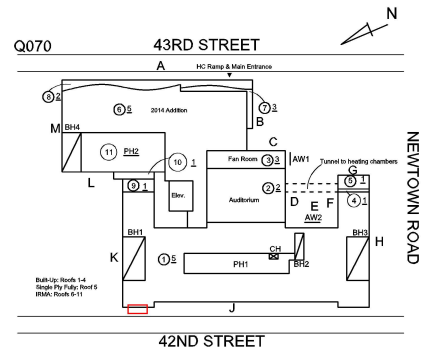
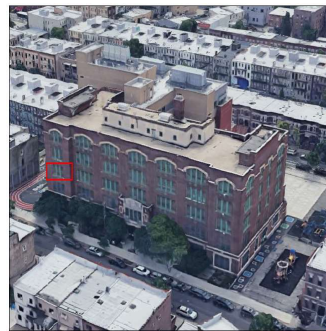
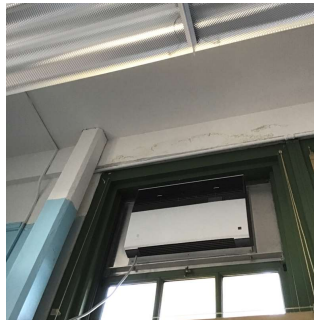
Facade J - Rooms 201

Violations	<p>Facade K</p> <p>No violations recorded.</p>
<b>DOOR HARDWARE</b>	Inspected
Condition	3 - Fair
Deficiency	No deficiencies recorded
<b>LINTELS</b>	Inspected
Condition	2 - Between Good and Fair
Deficiency	No deficiencies recorded
<b>TRANSOM/SIDE LIGHT</b>	Inspected
Condition	2 - Between Good and Fair
Deficiency	No deficiencies recorded
<b>EXTERIOR WALLS</b>	Inspected
Material Type(s)	Masonry
Replacement Quantity	66,000
Replacement Uom	S.F.
Instance on All Facades	Inspected
Instance Condition	3 - Fair
Instance Quantity	66,000
Instance Quantity Uom	S.F.
Deficiency	BRICK: WATER INFILTRATION IN INSTRUCTIONAL SPACE

REPAIR

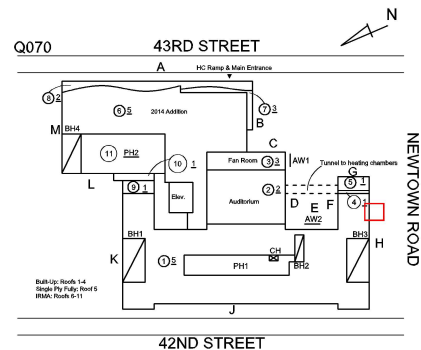
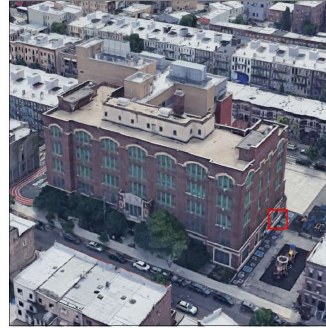
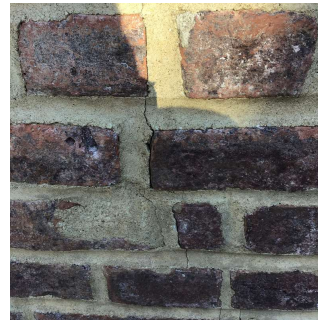
Facade H

BRICK: MINOR CRACKS AND SPALLING

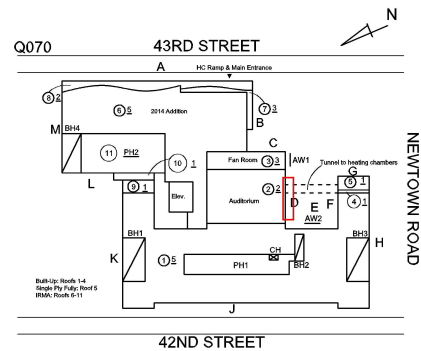
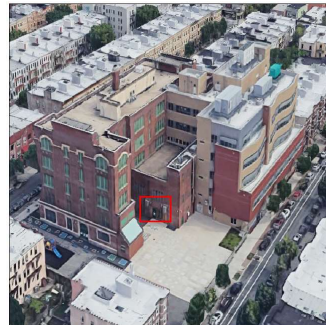
BRICK: EFFLORESCENCE

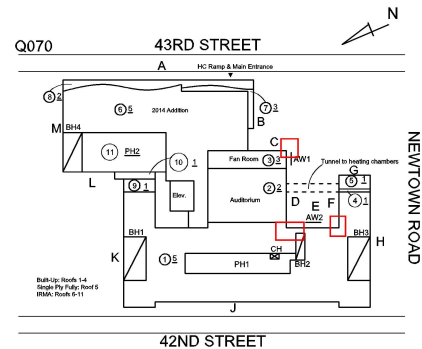
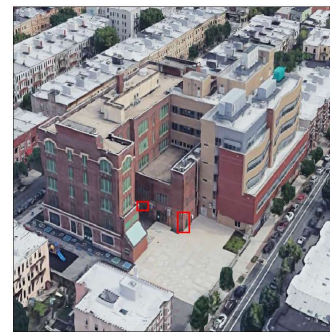
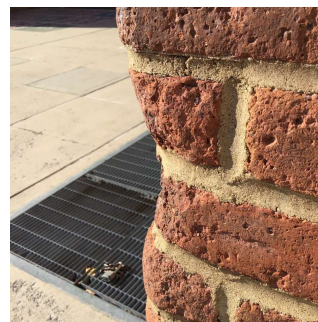
Facade C

BRICK: CRACKS/DISPLACED/SPALLED BRICK AT BUILDING CORNERS

25  
 S.F.  
 REMOVE AND REBUILD  
 PRIORITY 4  
 LEVEL 2

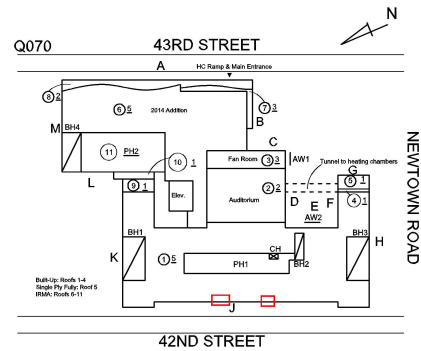
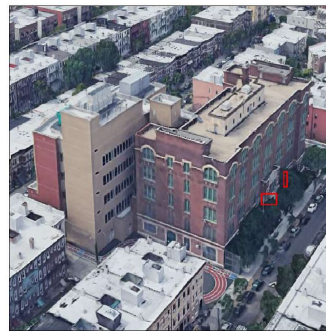
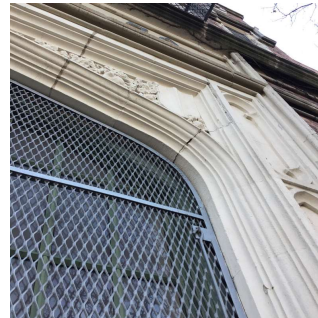
Facade J

STONE: DETERIORATED JOINTS

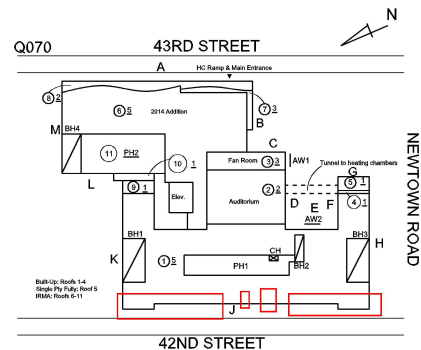
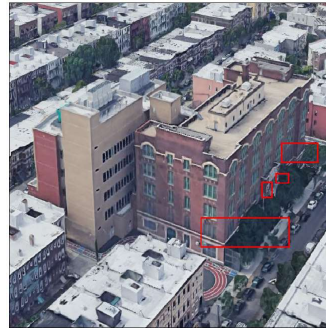
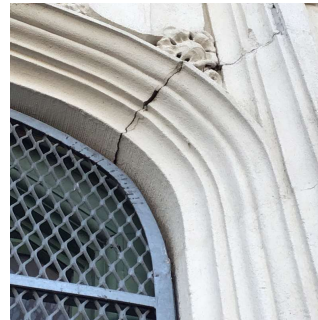
Facade J

STONE: CHIPPED/SPALLED/BROKEN PIECES - MINOR

REPAIR

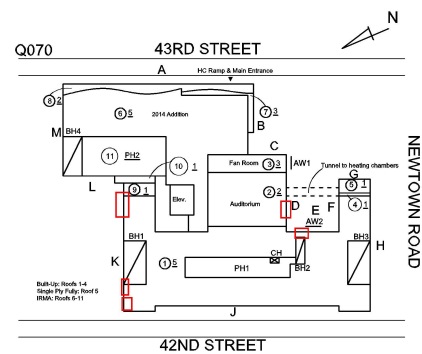
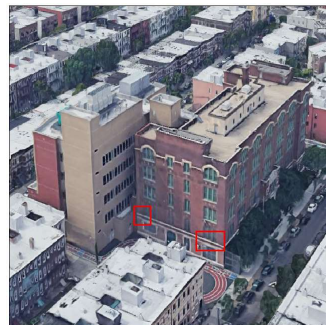
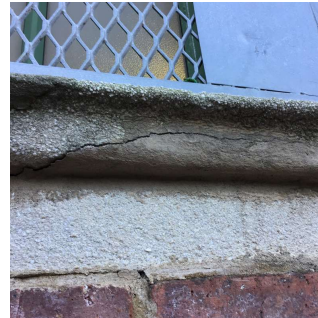
Facade K

BRICK: DETERIORATED MASONRY SILLS - MAJOR

REMOVE AND REPLACE

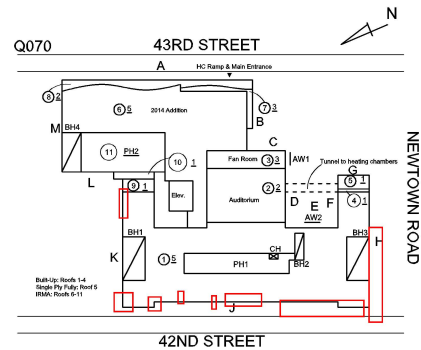
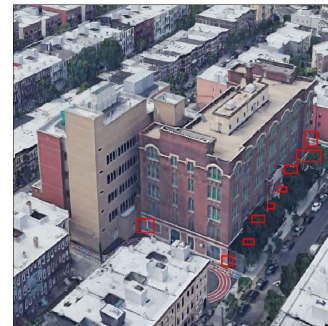
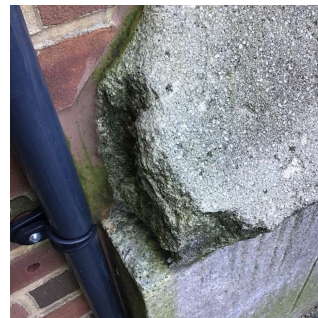
Facade K

STONE: CHIPPED/SPALLED/BROKEN PIECES - MAJOR

REPLACE

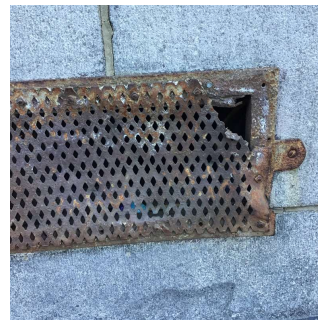
10

<b>LOADING DOCK</b>	Does not Exist
<b>LOUVER</b>	Inspected
Condition	3 - Fair
Deficiency	BROKEN/ DENTED BLADES

REPLACE

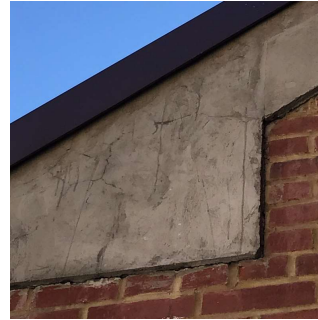
Roof 5

CONCRETE: MINOR CRACKS, SPALLING

REPAIR

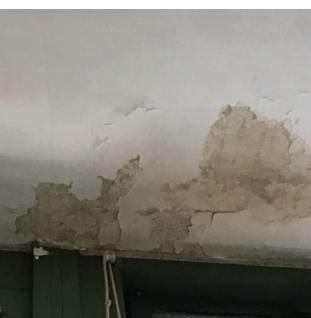
Violations	Roof 1 - Rooms 501, 503, 505, 506, 507, 508, 509 (Shown), 511, 512 No violations recorded.
Instance on IRMA: Roofs 6 - 11	Inspected
Instance Condition	1 - Good
Instance Photo

<p>Roof 1</p>
Instance Quantity	18,000
Instance Quantity Uom	S.F.
Does the roof have major mechanical equipment sitting on Dunnage Steel less than 18" above the Roofing?	No
Does this roof instance have a Sustainable Roof System?	No
Do solar panels exist on these roofs?	No
Is/Are the roof(s) suitable for Solar Panel installation?	Yes
Installation Year	1998
Source of Installation	Custodial Staff
Deficiency	BUILT-UP: ROOFING: MAJOR ACTIVE ROOF LEAKS IN INSTRUCTIONAL SPACE

Deficiency Quantity	900
Quantity Uom	S.F.
Potential Action	REPLACE ROOFING WITHOUT MAJOR EQUIPMENT REMOVAL
Urgency of Action	PRIORITY 5
Purpose of Action	LEVEL 2
Deficiency Photo1

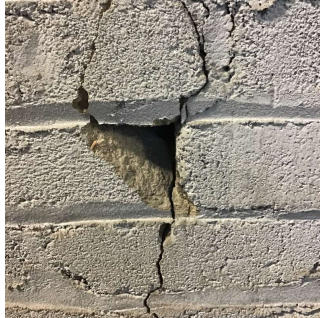
Violations	PH1
Deficiency	35671978K
Roof Plan reference	<p><b>BULKHEAD/PENTHOUSE WALLS/INTERIOR: CMU CRACKS/SPALLING</b></p>

Violations	Roof 1 No violations recorded.
<b>Specialties</b>	Inspected
<b>BULKHEAD/PENTHOUSE</b>	Inspected
Condition	4 - Between Fair and Poor
Deficiency	BULKHEAD/PENTHOUSE WALLS/INTERIOR: BRICK CRACKS/SPALLING
Roof Plan reference

Deficiency Quantity	60
Quantity Uom	S.F.
Potential Action	REPLACE
Urgency of Action	PRIORITY 4

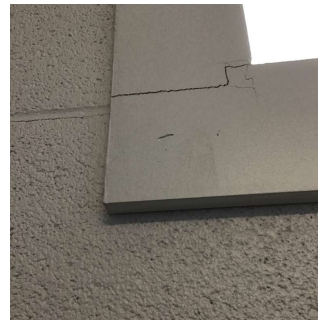
BH4  
No violations recorded.

Violations	BH4
Deficiency	No violations recorded.
	<p><b>BULKHEAD/PENTHOUSE WINDOWS: AIR/WATER INFILTRATION WITH DAMAGED TRIM OR SILLS</b></p>

10  
L.F.  
MAINTENANCE  
PRIORITY 3  
LEVEL 2

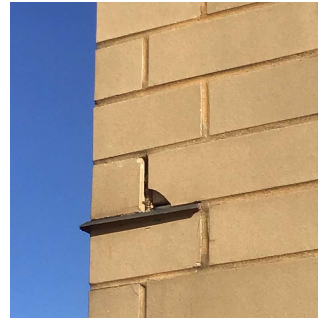
PH2

**BULKHEAD/PENTHOUSE WALLS/EXTERIOR:  
CRACKS/SPALLING - MAJOR**

40  
S.F.  
REPLACE  
PRIORITY 4  
LEVEL 2

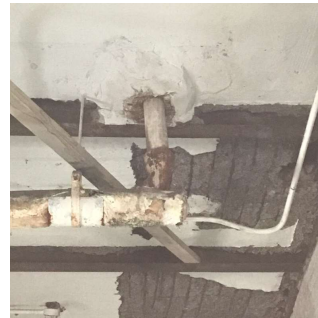
PH1

**BULKHEAD/PENTHOUSE ROOF: MAJOR LEAKAGE**

REPLACE

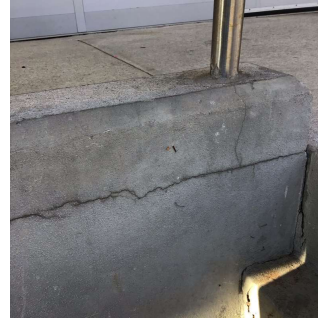
Facade A

CAST IN PLACE CONCRETE: CRACKS/SPALLING - MINOR

REPAIR

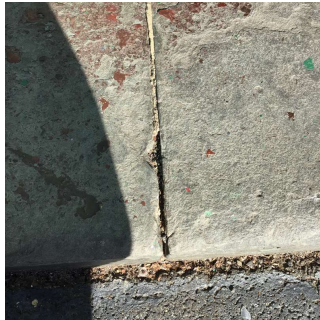
Violations	<p>Facade A</p> <p>No violations recorded.</p>
<b>RAILINGS</b>	Inspected
Condition	2 - Between Good and Fair
Deficiency	No deficiencies recorded
<b>STAIRS/RAMPS</b>	Inspected
Condition	4 - Between Fair and Poor
Deficiency	STONE: DETERIORATED JOINTS
Roof Plan reference

Deficiency Quantity	10
Quantity Uom	L.F.
Potential Action	REPOINT
Urgency of Action	PRIORITY 3
Purpose of Action	LEVEL 2
Deficiency Photo1

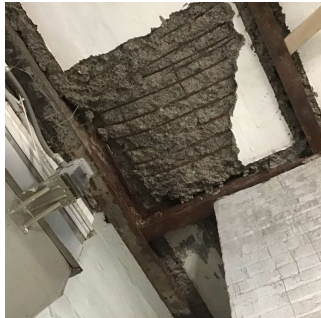
Question	Response
<b>INTERIOR</b>	
<b>STRUCTURAL</b>	
<b>ROOF STRUCTURE</b>	
Violations	No violations recorded.
Deficiency	STEEL COLUMNS/BEAMS: MAJOR RUSTING
Deficiency Location/Instance	PH1
Deficiency Quantity	30
Quantity Uom	S.F.
Potential Action	REPLACE
Urgency of Action	PRIORITY 4
Purpose of Action	LEVEL 5
Deficiency Photo1

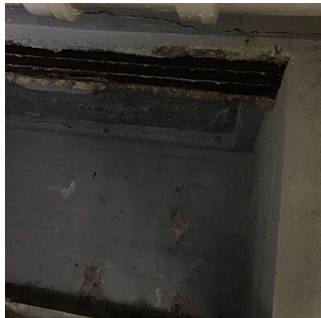
Violations	PH1 No violations recorded.
<b>VAULTS-BUNKERS</b>	Inspected
<b>Foundation Walls</b>	Inspected
Condition	3 - Fair
Deficiency	CRACKS, SPALLING
Deficiency Location/Instance	Basement - Vault
Deficiency Quantity	30
Quantity Uom	S.F.
Potential Action	REPAIR
Urgency of Action	PRIORITY 4
Purpose of Action	LEVEL 5
Deficiency Photo1

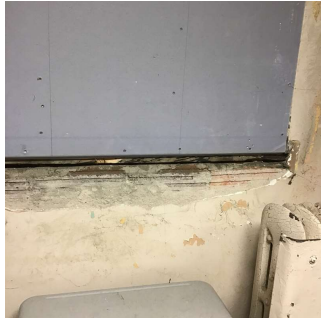
Question	Response
<b>INTERIOR</b>	
<b>AUDITORIUM</b>	
<b>Walls</b>	
Deficiency	PLASTER: CRACKS/SPALLING
Deficiency Location/Instance	Room Right Side Stage
Deficiency Quantity	20
Quantity Uom	S.F.
Potential Action	REPLACE
Urgency of Action	PRIORITY 3
Purpose of Action	LEVEL 2
Deficiency Photo1

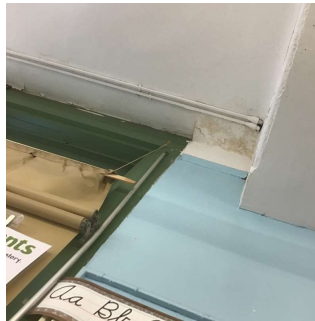
Near Room 119
Violations	No violations recorded.
<b>Window Curtains/Shades/Blinds</b>	
Instance on 1st Floor	Does not Exist
<b>CLASSROOMS/CORRIDORS/ADMIN SPACES</b>	
<b>Ceiling</b>	Inspected
Condition	2 - Between Good and Fair
Deficiency	PLASTER: CRACKS/SPALLING - ACTIVE LEAK

Deficiency Location/Instance	Rooms 501, 503, 505, 506, 507, 508, 509, 511, 512
Deficiency Quantity	100
Quantity Uom	S.F.

Question	Response
<b>INTERIOR</b>	
<b>CLASSROOMS/CORRIDORS/ADMIN SPACES</b>	
<b>Ceiling</b>	
Potential Action	REPLACE
Urgency of Action	PRIORITY 5
Purpose of Action	LEVEL 2
Deficiency Photo1

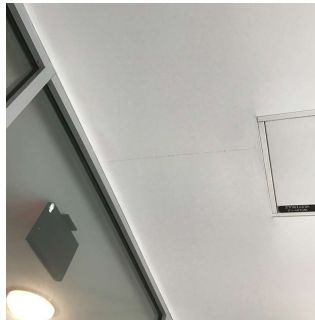
Main Entrance Vestibule
Violations	No violations recorded.
<b>Deficiency</b>	<b>ACOUSTIC TILES: DAMAGED/MISSING</b>
Deficiency Location/Instance	Inside room 205A
Deficiency Quantity	10
Quantity Uom	S.F.
Potential Action	REPLACE
Urgency of Action	PRIORITY 3
Purpose of Action	LEVEL 2

Room 501
Violations	No violations recorded.
<b>Deficiency</b>	<b>GYPSUM BOARD: DAMAGED/DETERIORATED</b>
Deficiency Location/Instance	Main Entrance Vestibule, Near Stair X/5, Elevator A/1.
Deficiency Quantity	50
Quantity Uom	S.F.
Potential Action	REPLACE
Urgency of Action	PRIORITY 3
Purpose of Action	LEVEL 2
Deficiency Photo1

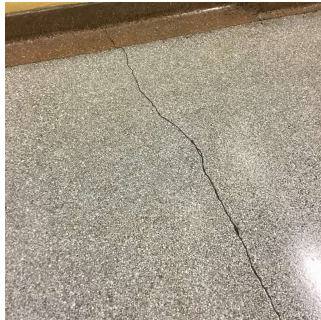
Question	Response
<b>INTERIOR</b>	
<b>CLASSROOMS/CORRIDORS/ADMIN SPACES</b>	
<b>Door(s)</b>	Inspected
	Room 504
Violations	No violations recorded.
<b>Floor Finish</b>	Inspected
Condition	3 - Fair
Deficiency	TERRAZZO: CRACKS
Deficiency Location/Instance	Corridor near Rooms 205A, 209, Vestibule Exit 12, near Multi-Purpose Rooms.
Deficiency Quantity	250
Quantity Uom	S.F.
Potential Action	REPLACE
Urgency of Action	PRIORITY 3
Purpose of Action	LEVEL 2
Deficiency Photo1

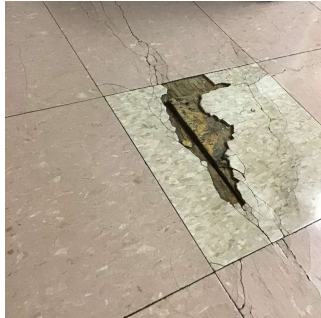
Corridor near Room 209
Violations	No violations recorded.
Deficiency	VINYL TILES: DETERIORATED SUBSTRATE
Deficiency Location/Instance	Room 211
Deficiency Quantity	10
Quantity Uom	S.F.
Potential Action	REPLACE
Urgency of Action	PRIORITY 5
Purpose of Action	LEVEL 6
Deficiency Photo1

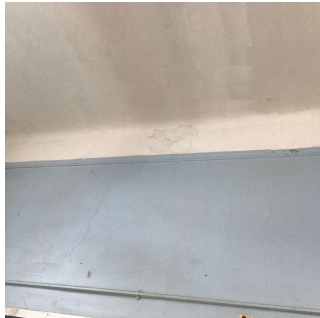
Violations	Stair Near Room 207 No violations recorded.
Deficiency	PLASTER: CRACKS/SPALLING - ACTIVE LEAK
Deficiency Location/Instance	Rooms 201, 508
Deficiency Quantity	20
Quantity Uom	S.F.
Potential Action	REPLACE
Urgency of Action	PRIORITY 5
Purpose of Action	LEVEL 2
Deficiency Photo1

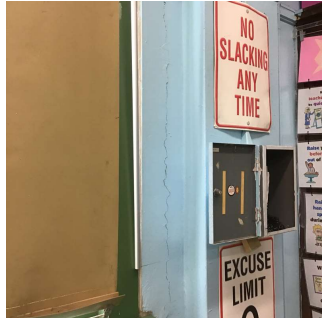
Question	Response
<b>INTERIOR</b>	
<b>CLASSROOMS/CORRIDORS/ADMIN SPACES</b>	
<b>Walls</b>	
Deficiency	PLASTER: CRACKS/SPALLING
Deficiency Location/Instance	Rooms 102, 403, 407, 409, 506, and others.
Deficiency Quantity	600
Quantity Uom	S.F.
Potential Action	REPLACE
Urgency of Action	PRIORITY 3
Purpose of Action	LEVEL 2
Deficiency Photo1

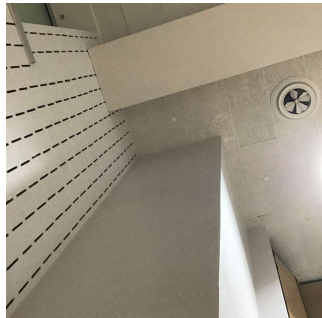
Room 506
Violations	No violations recorded.
<b>Specialties</b>	Does not Exist
<b>GYMNASIUM</b>	
Instance on Basement	Inspected
<b>Ceiling</b>	
Instance on Basement	Inspected
Condition	2 - Between Good and Fair
Deficiency	TECTUM: DAMAGED/MISSING
Deficiency Location/Instance	Near Entrance
Deficiency Quantity	10
Quantity Uom	S.F.
Potential Action	REPLACE
Urgency of Action	PRIORITY 3
Purpose of Action	LEVEL 2
Deficiency Photo1

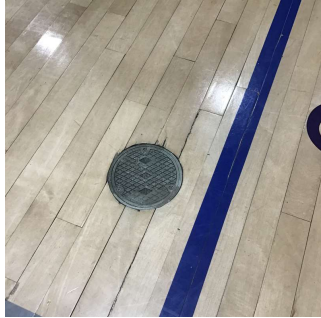
Question	Response
<b>INTERIOR</b>	
<b>GYMNASIUM</b>	
<b>Fixed Equipment</b>	
Instance on Basement	Inspected
Condition	2 - Between Good and Fair
Deficiency	No deficiencies recorded
<b>Floor Finish</b>	
Instance on Basement	Inspected
Condition	2 - Between Good and Fair
Deficiency	WOOD: DAMAGED/DETERIORATED
Deficiency Location/Instance	Near Entrance
Deficiency Quantity	20
Quantity Uom	S.F.
Potential Action	REPLACE
Urgency of Action	PRIORITY 3
Purpose of Action	LEVEL 2
Deficiency Photo1

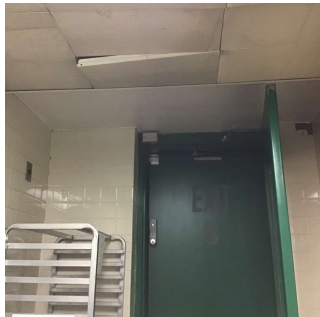
Question	Response
<b>INTERIOR</b>	
<b>KITCHEN</b>	
<b>Ceiling</b>	
Purpose of Action	LEVEL 2
Deficiency Photo1	 
	Office
Violations	No violations recorded.
Deficiency	METAL PAN: DAMAGED/MISSING
Deficiency Location/Instance	Near Exit 5, Rooms 110, 111, Serving Area
Deficiency Quantity	10
Quantity Uom	S.F.
Potential Action	REPLACE
Urgency of Action	PRIORITY 5
Purpose of Action	LEVEL 6
Deficiency Photo1

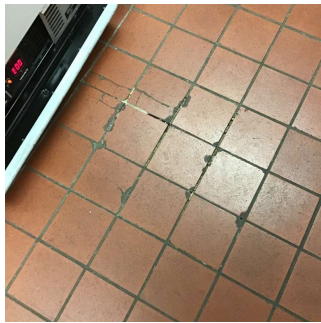
Question	Response
<b>INTERIOR</b>	
<b>KITCHEN</b>	
<b>Ceiling</b>	
Violations	No violations recorded.
<b>Door(s)</b>	
Instance on 1st Floor	Inspected
Condition	2 - Between Good and Fair
Deficiency	No deficiencies recorded
<b>Floor Finish</b>	
Instance on 1st Floor	Inspected
Condition	2 - Between Good and Fair
Deficiency	QUARRY TILE: BROKEN/MISSING TILES
Deficiency Location/Instance	Near Room 111, Serving Area, Office
Deficiency Quantity	20
Quantity Uom	S.F.
Potential Action	REPLACE
Urgency of Action	PRIORITY 3
Purpose of Action	LEVEL 2
Deficiency Photo1

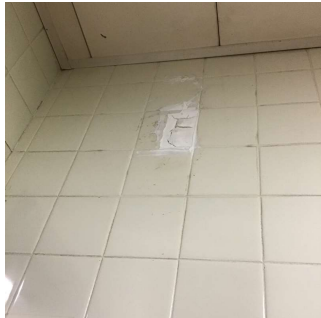
Violations	Serving Area No violations recorded.
<b>Walls</b>	
Instance on 1st Floor	Inspected
Condition	2 - Between Good and Fair
Deficiency	CERAMIC TILE: BROKEN/ MISSING
Deficiency Location/Instance	Room 111, Near Entrance, Office,
Deficiency Quantity	10
Quantity Uom	S.F.
Potential Action	REPLACE
Urgency of Action	PRIORITY 3
Purpose of Action	LEVEL 2
Deficiency Photo1

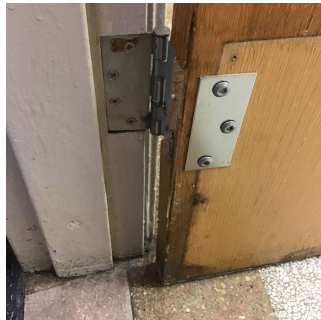
Violations	Entrance No violations recorded.

Instance on 1st Floor - North	Inspected
Condition	4 - Between Fair and Poor
Deficiency	WOOD: DETERIORATED DOOR
Deficiency Location/Instance	Entrance
Deficiency Quantity	2
Quantity Uom	EACH
Potential Action	MAINTENANCE
Urgency of Action	PRIORITY 3
Purpose of Action	LEVEL 2

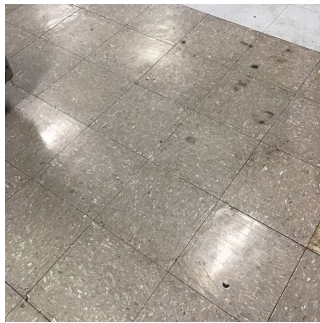
Question	Response
<b>INTERIOR</b>	
<b>MULTI-PURPOSE ROOM</b>	
<b>Door(s)</b>	
Deficiency Photo1	 
Violations	Entrance No violations recorded.
<b>Fixed Equipment</b>	
Instance on 1st Floor - North	Inspected
Condition	2 - Between Good and Fair
Deficiency	No deficiencies recorded
Instance on 1st Floor - South	Inspected
Condition	2 - Between Good and Fair
Deficiency	No deficiencies recorded
<b>Floor Finish</b>	
Instance on 1st Floor - South	Inspected
Condition	3 - Fair
Deficiency	VINYL TILES: BROKEN/DETERIORATED/MISSING TILES
Deficiency Location/Instance	Near Cafeteria, Center, Windows
Deficiency Quantity	130
Quantity Uom	S.F.
Potential Action	REPLACE
Urgency of Action	PRIORITY 3
Purpose of Action	LEVEL 2
Deficiency Photo1

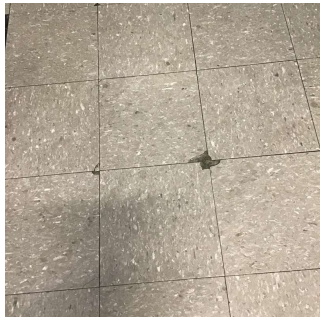
Violations	Near Cafeteria No violations recorded.
Instance on 1st Floor - North	Inspected
Condition	2 - Between Good and Fair
Deficiency	VINYL TILES: BROKEN/DETERIORATED/MISSING TILES
Deficiency Location/Instance	Near Stairs A, B, Windows, Rooms 101A, 105, and others

Deficiency Quantity	120
Quantity Uom	S.F.
Potential Action	REPLACE
Urgency of Action	PRIORITY 3

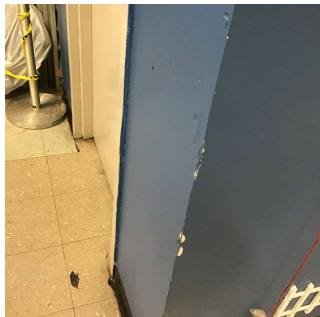
Near Entrance
Violations	No violations recorded.
Deficiency	BRICK: CRACKS/SPALLING
Deficiency Location/Instance	Near Cafeteria
Deficiency Quantity	10
Quantity Uom	S.F.
Potential Action	REPLACE
Urgency of Action	PRIORITY 3

Stair A
Violations	No violations recorded.
<b>Sliding-folding Partition</b>	
Instance on 1st Floor - North	Does not Exist
Instance on 1st Floor - South	Does not Exist
<b>Stage</b>	
Instance on 1st Floor - South	Does not Exist
Instance on 1st Floor - North	Does not Exist
<b>Walls</b>	
Instance on 1st Floor - South	Inspected
Condition	2 - Between Good and Fair
Deficiency	GYPSUM BOARD: DETERIORATED
Deficiency Location/Instance	Near Entrance
Deficiency Quantity	10
Quantity Uom	S.F.
Potential Action	REPLACE
Urgency of Action	PRIORITY 3
Purpose of Action	LEVEL 2
Deficiency Photo1

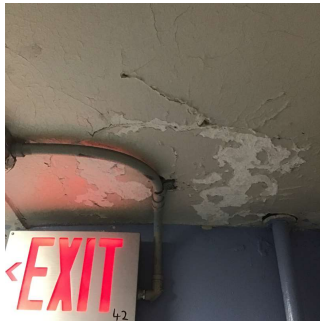
Question	Response
<b>INTERIOR</b>	
<b>STAIRS/RAMPS: INTERIOR</b>	
<b>Ceiling</b>	
Deficiency Photo1

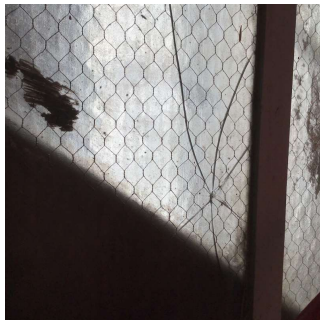
Stair D/1
Violations	No violations recorded.
<b>Door(s)</b>	Inspected
Condition	2 - Between Good and Fair
Deficiency	No deficiencies recorded
<b>Partition</b>	Inspected
Condition	2 - Between Good and Fair
Deficiency	GLASS PANEL: DAMAGED/DETERIORATED
Deficiency Location/Instance	Stairs AB/1, 2, 5, EF/2, 5, and others.
Deficiency Quantity	30
Quantity Uom	S.F.
Potential Action	REPLACE
Urgency of Action	PRIORITY 3
Purpose of Action	LEVEL 2
Deficiency Photo1

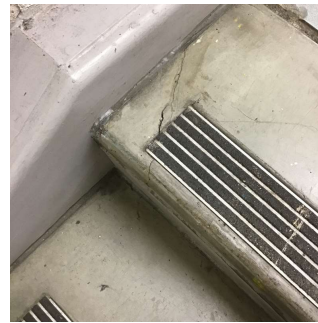
Stair EF/5
Violations	No violations recorded.
<b>Railings</b>	Inspected
Condition	2 - Between Good and Fair
Deficiency	No deficiencies recorded
<b>Stairs and Landings</b>	Inspected
Condition	5 - Poor
Deficiency	CONCRETE: CRACKS/SPALLING - MAJOR
Deficiency Location/Instance	Stair Y/Basement
Deficiency Quantity	10
Quantity Uom	S.F.
Potential Action	REPLACE
Urgency of Action	PRIORITY 3

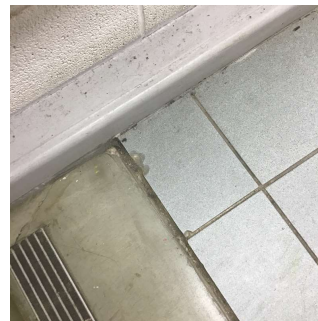
Stair Y/Basement

CERAMIC TILE: BROKEN/MISSING

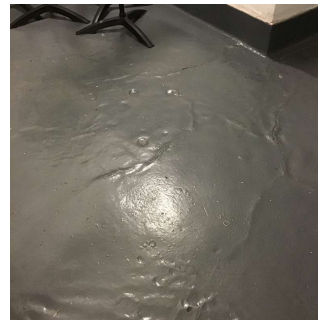
Stair G/2

ROLLED ASPHALT: CRACKS

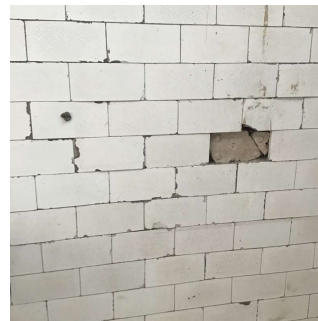
Stair EF/1 - Vestibule Exit 9

CERAMIC TILE: BROKEN/ MISSING

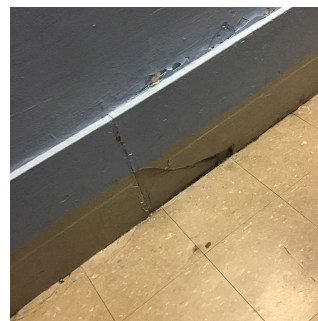
Stair D/1

STONE MOLDINGS: CRACKS/SPALLING

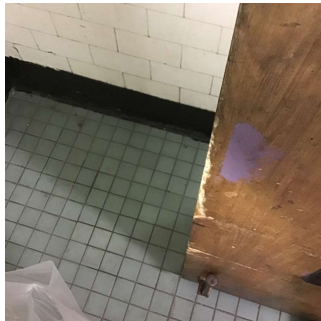
Question	Response
<b>INTERIOR</b>	
<b>TOILET ROOMS - STUDENTS</b>	
<b>Door(s)</b>	
Deficiency Photo1

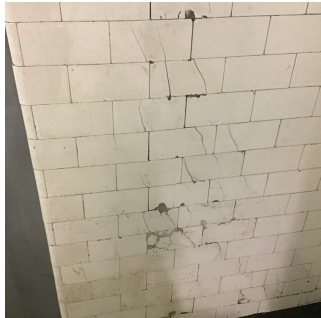
Question	Response
<b>INTERIOR</b>	
<b>TOILET ROOMS - STUDENTS</b>	
<b>Walls</b>	
Violations	Room 558 No violations recorded.
Deficiency	CERAMIC TILE: BROKEN/ MISSING
Deficiency Location/Instance	Rooms 105, 121
Deficiency Quantity	60
Quantity Uom	S.F.
Potential Action	REPLACE
Urgency of Action	PRIORITY 3
Purpose of Action	LEVEL 2
Deficiency Photo1

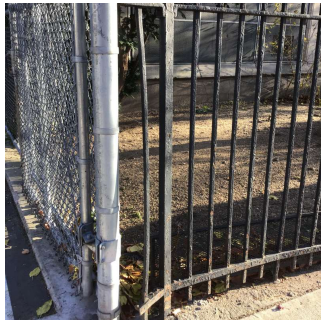
Question	Response
<b>SITE</b>	
<b>DRINKING FOUNTAINS</b>	
Potential Action	MAINTENANCE
Urgency of Action	PRIORITY 3
Purpose of Action	LEVEL 2
Deficiency Photo1	No photo recorded
Violations	No violations recorded.
<b>FENCES</b>	Inspected
Condition	3 - Fair
Deficiency	WROUGHT IRON: DAMAGED/DETERIORATED
Deficiency Location/Instance	42nd Street
Deficiency Quantity	80
Quantity Uom	S.F.
Potential Action	REPLACE
Urgency of Action	PRIORITY 3
Purpose of Action	LEVEL 2
Deficiency Photo1

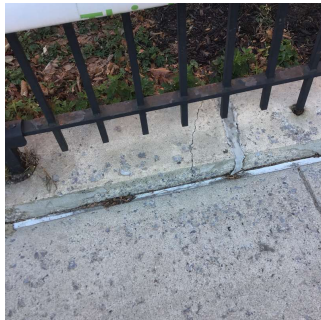
Violations	42nd Street No violations recorded.
Deficiency	CONCRETE CURB: DAMAGED/DETERIORATED
Deficiency Location/Instance	42nd Street, 43rd Street, Near Exits 3, 10.
Deficiency Quantity	100
Quantity Uom	S.F.
Potential Action	REPLACE
Urgency of Action	PRIORITY 3
Purpose of Action	LEVEL 2
Deficiency Photo1

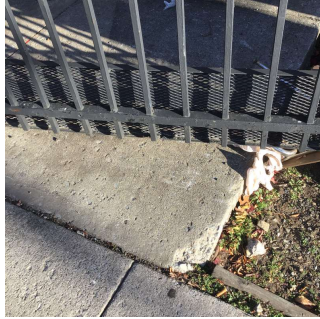
Question	Response
<b>SITE</b>	
<b>PAVING</b>	
<b>Student Non-Use</b>	
<b>Asphalt</b>	Does not Exist
<b>Concrete</b>	Inspected
Condition	3 - Fair
Deficiency	DAMAGED/DETERIORATED/MISSING SECTIONS
Deficiency Location/Instance	42nd Street
Deficiency Quantity	50
Quantity Uom	S.F.
Potential Action	REPLACE
Urgency of Action	PRIORITY 3
Purpose of Action	LEVEL 2
Deficiency Photo1

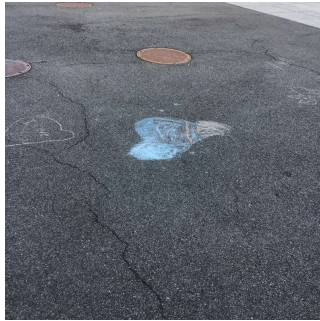
Violations	42nd Street No violations recorded.
<b>Pavers</b>	Does not Exist
<b>Student Use</b>	Inspected
Gravel Exists?	No
<b>Asphalt</b>	Inspected
Condition	3 - Fair
Deficiency	CRACKS - MAJOR
Deficiency Location/Instance	Near Playground, Exit 10
Deficiency Quantity	400
Quantity Uom	S.F.
Potential Action	REPLACE
Urgency of Action	PRIORITY 3
Purpose of Action	LEVEL 2
Deficiency Photo1

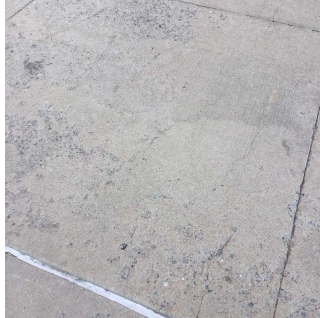
Violations	Near Playground No violations recorded.
<b>Concrete</b>	Inspected
Condition	4 - Between Fair and Poor
Deficiency	CRACKS - MAJOR

Question	Response
<b>SITE</b>	
<b>PAVING</b>	
<b>Student Use</b>	
<b>Concrete</b>	
Deficiency Location/Instance	Near Exits 8, 9 11
Deficiency Quantity	500
Quantity Uom	S.F.
Potential Action	REPLACE
Urgency of Action	PRIORITY 3
Purpose of Action	LEVEL 2
Deficiency Photo1

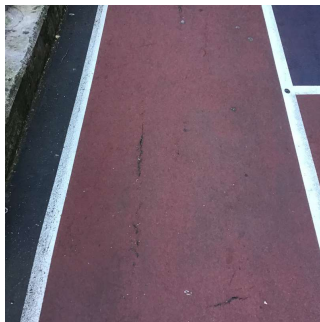
Violations	Near Exit 11 No violations recorded.
<b>Pavers</b>	Does not Exist
<b>Site Sidewalks &amp; Walkways</b>	Inspected
<b>Asphalt</b>	Inspected
Condition	2 - Between Good and Fair
Deficiency	CRACKS - MAJOR
Deficiency Location/Instance	Near Exit 10
Deficiency Quantity	20
Quantity Uom	S.F.
Potential Action	REPLACE
Urgency of Action	PRIORITY 3
Purpose of Action	LEVEL 2
Deficiency Photo1

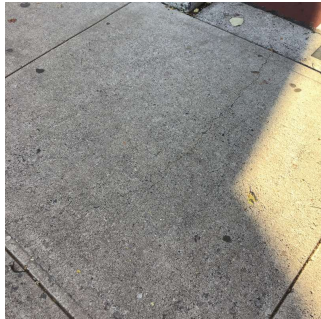
Violations	42nd Street No violations recorded.
Deficiency	DAMAGED/DETERIORATED/MISSING SECTIONS
Deficiency Location/Instance	42nd Street, 43rd Street
Deficiency Quantity	100
Quantity Uom	S.F.
Potential Action	REPLACE
Urgency of Action	PRIORITY 3
Purpose of Action	LEVEL 2
Deficiency Photo1

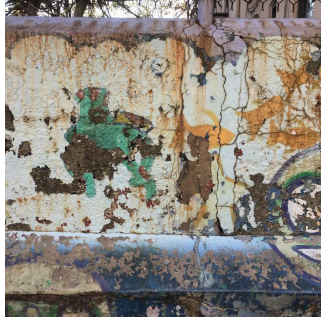
Question	Response
<b>SITE</b>	
<b>SITE WALLS (NOT RETAINING WALLS)</b>	
Deficiency	CAST IN PLACE CONCRETE: CRACKS/SPALLING - MAJOR
Deficiency Location/Instance	Near Playgrounds
Deficiency Quantity	50
Quantity Uom	S.F.
Potential Action	REPLACE
Urgency of Action	PRIORITY 3
Purpose of Action	LEVEL 2
Deficiency Photo1
