**NYC Department of Education**  
**Building Condition Assessment Survey 2023 - 2024**

Architectural Inspection

**Asset:** P.S. 151 - QUEENS, 50-05 31 AVENUE, New York, 11377

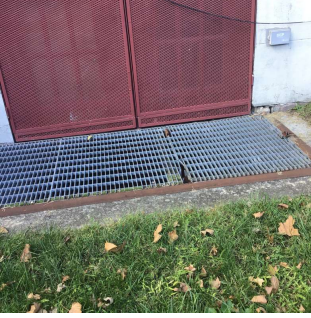
Question	Response
<b>Architectural</b>	
<b>EXTERIOR</b>	Inspected
<b>AREAWAY</b>	Inspected
Instance on AW1 - AW11	Inspected
Instance Condition	3 - Fair
Instance Quantity	11
Instance Quantity Uom	EACH
Deficiency	AREAWAY GRATINGS: MAJOR RUSTING / OR BROKEN
Roof Plan reference	<p>Q151</p>

Deficiency Quantity	80
Quantity Uom	S.F.
Potential Action	REPLACE
Urgency of Action	PRIORITY 4
Purpose of Action	LEVEL 2
Deficiency Photo1

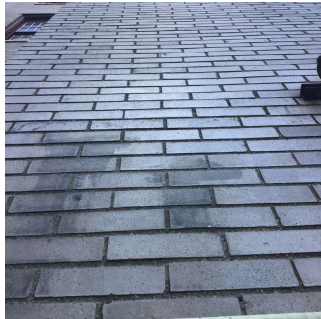
Violations	<p>Facade A</p> <p>No violations recorded.</p>
<b>AWNINGS AND CANOPIES</b>	Does not Exist
<b>CHIMNEY</b>	Inspected
Material Type(s)	Masonry
Condition	3 - Fair
Deficiency	BRICK: DETERIORATED JOINTS
Roof Plan reference	<p>Q151</p>

Deficiency Quantity	300
Quantity Uom	S.F.
Potential Action	REPOINT
Urgency of Action	PRIORITY 3
Purpose of Action	LEVEL 2
Deficiency Photo1

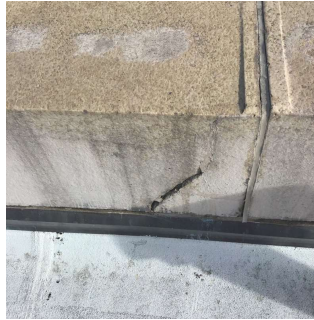
Roof 2

Violations	<p>Facade C</p> <p>No violations recorded.</p>
<b>COPING</b>	Inspected
Condition	3 - Fair
Deficiency	TERRA COTTA: DETERIORATED TRANSVERSE JOINTS

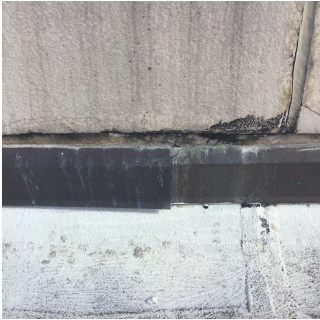
TERRA COTTA: DETERIORATED BED JOINT

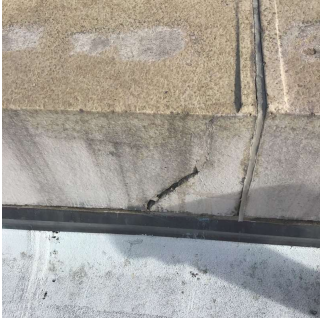
Violations	<p>Roof 2</p> <p>No violations recorded.</p>
Deficiency	CAST STONE: CRACKED/BROKEN PIECES
Roof Plan reference	<p>Q151</p>

Deficiency Quantity	50
Quantity Uom	L.F.
Potential Action	REPLACE-IN-KIND
Urgency of Action	PRIORITY 4
Purpose of Action	LEVEL 2
Deficiency Photo1

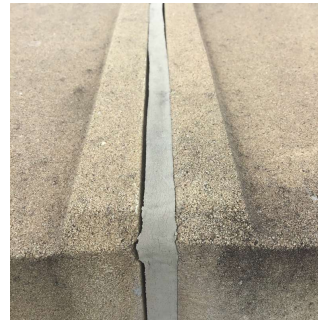
Roof 1

Violations	<p>Roof 3</p> <p>No violations recorded.</p>
Deficiency	CAST STONE: DETERIORATED TRANSVERSE JOINTS

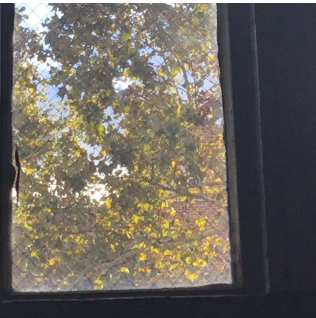
Question	Response
<b>EXTERIOR</b>	
<b>DOORS</b>	
<b>DOORS AND FRAMES</b>	Inspected
Violations	No violations recorded.
<b>DOOR HARDWARE</b>	Inspected
Condition	3 - Fair
Deficiency	No deficiencies recorded
<b>LINTELS</b>	Inspected
Condition	2 - Between Good and Fair
Deficiency	No deficiencies recorded
<b>TRANSOM/SIDE LIGHT</b>	Inspected
Condition	3 - Fair
Deficiency	METAL: BROKEN GLASS
Roof Plan reference	<p>Q151</p>

<p>50TH STREET</p> <p>31ST AVENUE</p> <p>HOBART STREET</p>
Deficiency Quantity	40
Quantity Uom	S.F.
Potential Action	MAINTENANCE
Urgency of Action	PRIORITY 3
Purpose of Action	LEVEL 2
Deficiency Photo1

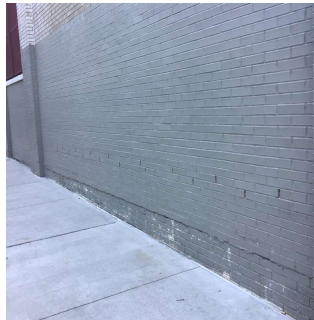
Facade C

Violations	<p>Facade A</p> <p>No violations recorded.</p>
<b>EXTERIOR WALLS</b>	Inspected
Material Type(s)	Masonry
Replacement Quantity	38,000
Replacement Uom	S.F.
Instance on All Facades	Inspected
Instance Condition	3 - Fair
Instance Quantity	38,000
Instance Quantity Uom	S.F.
Deficiency	BRICK: MAJOR / THRU CRACKS

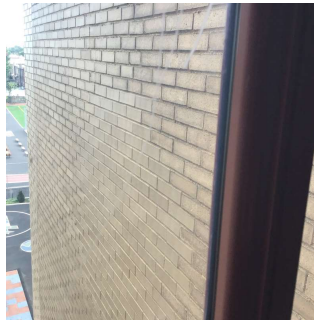
Facade C

BRICK: DETERIORATED JOINTS

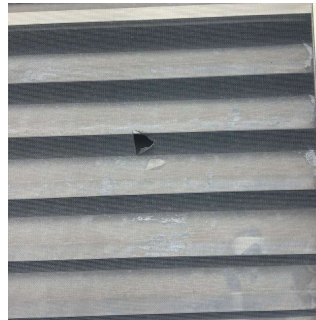
Roof 2

MISSING/DAMAGED SCREEN

REPLACE

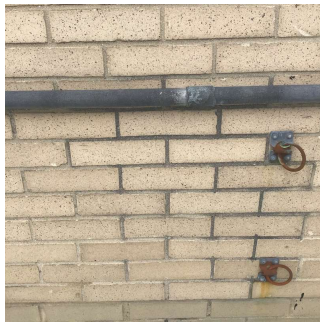
Violations	Roof 2 No violations recorded.
Deficiency	BRICK: DETERIORATED JOINTS
Roof Plan reference	<p>Q151</p>

Deficiency Quantity	500
Quantity Uom	S.F.
Potential Action	REPOINT
Urgency of Action	PRIORITY 3
Purpose of Action	LEVEL 2
Deficiency Photo1

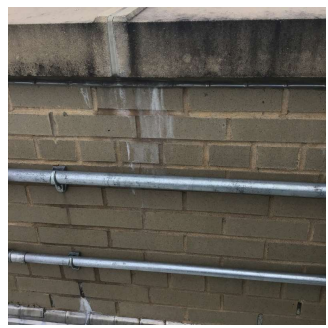
Violations	Roof 1 and 2 No violations recorded.
Deficiency	BRICK: EFFLORESCENCE

Deficiency Quantity	50
Quantity Uom	S.F.
Potential Action	MAINTENANCE
Urgency of Action	PRIORITY 3
Purpose of Action	LEVEL 2
Deficiency Photo1

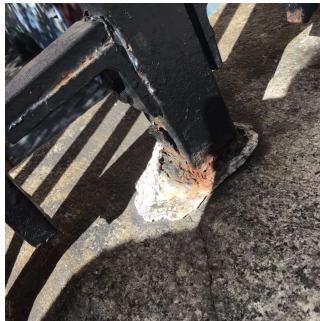
Violations	Facade C No violations recorded.
<b>RAILINGS</b>	Inspected
Condition	4 - Between Fair and Poor
Deficiency	RUST - MAJOR
Roof Plan reference	Q151
Deficiency Quantity	20
Quantity Uom	L.F.
Potential Action	REPLACE
Urgency of Action	PRIORITY 4
Purpose of Action	LEVEL 2
Deficiency Photo1

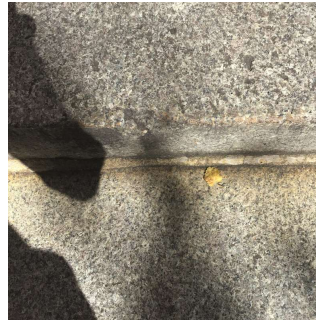
Facade A

STONE: WORN-OUT TREAD/RISER/NOSING

REPLACE

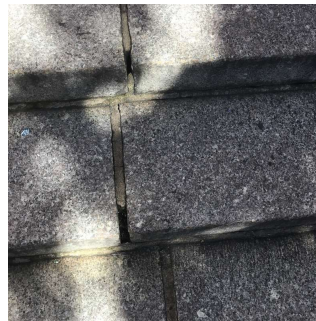
Facade A

**STONE: DETERIORATED JOINTS**

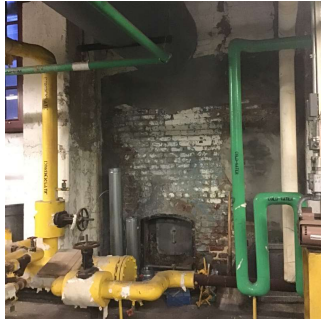
Basement - Storage Room
Violations	No violations recorded.
<b>FOUNDATION WALLS</b>	Inspected
Material Type(s)	Concrete, Masonry
Condition	4 - Between Fair and Poor
Deficiency	BRICK: DETERIORATED JOINTS
Deficiency Location/Instance	Basement - Boiler Room and Storage Room
Deficiency Quantity	150
Quantity Uom	S.F.
Potential Action	REPOINT
Urgency of Action	PRIORITY 3
Purpose of Action	LEVEL 5
Deficiency Photo1

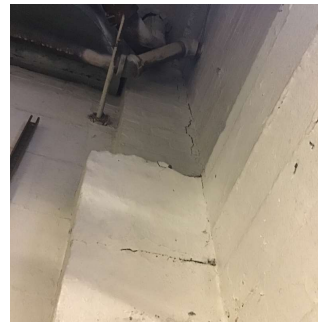
Basement - Boiler Room and Storage Room
Violations	No violations recorded.
Deficiency	BRICK: CRACKED/SPALLED
Deficiency Location/Instance	Basement - Boiler room
Deficiency Quantity	50
Quantity Uom	S.F.
Potential Action	RESTITCH
Urgency of Action	PRIORITY 3
Purpose of Action	LEVEL 5

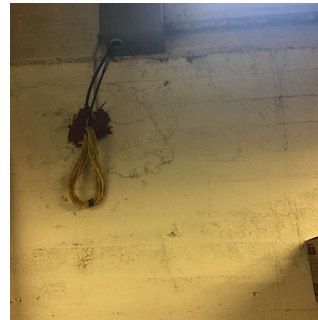
Basement, Electrical Room and Storage Room

CONCRETE: CRACKED/SPALLED/REINFORCEMENT EXPOSED

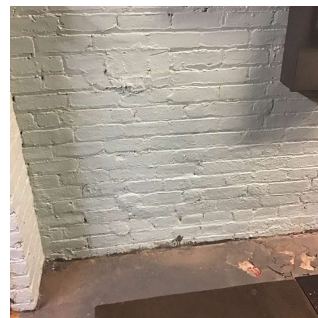
Basement - Electrical Room

CONCRETE: WATER INFILTRATION IN ELECTRICAL PANEL ROOM

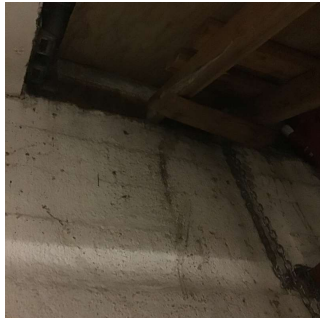
Question	Response
<b>INTERIOR</b>	
<b>STRUCTURAL</b>	
<b>FOUNDATION WALLS</b>	Inspected
Violations	No violations recorded.
<b>ROOF STRUCTURE</b>	Inspected
Condition	2 - Between Good and Fair
Deficiency	No deficiencies recorded
<b>VAULTS-BUNKERS</b>	Inspected
<b>Foundation Walls</b>	Inspected
Condition	4 - Between Fair and Poor
Deficiency	WATER INFILTRATION IN NON- INSTRUCTIONAL SPACE
Deficiency Location/Instance	Basement
Deficiency Quantity	100
Quantity Uom	S.F.
Potential Action	INSTALL WATERPROOFING
Urgency of Action	PRIORITY 5
Purpose of Action	LEVEL 5
Deficiency Photo1

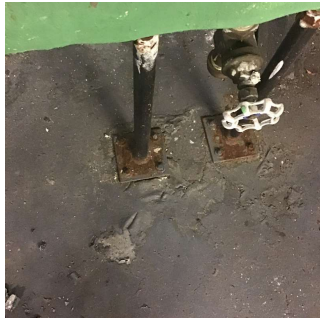
Violations	Basement No violations recorded.
<b>Slab Structure</b>	Inspected
Condition	4 - Between Fair and Poor
Deficiency	CONCRETE: CRACKS/SPALLED/REINFORCEMENT EXPOSED
Deficiency Location/Instance	Basement
Deficiency Quantity	100
Quantity Uom	S.F.
Potential Action	REPAIR
Urgency of Action	PRIORITY 3
Purpose of Action	LEVEL 5
Deficiency Photo1

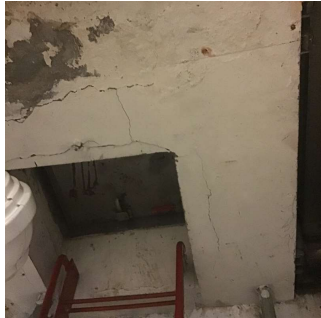
Violations	Basement No violations recorded.
Deficiency	CONCRETE: WATER INFILTRATION IN NON- INSTRUCTIONAL SPACE

Question	Response
<b>INTERIOR</b>	
<b>STRUCTURAL</b>	
<b>VAULTS-BUNKERS</b>	
<b>Slab Structure</b>	
Deficiency Location/Instance	Basement
Deficiency Quantity	100
Quantity Uom	S.F.
Potential Action	INSTALL WATERPROOFING
Urgency of Action	PRIORITY 5
Purpose of Action	LEVEL 5
Deficiency Photo1

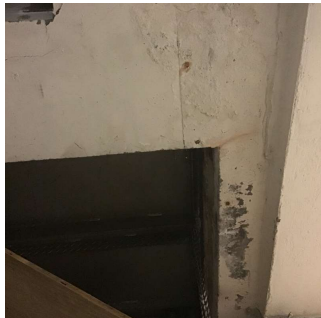
Violations	Basement No violations recorded.
<b>Vault/Ash Hoist Doors and Framing</b>	Inspected
Condition	5 - Poor
Deficiency	WATER INFILTRATION
Deficiency Location/Instance	Basement
Deficiency Quantity	10
Quantity Uom	S.F.
Potential Action	REPAIR
Urgency of Action	PRIORITY 5
Purpose of Action	LEVEL 2
Deficiency Photo1

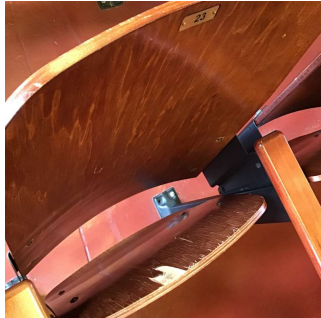
Violations	Entrance No violations recorded.
<b>Fixed H/C Lift</b>	
Instance on 1st Floor (549 Seats)	Does not Exist
<b>Fixed Seating</b>	
Instance on 1st Floor (549 Seats)	Inspected
Condition	3 - Fair
Deficiency	DAMAGED/BROKEN/INOPERABLE
Deficiency Location/Instance	Seats B/14, C/17, P/22, Q/ 23, X/16, and others.
Deficiency Quantity	17
Quantity Uom	EACH
Potential Action	REPLACE
Urgency of Action	PRIORITY 3
Purpose of Action	LEVEL 2
Deficiency Photo1

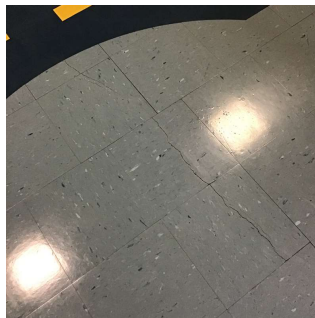
Near Exit 2
Violations	No violations recorded.
<b>Fixed Equipment</b>	
Instance on 1st Floor	Inspected
Condition	2 - Between Good and Fair
Deficiency	No deficiencies recorded
<b>Floor Finish</b>	
Instance on 1st Floor	Inspected
Condition	2 - Between Good and Fair
Deficiency	VINYL TILES: DETERIORATED SUBSTRATE
Deficiency Location/Instance	Near Entrance, Center, Room 157
Deficiency Quantity	100
Quantity Uom	S.F.
Potential Action	REPLACE
Urgency of Action	PRIORITY 3
Purpose of Action	LEVEL 2
Deficiency Photo1

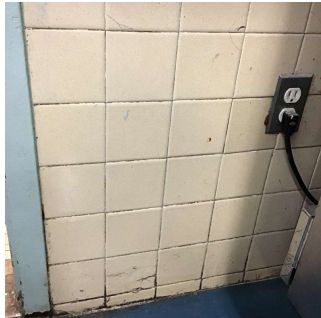
Near Entrance
Violations	No violations recorded.
<b>Sliding-folding Partition</b>	
Instance on 1st Floor	Does not Exist
<b>Stage</b>	
Instance on 1st Floor	Does not Exist
<b>Walls</b>	
Instance on 1st Floor	Inspected
Condition	2 - Between Good and Fair
Deficiency	CERAMIC TILE: BROKEN/ MISSING

Question	Response
<b>INTERIOR</b>	
<b>CAFETERIA</b>	
<b>Walls</b>	
Deficiency Quantity	10
Quantity Uom	S.F.
Potential Action	REPLACE
Urgency of Action	PRIORITY 3
Purpose of Action	LEVEL 2
Deficiency Photo1

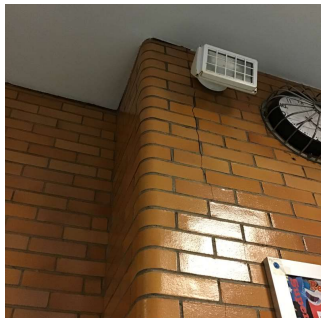
Near Kitchen Entrance
Violations	No violations recorded.
Deficiency	SALT GLAZED BRICK: CRACKS/SPALLING
Deficiency Location/Instance	Near Room 157
Deficiency Quantity	10
Quantity Uom	S.F.
Potential Action	REPLACE
Urgency of Action	PRIORITY 3
Purpose of Action	LEVEL 2
Deficiency Photo1

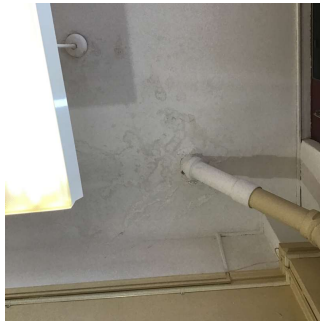
Near Room 157
Violations	No violations recorded.
<b>Window Curtains/Shades/Blinds</b>	
Instance on 1st Floor	Does not Exist
<b>CLASSROOMS/CORRIDORS/ADMIN SPACES</b>	
<b>Ceiling</b>	
Condition	Inspected
Condition	2 - Between Good and Fair
Deficiency	PLASTER: CRACKS/SPALLING
Deficiency Location/Instance	Room 402
Deficiency Quantity	20
Quantity Uom	S.F.
Potential Action	REPLACE
Urgency of Action	PRIORITY 3
Purpose of Action	LEVEL 2

Question	Response
<b>INTERIOR</b>	
<b>CLASSROOMS/CORRIDORS/ADMIN SPACES</b>	
<b>Ceiling</b>	
Deficiency Photo1

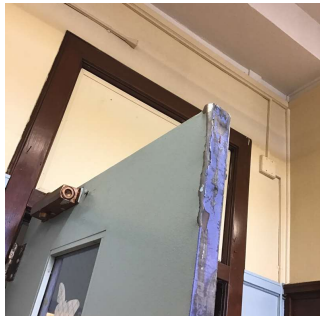
Room 262
Violations	No violations recorded.
Deficiency	METAL: DETERIORATED DOOR
Deficiency Location/Instance	Room 202
Deficiency Quantity	1
Quantity Uom	EACH
Potential Action	MAINTENANCE
Urgency of Action	PRIORITY 3
Purpose of Action	LEVEL 2
Deficiency Photo1

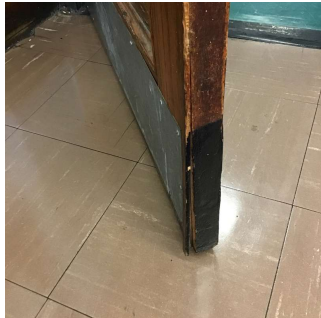
Question	Response
<b>INTERIOR</b>	
<b>CLASSROOMS/CORRIDORS/ADMIN SPACES</b>	
<b>Door(s)</b>	
	Room 202
Violations	No violations recorded.
Deficiency	WOOD: DETERIORATED DOOR
Deficiency Location/Instance	Rooms 218, 255, 302, 417, Main Entrance, and others.
Deficiency Quantity	17
Quantity Uom	EACH
Potential Action	MAINTENANCE
Urgency of Action	PRIORITY 3
Purpose of Action	LEVEL 2
Deficiency Photo1

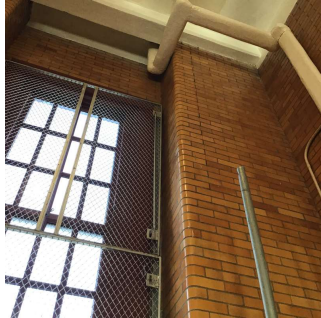
Question	Response
<b>INTERIOR</b>	
<b>GYMNASIUM</b>	
<b>Floor Finish</b>	
Urgency of Action	PRIORITY 3
Purpose of Action	LEVEL 2
Deficiency Photo1	 
	Near Center
Violations	No violations recorded.
<b>Seating</b>	
Instance on 3rd Floor	Inspected
Condition	2 - Between Good and Fair
Deficiency	No deficiencies recorded
<b>Sliding-folding Partition</b>	
Instance on 3rd Floor	Does not Exist
<b>Stage</b>	
Instance on 3rd Floor	Does not Exist
<b>Walls</b>	
Instance on 3rd Floor	Inspected
Condition	2 - Between Good and Fair
Deficiency	PLASTER: CRACKS/SPALLING
Deficiency Location/Instance	Inside Offices, Storage
Deficiency Quantity	20
Quantity Uom	S.F.
Potential Action	REPLACE
Urgency of Action	PRIORITY 3
Purpose of Action	LEVEL 2
Deficiency Photo1	 
	Inside Office
Violations	No violations recorded.
Deficiency	SALT GLAZED BRICK: CRACKS/SPALLING
Deficiency Location/Instance	Near Windows
Deficiency Quantity	80
Quantity Uom	S.F.
Potential Action	REPLACE

Question	Response
<b>INTERIOR</b>	
<b>GYMNASIUM</b>	
<b>Walls</b>	
Urgency of Action	PRIORITY 3
Purpose of Action	LEVEL 2
Deficiency Photo1

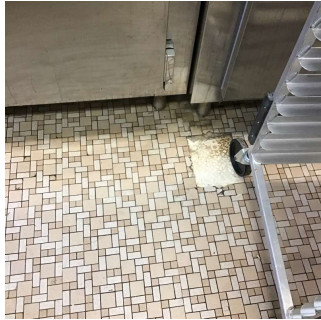
Question	Response
<b>INTERIOR</b>	
<b>KITCHEN</b>	
<b>Door(s)</b>	
Deficiency	No deficiencies recorded
<b>Floor Finish</b>	
Instance on 1st Floor (500 SF)	Inspected
Condition	2 - Between Good and Fair
Deficiency	CERAMIC TILE: BROKEN/MISSING TILES
Deficiency Location/Instance	Near Center
Deficiency Quantity	10
Quantity Uom	S.F.
Potential Action	REPLACE
Urgency of Action	PRIORITY 3
Purpose of Action	LEVEL 2
Deficiency Photo1

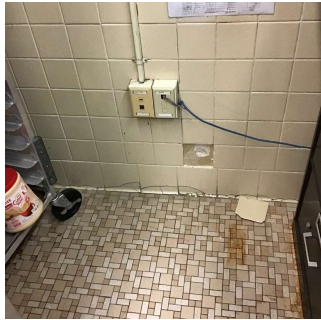
Near Center
Violations	No violations recorded.
<b>Walls</b>	
Instance on 1st Floor (500 SF)	Inspected
Condition	3 - Fair
Deficiency	CERAMIC TILE: BROKEN/ MISSING
Deficiency Location/Instance	Near Desk Area
Deficiency Quantity	20
Quantity Uom	S.F.
Potential Action	REPLACE
Urgency of Action	PRIORITY 3
Purpose of Action	LEVEL 2
Deficiency Photo1

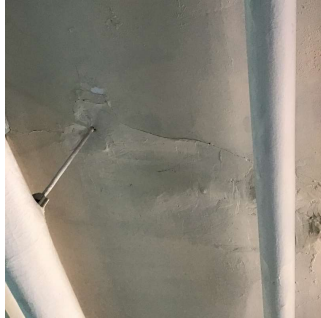
Question	Response
<b>INTERIOR</b>	
<b>LOCKER ROOM</b>	
<b>Ceiling</b>	
Condition	2 - Between Good and Fair
Deficiency	PLASTER: CRACKS/SPALLING
Deficiency Location/Instance	Near Windows, Center
Deficiency Quantity	10
Quantity Uom	S.F.
Potential Action	REPLACE
Urgency of Action	PRIORITY 3
Purpose of Action	LEVEL 2
Deficiency Photo1

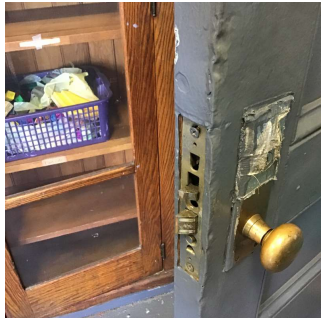
Violations	Near Windows No violations recorded.
<b>Door(s)</b>	
Instance on 4th Floor	Inspected
Condition	3 - Fair
Deficiency	METAL CLAD WOOD: DETERIORATED DOOR
Deficiency Location/Instance	Entrance
Deficiency Quantity	1
Quantity Uom	EACH
Potential Action	MAINTENANCE
Urgency of Action	PRIORITY 3
Purpose of Action	LEVEL 2
Deficiency Photo1

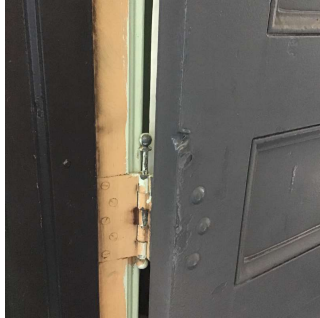
Violations	Entrance No violations recorded.
Instance on 3rd Floor	Inspected
Condition	3 - Fair
Deficiency	WOOD: DETERIORATED DOOR
Deficiency Location/Instance	Entrance
Deficiency Quantity	1
Quantity Uom	EACH
Potential Action	MAINTENANCE

Question	Response
<b>INTERIOR</b>	
<b>LOCKER ROOM</b>	
<b>Door(s)</b>	
Urgency of Action	PRIORITY 3
Purpose of Action	LEVEL 2
Deficiency Photo1

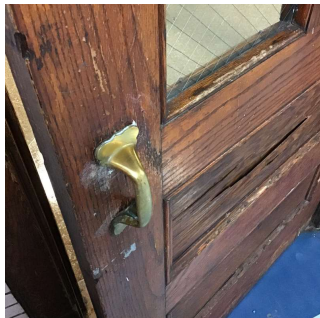
Violations	Vestibule Exit 5/6 No violations recorded.

Violations	Stair CD/3 No violations recorded.
Deficiency	WOOD: DETERIORATED DOOR
Deficiency Location/Instance	Vestibule Exits 3/4, 5/6, 9
Deficiency Quantity	6
Quantity Uom	EACH
Potential Action	MAINTENANCE
Urgency of Action	PRIORITY 3
Purpose of Action	LEVEL 2
Deficiency Photo1

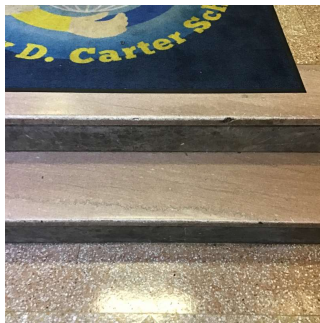
Violations	Main Entrance No violations recorded.
Deficiency	STONE: WORN-OUT TREAD/NOSINGS
Deficiency Location/Instance	Stair CD/1
Deficiency Quantity	260
Quantity Uom	S.F.
Potential Action	REPLACE
Urgency of Action	PRIORITY 3
Purpose of Action	LEVEL 2
Deficiency Photo1

Question	Response
<b>INTERIOR</b>	
<b>STAIRS/RAMPS: INTERIOR</b>	
<b>Stairs and Landings</b>	
Deficiency Photo1

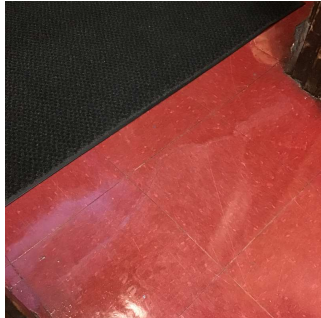
Question	Response
<b>INTERIOR</b>	
<b>STAIRS/RAMPS: INTERIOR</b>	
<b>Stairs and Landings</b>	
Deficiency	VINYL TILES: DETERIORATED SUBSTRATE
Deficiency Location/Instance	Stair CD/4, E/1
Deficiency Quantity	20
Quantity Uom	S.F.
Potential Action	REPLACE
Urgency of Action	PRIORITY 3
Purpose of Action	LEVEL 2
Deficiency Photo1

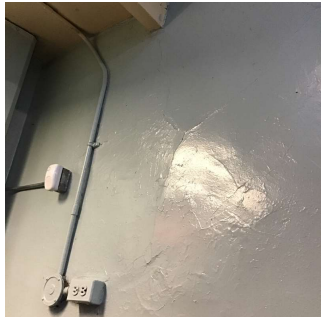
Stair 9/1
Violations	No violations recorded.
Deficiency	BRICK: CRACKS/SPALLING
Deficiency Location/Instance	Vestibule Exit 9
Deficiency Quantity	20
Quantity Uom	S.F.
Potential Action	REPLACE
Urgency of Action	PRIORITY 3
Purpose of Action	LEVEL 2

Stair 9/1
Violations	No violations recorded.
<b>Walls</b>	
Condition	Inspected
	2 - Between Good and Fair
Deficiency	PLASTER: CRACKS/SPALLING
Deficiency Location/Instance	Stair AB/1, E/1, 2, 3, 4
Deficiency Quantity	40
Quantity Uom	S.F.
Potential Action	REPLACE
Urgency of Action	PRIORITY 3
Purpose of Action	LEVEL 2
Deficiency Photo1

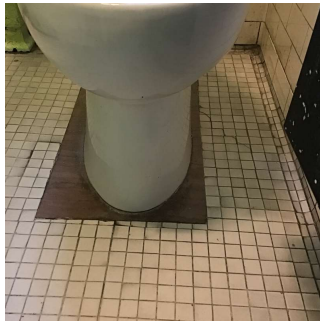
Violations	Room 351 No violations recorded.
<b>Stalls</b>	Inspected
Condition	5 - Poor
Deficiency	RUST - MAJOR
Deficiency Location/Instance	Rooms 351
Deficiency Quantity	1
Quantity Uom	EACH
Potential Action	REPLACE
Urgency of Action	PRIORITY 3
Purpose of Action	LEVEL 2
Deficiency Photo1

Question	Response
<b>INTERIOR</b>	
<b>TOILET ROOMS - STAFF</b>	
<b>Floor Finish</b>	
Deficiency Photo1

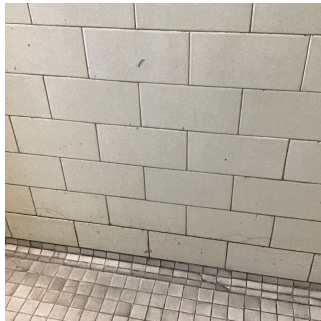
Violations	Room 351 No violations recorded.
Deficiency	PLASTER: CRACKS/SPALLING
Deficiency Location/Instance	Room 356
Deficiency Quantity	10
Quantity Uom	S.F.
Potential Action	REPLACE
Urgency of Action	PRIORITY 3
Purpose of Action	LEVEL 2
Deficiency Photo1

Violations	Room 351 No violations recorded.
<b>Walls</b>	Inspected
Condition	2 - Between Good and Fair
Deficiency	CERAMIC TILE: BROKEN/ MISSING
Deficiency Location/Instance	Room 351
Deficiency Quantity	10
Quantity Uom	S.F.
Potential Action	REPLACE
Urgency of Action	PRIORITY 3
Purpose of Action	LEVEL 2

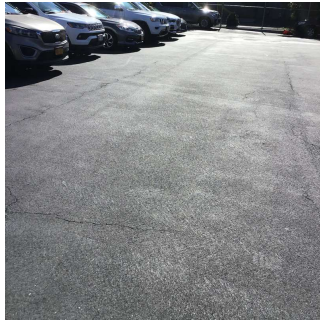
Violations	Parking Lot No violations recorded.
<b>Concrete</b>	Inspected
Condition	3 - Fair
Deficiency	CRACKS - MAJOR
Deficiency Location/Instance	50th Street
Deficiency Quantity	50
Quantity Uom	S.F.
Potential Action	REPLACE
Urgency of Action	PRIORITY 3
Purpose of Action	LEVEL 2
Deficiency Photo1

Question	Response
<b>SITE</b>	
<b>PAVING</b>	
<b>Student Non-Use</b>	
<b>Asphalt</b>	
Deficiency Photo1

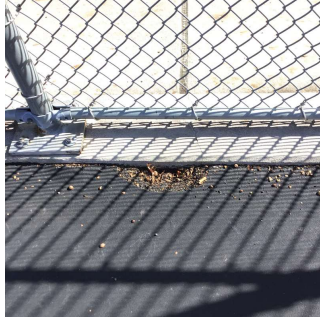
Violations	59th No violations recorded.
<b>Pavers</b>	Does not Exist
<b>Student Use</b>	Inspected
Gravel Exists?	No
<b>Asphalt</b>	Inspected
Condition	3 - Fair
Deficiency	CRACKS - MAJOR
Deficiency Location/Instance	Near Hobart Street, Center, North and South Playground, Safety Surfacing, Basketball Area.
Deficiency Quantity	200
Quantity Uom	S.F.
Potential Action	REPLACE
Urgency of Action	PRIORITY 3
Purpose of Action	LEVEL 2

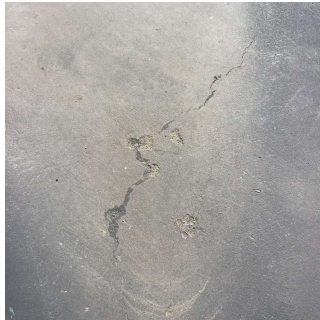
Violations	Near Exit 9 No violations recorded.
<b>Concrete</b>	Inspected
Condition	3 - Fair
Deficiency	CRACKS - MAJOR
Deficiency Location/Instance	Near Exit 2
Deficiency Quantity	50
Quantity Uom	S.F.
Potential Action	REPLACE
Urgency of Action	PRIORITY 3
Purpose of Action	LEVEL 2

Violations	Near Hobart Street No violations recorded.
<b>Concrete</b>	Does not Exist
<b>Pavers</b>	Does not Exist
<b>Site Sidewalks &amp; Walkways</b>	Inspected
<b>Asphalt</b>	Inspected
Condition	2 - Between Good and Fair
Deficiency	CRACKS - MAJOR
Deficiency Location/Instance	Near Exits 3/4, 9
Deficiency Quantity	20
Quantity Uom	S.F.
Potential Action	REPLACE
Urgency of Action	PRIORITY 3
Purpose of Action	LEVEL 2
Deficiency Photo1

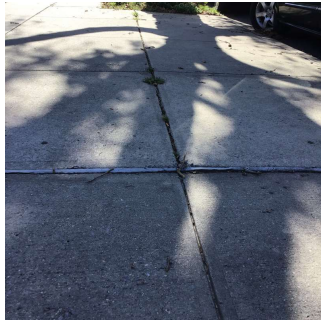
50th Street
Violations	No violations recorded.
Deficiency	DAMAGED/DETERIORATED/MISSING SECTIONS
Deficiency Location/Instance	50th Street, 31st Avenue, Hobart Street.
Deficiency Quantity	1,625
Quantity Uom	S.F.
Potential Action	REPLACE
Urgency of Action	PRIORITY 3
Purpose of Action	LEVEL 2

Near Exit 2
Violations	No violations recorded.
<b>Pavers</b>	Does not Exist
<b>DOT Sidewalk</b>	Inspected
<b>Asphalt</b>	Does not Exist
<b>Concrete</b>	Inspected
Condition	4 - Between Fair and Poor
Deficiency	HEAVING
Deficiency Location/Instance	50th Street.
Deficiency Quantity	50
Quantity Uom	S.F.
Potential Action	REPLACE
Urgency of Action	PRIORITY 3
Purpose of Action	LEVEL 2
Deficiency Photo1

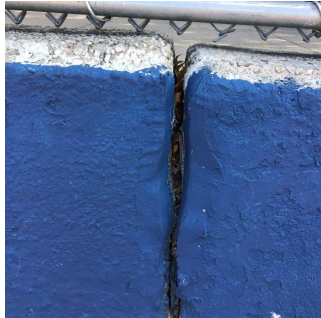
Violations	Hobart Street No violations recorded.
Deficiency	CAST IN PLACE CONCRETE: CRACKS/SPALLING - MAJOR
Deficiency Location/Instance	Hobart Street
Deficiency Quantity	80
Quantity Uom	S.F.
Potential Action	REPLACE
Urgency of Action	PRIORITY 3
Purpose of Action	LEVEL 2
Deficiency Photo1

Question	Response
<b>SITE</b>	
<b>PLAYING SURFACE</b>	Inspected
<b>Running Track</b>	Does not Exist
<b>RETAINING WALLS</b>	Inspected
Are there any Retaining Walls 6' OR higher facing public street/sidewalk?	No
Condition	3 - Fair
Deficiency	CAST IN PLACE CONCRETE: DETERIORATED CONTROL/EXPANSION JOINT
Deficiency Location/Instance	Hobart Street
Deficiency Quantity	10
Quantity Uom	L.F.
Potential Action	REPLACE
Urgency of Action	PRIORITY 3
Purpose of Action	LEVEL 2
Deficiency Photo1
