NYC Department of Education
Building Condition Assessment Survey 2023 - 2024

Architectural Inspection

Asset: P.S. 173 - QUEENS, 174-10 67TH AVENUE, New York, 11365

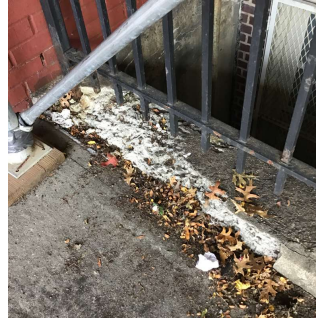
AW6

Question	Response
Architectural	
EXTERIOR	Inspected
AREAWAY	Inspected
Instance on AW1-AW7	Inspected
Instance Condition	4 - Between Fair and Poor
Instance Quantity	7
Instance Quantity Uom	EACH
Deficiency	AREAWAY WALLS: DETERIORATED COPING STONE
Roof Plan reference	
Deficiency Quantity	50
Quantity Uom	S.F.
Potential Action	REPLACE
Urgency of Action	PRIORITY 4
Purpose of Action	LEVEL 2

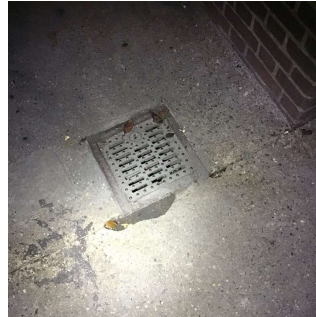
AW1

AREAWAY SLAB: CRACKS AND SPALLING

REPLACE

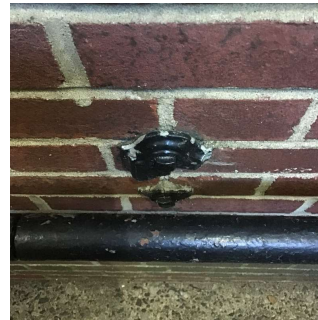
AW1

AREAWAY STAIRS: DETERIORATED RAILINGS

REPLACE

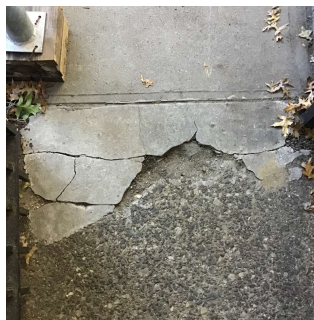
AW1

AREAWAY STAIRS: DETERIORATED
TREADS/RISERS/NOSINGS

REPLACE

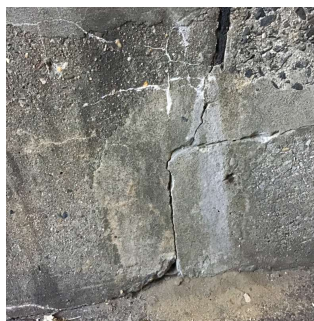
AW1

AREAWAY WALLS: CRACKS AND SPALLING

REPLACE

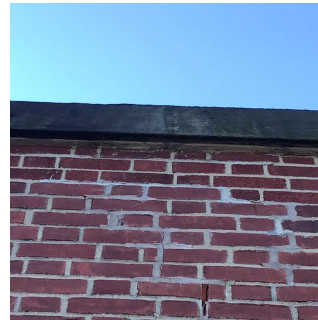
CH

BRICK: DETERIORATED CAP

REPLACE

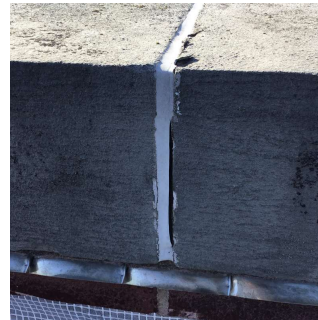
Roof 1

Violations	<p>Roof 1</p> <p>No violations recorded.</p>
Deficiency	CAST STONE: DETERIORATED TRANSVERSE JOINTS

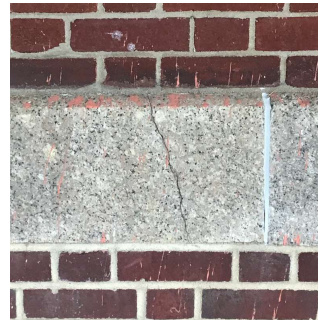
Facade F

Violations	Facade A - Main Entrance No violations recorded.
EXTERIOR WALLS	Inspected
Material Type(s)	Masonry
Replacement Quantity	33,000
Replacement Uom	S.F.
Instance on All Facades	Inspected
Instance Condition	3 - Fair
Instance Quantity	33,000
Instance Quantity Uom	S.F.
Deficiency	STONE: CHIPPED/SPALLED/BROKEN PIECES - MINOR
Roof Plan reference

REPAIR

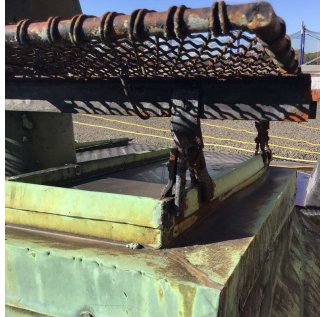
Violations	<p>BH1</p> <p>No violations recorded.</p>
ROOF BARRIER/FENCE	Does not Exist
ROOF CAGE	Does not Exist
ROOFING	Inspected
Instance on Built-Up: All Roofs	Under Construction
Instance Quantity	32,000
Instance Quantity Uom	S.F.
ROOFING DRAINS	Under Construction
Specialties	Inspected
BULKHEAD/PENTHOUSE	Under Construction
CUPOLA/ SPIRES/ TOWERS	Does not Exist
DORMER	Does not Exist
DUNNAGE STEEL	Does not Exist
SKYLIGHT/ROOF VENT	Inspected
Material Type(s)	Glass, Plastic
Condition	3 - Fair
Deficiency	DAMAGED GUARDS
Roof Plan reference	<p>Q173</p>

Deficiency Quantity	25
Quantity Uom	S.F.
Potential Action	MAINTENANCE
Urgency of Action	PRIORITY 3
Purpose of Action	LEVEL 2

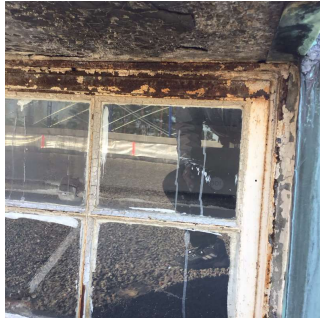
Violations	SK1 No violations recorded.
Deficiency	BROKEN FRAMING
Roof Plan reference

Deficiency Quantity	20
Quantity Uom	L.F.
Potential Action	MAINTENANCE
Urgency of Action	PRIORITY 3
Purpose of Action	LEVEL 2
Deficiency Photo1

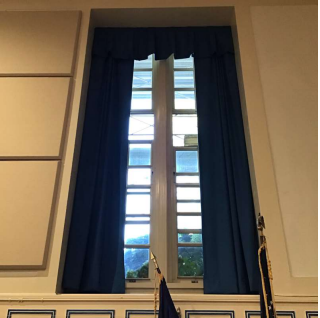
Deficiency Quantity	25
Quantity Uom	EACH
Potential Action	MAINTENANCE
Urgency of Action	PRIORITY 3
Purpose of Action	LEVEL 2
Deficiency Photo1

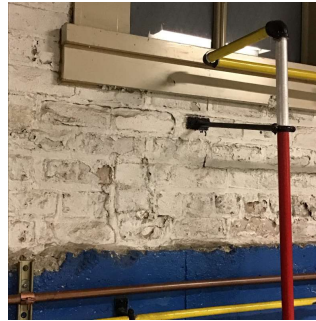
Basement - Boiler Room

BRICK: WATER INFILTRATION IN NON- INSTRUCTIONAL SPACE

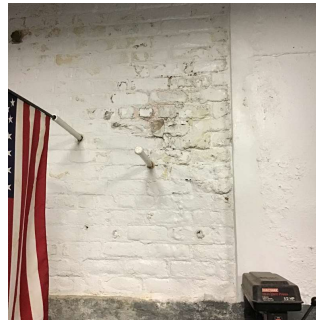
Basement - Shop

CONCRETE: WATER INFILTRATION IN NON- INSTRUCTIONAL SPACE

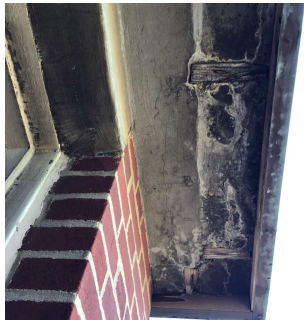
Question	Response
INTERIOR	
STRUCTURAL	
FOUNDATION WALLS	Inspected
Violations	No violations recorded.
ROOF STRUCTURE	Inspected
Condition	3 - Fair
Deficiency	CONCRETE: CRACKED/SPALLED/REINFORCEMENT EXPOSED
Deficiency Location/Instance	BH2, BH3
Deficiency Quantity	20
Quantity Uom	S.F.
Potential Action	REPAIR
Urgency of Action	PRIORITY 4
Purpose of Action	LEVEL 5
Deficiency Photo1

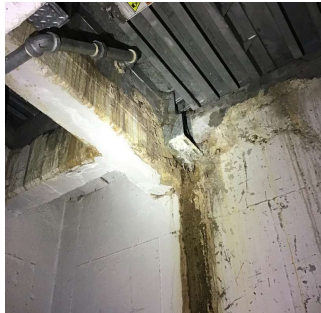
Violations	BH3 No violations recorded.
VAULTS-BUNKERS	Inspected
Foundation Walls	Inspected
Condition	2 - Between Good and Fair
Deficiency	No deficiencies recorded
Slab Structure	Inspected
Condition	2 - Between Good and Fair
Deficiency	No deficiencies recorded
Vault/Ash Hoist Doors and Framing	Inspected
Condition	5 - Poor
Deficiency	WATER INFILTRATION
Deficiency Location/Instance	Ash Hoist Vault
Deficiency Quantity	10
Quantity Uom	S.F.
Potential Action	REPAIR
Urgency of Action	PRIORITY 5
Purpose of Action	LEVEL 2
Deficiency Photo1

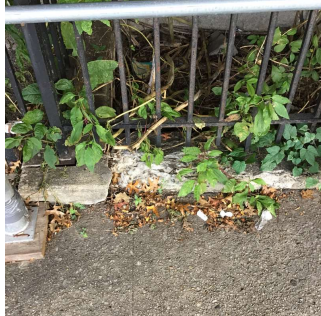
Violations	67th Avenue No violations recorded.
Drainage System for Asphalt	Inspected
Catch Basins/Manhole - Surrounded by asphalt	Inspected
Condition	2 - Between Good and Fair
Deficiency	No deficiencies recorded
Culverts - Asphalt Covering	Does not Exist
Drainage System for Concrete	Inspected
Catch Basins/Manhole - Surrounded by concrete	Inspected
Condition	2 - Between Good and Fair
Deficiency	No deficiencies recorded
Culverts - Concrete Covering	Does not Exist
Drainage System for Soil	Inspected
Catch Basins/Manhole - Surrounded by Soil	Inspected
Condition	2 - Between Good and Fair
Deficiency	No deficiencies recorded
Culverts - Soil Covering	Does not Exist
DRINKING FOUNTAINS	Does not Exist
FENCES	Inspected
Condition	2 - Between Good and Fair
Deficiency	CONCRETE CURB: DAMAGED/DETERIORATED
Deficiency Location/Instance	Along New York City Park
Deficiency Quantity	20

Quantity Uom	S.F.
Potential Action	REPLACE
Urgency of Action	PRIORITY 3
Purpose of Action	LEVEL 2
Deficiency Photo1

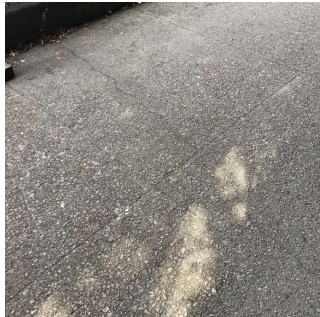
Violations	Near New York City Park No violations recorded.
Pavers	Inaccessible
DOT Sidewalk	Inspected
Asphalt	Does not Exist
Concrete	Inspected
Condition	4 - Between Fair and Poor
Deficiency	DAMAGED CURBS
Deficiency Location/Instance	67th Avenue, Fresh Meadows Lane
Deficiency Quantity	20
Quantity Uom	L.F.
Potential Action	REPLACE
Urgency of Action	PRIORITY 5
Purpose of Action	LEVEL 6
Deficiency Photo1

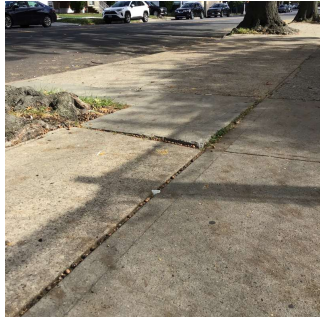
Violations	67th Avenue No violations recorded.
Deficiency	HEAVING
Deficiency Location/Instance	67th Avenue, Fresh Meadow Lane
Deficiency Quantity	200
Quantity Uom	S.F.
Potential Action	REPLACE
Urgency of Action	PRIORITY 3
Purpose of Action	LEVEL 2
Deficiency Photo1

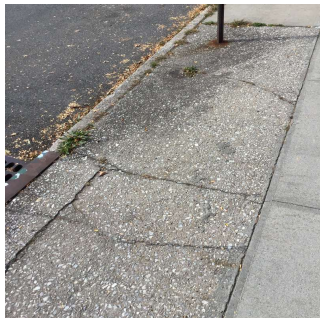
Violations	67th Avenue No violations recorded.
Deficiency	DAMAGED/DETERIORATED/MISSING SECTIONS
Deficiency Location/Instance	67th Avenue,Fresh Meadows Lane, 68th Avenue
Deficiency Quantity	1,300
Quantity Uom	S.F.
Potential Action	REPLACE
Urgency of Action	PRIORITY 3
Purpose of Action	LEVEL 2
Deficiency Photo1

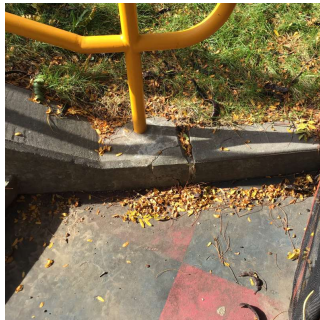
Question	Response
SITE	
PAVING	Inspected
DOT Sidewalk	
Concrete	Inspected
Violations	No violations recorded.
Pavers	Does not Exist
PLAYGROUNDS	Inspected
Instance on Schoolyard	Inaccessible
PLAYING SURFACE	Does not Exist
RETAINING WALLS	Inspected
Are there any Retaining Walls 6' OR higher facing public street/sidewalk?	No
Condition	2 - Between Good and Fair
Deficiency	No deficiencies recorded
SEATING	Inspected
Benches	Inspected
Concrete	Does not Exist
Metal/Wood/Plastic	Inaccessible
Bleachers	Does not Exist
SITE WALLS (NOT RETAINING WALLS)	Inspected
Condition	2 - Between Good and Fair
Deficiency	No deficiencies recorded
STAIRS/RAMPS: EXTERIOR	Inspected
Railings	Inspected
Condition	2 - Between Good and Fair
Deficiency	No deficiencies recorded
Site Cheek/flank Walls	Inspected
Condition	2 - Between Good and Fair
Deficiency	CAST IN PLACE CONCRETE: CRACKS/SPALLING - MAJOR
Deficiency Location/Instance	Near Exit 10
Deficiency Quantity	10

Quantity Uom	S.F.
Potential Action	REPLACE
Urgency of Action	PRIORITY 3
Purpose of Action	LEVEL 2
Deficiency Photo1
