**NYC Department of Education**  
**Building Condition Assessment Survey 2023 - 2024**

Architectural Inspection

Q430

**Asset:** FRANCIS LEWIS HS - Q, 58-20 UTOPIA PKWY, New York, 11365

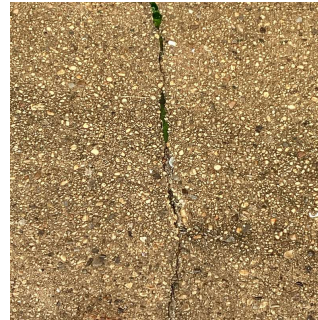
Facade C - AW2

Question	Response
<b>Architectural</b>	
<b>EXTERIOR</b>	Inspected
<b>AREAWAY</b>	Inspected
Instance on AW1-AW6	Inspected
Instance Condition	3 - Fair
Instance Quantity	6
Instance Quantity Uom	EACH
Deficiency	AREAWAY SLAB: CRACKS AND SPALLING
Roof Plan reference	
Deficiency Quantity	20
Quantity Uom	S.F.
Potential Action	REPAIR
Urgency of Action	PRIORITY 3
Purpose of Action	LEVEL 2

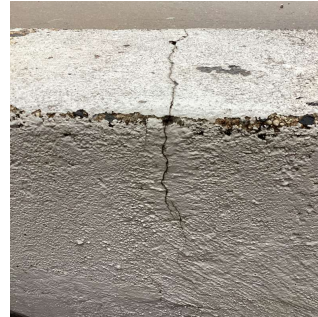
Facade D - AW6

**AREAWAY WALLS: CRACKS AND SPALLING**

REPAIR

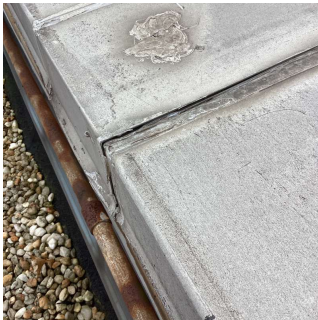
Violations	Roof 1 No violations recorded.
<b>COPING</b>	Inspected
Condition	3 - Fair
Deficiency	METAL: DETERIORATED JOINTS
Roof Plan reference

Deficiency Quantity	50
Quantity Uom	L.F.
Potential Action	REPAIR
Urgency of Action	PRIORITY 3
Purpose of Action	LEVEL 2
Deficiency Photo1

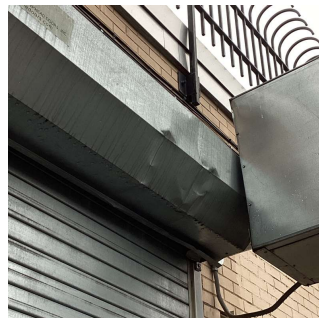
Deficiency Quantity	2
Quantity Uom	EACH
Potential Action	MAINTENANCE
Urgency of Action	PRIORITY 3
Purpose of Action	LEVEL 2
Deficiency Photo1	No photo recorded
Violations	No violations recorded.
Deficiency	ROLL-UP DOOR: DETERIORATED DOOR AND FRAME - MINOR DETERIORATION
Roof Plan reference

Deficiency Quantity	240
Quantity Uom	S.F.
Potential Action	MAINTENANCE
Urgency of Action	PRIORITY 3
Purpose of Action	LEVEL 2
Deficiency Photo1

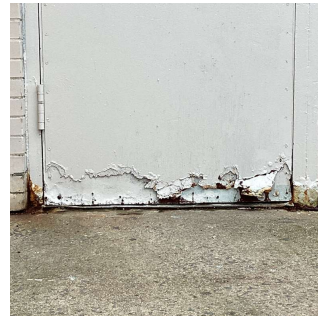
Facade D

**METAL CLAD: DETERIORATED DOOR AND FRAME - MAJOR DETERIORATION**

REPLACE

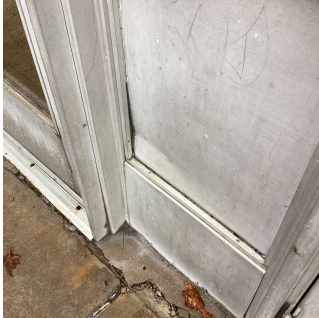
Question	Response
<b>EXTERIOR</b>	
<b>DOORS</b>	
<b>TRANSOM/SIDE LIGHT</b>	
Urgency of Action	PRIORITY 4
Purpose of Action	LEVEL 2
Deficiency Photo1

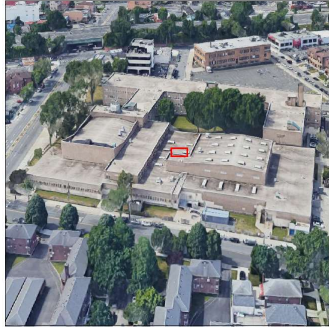
Question	Response
<div>EXTERIOR</div> <div>EXTERIOR WALLS</div> <div>Deficiency Photo1</div>	<div> </div> <div>Facade E</div> <div>No violations recorded.</div>
<div>Violations</div>	<div>No violations recorded.</div>
<div>Deficiency</div> <div>Roof Plan reference</div>	<div>BRICK: MAJOR / THRU CRACKS</div> <div> </div>
<div>Elevation</div>	<div>

</div>
<div>Deficiency Quantity</div> <div>Quantity Uom</div> <div>Potential Action</div> <div>Urgency of Action</div> <div>Purpose of Action</div> <div>Deficiency Photo1</div>	<div>10</div> <div>S.F.</div> <div>REMOVE AND REBUILD</div> <div>PRIORITY 4</div> <div>LEVEL 2</div> <div> </div>
<div>Violations</div>	<div>No violations recorded.</div>
<div>Deficiency</div>	<div>BRICK: DETERIORATED JOINTS</div>

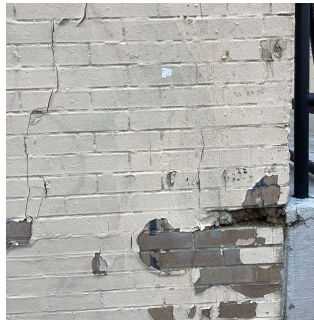
Facade D

BRICK: CRACKS/DISPLACED/SPALLED BRICK AT BUILDING CORNERS

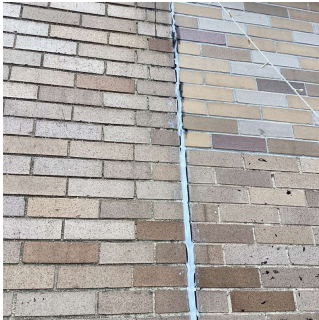
BRICK: DETERIORATED CONTROL/EXPANSION JOINTS

Question	Response
<b>EXTERIOR</b>	
<b>EXTERIOR WALLS</b>	
Urgency of Action	PRIORITY 3
Purpose of Action	LEVEL 2
Deficiency Photo1

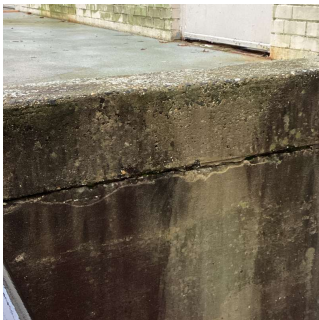
Violations	<p>Facade H</p> <p>No violations recorded.</p>
<b>EXTERIOR SOFFITS</b>	Inspected
Condition	2 - Between Good and Fair
Deficiency	No deficiencies recorded
<b>LOADING DOCK</b>	Inspected
Condition	3 - Fair
Deficiency	CHEEK WALL/CRACKS, SPALLING - MINOR
Roof Plan reference

Deficiency Quantity	15
Quantity Uom	S.F.
Potential Action	REPAIR
Urgency of Action	PRIORITY 3
Purpose of Action	LEVEL 2
Deficiency Photo1

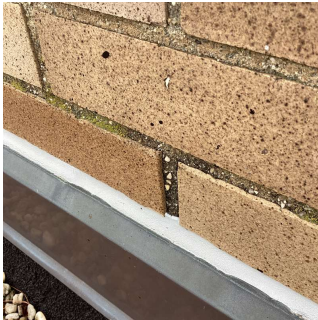
Violations	Roof 1 No violations recorded.
Deficiency	<b>BRICK: DETERIORATED JOINTS</b>
Roof Plan reference

Deficiency Quantity	1,000
Quantity Uom	S.F.
Potential Action	REPOINT
Urgency of Action	PRIORITY 3
Purpose of Action	LEVEL 2
Deficiency Photo1

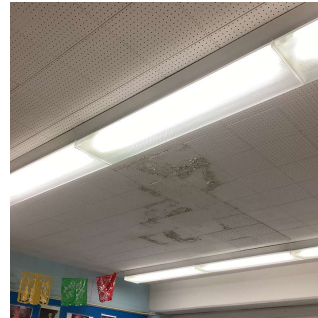
Roof 1 - Room 306, also Room 304, Roof 5 - Rooms 157, 176

Roof 1
Instance Quantity	118,000
Instance Quantity Uom	S.F.
Does the roof have major mechanical equipment sitting on Dunnage Steel less than 18" above the Roofing?	No
Does this roof instance have a Sustainable Roof System?	No
Do solar panels exist on these roofs?	No
Is/Are the roof(s) suitable for Solar Panel installation?	Yes
Installation Year	2000
Source of Installation	Custodial Staff
Deficiency	BUILT-UP: ROOFING: MAJOR ACTIVE ROOF LEAKS IN INSTRUCTIONAL SPACE
Roof Plan reference

Deficiency Quantity	400
Quantity Uom	S.F.
Potential Action	REPLACE ROOFING WITHOUT MAJOR EQUIPMENT REMOVAL
Urgency of Action	PRIORITY 5

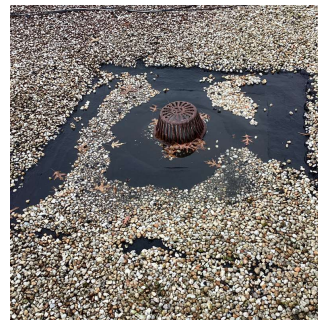
Roof 1

**BUILT-UP: ROOFING: LOSS OF GRAVEL**

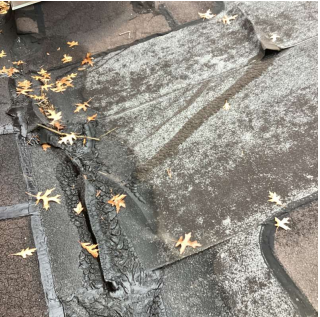
Question	Response
<b>EXTERIOR</b>	
<b>ROOF</b>	
<b>Roofing</b>	
<b>ROOFING</b>	Roof 6
Instance Quantity	7,000
Instance Quantity Uom	S.F.
Does the roof have major mechanical equipment sitting on Dunnage Steel less than 18" above the Roofing?	No
Does this roof instance have a Sustainable Roof System?	No
Do solar panels exist on these roofs?	No
Is/Are the roof(s) suitable for Solar Panel installation?	No
Installation Year	2000
Source of Installation	Custodial Staff
Deficiency	MODIFIED BITUMEN: ROOFING: DELAMINATION
Roof Plan reference

Deficiency Quantity	200
Quantity Uom	S.F.
Potential Action	REPLACE ROOFING WITHOUT MAJOR EQUIPMENT REMOVAL
Urgency of Action	PRIORITY 4
Purpose of Action	LEVEL 2
Deficiency Photo1

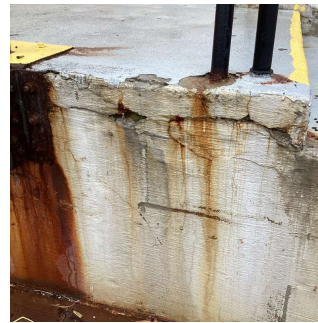
Facade D

**BUILDING CHEEK/FLANK WALLS**

REPLACE

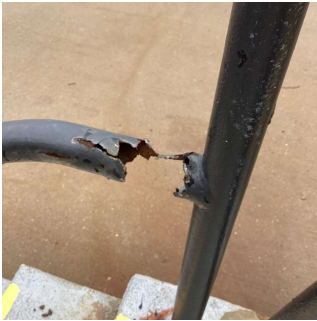
RUST - MAJOR

Question	Response
EXTERIOR	
STAIRS/RAMPS: EXTERIOR	
RAILINGS	
Deficiency Photo1

REPLACE

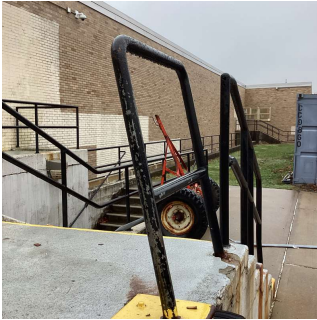
Violations	Facade D - Loading Dock No violations recorded.
Deficiency	DAMAGED
Roof Plan reference

Deficiency Quantity	10
Quantity Uom	L.F.
Potential Action	REPLACE
Urgency of Action	PRIORITY 4
Purpose of Action	LEVEL 2
Deficiency Photo1

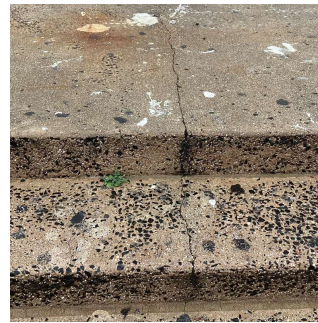
Facade B

CONCRETE: CRACKS/SPALLING - MINOR

REPAIR

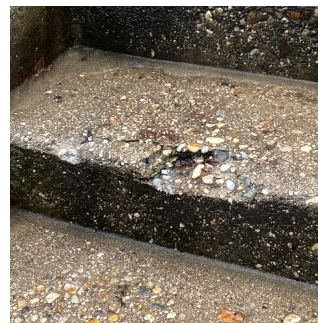
Facade D - Exit 13

**CONCRETE: WORN-OUT TREAD/RISER/NOSING**

REPLACE

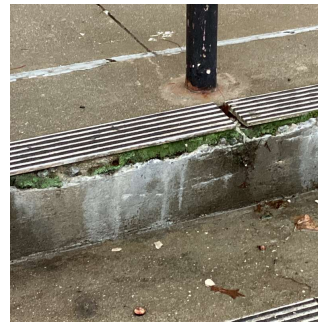
Facade A

**CONCRETE: WORN-OUT TREAD/RISER/NOSING**

REPLACE

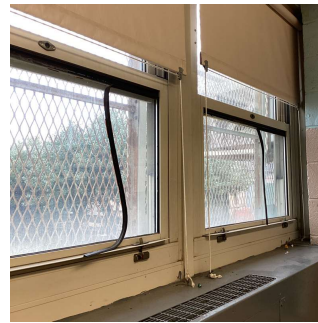
Facade B - Room 142

ALUMINUM - DOUBLE HUNG: AIR/WATER INFILTRATION, DETERIORATED JOINTS WITH DAMAGED CAULKING

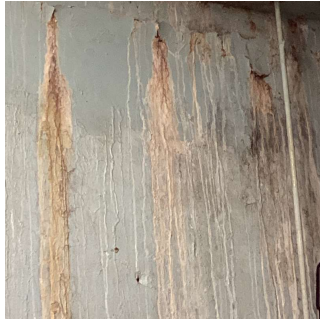
Question	Response
<b>INTERIOR</b>	
<b>STRUCTURAL</b>	
<b>VAULTS-BUNKERS</b>	
<b>Foundation Walls</b>	Inspected
Condition	4 - Between Fair and Poor
Deficiency	WATER INFILTRATION IN ELECTRICAL PANEL ROOM
Deficiency Location/Instance	Sub-Basement - Vault
Deficiency Quantity	100
Quantity Uom	S.F.
Potential Action	INSTALL WATERPROOFING
Urgency of Action	PRIORITY 5
Purpose of Action	LEVEL 6
Deficiency Photo1

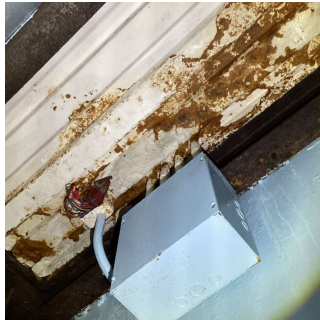
Violations	Sub-Basement - Vault No violations recorded.
<b>Slab Structure</b>	Inspected
Condition	4 - Between Fair and Poor
Deficiency	METAL DECK AND CONCRETE: WATER INFILTRATION IN NON- INSTRUCTIONAL SPACE
Deficiency Location/Instance	Basement - Vault
Deficiency Quantity	100
Quantity Uom	S.F.
Potential Action	INSTALL WATERPROOFING
Urgency of Action	PRIORITY 5
Purpose of Action	LEVEL 5
Deficiency Photo1

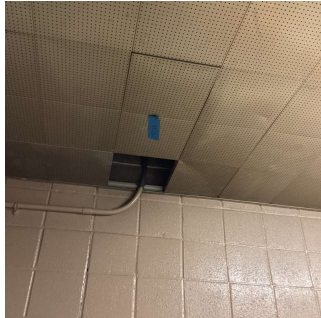
Question	Response
<b>INTERIOR</b>	
<b>AUDITORIUM</b>	
<b>Ceiling</b>	
Deficiency	METAL PAN: DAMAGED/MISSING
Deficiency Location/Instance	Vestibule- Exit 7
Deficiency Quantity	10
Quantity Uom	S.F.
Potential Action	REPLACE
Urgency of Action	PRIORITY 3
Purpose of Action	LEVEL 2
Deficiency Photo1

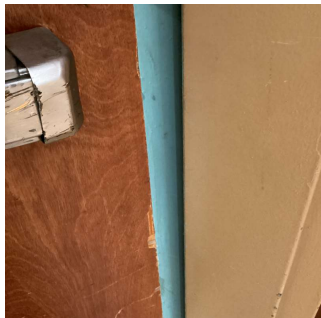
Vestibule- Exit 7
Violations	No violations recorded.
<b>Door(s)</b>	
Instance on 1st Floor (961 Seats)	Inspected
Condition	5 - Poor
Deficiency	WOOD: DETERIORATED DOOR
Deficiency Location/Instance	Back Stage, Lateral Entrance
Deficiency Quantity	2
Quantity Uom	EACH
Potential Action	MAINTENANCE
Urgency of Action	PRIORITY 3
Purpose of Action	LEVEL 2
Deficiency Photo1

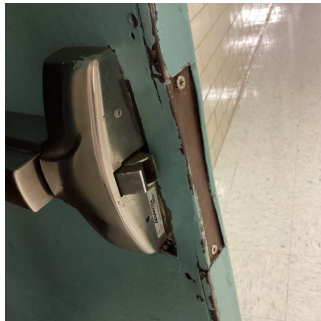
Lateral Entrance
Violations	No violations recorded.
Deficiency	METAL: DETERIORATED DOOR
Deficiency Location/Instance	Back stage
Deficiency Quantity	1
Quantity Uom	EACH
Potential Action	MAINTENANCE
Urgency of Action	PRIORITY 3
Purpose of Action	LEVEL 2

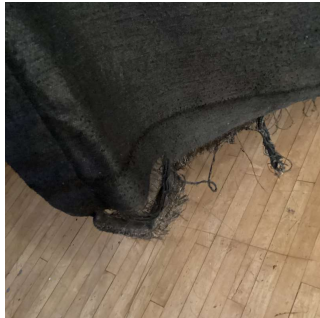
Left Side
Violations	No violations recorded.
<b>Stage Curtain Rigging</b>	Inspected
Instance on 1st Floor (961 Seats)	Inspected
Condition	3 - Fair
Deficiency	DAMAGED/DETERIORATED
Deficiency Location/Instance	Main Curtain
Deficiency Quantity	1
Quantity Uom	EACH
Potential Action	REPLACE
Urgency of Action	PRIORITY 3
Purpose of Action	LEVEL 2
Deficiency Photo1	 
	Main Curtain
Violations	No violations recorded.
<b>Stage Curtains</b>	Inspected
Instance on 1st Floor (961 Seats)	Inspected
Condition	4 - Between Fair and Poor
Deficiency	WORN/DETERIORATED
Deficiency Location/Instance	Middle Right And Left Side, Back
Deficiency Quantity	600
Quantity Uom	S.F.
Potential Action	REPLACE
Urgency of Action	PRIORITY 3
Purpose of Action	LEVEL 2

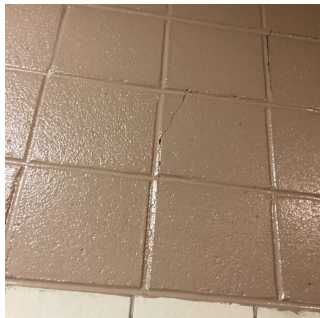
Violations	Lateral - Middle No violations recorded.
<b>Walls</b>	
Instance on 1st Floor (961 Seats)	Inspected
Condition	2 - Between Good and Fair
Deficiency	MASONRY: CRACKS/SPALLING
Deficiency Location/Instance	Vestibule- Exit 7
Deficiency Quantity	10
Quantity Uom	S.F.
Potential Action	REPLACE
Urgency of Action	PRIORITY 3
Purpose of Action	LEVEL 2
Deficiency Photo1

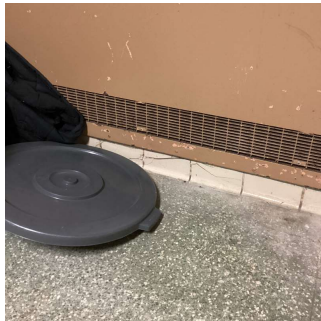
Violations	Vestibule- Exit 7 No violations recorded.
Deficiency	GLAZED BLOCK: CRACKS/SPALLING
Deficiency Location/Instance	Vestibule- Exit 7
Deficiency Quantity	10
Quantity Uom	S.F.
Potential Action	REPLACE
Urgency of Action	PRIORITY 3
Purpose of Action	LEVEL 2

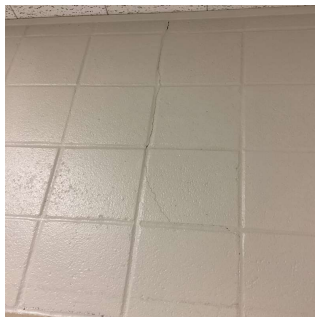
Condition	2 - Between Good and Fair
Deficiency	MASONRY: CRACKS/SPALLING
Deficiency Location/Instance	Corridor near Room 165

Question	Response
<b>INTERIOR</b>	
<b>CAFETERIA</b>	
<b>Walls</b>	
Deficiency Quantity	10
Quantity Uom	S.F.
Potential Action	REPLACE
Urgency of Action	PRIORITY 3
Purpose of Action	LEVEL 2
Deficiency Photo1

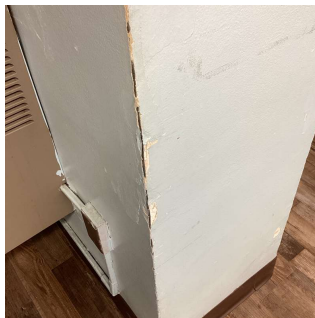
Corridor near Room 165
Violations	No violations recorded.
Instance on 1st Floor - Staff	Inspected
Condition	2 - Between Good and Fair
Deficiency	PLASTER: CRACKS/SPALLING
Deficiency Location/Instance	Near Entrance Kitchen
Deficiency Quantity	10
Quantity Uom	S.F.
Potential Action	REPLACE
Urgency of Action	PRIORITY 3
Purpose of Action	LEVEL 2
Deficiency Photo1

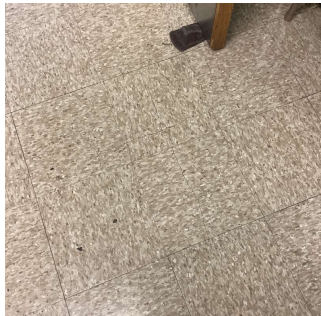
Main Entrance Area
Violations	No violations recorded.
Deficiency	VINYL TILES: BROKEN/DETERIORATED/MISSING TILES
Deficiency Location/Instance	Rooms 339B, 324, 320, 207, 122, and others
Deficiency Quantity	3,400
Quantity Uom	S.F.
Potential Action	REPLACE
Urgency of Action	PRIORITY 3
Purpose of Action	LEVEL 2
Deficiency Photo1

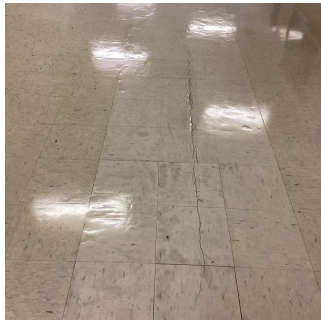
Question	Response
<b>INTERIOR</b>	
<b>CLASSROOMS/CORRIDORS/ADMIN SPACES</b>	
<b>Floor Finish</b>	
Violations	Room 339B No violations recorded.
Deficiency	VINYL TILES: DETERIORATED SUBSTRATE
Deficiency Location/Instance	Room 137B, Corridor near Rooms 113, 142, 344, Cafeteria, and others.
Deficiency Quantity	300
Quantity Uom	S.F.
Potential Action	REPLACE
Urgency of Action	PRIORITY 3
Purpose of Action	LEVEL 2
Deficiency Photo1

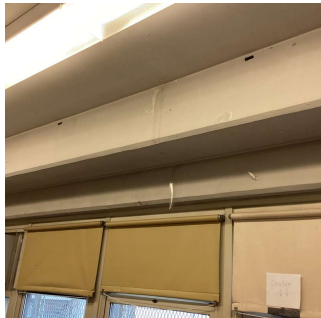
Violations	Corridor near Room 142 No violations recorded.
<b>Walls</b>	
Condition	Inspected 2 - Between Good and Fair
Deficiency	PLASTER: CRACKS/SPALLING
Deficiency Location/Instance	Rooms 136, 253, 307, 136
Deficiency Quantity	40
Quantity Uom	S.F.
Potential Action	REPLACE
Urgency of Action	PRIORITY 3
Purpose of Action	LEVEL 2
Deficiency Photo1

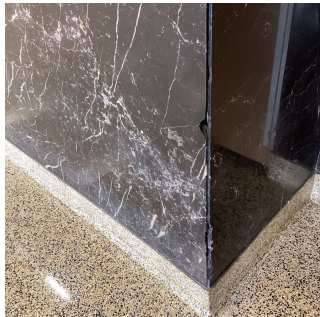
Question	Response
<b>INTERIOR</b>	
<b>CLASSROOMS/CORRIDORS/ADMIN SPACES</b>	
<b>Walls</b>	
Purpose of Action	LEVEL 2
Deficiency Photo1	 
Violations	Room 311 No violations recorded.
Deficiency	STONE: CRACKS/SPALLING
Deficiency Location/Instance	Near Auditorium
Deficiency Quantity	30
Quantity Uom	S.F.
Potential Action	REPLACE
Urgency of Action	PRIORITY 3
Purpose of Action	LEVEL 2
Deficiency Photo1

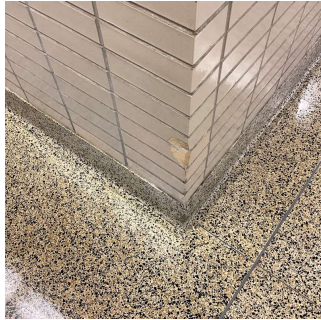
Question	Response
<b>INTERIOR</b>	
<b>CLASSROOMS/CORRIDORS/ADMIN SPACES</b>	
<b>Walls</b>	
Violations	No violations recorded.
Deficiency	GLAZED BLOCK: CRACKS/SPALLING
Deficiency Location/Instance	Main Entrance Area, Corridor near Rooms 149, 169, 253, 306, and others.
Deficiency Quantity	100
Quantity Uom	S.F.
Potential Action	REPLACE
Urgency of Action	PRIORITY 3
Purpose of Action	LEVEL 2
Deficiency Photo1

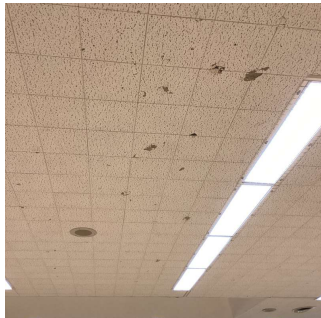
Purpose of Action	ACOUSTIC TILES ON PLASTER: DAMAGED/MISSING
Deficiency Photo1	Near Exit 13
	20
	S.F.
	REPLACE
	PRIORITY 3
	LEVEL 2

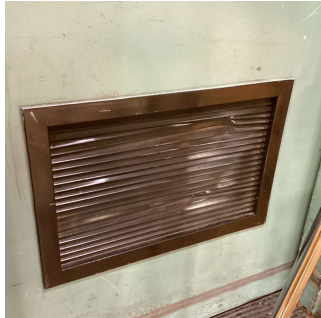
Question	Response
<b>INTERIOR</b>	
<b>GYMNASIUM</b>	
<b>Ceiling</b>	
Violations	No violations recorded.
<b>Door(s)</b>	
Instance on 1st Floor	Inspected
Condition	5 - Poor
Deficiency	METAL: DAMAGED LOUVER
Deficiency Location/Instance	Storage Room
Deficiency Quantity	1
Quantity Uom	EACH
Potential Action	MAINTENANCE
Urgency of Action	PRIORITY 3
Purpose of Action	LEVEL 2
Deficiency Photo1

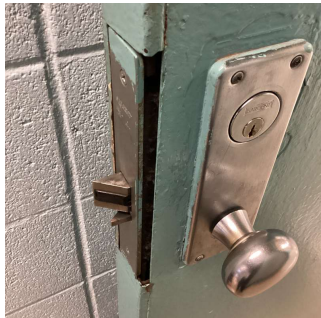
Violations	No violations recorded.
Deficiency	METAL: DETERIORATED DOOR
Deficiency Location/Instance	Room 151, Entrance
Deficiency Quantity	2
Quantity Uom	EACH
Potential Action	MAINTENANCE
Urgency of Action	PRIORITY 3
Purpose of Action	LEVEL 2
Deficiency Photo1

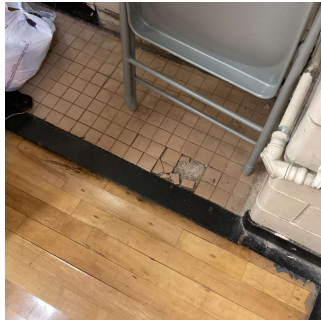
Question	Response
<b>INTERIOR</b>	
<b>GYMNASIUM</b>	
<b>Floor Finish</b>	
Deficiency	WOOD: DAMAGED/DETERIORATED
Deficiency Location/Instance	Near Drinking Fountain
Deficiency Quantity	40
Quantity Uom	S.F.
Potential Action	REPLACE
Urgency of Action	PRIORITY 3
Purpose of Action	LEVEL 2
Deficiency Photo1	 
	Near Drinking Fountain
Violations	No violations recorded.
Deficiency	WOOD: DAMAGED/DETERIORATED
Deficiency Location/Instance	Near Drinking Fountain
Deficiency Quantity	30
Quantity Uom	S.F.
Potential Action	REPLACE
Urgency of Action	PRIORITY 5
Purpose of Action	LEVEL 6
Deficiency Photo1	 
	Near Drinking Fountain
Violations	No violations recorded.
Deficiency	CERAMIC TILE: BROKEN/MISSING TILES
Deficiency Location/Instance	Near Exit 13
Deficiency Quantity	10
Quantity Uom	S.F.
Potential Action	REPLACE
Urgency of Action	PRIORITY 3
Purpose of Action	LEVEL 2

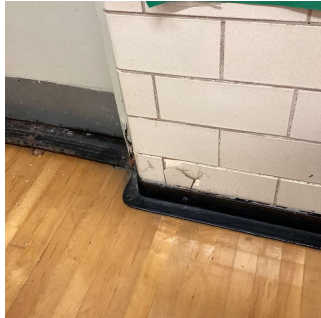
Near Room 151
Violations	No violations recorded.
Deficiency	GLAZED BLOCK: CRACKS/SPALLING
Deficiency Location/Instance	Near Stair K, Exit 13
Deficiency Quantity	20
Quantity Uom	S.F.
Potential Action	REPLACE
Urgency of Action	PRIORITY 3
Purpose of Action	LEVEL 2
Deficiency Photo1

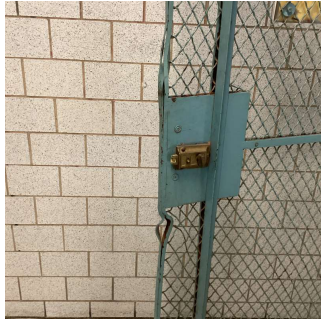
Near Exit 13
Violations	No violations recorded.
<b>Window Curtains/Shades/Blinds</b>	
Instance on 1st Floor	Does not Exist
<b>INTERIOR DOOR HARDWARE</b>	Inspected
Condition	3 - Fair
Deficiency	No deficiencies recorded
<b>INTERIOR GUARDS</b>	Inspected
Condition	3 - Fair
Deficiency	DETERIORATED/TORN-OUT/MISSING
Deficiency Location/Instance	Stairs GH/3, LM/3
Deficiency Quantity	50
Quantity Uom	S.F.
Potential Action	REPLACE
Urgency of Action	PRIORITY 3
Purpose of Action	LEVEL 2

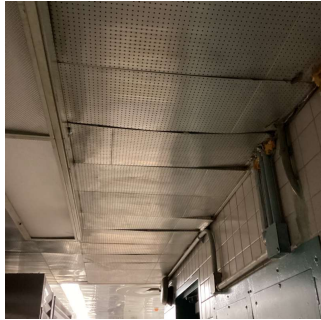
Violations	Stair LM/3 No violations recorded.
<b>KITCHEN</b>	Inspected
Instance on 1st Floor	Inspected
<b>Ceiling</b>	
Instance on 1st Floor	Inspected
Condition	2 - Between Good and Fair
Deficiency	METAL PAN: DAMAGED/MISSING
Deficiency Location/Instance	Near Staff Cafeteria, mopping Room, Staff Serving Area.
Deficiency Quantity	30
Quantity Uom	S.F.
Potential Action	REPLACE
Urgency of Action	PRIORITY 3
Purpose of Action	LEVEL 2
Deficiency Photo1

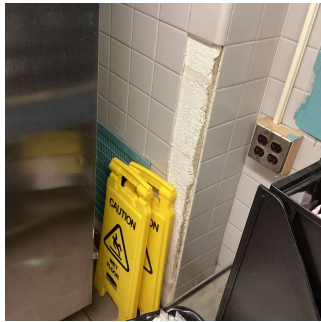
Violations	Office No violations recorded.
Deficiency	CERAMIC TILE: BROKEN/ MISSING
Deficiency Location/Instance	Serving Area, Freezer Area, windows, Sink Area, Columns.
Deficiency Quantity	30
Quantity Uom	S.F.
Potential Action	REPLACE
Urgency of Action	PRIORITY 3
Purpose of Action	LEVEL 2
Deficiency Photo1

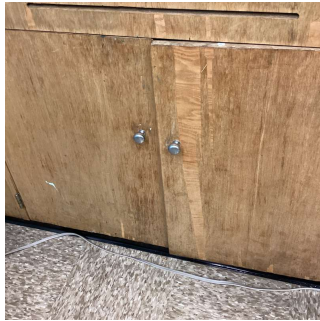
Violations	Serving Area No violations recorded.
<b>LIBRARY</b>	Inspected
Instance on Room 209	Inspected
<b>Built-in Furnishing</b>	
Instance on Room 209	Inspected
Condition	2 - Between Good and Fair
Deficiency	SINK/STORAGE CABINET - DAMAGED/DETERIORATED
Deficiency Location/Instance	Room C
Deficiency Quantity	10
Quantity Uom	L.F.
Potential Action	REPLACE
Urgency of Action	PRIORITY 3
Purpose of Action	LEVEL 2

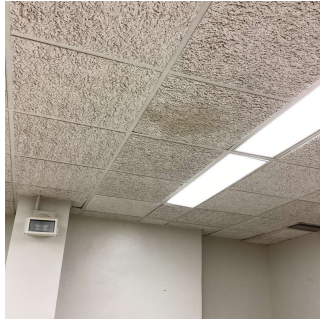
Violations	Room C No violations recorded.
<b>Ceiling</b>	
Instance on Room 209	Inspected
Condition	2 - Between Good and Fair
Deficiency	ACOUSTIC TILES: DAMAGED/MISSING
Deficiency Location/Instance	Near Entrance
Deficiency Quantity	10
Quantity Uom	S.F.
Potential Action	REPLACE
Urgency of Action	PRIORITY 3
Purpose of Action	LEVEL 2
Deficiency Photo1

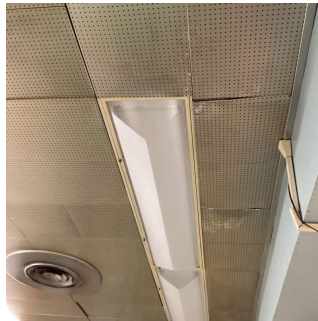
Violations	Near Entrance No violations recorded.
Deficiency	METAL PAN: DAMAGED/MISSING
Deficiency Location/Instance	Room D
Deficiency Quantity	10
Quantity Uom	S.F.
Potential Action	REPLACE
Urgency of Action	PRIORITY 3
Purpose of Action	LEVEL 2

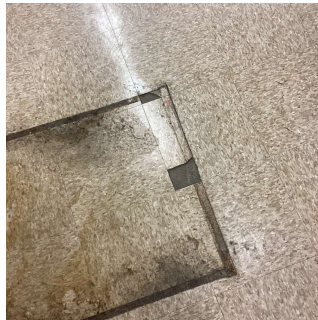
Violations	Room D No violations recorded.
<b>Door(s)</b>	
Instance on Room 209	Inspected
Condition	2 - Between Good and Fair
Deficiency	No deficiencies recorded
<b>Floor Finish</b>	
Instance on Room 209	Inspected
Condition	2 - Between Good and Fair
Deficiency	VINYL TILES: BROKEN/DETERIORATED/MISSING TILES
Deficiency Location/Instance	Near Entrance, Center
Deficiency Quantity	20
Quantity Uom	S.F.
Potential Action	REPLACE
Urgency of Action	PRIORITY 3
Purpose of Action	LEVEL 2
Deficiency Photo1

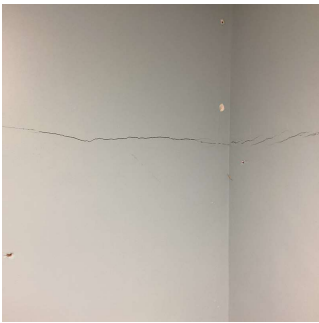
Violations	Near Entrance No violations recorded.
<b>Walls</b>	
Instance on Room 209	Inspected
Condition	2 - Between Good and Fair
Deficiency	PLASTER: CRACKS/SPALLING
Deficiency Location/Instance	Rooms C, D, Near Windows, Entrance.
Deficiency Quantity	40
Quantity Uom	S.F.
Potential Action	REPLACE
Urgency of Action	PRIORITY 3
Purpose of Action	LEVEL 2

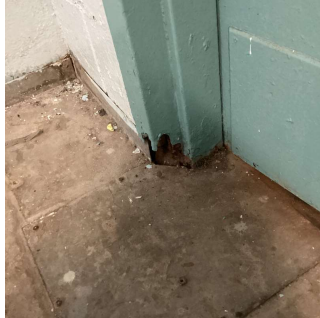
Instance on Basement - Boys (1719 Lockers)	Inspected
Condition	4 - Between Fair and Poor
Deficiency	METAL: DETERIORATED DOOR AND FRAME

Question	Response
<b>INTERIOR</b>	
<b>LOCKER ROOM</b>	
<b>Door(s)</b>	
Deficiency Location/Instance	Vestibule - Exit 12
Deficiency Quantity	2
Quantity Uom	EACH
Potential Action	MAINTENANCE
Urgency of Action	PRIORITY 3
Purpose of Action	LEVEL 2
Deficiency Photo1

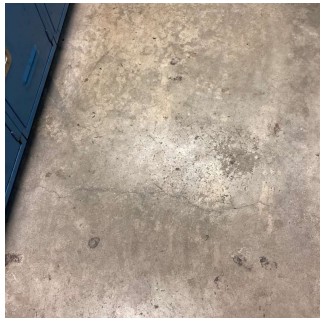
Vestibule - Exit 12
Violations	No violations recorded.
<b>Floor Finish</b>	
Instance on Basement - Boys (1719 Lockers)	Inspected
Condition	2 - Between Good and Fair
Deficiency	CONCRETE: CRACKS
Deficiency Location/Instance	Near Lockers 283, 303, 338, 740, 1211, and others.
Deficiency Quantity	32
Quantity Uom	S.F.
Potential Action	REPLACE
Urgency of Action	PRIORITY 3
Purpose of Action	LEVEL 2
Deficiency Photo1

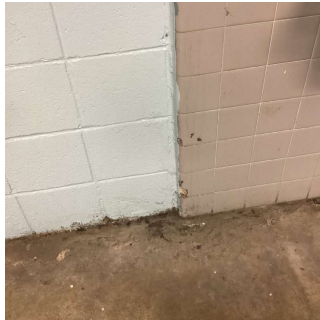
Locker 65
Violations	No violations recorded.
<b>Walls</b>	
Instance on Basement - Boys (1719 Lockers)	Inspected
Condition	2 - Between Good and Fair
Deficiency	CERAMIC TILE: BROKEN/ MISSING
Deficiency Location/Instance	Drinking Fountain Area
Deficiency Quantity	10
Quantity Uom	S.F.
Potential Action	REPLACE
Urgency of Action	PRIORITY 3
Purpose of Action	LEVEL 2
Deficiency Photo1

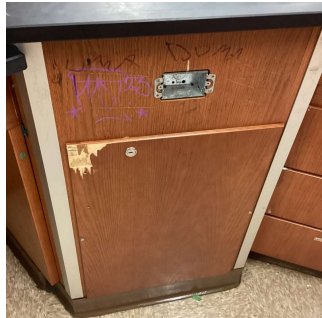
Question	Response
<b>INTERIOR</b>	
<b>MULTI-PURPOSE ROOM</b>	Does not Exist
<b>SCIENCE DEMO ROOM</b>	Inspected
Instance on Rooms 238, 250, 306, 308, 309, 310	Inspected
Alternative use	Yes
Instance on Rooms 307, 318, 320, 322, 324, 326.	Inspected
Alternative use	No
<b>Fixed Equipment</b>	
Instance on Rooms 238, 250, 306, 308, 309, 310	Inspected
Condition	2 - Between Good and Fair
Deficiency	No deficiencies recorded
Instance on Rooms 307, 318, 320, 322, 324, 326.	Inspected
Condition	2 - Between Good and Fair
Deficiency	No deficiencies recorded
<b>SCIENCE LAB</b>	Inspected
Instance on Rooms 304, 313	Inspected
Alternative use	No
Instance on Rooms 307L, 319	Inspected
Alternative use	No
<b>Fixed Equipment</b>	
Instance on Rooms 304, 313	Inspected
Condition	3 - Fair
Deficiency	CABINETRY: MISSING/DAMAGED
Deficiency Location/Instance	Rooms 304, 313
Deficiency Quantity	10
Quantity Uom	L.F.
Potential Action	REPLACE
Urgency of Action	PRIORITY 3

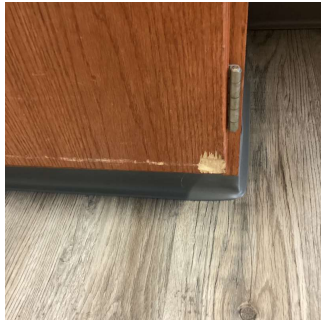
Question	Response
<b>INTERIOR</b>	
<b>SCIENCE PREP ROOM</b>	
<b>Fixed Equipment</b>	
Condition	3 - Fair
Deficiency	CABINETRY: MISSING/DAMAGED
Deficiency Location/Instance	Room 311
Deficiency Quantity	10
Quantity Uom	L.F.
Potential Action	REPLACE
Urgency of Action	PRIORITY 3
Purpose of Action	LEVEL 2
Deficiency Photo1

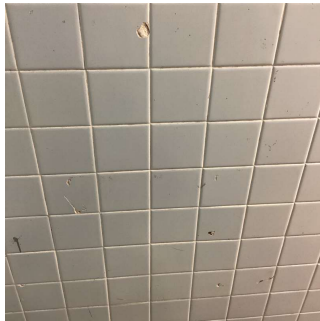
Violations	Room 311 No violations recorded.
<b>SHOWER ROOM</b>	
Instance on Basement - Boys	Inspected
Alternative use	Yes
<b>Ceiling</b>	
Instance on Basement - Boys	Inspected
Condition	2 - Between Good and Fair
Deficiency	No deficiencies recorded
<b>Door(s)</b>	
Instance on Basement - Boys	Does not Exist
<b>Floor Finish</b>	
Instance on Basement - Boys	Inspected
Condition	2 - Between Good and Fair
Deficiency	No deficiencies recorded
<b>Walls</b>	
Instance on Basement - Boys	Inspected
Condition	2 - Between Good and Fair
Deficiency	CERAMIC TILE: BROKEN/ MISSING
Deficiency Location/Instance	Near Entrance

Deficiency Quantity	10
Quantity Uom	S.F.
Potential Action	REPLACE
Urgency of Action	PRIORITY 3
Purpose of Action	LEVEL 2

Near Entrance
Violations	No violations recorded.
<b>STAIRS/RAMPS: INTERIOR</b>	
Do Letter Stair Signs Exist?	Inspected Yes
<b>Ceiling</b>	Inspected
Condition	2 - Between Good and Fair
Deficiency	ACOUSTIC TILES ON PLASTER: DAMAGED/MISSING
Deficiency Location/Instance	Stair J/1
Deficiency Quantity	20
Quantity Uom	S.F.
Potential Action	REPLACE
Urgency of Action	PRIORITY 3
Purpose of Action	LEVEL 2
Deficiency Photo1	 
	Stair J/1
Violations	No violations recorded.
Deficiency	METAL PAN: DAMAGED/MISSING
Deficiency Location/Instance	Stair K/1
Deficiency Quantity	40
Quantity Uom	S.F.
Potential Action	REPLACE
Urgency of Action	PRIORITY 3
Purpose of Action	LEVEL 2

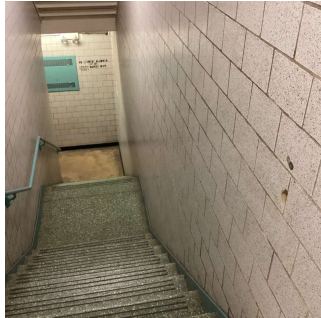
Question	Response
<b>INTERIOR</b>	
<b>STAIRS/RAMPS: INTERIOR</b>	
<b>Door(s)</b>	
Violations	Stair J/Basement No violations recorded.
Deficiency	METAL: DETERIORATED DOOR
Deficiency Location/Instance	Stairs AB/3, I/1, J/1, K/1,
Deficiency Quantity	9
Quantity Uom	EACH
Potential Action	MAINTENANCE
Urgency of Action	PRIORITY 3
Purpose of Action	LEVEL 2
Deficiency Photo1	 
Violations	Stair K/1 No violations recorded.
<b>Partition</b>	Does not Exist
<b>Railings</b>	Inspected
Condition	5 - Poor
Deficiency	METAL: MISSING
Deficiency Location/Instance	Stair J/Basement
Deficiency Quantity	25
Quantity Uom	L.F.
Potential Action	REPLACE
Urgency of Action	PRIORITY 5
Purpose of Action	LEVEL 6
Deficiency Photo1

Violations	Stair J/Basement No violations recorded.
<b>Stairs and Landings</b>	Inspected
Condition	3 - Fair
Deficiency	VINYL TILES: DETERIORATED SUBSTRATE
Deficiency Location/Instance	Stairs CD/2, LM/1, 2
Deficiency Quantity	10

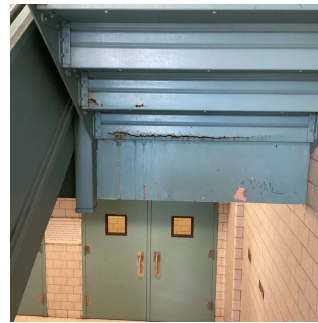
Stair LM/1

VINYL TILES: BROKEN/DETERIORATED/MISSING TILES

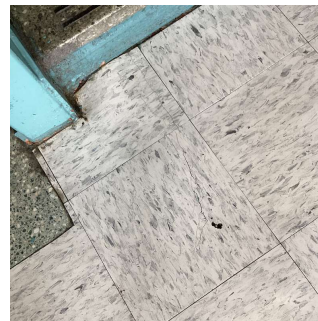
Stair EF/2

VINYL TILES: DETERIORATED SUBSTRATE

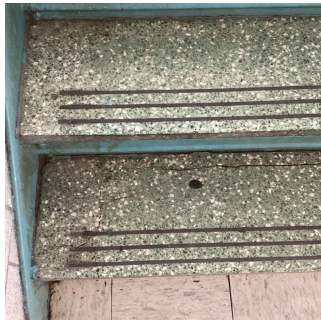
Stair K/Basement
Violations	No violations recorded.
Deficiency	TERRAZZO: CRACKS
Deficiency Location/Instance	Stairs CD/2, GH/1, 2, EF/2, J/1, and others.
Deficiency Quantity	250
Quantity Uom	S.F.
Potential Action	REPLACE
Urgency of Action	PRIORITY 3
Purpose of Action	LEVEL 2
Deficiency Photo1

Stair CD/2
Violations	No violations recorded.
<b>Walls</b>	Inspected
Condition	2 - Between Good and Fair
Deficiency	GLAZED BLOCK: CRACKS/SPALLING
Deficiency Location/Instance	Stairs CD/1, EF/1, 2, GH/3, K/1, and others.
Deficiency Quantity	100
Quantity Uom	S.F.
Potential Action	REPLACE
Urgency of Action	PRIORITY 3

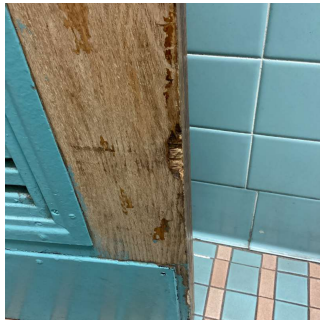
Violations	Room 151 No violations recorded.
Deficiency	WOOD: DETERIORATED DOOR
Deficiency Location/Instance	Rooms 133B, 259, 260A, 301A, 325, and others.
Deficiency Quantity	10
Quantity Uom	EACH
Potential Action	MAINTENANCE
Urgency of Action	PRIORITY 3
Purpose of Action	LEVEL 2
Deficiency Photo1

Violations	Room 325 No violations recorded.
<b>Floor Finish</b>	Inspected
Condition	3 - Fair
Deficiency	CERAMIC TILE: BROKEN/MISSING TILES
Deficiency Location/Instance	Rooms 154F, 259, 260A, 303, 325, and others.
Deficiency Quantity	40
Quantity Uom	S.F.
Potential Action	REPLACE
Urgency of Action	PRIORITY 3
Purpose of Action	LEVEL 2
Deficiency Photo1

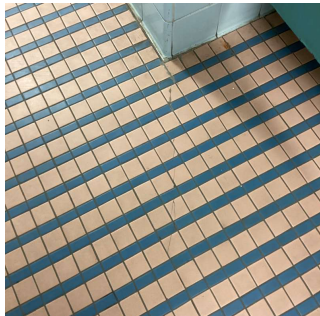
Question	Response
<b>INTERIOR</b>	
<b>TOILET ROOMS - STAFF</b>	
<b>Floor Finish</b>	Inspected
	Room 260A
Violations	No violations recorded.
<b>Stalls</b>	Inspected
Condition	5 - Poor
Deficiency	RUST - MAJOR
Deficiency Location/Instance	Rooms 165, 260A, 231, 301A, Kitchen - Mens
Deficiency Quantity	5
Quantity Uom	EACH
Potential Action	REPLACE
Urgency of Action	PRIORITY 3
Purpose of Action	LEVEL 2
Deficiency Photo1

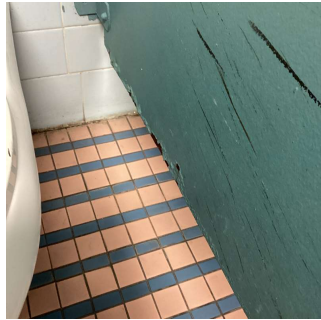
Room 260A
Violations	No violations recorded.
<b>Walls</b>	Inspected
Condition	2 - Between Good and Fair
Deficiency	GYPSUM BOARD: DETERIORATED
Deficiency Location/Instance	Room 182
Deficiency Quantity	10
Quantity Uom	S.F.
Potential Action	REPLACE
Urgency of Action	PRIORITY 3
Purpose of Action	LEVEL 2
Deficiency Photo1

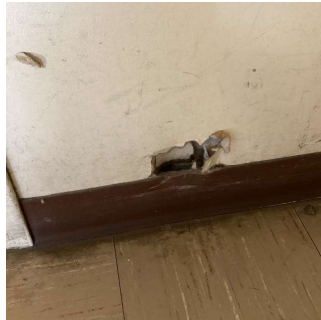
Room 182
Violations	No violations recorded.
Deficiency	PLASTER: CRACKS/SPALLING
Deficiency Location/Instance	Rooms 154D, 151, 172, 303, 325, and others.
Deficiency Quantity	50
Quantity Uom	S.F.

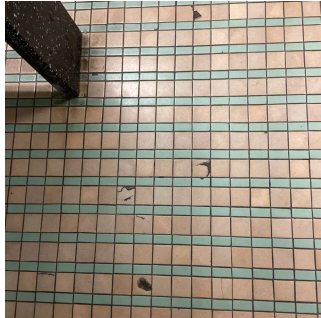
Question	Response
<b>INTERIOR</b>	
<b>TOILET ROOMS - STUDENTS</b>	
<b>Door(s)</b>	Inspected
	Room 118
Violations	No violations recorded.
<b>Floor Finish</b>	Inspected
Condition	2 - Between Good and Fair
Deficiency	CERAMIC TILE: BROKEN/MISSING TILES
Deficiency Location/Instance	Rooms 161, 170, 216, 218,
Deficiency Quantity	40
Quantity Uom	S.F.
Potential Action	REPLACE
Urgency of Action	PRIORITY 3
Purpose of Action	LEVEL 2
Deficiency Photo1

Room 161
Violations	No violations recorded.
<b>Stalls</b>	Inspected
Condition	3 - Fair
Deficiency	BROKEN/MISSING
Deficiency Location/Instance	Rooms 218, 314
Deficiency Quantity	2
Quantity Uom	EACH
Potential Action	REPLACE
Urgency of Action	PRIORITY 3
Purpose of Action	LEVEL 2
Deficiency Photo1

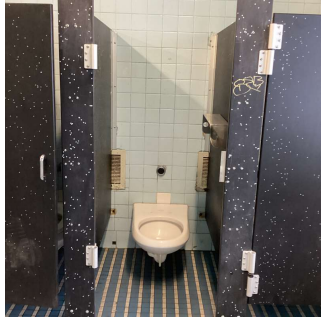
Room 218
Violations	No violations recorded.
<b>Walls</b>	Inspected
Condition	2 - Between Good and Fair
Deficiency	PLASTER: CRACKS/SPALLING
Deficiency Location/Instance	Rooms 118, 120, 216, 218, 325

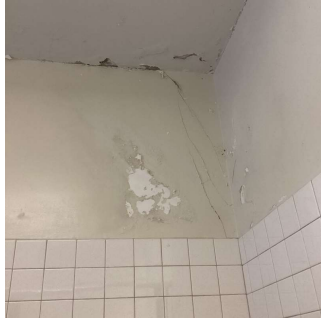
Room 118
Violations	No violations recorded.
Deficiency	CERAMIC TILE: BROKEN/ MISSING
Deficiency Location/Instance	Rooms 120, 170, 216, 218, 161, and others.
Deficiency Quantity	50
Quantity Uom	S.F.
Potential Action	REPLACE
Urgency of Action	PRIORITY 3
Purpose of Action	LEVEL 2
Deficiency Photo1

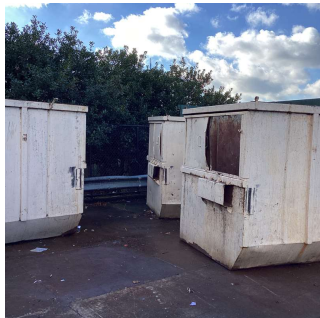
Question	Response
<b>SITE</b>	
<b>CONTAINERIZATION</b>	
Deficiency Photo1	 
Violations	Parking Lot - Booth Memorial Side No violations recorded.
Deficiency	CONTAINER DAMAGED
Deficiency Location/Instance	Parking Lot - Booth Memorial Side
Deficiency Quantity	6
Quantity Uom	EACH
Potential Action	REPLACE
Urgency of Action	PRIORITY 3
Purpose of Action	LEVEL 2
Deficiency Photo1

Violations	Parking Lot - Booth Memorial Side No violations recorded.
<b>Drainage System for Asphalt</b>	Inspected
<b>Catch Basins/Manhole - Surrounded by asphalt</b>	Inspected
Condition	2 - Between Good and Fair
Deficiency	No deficiencies recorded
<b>Culverts - Asphalt Covering</b>	Does not Exist
<b>Drainage System for Concrete</b>	Inspected
<b>Catch Basins/Manhole - Surrounded by concrete</b>	Inspected
Condition	2 - Between Good and Fair
Deficiency	No deficiencies recorded
<b>Culverts - Concrete Covering</b>	Does not Exist
<b>Drainage System for Soil</b>	Inspected

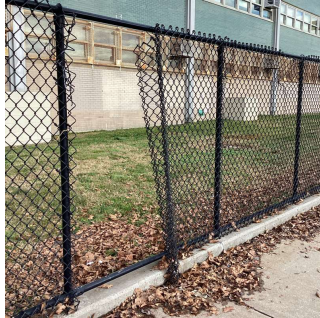
Question	Response
<b>SITE</b>	
<b>FENCES</b>	
Deficiency	CHAIN LINK: DAMAGED/DETERIORATED
Deficiency Location/Instance	59th Avenue, Booth Memorial Avenue
Deficiency Quantity	200
Quantity Uom	S.F.
Potential Action	REPLACE
Urgency of Action	PRIORITY 3
Purpose of Action	LEVEL 2
Deficiency Photo1

Violations	59th Avenue No violations recorded.
Deficiency	WROUGHT IRON: DAMAGED/DETERIORATED
Deficiency Location/Instance	Utopia Parkway, 59th Avenue
Deficiency Quantity	360
Quantity Uom	S.F.
Potential Action	REPLACE
Urgency of Action	PRIORITY 3
Purpose of Action	LEVEL 2
Deficiency Photo1

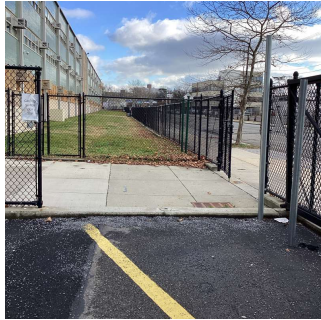
Violations	Utopia Parkway No violations recorded.
Deficiency	CHAIN LINK: MISSING SECTIONS
Deficiency Location/Instance	Parking Lot
Deficiency Quantity	100
Quantity Uom	S.F.
Potential Action	REPLACE
Urgency of Action	PRIORITY 3
Purpose of Action	LEVEL 2

Violations	Parking Lot No violations recorded.
Deficiency	CONCRETE CURB: DAMAGED/DETERIORATED
Deficiency Location/Instance	Utopia Parkway, 59th Avenue, Booth Memorial.
Deficiency Quantity	180
Quantity Uom	S.F.
Potential Action	REPLACE
Urgency of Action	PRIORITY 3
Purpose of Action	LEVEL 2
Deficiency Photo1	 
Violations	Utopia Parkway No violations recorded.
<b>IRRIGATION SYSTEM</b>	Does not Exist
<b>PAVING</b>	Inspected
<b>Student Non-Use</b>	Inspected
Gravel Exists?	No
<b>Asphalt</b>	Inspected
Condition	3 - Fair
Deficiency	CRACKS - MAJOR
Deficiency Location/Instance	Parking Lot
Deficiency Quantity	300
Quantity Uom	S.F.
Potential Action	REPLACE
Urgency of Action	PRIORITY 3
Purpose of Action	LEVEL 2

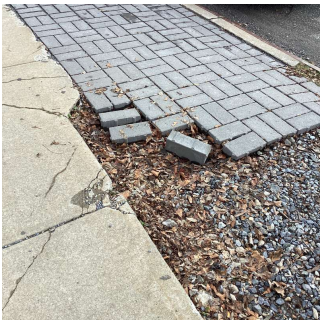
Question	Response
<b>SITE</b>	
<b>PAVING</b>	Inspected
<b>DOT Sidewalk</b>	
<b>Pavers</b>	
Deficiency Photo1

Violations	59th Avenue No violations recorded.
<b>PLAYGROUNDS</b>	Does not Exist
<b>PLAYING SURFACE</b>	Does not Exist
<b>RETAINING WALLS</b>	Does not Exist
<b>SEATING</b>	Inspected
<b>Benches</b>	Inspected
<b>Concrete</b>	Does not Exist
<b>Metal/Wood/Plastic</b>	Inspected
Condition	2 - Between Good and Fair
Deficiency	No deficiencies recorded
<b>Bleachers</b>	Does not Exist
<b>SITE WALLS (NOT RETAINING WALLS)</b>	Does not Exist
<b>STAIRS/RAMPS: EXTERIOR</b>	Does not Exist
<b>ARTWORK</b>	Does not Exist
