NYC Department of Education
Building Condition Assessment Survey 2023 - 2024

Architectural Inspection

Asset: P.S. 16 (OLD Q721 SPED) - QUEENS, 41-15 104 STREET, New York, 11368

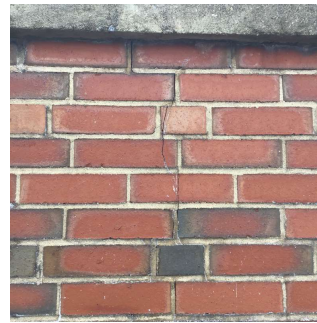
CH

BRICK: MINOR CRACKS AND SPALLING

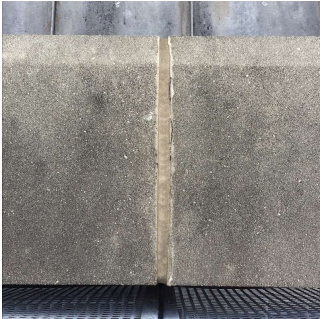
Violations	Roof 1 No violations recorded.
Deficiency	CAST STONE: DETERIORATED TRANSVERSE JOINTS
Roof Plan reference

Deficiency Quantity	50
Quantity Uom	L.F.
Potential Action	MAINTENANCE
Urgency of Action	PRIORITY 3
Purpose of Action	LEVEL 2
Deficiency Photo1

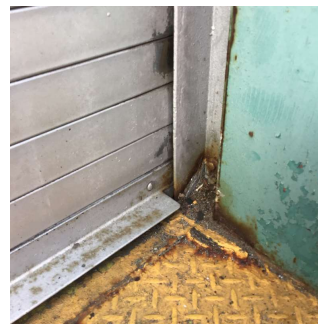
Facade G

Violations	Roof 1 No violations recorded.
CORNICE	Inspected
Condition	2 - Between Good and Fair
Deficiency	No deficiencies recorded
DOORS	Inspected
DOORS AND FRAMES	Inspected
Condition	5 - Poor
Deficiency	ROLL-UP DOOR: DETERIORATED DOOR AND FRAME - MINOR DETERIORATION

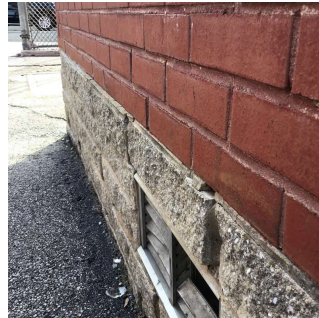
Question	Response
EXTERIOR	
EXTERIOR WALLS	Inspected
Material Type(s)	Masonry
Replacement Quantity	60,000
Replacement Uom	S.F.
Instance on All Facades	Inspected
Instance Condition	3 - Fair
Instance Quantity	60,000
Instance Quantity Uom	S.F.
Deficiency	BRICK: MINOR BULGING
Roof Plan reference

Deficiency Quantity	20
Quantity Uom	S.F.
Potential Action	REMOVE AND REBUILD
Urgency of Action	PRIORITY 3
Purpose of Action	LEVEL 2
Deficiency Photo1

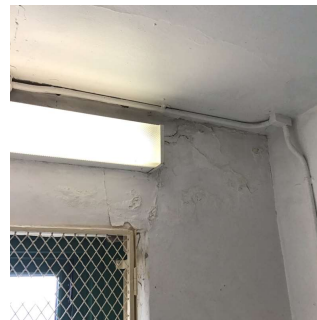
Facade H - Stair B/2 (Facade A - Room 321, Facade J - Library, Room 314 similar)

Violations	Facade C No violations recorded.
Deficiency	BRICK: WATER INFILTRATION IN INSTRUCTIONAL SPACE

REPAIR

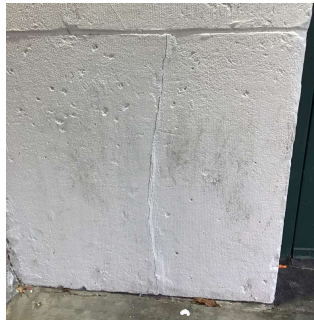
Facade C

STONE: CHIPPED/SPALLED/BROKEN PIECES - MINOR

REPAIR

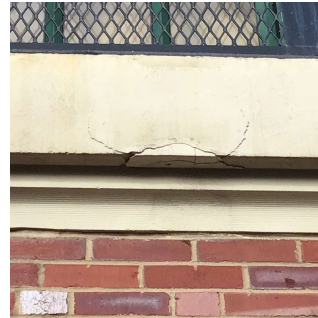
Facade F

TERRA COTTA: CHIPPED/SPALLED/BROKEN PIECES - MAJOR

REPLACE

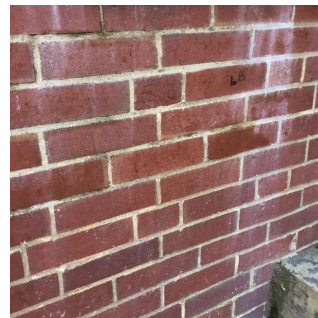
Facade G

BRICK: EFFLORESCENCE

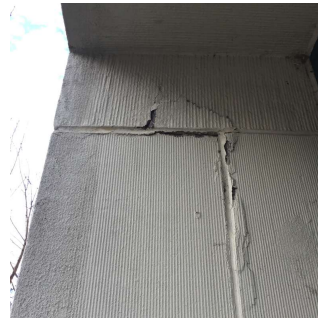
Facade H

STONE: DETERIORATED JOINTS

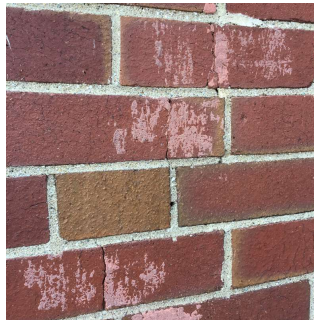
Facade G

BRICK: MINOR CRACKS AND SPALLING

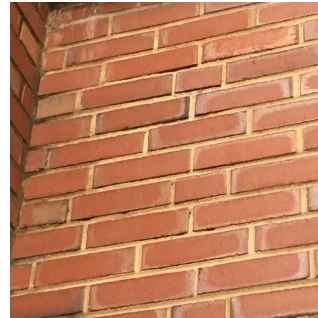
Facade G

BRICK: DETERIORATED JOINTS

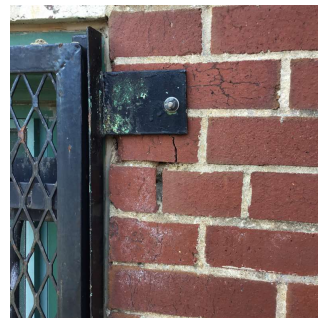
Facade G

BRICK: MAJOR / THRU CRACKS

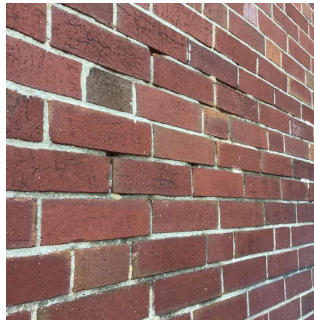
Facade G

BRICK: CRACKS/DISPLACED/SPALLED BRICK AT BUILDING CORNERS

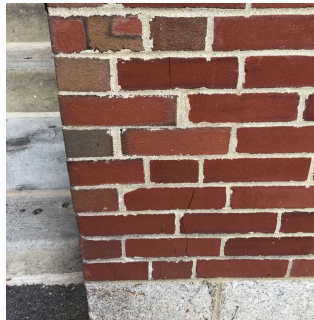
Facade F

CONCRETE: MINOR CRACKS/SPALLING

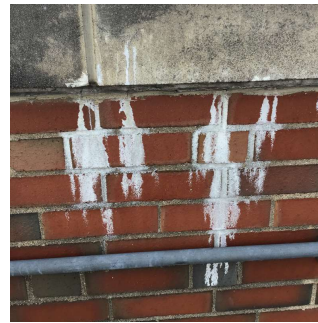
Roof 1

BRICK: MINOR CRACKS, SPALLING

REPAIR

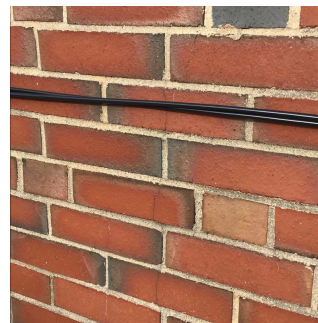
Roof 5

BRICK: DETERIORATED JOINTS

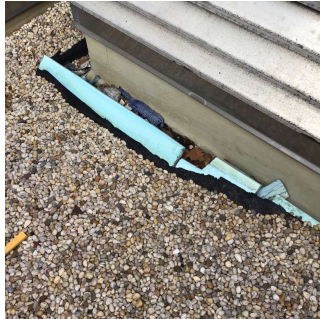
Roof 6
Violations	No violations recorded.
Instance on Single Ply, Mechanically Fastened Roof: Roofs 7 - 8	Inspected
Instance Condition	5 - Poor
Instance Photo

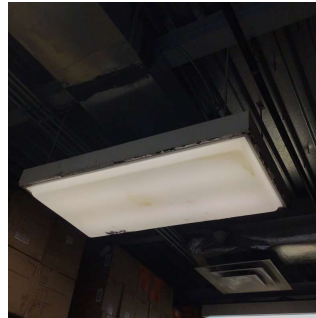
Roof 7 - Room A207

SINGLE PLY, MECHANICALLY FASTENED ROOF: ROOFING: MAJOR ACTIVE ROOF LEAKS IN INSTRUCTIONAL SPACE

REPLACE ROOFING WITHOUT MAJOR EQUIPMENT REMOVAL

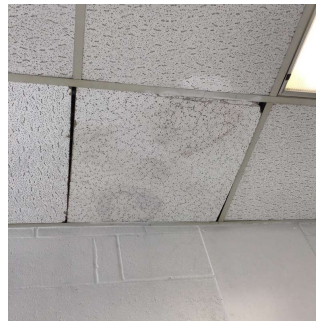
Roof 7 - Corridor near Room A207 (Roof 7 - Rooms A105, A105A, A202, A204, A205, A208, A208A, A209, Corridor near Rooms A203, A209, A210, Roof 8 - Corridor near Exit 5 similar)

DETERIORATED

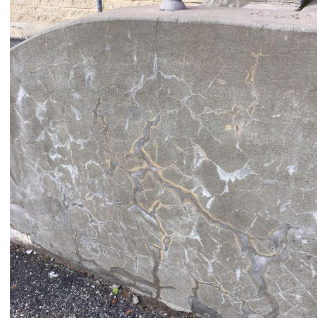
Facade D

CAST IN PLACE CONCRETE: DETERIORATED JOINTS AT COPING STONES

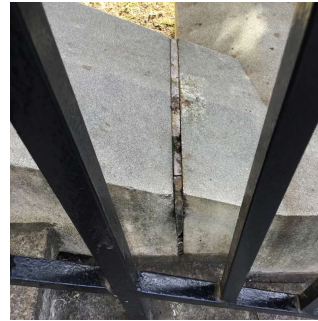
Facade A

CAST IN PLACE CONCRETE: CRACKS/SPALLING - MAJOR

REPLACE

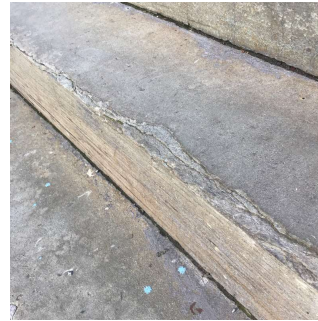
Facade G - Exit 10

STONE: DETERIORATED JOINTS

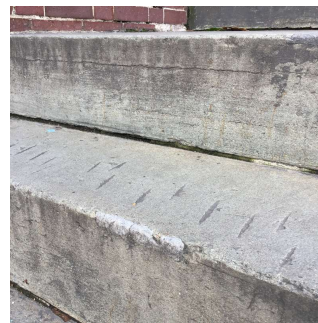
Facade G - Exit 10

STONE: CRACKS/SPALLING - MAJOR

REPLACE

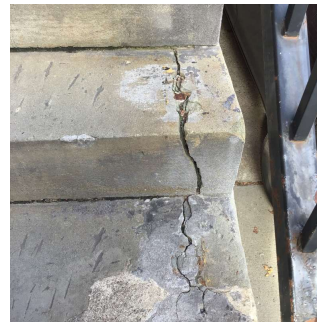
Facade G - Exit 10

CONCRETE: CRACKS/SPALLING - MAJOR

REPLACE

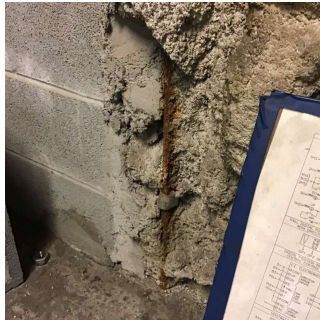
Violations	Roof 5 - EMR No violations recorded.
Deficiency	STEEL COLUMNS/BEAMS: DETERIORATED CONCRETE FIREPROOFING
Deficiency Location/Instance	Fuel Oil Tank Room, Mechanical Room 010, Electrical Panel Room, Emergency Generator Room 022, Boiler Room
Deficiency Quantity	60
Quantity Uom	S.F.
Potential Action	REPLACE
Urgency of Action	PRIORITY 4
Purpose of Action	LEVEL 5
Deficiency Photo1

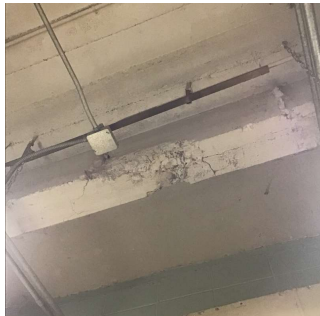
Question	Response
INTERIOR	
STRUCTURAL	
COLUMNS/BEAMS/BEARING WALLS	Inspected
	Electrical Panel Room
Violations	No violations recorded.
FLOOR STRUCTURE	Inspected
Condition	3 - Fair
Deficiency	CINDER CONCRETE FLAT SLAB: CRACKED/SPALLED/REINFORCEMENT EXPOSED
Deficiency Location/Instance	Electrical Panel Room
Deficiency Quantity	40
Quantity Uom	S.F.
Potential Action	REPAIR
Urgency of Action	PRIORITY 4
Purpose of Action	LEVEL 5
Deficiency Photo1

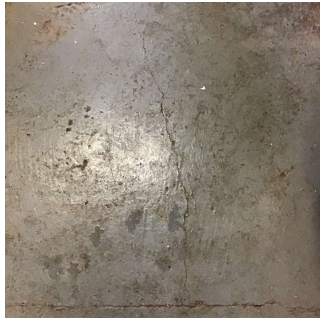
Electrical Panel Room
Violations	No violations recorded.
Deficiency	CONCRETE SLAB ON GRADE: THRU CRACKS
Deficiency Location/Instance	Electrical Panel Room, Boiler Room, Gas Meter Room, Chiller Room
Deficiency Quantity	60
Quantity Uom	S.F.
Potential Action	REPAIR
Urgency of Action	PRIORITY 3
Purpose of Action	LEVEL 5
Deficiency Photo1

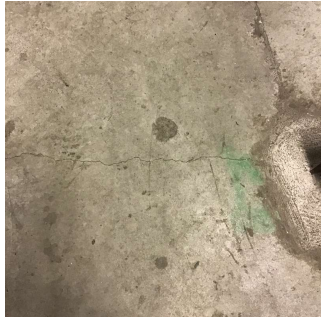
Boiler Room
Violations	No violations recorded.
Deficiency	CONCRETE: CRACKS/SPALLED/REINFORCEMENT EXPOSED
Deficiency Location/Instance	Roof 5 - EMR

Deficiency Quantity	20
Quantity Uom	S.F.
Potential Action	REPAIR
Urgency of Action	PRIORITY 3

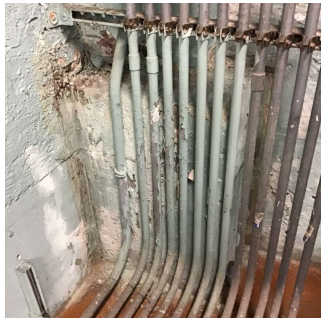
Violations	Roof 5 - EMR No violations recorded.
FOUNDATION WALLS	Inspected
Material Type(s)	Concrete, Masonry
Condition	4 - Between Fair and Poor
Deficiency	BRICK: WATER INFILTRATION IN NON- INSTRUCTIONAL SPACE
Deficiency Location/Instance	Mechanical Room 010
Deficiency Quantity	100
Quantity Uom	S.F.
Potential Action	INSTALL WATERPROOFING
Urgency of Action	PRIORITY 5
Purpose of Action	LEVEL 5
Deficiency Photo1

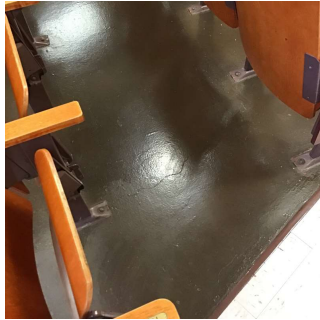
Near Seat H/1
Violations	No violations recorded.
Deficiency	VINYL TILES: BROKEN/DETERIORATED/MISSING TILES
Deficiency Location/Instance	Rear Near Windows, near Stage
Deficiency Quantity	10
Quantity Uom	S.F.
Potential Action	REPLACE
Urgency of Action	PRIORITY 3
Purpose of Action	LEVEL 2

Seat G/17
Violations	No violations recorded.
Floor Finish	
Instance on 1st Floor (400 Seats)	Inspected
Condition	2 - Between Good and Fair
Deficiency	CONCRETE: CRACKS
Deficiency Location/Instance	Near Seats E/1, F/1, G/1, H/1, J/1 and others
Deficiency Quantity	60
Quantity Uom	S.F.
Potential Action	REPLACE
Urgency of Action	PRIORITY 3
Purpose of Action	LEVEL 2
Deficiency Photo1

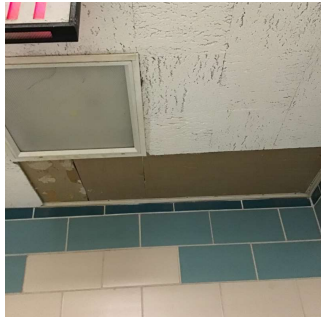
Question	Response
INTERIOR	
CAFETERIA	
Ceiling	
Purpose of Action	LEVEL 2
Deficiency Photo1

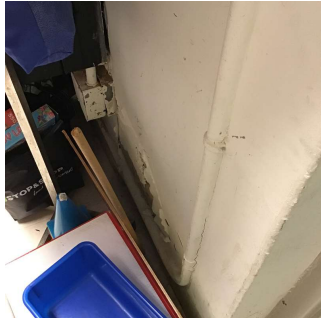
Question	Response
INTERIOR	
CAFETERIA	
Walls	
Deficiency	PLASTER: CRACKS/SPALLING
Deficiency Location/Instance	Storage Room
Deficiency Quantity	10
Quantity Uom	S.F.
Potential Action	REPLACE
Urgency of Action	PRIORITY 3
Purpose of Action	LEVEL 2
Deficiency Photo1

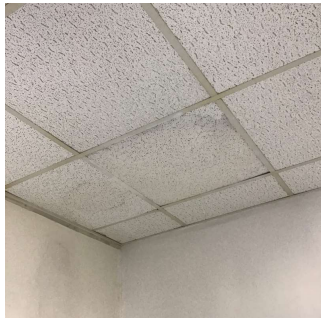
Corridor Near Exit 5
Violations	35560948H
Deficiency	ACOUSTIC TILES: DAMAGED/MISSING
Deficiency Location/Instance	Corridor near Rooms 408, 127, A110, 101, 008 and others

Storage Room
Violations	No violations recorded.
Window Curtains/Shades/Blinds	
Instance on Basement	Does not Exist
CLASSROOMS/CORRIDORS/ADMIN SPACES	
Ceiling	
Condition	Inspected
	2 - Between Good and Fair
Deficiency	ACOUSTIC TILES: DAMAGED/MISSING - ACTIVE LEAK
Deficiency Location/Instance	Rooms A202, A204, A205, A208, A209, Corridor near Rooms A203, A207, A209, A210, Corridor near Exit 5
Deficiency Quantity	300
Quantity Uom	S.F.
Potential Action	REPLACE
Urgency of Action	PRIORITY 5
Purpose of Action	LEVEL 4
Deficiency Photo1

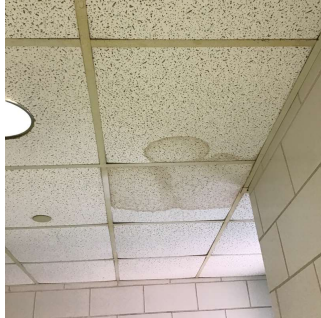
Deficiency Quantity	150
Quantity Uom	S.F.
Potential Action	REPLACE

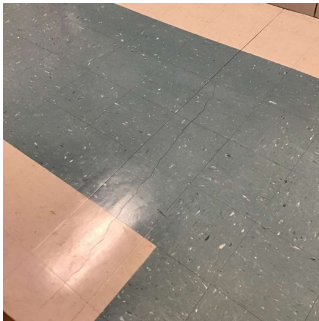
Room 306
Violations	No violations recorded.
Floor Finish	Inspected
Condition	2 - Between Good and Fair
Deficiency	VINYL TILES: DETERIORATED SUBSTRATE
Deficiency Location/Instance	Corridor near Rooms A211, A207, A202, 124, 117 and others
Deficiency Quantity	700
Quantity Uom	S.F.
Potential Action	REPLACE
Urgency of Action	PRIORITY 3
Purpose of Action	LEVEL 2

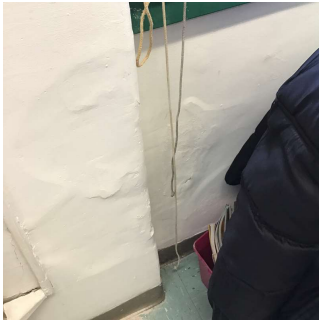
Violations	Corridor near Room 124 No violations recorded.
Walls	Inspected
Condition	2 - Between Good and Fair
Deficiency	PLASTER: CRACKS/SPALLING - ACTIVE LEAK
Deficiency Location/Instance	Rooms 321, 314
Deficiency Quantity	40
Quantity Uom	S.F.
Potential Action	REPLACE
Urgency of Action	PRIORITY 5
Purpose of Action	LEVEL 2
Deficiency Photo1

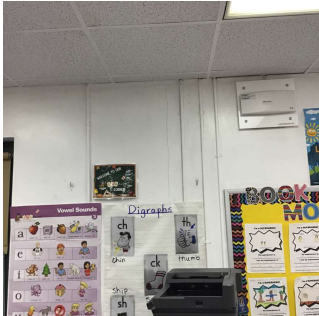
Violations	Room 321 No violations recorded.
Deficiency	GYPSUM BOARD: DETERIORATED
Deficiency Location/Instance	Rooms A205, A108, 108, A105,
Deficiency Quantity	80
Quantity Uom	S.F.
Potential Action	REPLACE
Urgency of Action	PRIORITY 3
Purpose of Action	LEVEL 2
Deficiency Photo1

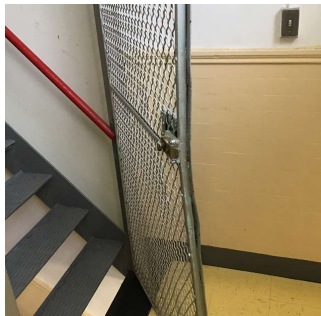
Violations	Office No violations recorded.
Window Curtains/Shades/Blinds	
Instance on 4th Floor	Does not Exist
INTERIOR DOOR HARDWARE	
Condition	Inspected
Deficiency	3 - Fair
Deficiency	No deficiencies recorded
INTERIOR GUARDS	
Condition	Inspected
Condition	2 - Between Good and Fair
Deficiency	DETERIORATED/TORN-OUT/MISSING
Deficiency Location/Instance	Stairs A/Bulkhead, B/2
Deficiency Quantity	40
Quantity Uom	S.F.
Potential Action	REPLACE
Urgency of Action	PRIORITY 3
Purpose of Action	LEVEL 2

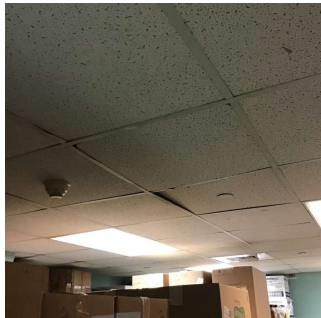
Storage Room	
Violations	No violations recorded.
Door(s)	
Instance on Basement	Inspected
Condition	3 - Fair
Deficiency	METAL: DETERIORATED DOOR

Question	Response
INTERIOR	
INTERIOR GUARDS	
Inspected	Inspected
Stair A/Bulkhead	Stair A/Bulkhead
Violations	No violations recorded.
KITCHEN	
Inspected	Inspected
Instance on Basement	Inspected
Ceiling	
Instance on Basement	Inspected
Condition	2 - Between Good and Fair
Deficiency	METAL PAN: DAMAGED/MISSING
Deficiency Location/Instance	Serving area
Deficiency Quantity	10
Quantity Uom	S.F.
Potential Action	REPLACE
Urgency of Action	PRIORITY 3
Purpose of Action	LEVEL 2
Deficiency Photo1	 
Serving area	
Violations	No violations recorded.
Deficiency	ACOUSTIC TILES: DAMAGED/MISSING
Deficiency Location/Instance	Storage Room
Deficiency Quantity	10
Quantity Uom	S.F.
Potential Action	REPLACE
Urgency of Action	PRIORITY 3
Purpose of Action	LEVEL 2
Deficiency Photo1

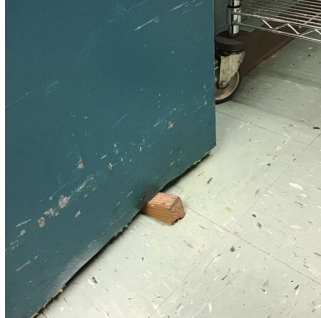
Question	Response
INTERIOR	
KITCHEN	Inspected
Door(s)	
Deficiency Location/Instance	Storage Room
Deficiency Quantity	1
Quantity Uom	EACH
Potential Action	MAINTENANCE
Urgency of Action	PRIORITY 3
Purpose of Action	LEVEL 2
Deficiency Photo1

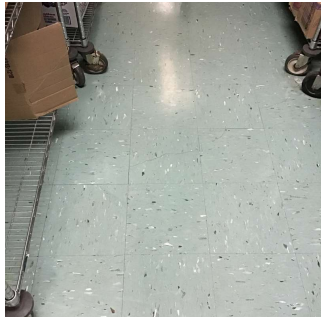
Storage Room
Violations	No violations recorded.
Deficiency	QUARRY TILE: BROKEN/MISSING TILES
Deficiency Location/Instance	Sinks area, Near Stoves, prep area
Deficiency Quantity	20
Quantity Uom	S.F.
Potential Action	REPLACE
Urgency of Action	PRIORITY 3
Purpose of Action	LEVEL 2

Storage Room
Violations	No violations recorded.
Floor Finish	
Instance on Basement	Inspected
Condition	2 - Between Good and Fair
Deficiency	VINYL TILES: BROKEN/DETERIORATED/MISSING TILES
Deficiency Location/Instance	Storage Room
Deficiency Quantity	10
Quantity Uom	S.F.
Potential Action	REPLACE
Urgency of Action	PRIORITY 3
Purpose of Action	LEVEL 2
Deficiency Photo1

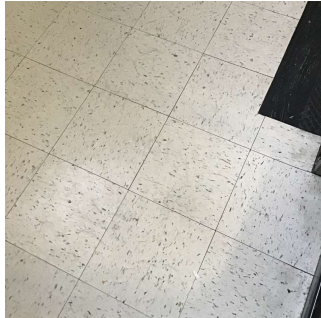
Violations	Stair B/2 No violations recorded.
Deficiency	VINYL TILES: BROKEN/DETERIORATED/MISSING TILES
Deficiency Location/Instance	Stairs A/2, B/1, C/1, I/1, 2 and others
Deficiency Quantity	80
Quantity Uom	S.F.
Potential Action	REPLACE
Urgency of Action	PRIORITY 3
Purpose of Action	LEVEL 2
Deficiency Photo1

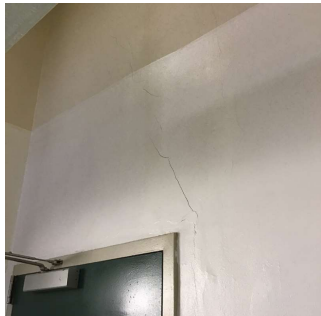
Violations	Stair I/2 No violations recorded.
Walls	Inspected
Condition	2 - Between Good and Fair
Deficiency	PLASTER: CRACKS/SPALLING
Deficiency Location/Instance	Stairs A/4, B/4, C/4, 3
Deficiency Quantity	80
Quantity Uom	S.F.
Potential Action	REPLACE
Urgency of Action	PRIORITY 3
Purpose of Action	LEVEL 2
Deficiency Photo1

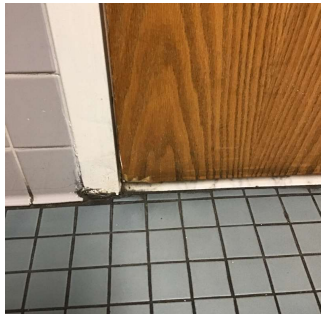
Violations	Room 404 No violations recorded.
Deficiency	WOOD: DETERIORATED DOOR
Deficiency Location/Instance	Rooms 127A, 111A
Deficiency Quantity	2
Quantity Uom	EACH
Potential Action	MAINTENANCE
Urgency of Action	PRIORITY 3
Purpose of Action	LEVEL 2
Deficiency Photo1

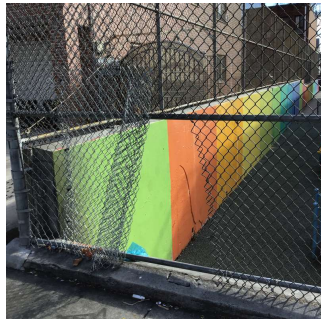
Question	Response
LIFE SAFETY	Inspected
F.D. HOLDING AREA	Does not Exist
STEEL STAIRS	Does not Exist
SITE	Inspected
CONTAINERIZATION	Does not Exist
Drainage System for Asphalt	Inspected
Catch Basins/Manhole - Surrounded by asphalt	Inspected
Condition	2 - Between Good and Fair
Deficiency	No deficiencies recorded
Culverts - Asphalt Covering	Does not Exist
Drainage System for Concrete	Inspected
Catch Basins/Manhole - Surrounded by concrete	Inspected
Condition	2 - Between Good and Fair
Deficiency	No deficiencies recorded
Culverts - Concrete Covering	Does not Exist
Drainage System for Soil	Inspected
Catch Basins/Manhole - Surrounded by Soil	Inspected
Condition	2 - Between Good and Fair
Deficiency	No deficiencies recorded
Culverts - Soil Covering	Does not Exist
DRINKING FOUNTAINS	Does not Exist
FENCES	Inspected
Condition	3 - Fair
Deficiency	CHAIN LINK: DAMAGED/DETERIORATED
Deficiency Location/Instance	41st Avenue
Deficiency Quantity	50

Quantity Uom	S.F.
Potential Action	REPLACE
Urgency of Action	PRIORITY 5
Purpose of Action	LEVEL 6
Deficiency Photo1

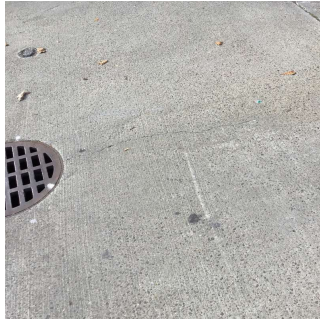
Violations	Near TCUs No violations recorded.
Concrete	Inspected
Condition	3 - Fair
Deficiency	CRACKS - MAJOR
Deficiency Location/Instance	Near Loading dock
Deficiency Quantity	100
Quantity Uom	S.F.
Potential Action	REPLACE
Urgency of Action	PRIORITY 3
Purpose of Action	LEVEL 2
Deficiency Photo1

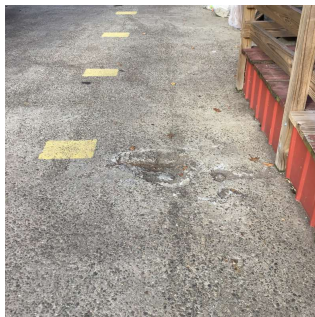
Violations	Near Loading dock No violations recorded.
Deficiency	POTHoles
Deficiency Location/Instance	Near Loading dock
Deficiency Quantity	20
Quantity Uom	S.F.
Potential Action	REPAIR
Urgency of Action	PRIORITY 3
Purpose of Action	LEVEL 2

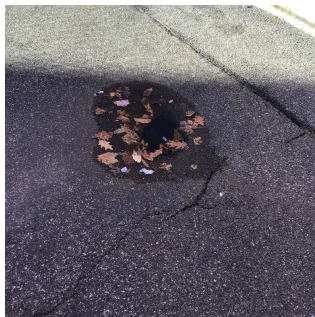
Violations	Near Loading dock No violations recorded.
Pavers	Does not Exist
Student Use	Inspected
Gravel Exists?	No
Asphalt	Inspected
Condition	4 - Between Fair and Poor
Deficiency	POTHOLE
Deficiency Location/Instance	Near Exit 6
Deficiency Quantity	20
Quantity Uom	S.F.
Potential Action	REPAIR
Urgency of Action	PRIORITY 3
Purpose of Action	LEVEL 2
Deficiency Photo1

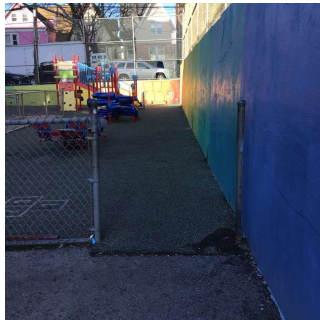
Violations	Near Entrance No violations recorded.
Deficiency	CHAIN LINK: MISSING SECTIONS
Deficiency Location/Instance	Entrance
Deficiency Quantity	50
Quantity Uom	S.F.
Potential Action	REPLACE
Urgency of Action	PRIORITY 3
Purpose of Action	LEVEL 2
Deficiency Photo1

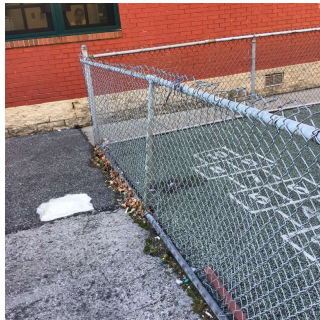
Violations	Entrance No violations recorded.
Deficiency	CHAIN LINK: DAMAGED POST/RAIL
Deficiency Location/Instance	Near Entrance, Left Side, Rear
Deficiency Quantity	30
Quantity Uom	L.F.
Potential Action	REPLACE
Urgency of Action	PRIORITY 3
Purpose of Action	LEVEL 2
Deficiency Photo1

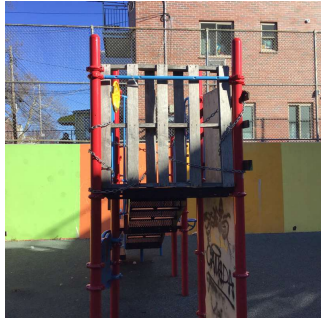
Question	Response
SITE	
PLAYGROUNDS	
Pavement	
Instance on 41st Avenue	Does not Exist
Play Equipment	
Instance on 41st Avenue	Inspected
Condition	5 - Poor
Deficiency	BROKEN/DETERIORATED/MISSING
Deficiency Location/Instance	Play Tower
Deficiency Quantity	1
Quantity Uom	EACH
Potential Action	REPLACE
Urgency of Action	PRIORITY 5
Purpose of Action	LEVEL 6
Deficiency Photo1

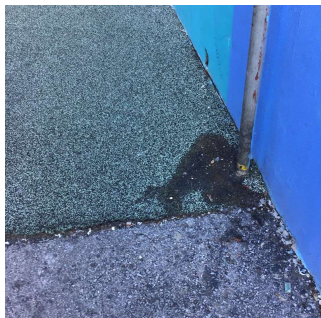
Violations	Play Tower No violations recorded.
Safety Surfacing	
Instance on 41st Avenue	Inspected
Condition	3 - Fair
Deficiency	DETERIORATED/MISSING
Deficiency Location/Instance	Near Entrance, Left and Right Side Center, Rear
Deficiency Quantity	80
Quantity Uom	S.F.
Potential Action	REPLACE
Urgency of Action	PRIORITY 3
Purpose of Action	LEVEL 2
Deficiency Photo1

Violations	Near Entrance No violations recorded.
Unpaved Area	
Instance on 41st Avenue	Does not Exist
PLAYING SURFACE	Does not Exist
RETAINING WALLS	Inspected

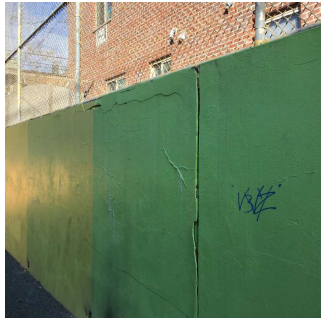
Question	Response
SITE	
RETAINING WALLS	
Are there any Retaining Walls 6' OR higher facing public street/sidewalk?	Yes
Condition	4 - Between Fair and Poor
Deficiency	CAST IN PLACE CONCRETE: BULGING/DISPLACED
Deficiency Location/Instance	Rear Near Playground, Inside Playground
Deficiency Quantity	80
Quantity Uom	S.F.
Potential Action	REPLACE
Urgency of Action	PRIORITY 5
Purpose of Action	LEVEL 6
Deficiency Photo1

Violations	Inside Playground No violations recorded.
Deficiency	CAST IN PLACE CONCRETE: CRACKS/SPALLING - MAJOR
Deficiency Location/Instance	42nd Avenue, 41st Avenue, Near Playground
Deficiency Quantity	450
Quantity Uom	S.F.
Potential Action	REPLACE
Urgency of Action	PRIORITY 3
Purpose of Action	LEVEL 2
Deficiency Photo1

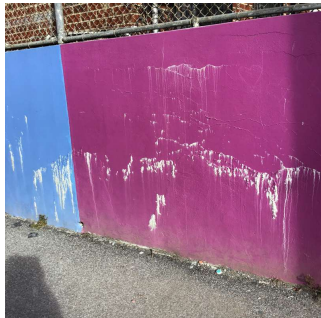
Violations	42nd Avenue No violations recorded.
SEATING	Does not Exist
SITE WALLS (NOT RETAINING WALLS)	Does not Exist
STAIRS/RAMPS: EXTERIOR	Inspected
Railings	Inspected
Condition	2 - Between Good and Fair
