NYC Department of Education
Building Condition Assessment Survey 2023 - 2024

Architectural Inspection

K874

Asset: I.S. 340 (OLD 249 AX) - BROOKLYN, 227 STERLING PLACE, New York, 11238

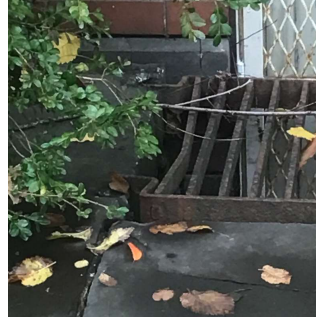
AW9

Question	Response
Architectural	
EXTERIOR	Inspected
AREAWAY	Inspected
Instance on AW1 - AW12	Inspected
Instance Condition	3 - Fair
Instance Quantity	12
Instance Quantity Uom	EACH
Deficiency	AREAWAY GRATINGS: MAJOR RUSTING / OR BROKEN
Roof Plan reference	
Deficiency Quantity	20
Quantity Uom	S.F.
Potential Action	REPLACE

PRIORITY 4
LEVEL 2

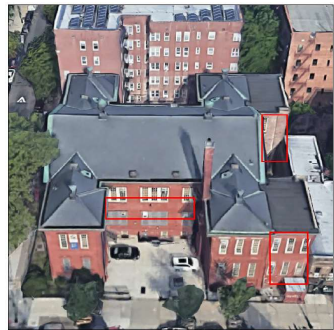
Facade A - Main Entrance
Violations	No violations recorded.
EXTERIOR WALLS	
Material Type(s)	Inspected Masonry
Replacement Quantity	18,000
Replacement Uom	S.F.
Instance on All Facades	Inspected
Instance Condition	4 - Between Fair and Poor
Instance Quantity	18,000
Instance Quantity Uom	S.F.
Deficiency	BRICK: EFFLORESCENCE
Roof Plan reference

Deficiency Quantity	500
Quantity Uom	S.F.
Potential Action	MAINTENANCE
Urgency of Action	PRIORITY 1
Purpose of Action	LEVEL 1

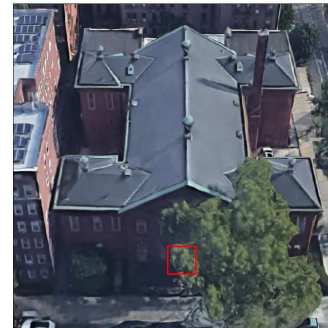
STONE: CHIPPED/SPALLED/BROKEN PIECES - MAJOR

40

REPLACE

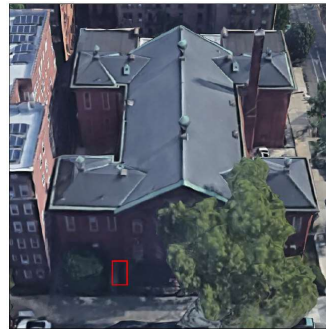
BRICK: DETERIORATED JOINTS

20

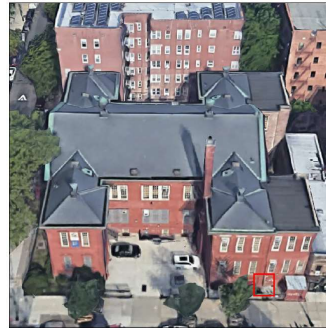
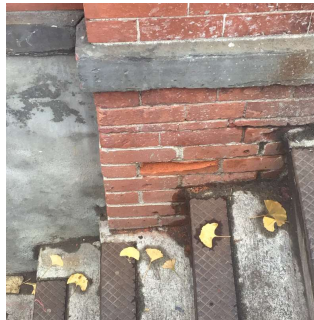
Facade M

BRICK: MAJOR / THRU CRACKS

10

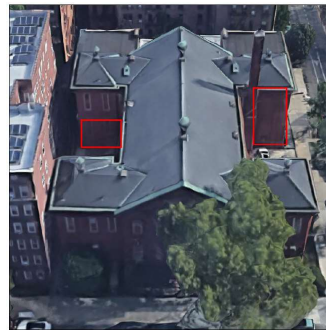
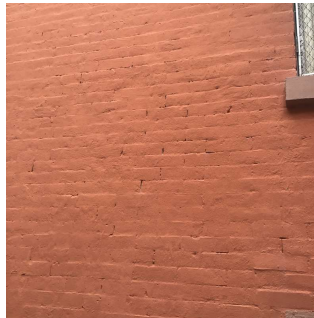
Facade E

BRICK: DETERIORATED JOINTS

400

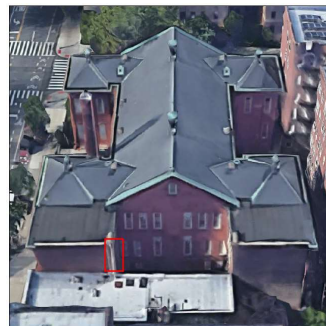
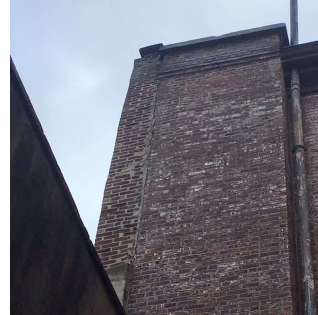
Facade K

BRICK: DETERIORATED CONTROL/EXPANSION JOINTS

30

MAINTENANCE
PRIORITY 3
LEVEL 2

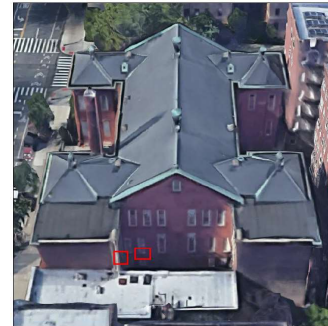
BRICK: DETERIORATED MASONRY SILLS - MINOR

40
L.F.
REPAIR
PRIORITY 3
LEVEL 2

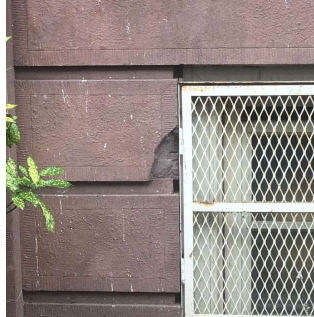
Facade A

STONE: CHIPPED/SPALLED/BROKEN PIECES - MAJOR

REPLACE

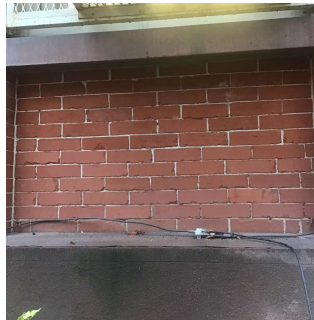
Facade A

BRICK: MINOR CRACKS AND SPALLING

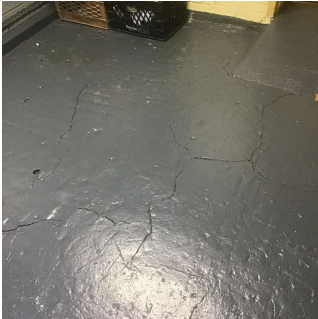
Question	Response
INTERIOR	
STRUCTURAL	
COLUMNS/BEAMS/BEARING WALLS	Inspected
Violations	No violations recorded.
FLOOR STRUCTURE	Inspected
Condition	3 - Fair
Deficiency	CONCRETE SLAB ON GRADE: THRU CRACKS
Deficiency Location/Instance	Basement - Electrical Panel Room
Deficiency Quantity	80
Quantity Uom	S.F.
Potential Action	REPLACE
Urgency of Action	PRIORITY 4
Purpose of Action	LEVEL 5
Deficiency Photo1

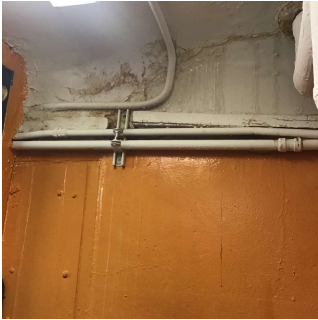
Violations	Basement - Electrical Panel Room No violations recorded.
FOUNDATION WALLS	Inspected
Material Type(s)	Concrete, Masonry
Condition	4 - Between Fair and Poor
Deficiency	BRICK: WATER INFILTRATION IN INSTRUCTIONAL SPACE
Deficiency Location/Instance	Basement - Stair D/Basement
Deficiency Quantity	100
Quantity Uom	S.F.
Potential Action	INSTALL WATERPROOFING
Urgency of Action	PRIORITY 5
Purpose of Action	LEVEL 5
Deficiency Photo1

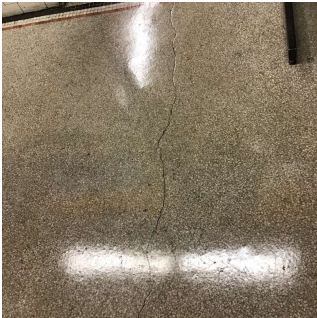
Question	Response
INTERIOR	
CLASSROOMS/CORRIDORS/ADMIN SPACES	
Floor Finish	
Violations	Corridor near Room 115 No violations recorded.
Deficiency	TERRAZZO: CRACKS
Deficiency Location/Instance	Main Entrance Lobby
Deficiency Quantity	20
Quantity Uom	S.F.
Potential Action	REPLACE
Urgency of Action	PRIORITY 3
Purpose of Action	LEVEL 2
Deficiency Photo1

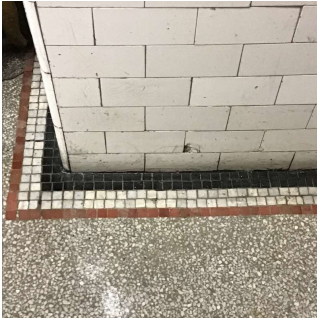
Violations	Main Entrance Lobby No violations recorded.
Walls	Inspected
Condition	2 - Between Good and Fair
Deficiency	CERAMIC TILE: BROKEN/ MISSING
Deficiency Location/Instance	Main Entrance Lobby
Deficiency Quantity	20
Quantity Uom	S.F.
Potential Action	REPLACE
Urgency of Action	PRIORITY 3
Purpose of Action	LEVEL 2
Deficiency Photo1

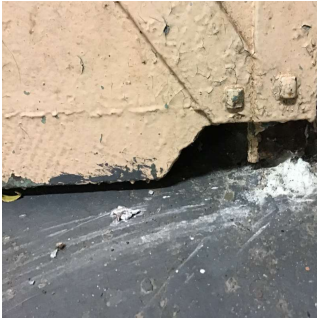
Deficiency Location/Instance	Kitchen locker room

Question	Response
INTERIOR	
KITCHEN	
Door(s)	
Deficiency Quantity	1
Quantity Uom	EACH
Potential Action	MAINTENANCE
Urgency of Action	PRIORITY 3
Purpose of Action	LEVEL 2
Deficiency Photo1

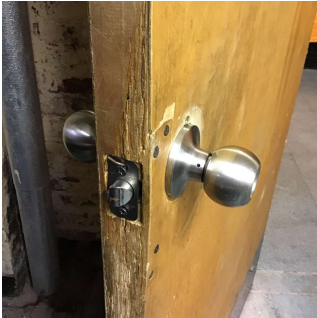
Kitchen locker room
Violations	No violations recorded.
<hr/>	
Deficiency	WOOD: DETERIORATED DOOR
Deficiency Location/Instance	Storage
Deficiency Quantity	1
Quantity Uom	EACH
Potential Action	MAINTENANCE
Urgency of Action	PRIORITY 3
Purpose of Action	LEVEL 2
Deficiency Photo1

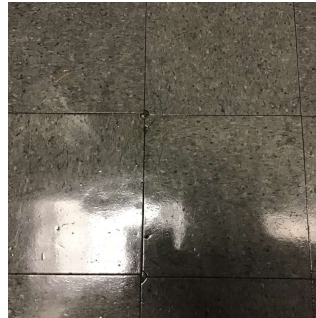
Near servery

Deficiency	VINYL TILES: BROKEN/DETERIORATED/MISSING TILES
Deficiency Location/Instance	Near Servery, center, sink
Deficiency Quantity	20
Quantity Uom	S.F.
Potential Action	REPLACE
Urgency of Action	PRIORITY 3
Purpose of Action	LEVEL 2
Deficiency Photo1

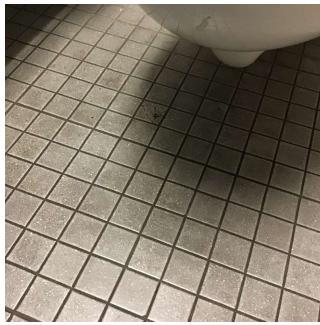
Question	Response
INTERIOR	
TOILET ROOMS - STUDENTS	
Floor Finish	
Deficiency Photo1

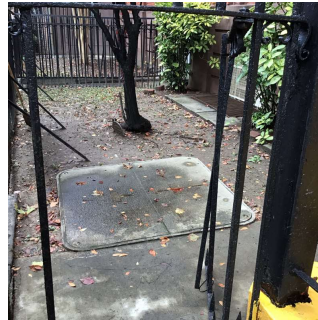
Entrance Along Sterling Street
35663264Z

Deficiency

WROUGHT IRON: MISSING SECTIONS

REPLACE

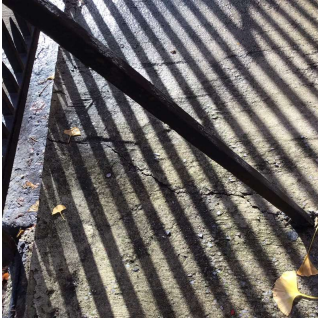
Question	Response
SITE	
PAVING	Inspected
Student Non-Use	Inspected
Gravel Exists?	No
Asphalt	Does not Exist
Concrete	Inspected
Condition	2 - Between Good and Fair
Deficiency	DAMAGED/DETERIORATED/MISSING SECTIONS
Deficiency Location/Instance	Along Vanderbilt Avenue
Deficiency Quantity	25
Quantity Uom	S.F.
Potential Action	REPLACE
Urgency of Action	PRIORITY 3
Purpose of Action	LEVEL 2
Deficiency Photo1

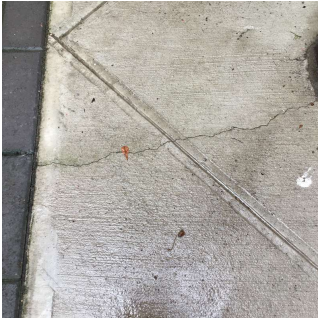
Violations	Courtyard - West No violations recorded.

Violations	Along Vanderbilt Avenue No violations recorded.
Pavers	Does not Exist
Student Use	Inspected
Gravel Exists?	No
Asphalt	Does not Exist
Concrete	Inspected
Condition	3 - Fair
Deficiency	DAMAGED/DETERIORATED/MISSING SECTIONS
Deficiency Location/Instance	Courtyard West, Courtyard along Vanderbilt Avenue
Deficiency Quantity	275
Quantity Uom	S.F.
Potential Action	REPLACE
Urgency of Action	PRIORITY 3
Purpose of Action	LEVEL 2
Deficiency Photo1

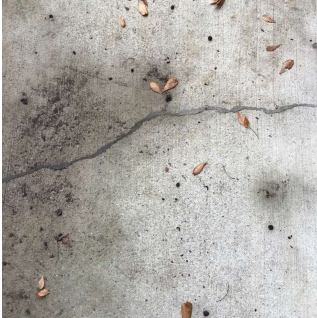
Question	Response
SITE	
PAVING	
Student Use	Inspected
Pavers	Inspected
Condition	2 - Between Good and Fair
Deficiency	No deficiencies recorded
Site Sidewalks & Walkways	Inspected
Asphalt	Does not Exist
Concrete	Inspected
Condition	3 - Fair
Deficiency	DAMAGED/DETERIORATED/MISSING SECTIONS
Deficiency Location/Instance	Near Courtyard West
Deficiency Quantity	75
Quantity Uom	S.F.
Potential Action	REPLACE
Urgency of Action	PRIORITY 3
Purpose of Action	LEVEL 2
Deficiency Photo1

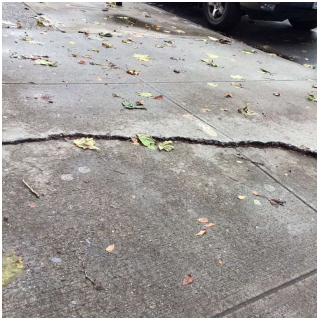
Along Sterling Place

Violations	Near Courtyard West No violations recorded.
Pavers	Does not Exist
DOT Sidewalk	Inspected
Asphalt	Does not Exist
Concrete	Inspected
Condition	4 - Between Fair and Poor
Deficiency	HEAVING
Deficiency Location/Instance	Along Sterling Place, Vanderbilt Avenue
Deficiency Quantity	100
Quantity Uom	S.F.
Potential Action	REPLACE
Urgency of Action	PRIORITY 3
Purpose of Action	LEVEL 2
Deficiency Photo1

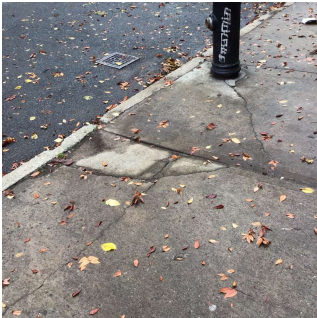
Question	Response
SITE	
PAVING	
DOT Sidewalk	
Concrete	
Violations	No violations recorded.
Deficiency	DAMAGED/DETERIORATED/MISSING SECTIONS
Deficiency Location/Instance	Along Sterling Place, Vanderbilt Avenue
Deficiency Quantity	700
Quantity Uom	S.F.
Potential Action	REPLACE
Urgency of Action	PRIORITY 3
Purpose of Action	LEVEL 2
Deficiency Photo1

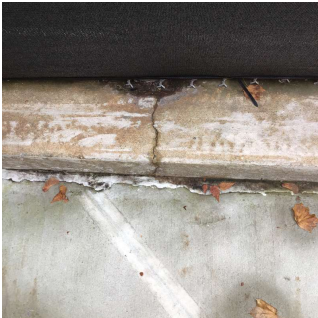
Question	Response
SITE	
PLAYGROUNDS	
Pavement	
Instance on Courtyard North	Inspected
Condition	2 - Between Good and Fair
Deficiency	No deficiencies recorded
Play Equipment	
Instance on Courtyard North	Does not Exist
Safety Surfacing	
Instance on Courtyard North	Inspected
Condition	2 - Between Good and Fair
Deficiency	No deficiencies recorded
Unpaved Area	
Instance on Courtyard North	Does not Exist
PLAYING SURFACE	Inspected
Playing Field	Inspected
Instance on Courtyard West	Inspected
Instance Condition	2 - Between Good and Fair
Deficiency	No deficiencies recorded
Running Track	Does not Exist
RETAINING WALLS	Inspected
Are there any Retaining Walls 6' OR higher facing public street/sidewalk?	No
Condition	2 - Between Good and Fair
Deficiency	CAST IN PLACE CONCRETE: CRACKS/SPALLING - MAJOR
Deficiency Location/Instance	Courtyard West
Deficiency Quantity	10
Quantity Uom	S.F.
Potential Action	REPLACE
Urgency of Action	PRIORITY 3

Purpose of Action	LEVEL 2
Deficiency Photo1
